12/28/1990
DEPARTMENT OF THE AIR FORCE
HEADQUARTERS 27TH COMBAT SUPPORT GROUP (TAC)
CANNON AIR FORCE BASE NM 88103

RE: Compliance Order/Schedule, Docket Number 901002
Cannon Air Force Base, NM7572124454

Construction Deviations in Closure of Landfill 5, Cell 3

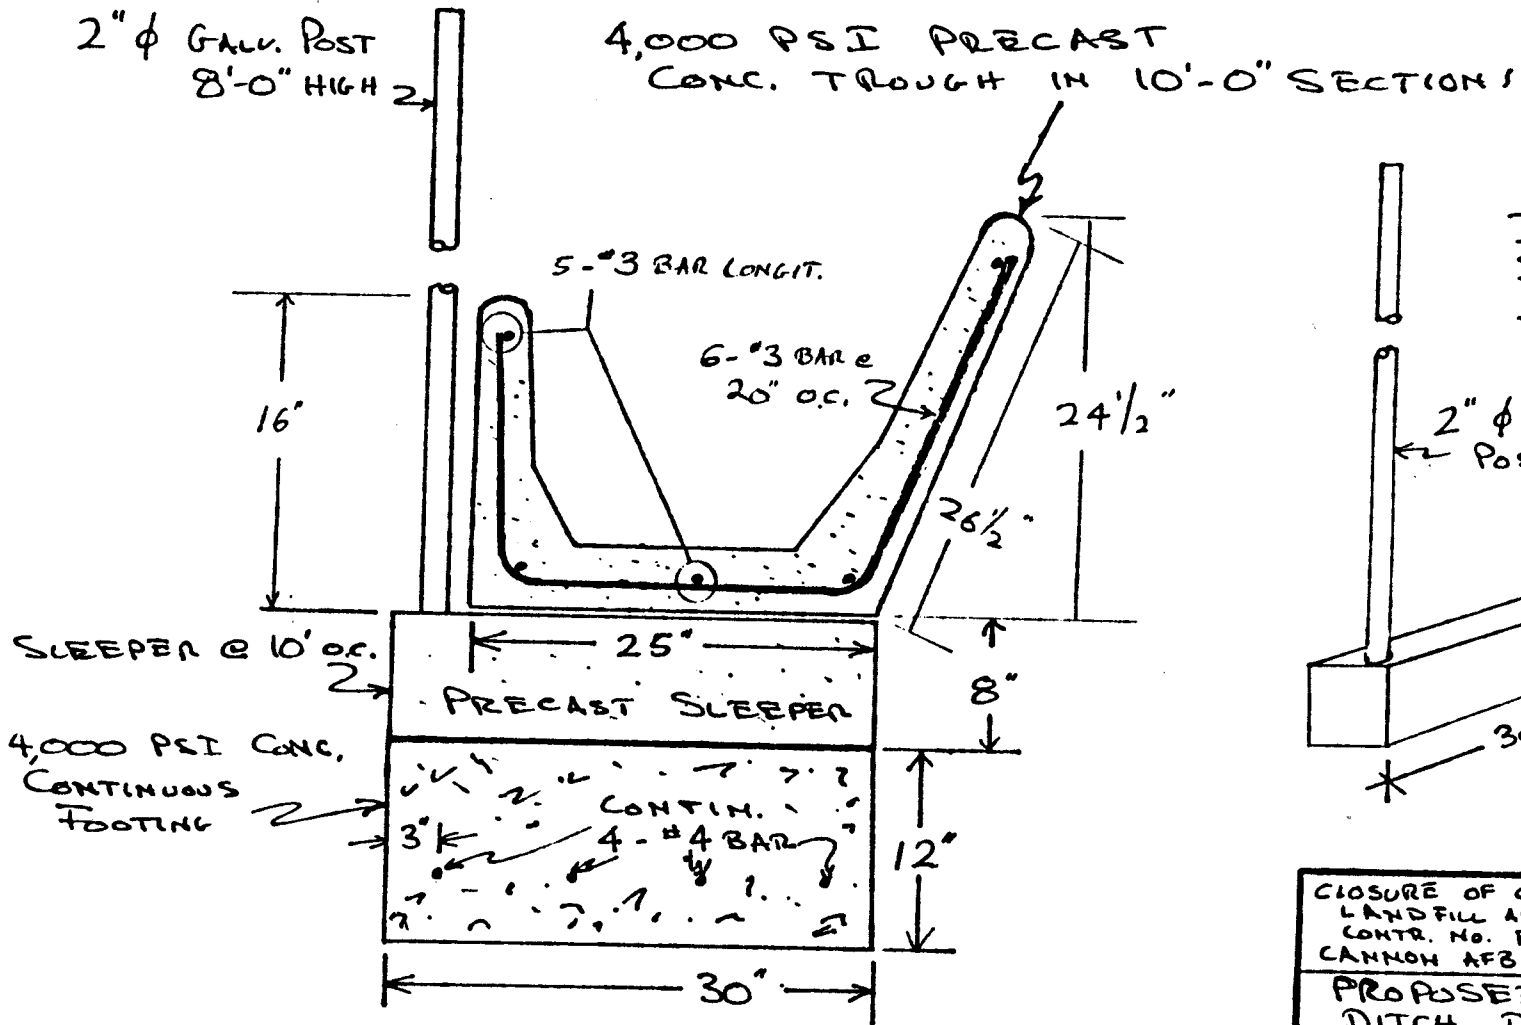
FIGURE 1

1. The fence post footings were installed in an eight-inch thick precast sleeper as illustrated in Figure 1. Section 3.2.1 on page 2E-2 of the Cannon Air Force Base Closure of Cell No. 3 of Landfill 5 - Designs and Specifications (Specs) document noted that the posts were to be anchored as shown in the construction drawings. Sheet 4 of the drawings indicates that the footing dimensions were to be 12x12x18 inches. The footings were originally designed assuming that the landfill material was buried 24 inches below the ground surface (Specs, Section 2B, Item 2, p. 2B-7); the footings were re-designed because landfill material was encountered 6 inches below the ground surface.

3. The dimensions of the precast gutter drain (Figure 1) differ from the dimensions shown on Sheet 5 of the construction drawings. A commercially available precast gutter drain was used per Item 2.1.1 of Section 2C on page 2C-1 of the Specs. The revised gutter drain drawings were sent to the EID prior to the installation of the gutter drain.

4. The gutter drain was constructed with continuous wire reinforcement in lieu of the welded wire fabric called for in Item 2.1.2 of Section 2C on page 2C-1 of the Specs. The gutter drain was constructed with locally available precast troughs that were available only with continuous reinforcement wire.

At that point we elected to use the available pre-cast trough units from the local supplier rather than re-design the drain trough. This did require us to re-design the footing, but that was simple enough for us to quickly handle.

3. The third difference, mentioned above, was the installation of differently shaped drain trough components. The footing was installed as a continuous, continuously reinforced with concrete reinforcing bars in lieu of welded wire fabric, concrete structure, one foot thick to provide a stable base for the drain trough units. The footing is able to bridge any weak soil pockets which may develop, as often happens along the edges of landfill cells. The footing is also able to resist lateral earth pressures from the call cap. This feature was enhanced by the added sloped fill we installed at the outboard side of the drain trough.
