**CLOSEOUT REPORT / CONTAMINATION ASSESSMENT  
SWMU 129 - FACILITY 244  
ABOVEGROUND TANK STORAGE AREA  
CANNON AIR FORCE BASE  
CLOVIS, NEW MEXICO**

**July 19, 2000**

**Submitted by:  
Parallax, Inc.  
20201 Century Blvd  
Germantown, MD 20874**

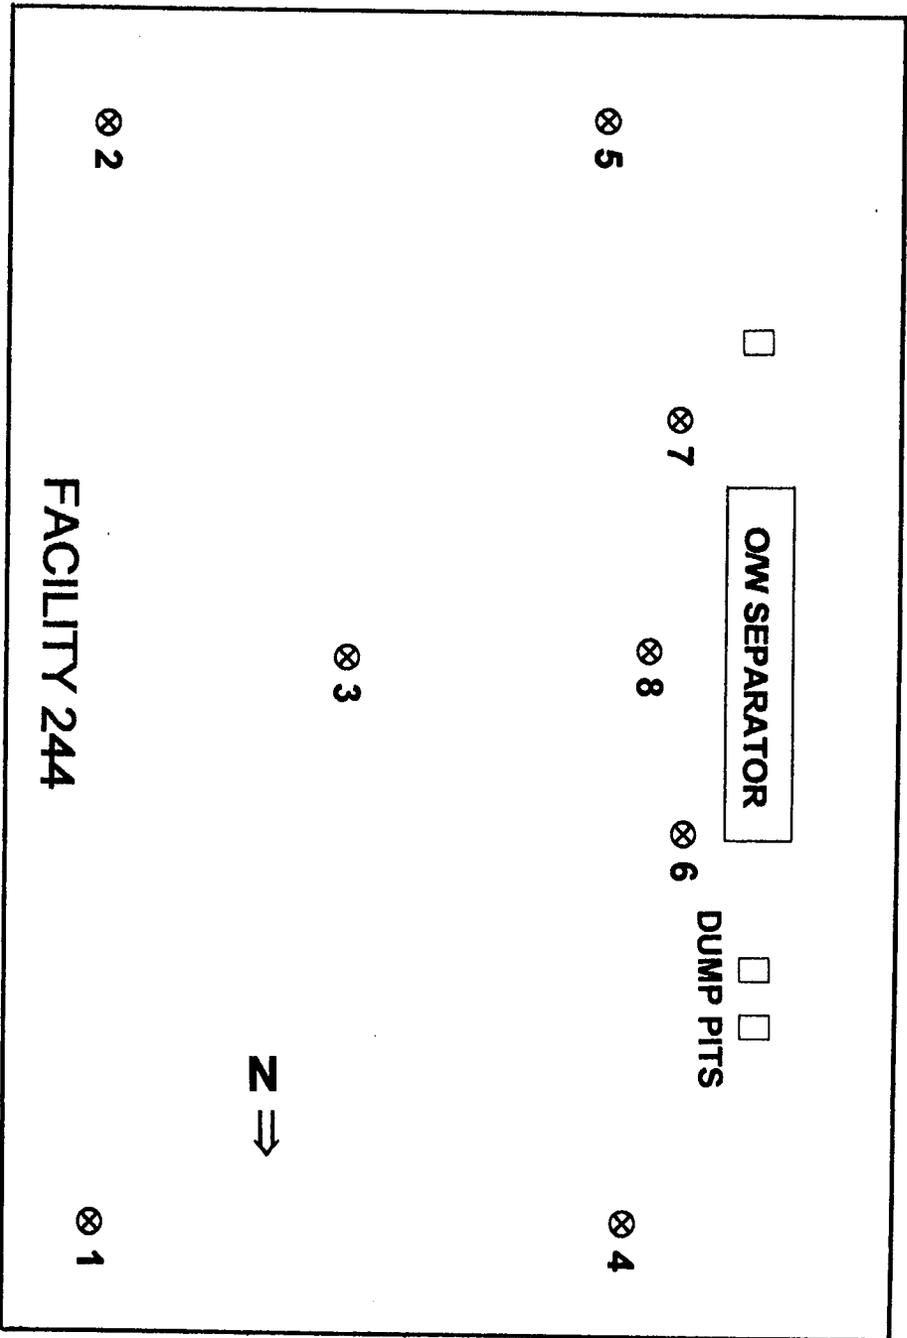
Figure 4-2: Plan View of Facility 244 Showing Soil Sampling Locations.

Eight sampling locations were selected to represent the entire surface of the Facility 244 soils. Figure 4-2 is a plan view of the Facility showing sampling locations. When the samples were collected, an error was made in interpreting the geographic orientation of Facility 244. The front fence segment, containing the gates, was recorded as facing north. Instead, the proper orientation was west; therefore, all sample location notations will be rotated 90 degrees clock-wise (e.g., a sample point originally recorded as the southeast corner is actually the northeast corner). The former and corrected sample locations, and ID numbers are presented in the following table:

- Sample 8:** East of mid-line of O/W separator vault - 5 feet south of north end of O/W separator vault; 5 feet, 6 inches east of east wall of vault. Depth - surface of excavation (3-foot, 6-inch deep pit). Time: 1445 MST.

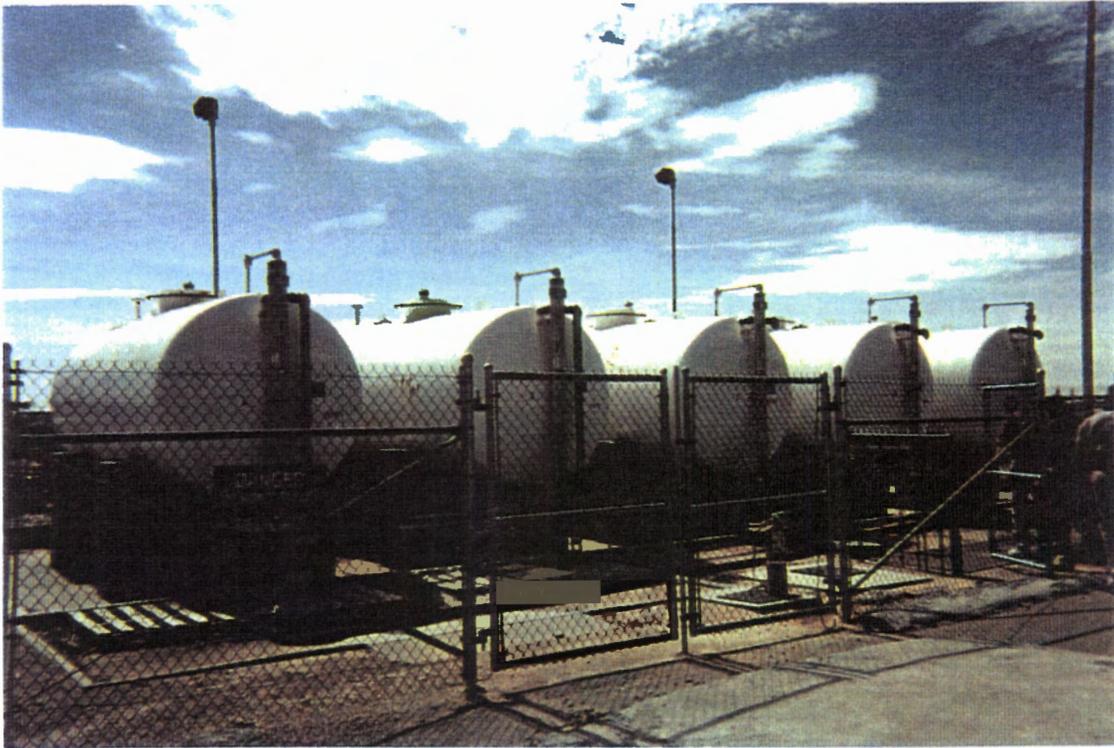
**Photograph 1:** View of Facility 244 Prior to Start of Dismantling Operations Showing Tank Locations and Fencing.

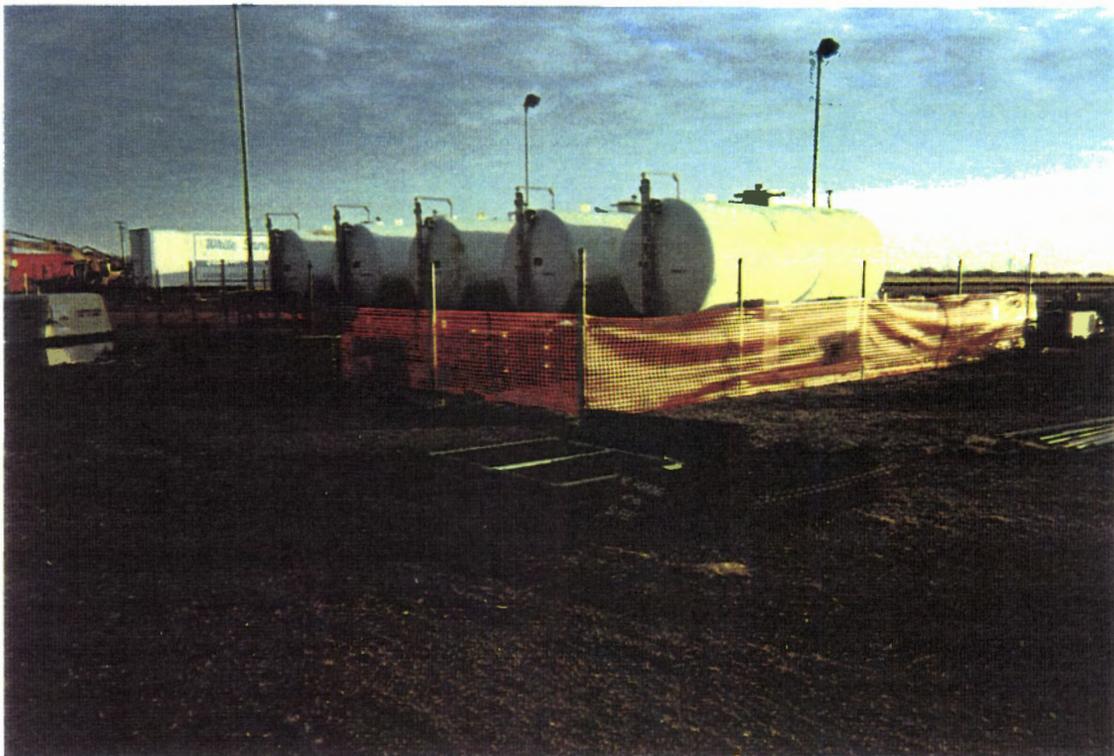
Facility 244 consisted of five 5,000-gallon aboveground storage tanks supported on reinforced concrete saddles. The tanks were surrounded by a 30-foot x 50-foot (approximate) concrete containment pad. A 9-inch retaining curb, designed to contain liquids released in the event of an accidental release or ruptured tank, surrounded the containment area. Photograph 1 is a view of Facility 244 prior to start of the removal action (tanks, saddles, and chain-link fence are intact). Photograph 2 is a view of the Facility with the fence fabric removed and temporary orange security webbing in place.

**Photograph 2:** Alternate View of the Facility with Fence Fabric Removed and Orange Safety Webbing Stretched.

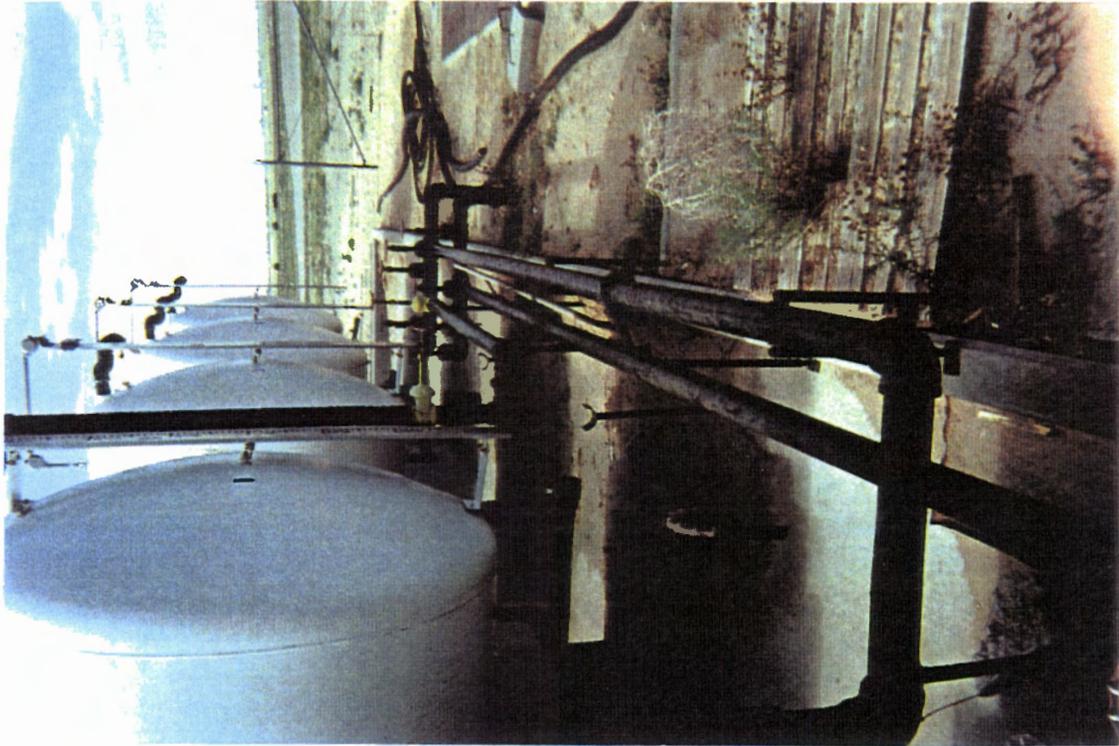
The storage tanks were filled through a network of supply pipes entering the tops of the tanks (Photograph 3 shows the distribution piping and valves). These pipes, controlled by manual gate valves, were connected to a central O/W separator located in the north end of the containment pad. Bulk waste oil was brought to Facility 244 and dumped into adjacent collection pits equipped with strainers. From the pits the oil drained into the O/W separator and was then pumped into the appropriate storage tanks. The water fraction, segregated by the O/W separator, exited through a port in the west-side of the structure.

**Photograph 3:** Associated Distribution Piping and Manual Valves.

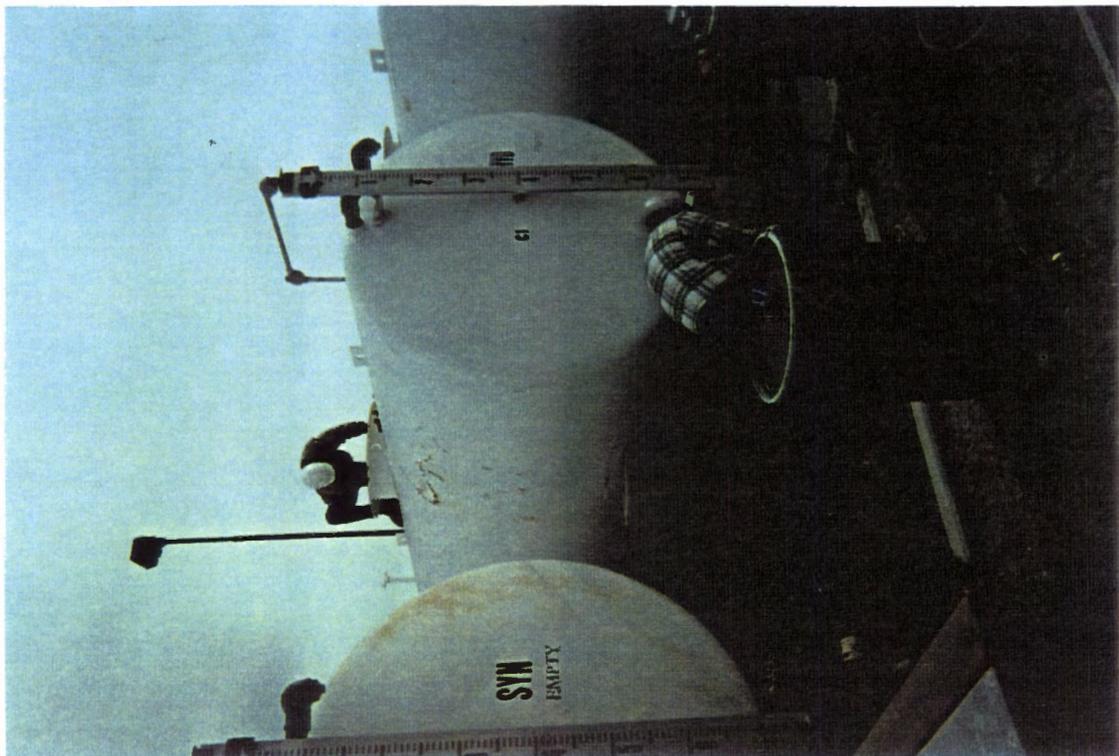
**Photograph 4:** Omegasys Personnel Pressure Washing Interior Surfaces of Tank and Using Drain Valve to Remove Sludges and Rinse Water.

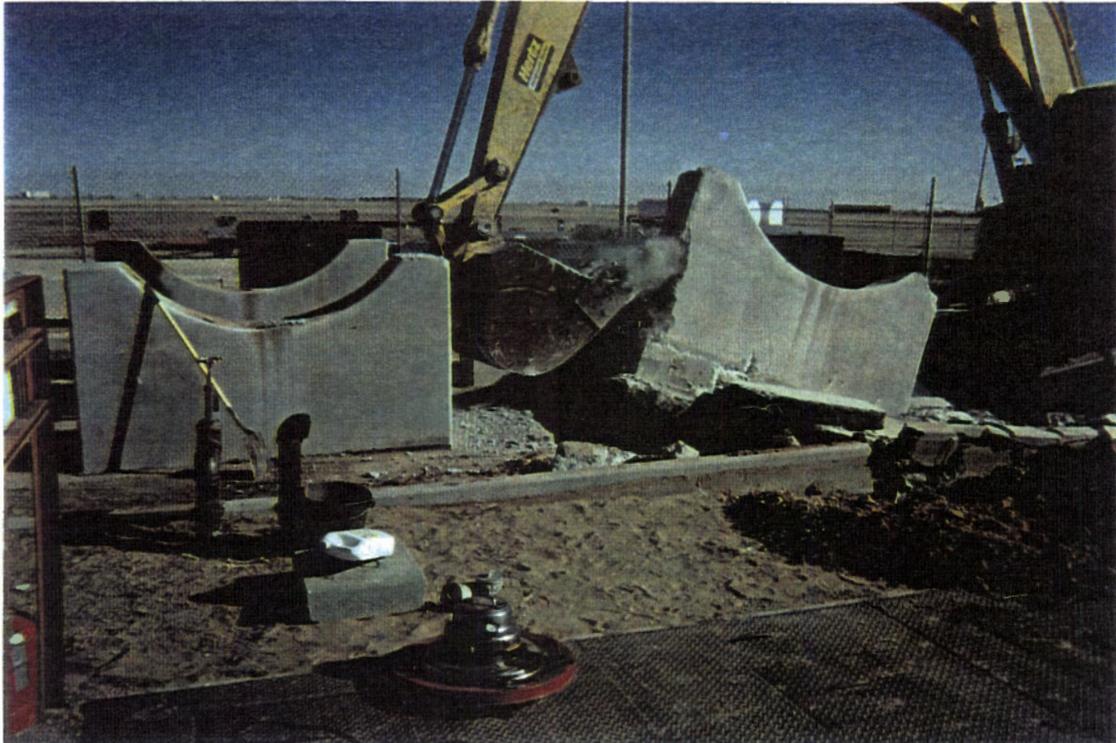
After dismantling the tanks, demolition began with removal of the concrete support saddles. There were two saddles per tank. Each support contained approximately one cubic yard of concrete. Saddles were dislodged by placing the trackhoe bucket on one end and lifting upward and backward. Photograph 5 shows a saddle being lifted from its foundation. Removal of the structures was hampered by the containment pad that surrounded each support, and the fact that the saddles had spread footings. The adjacent concrete had to be crushed so that each footing could be removed.

**Photograph 5:** Removal of Tank Support Saddle with Trackhoe Bucket.

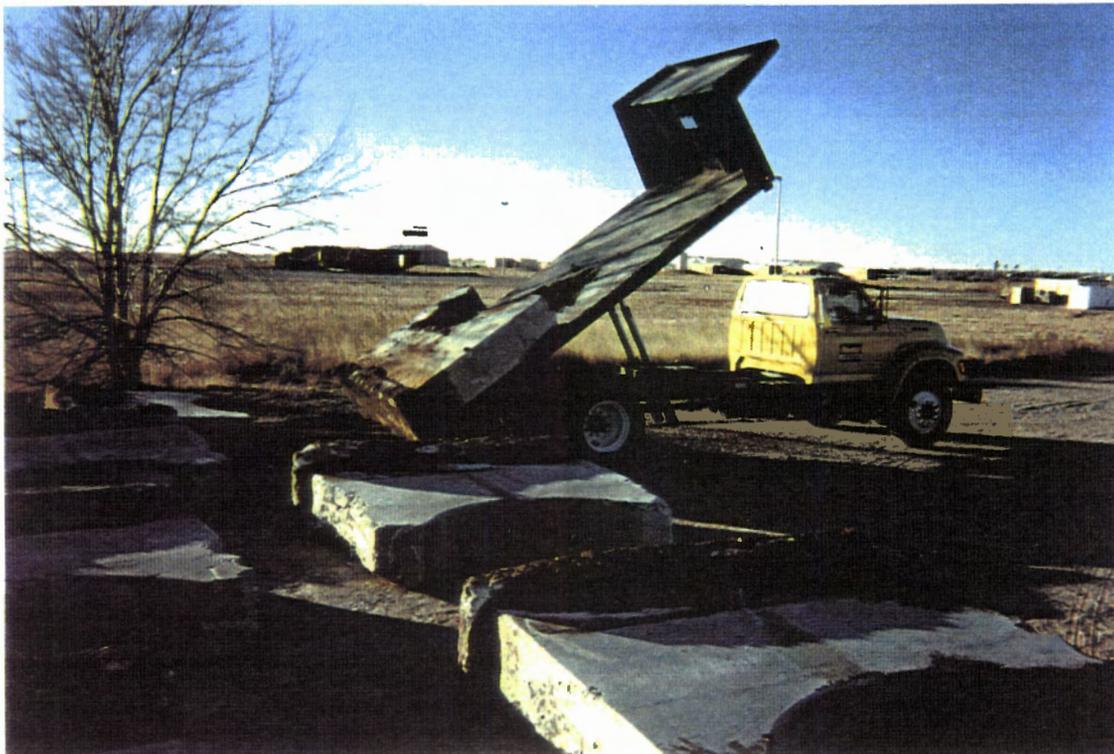
The saddles were generally removed intact, loaded directly onto the dump truck, and transported to the construction rubble storage area. Photograph 6 shows saddles stockpiled at the designated storage area. After removal of the saddles, the remaining portions of the containment pad and retaining curb were broken into manageable pieces by dropping the trackhoe bucket onto the concrete surface or lifting the edge of the pad until cracks developed (Photograph 7). Number 3 reinforcing steel rods were embedded in the pad and curb structures, but were readily snapped by creating tension with the trackhoe. The resulting construction debris was also transported to the rubble staging area. After removal of the O/W separator, the concrete vaults and dump pits were removed and transported to the storage area. Photograph 8 is a view of the exposed soil surface at Facility 244 after removal of the concrete containment pad and curb.

**Photograph 6:** Stockpiling Concrete Support Saddles at the Designated Staging Area.

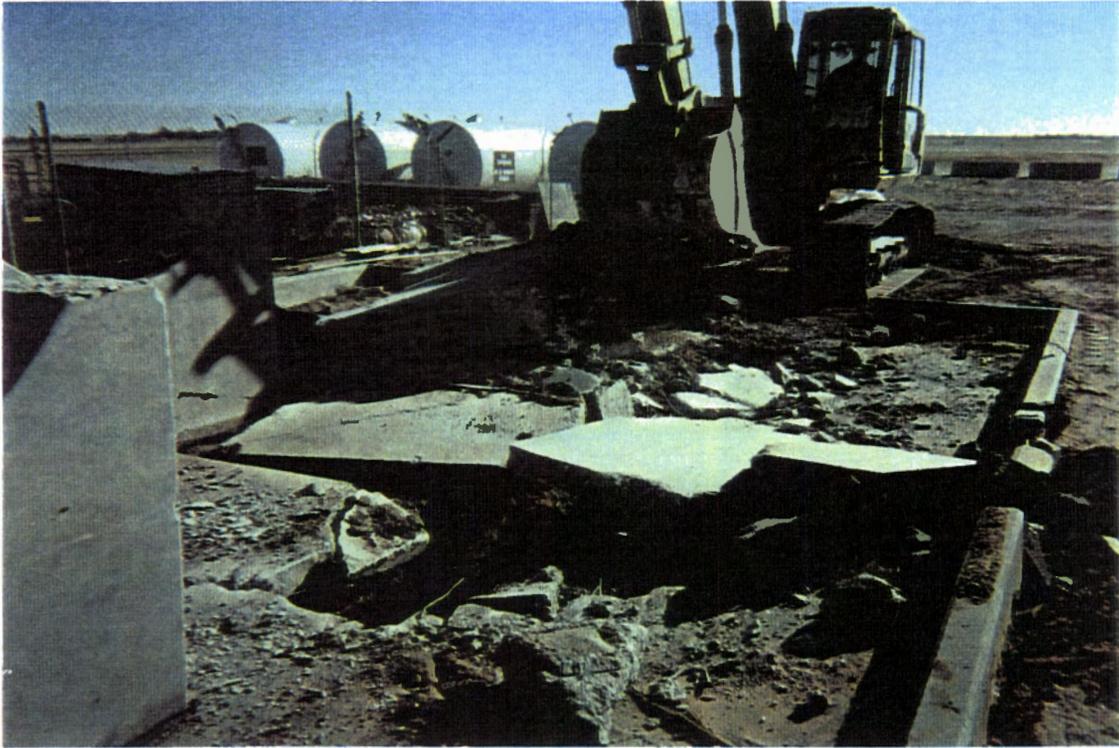
**Photograph 7:** Removal of Remaining Portions of the Concrete Containment Pad and Retaining Curb.

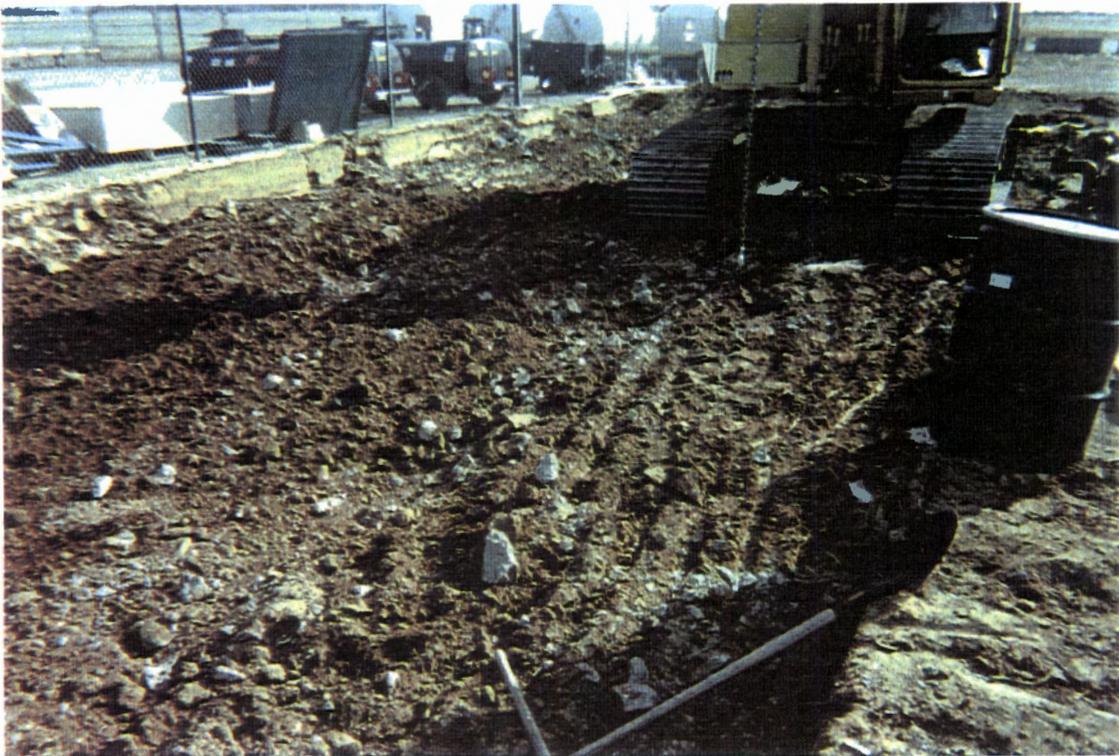
After removal of the overlying containment pad and appurtenances, the field geologist inspected the underlying exposed soils to determine the indication of petroleum hydrocarbon contamination. The soils were visually examined for the presence of discoloration due to petroleum staining or characteristic odors. No staining or odors were detected. The ambient atmospheres directly above the ground surfaces in areas most likely to exhibit contamination (e.g., soils under the O/W separator, dump pits, and areas surrounding the outside of the retaining curbs) were monitored for volatile organic vapors by the SHSO using a PID and Draeger® contaminant-specific (benzene) colorimetric tubes. None of these instrumentation surveys indicated concentrations of volatile hydrocarbon contaminants exceeding USEPA risk-based concentrations (RBCs).

**Photograph 8:** View of Soil Surface after Removal of the Containment Pad.

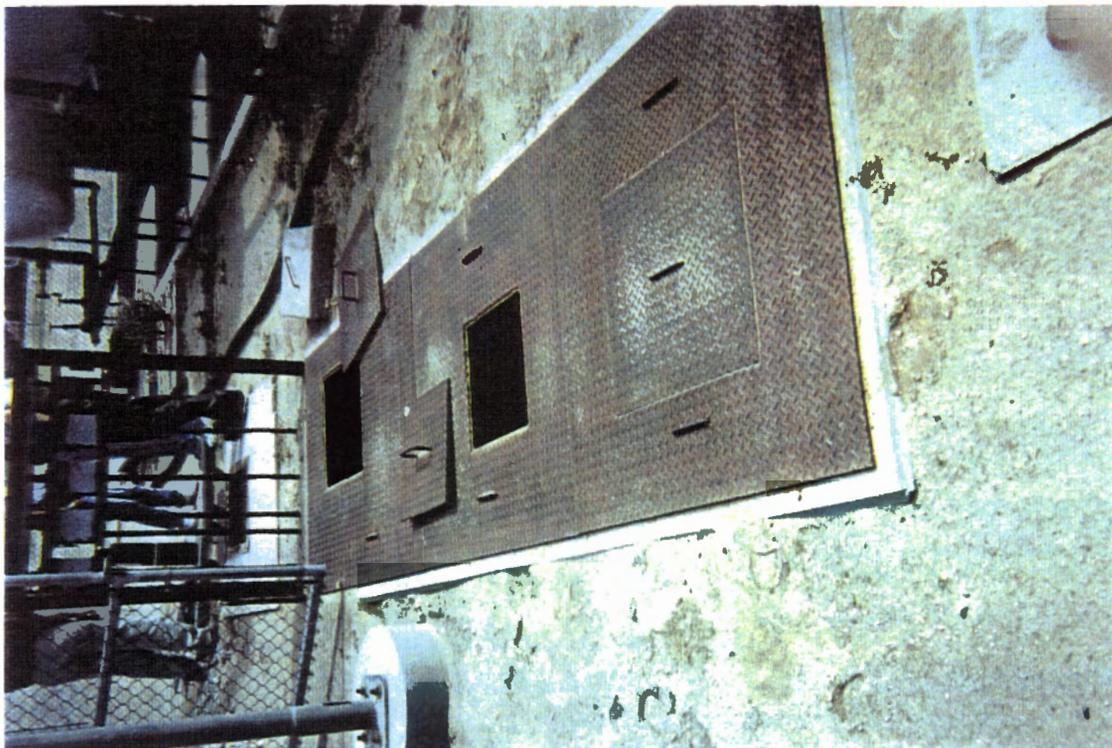
The separator was located in a liquid-tight concrete vault below ground surface. The vault was covered by a quarter-inch thick sheet metal cover plate (Photograph 9). Supply and distribution pipes were disconnected from the separator, and capped if leading away from the Facility. The top panel was removed to allow inspection. Photograph 10 shows Omegasys personnel removing the O/W cover panel and piping. There was a large deposit of sludge in the bottom, approximately 12 inches thick, and the baffles were heavily coated with oily residues. Photograph 11 is a view of the interior of the O/W separator showing the thick sludge deposit and the oil-coated baffles. The entire separator was lifted from the vault to allow easy access for cleaning and decontamination (Photograph 12). Shovels, scoops, and similar tools were used to remove the sludge. Photograph 13 shows removal of the sludges and oil residues. The entire interior was then pressure washed, and the rinse water containerized for disposal. The O/W separator was sold to a local metal recycler. The

**Photograph 9:** Sheet Metal Cover, with Accessways, for the O/W Separator and Concrete Vault.

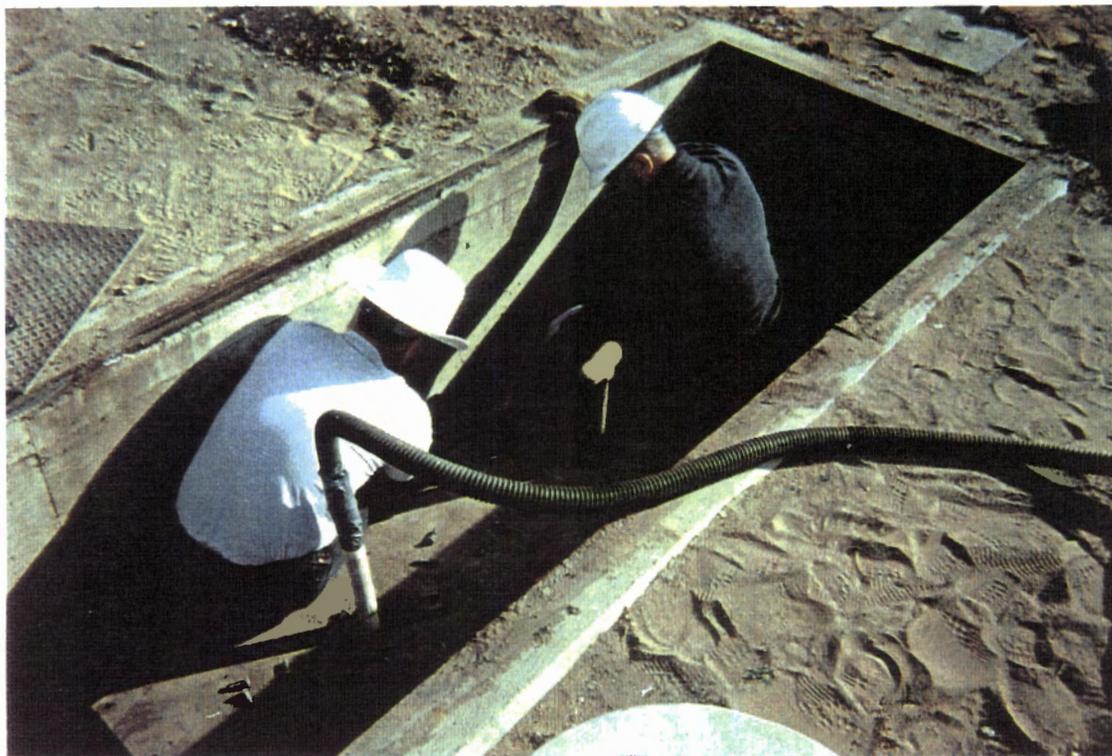
**Photograph 10:** Omegasys Personnel Removing Top Plate of O/W Separator and Disconnecting Supply/Distribution Pipes.

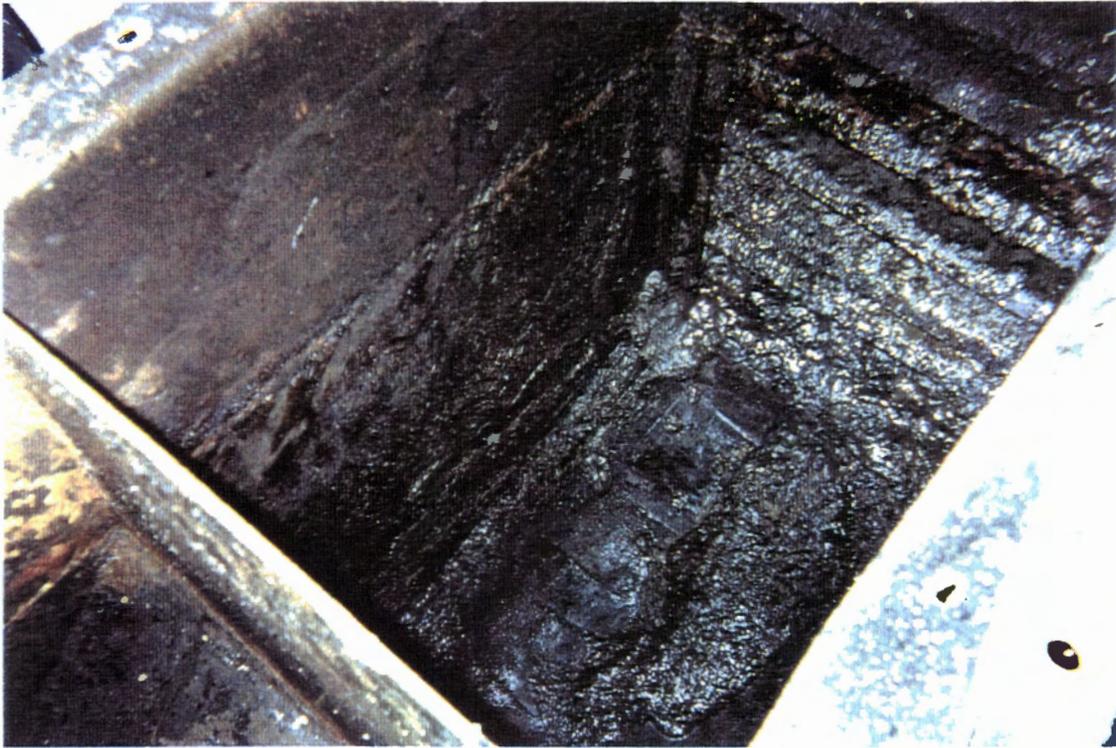
**Photograph 11:** View of O/W Separator Interior Structure Showing Thick Deposits of Sludge and Oil-Coated Baffles.

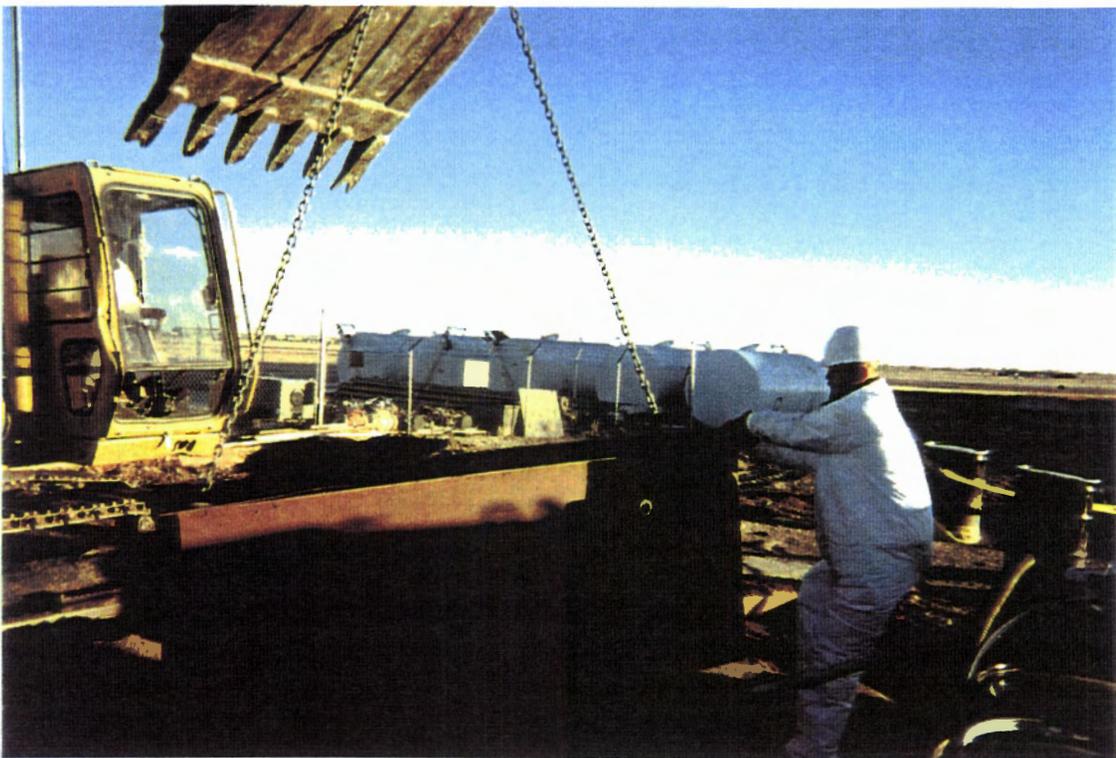
**Photograph 12:** The Trackhoe Bucket Is Used to Lift the O/W Separator from the Concrete Vault.

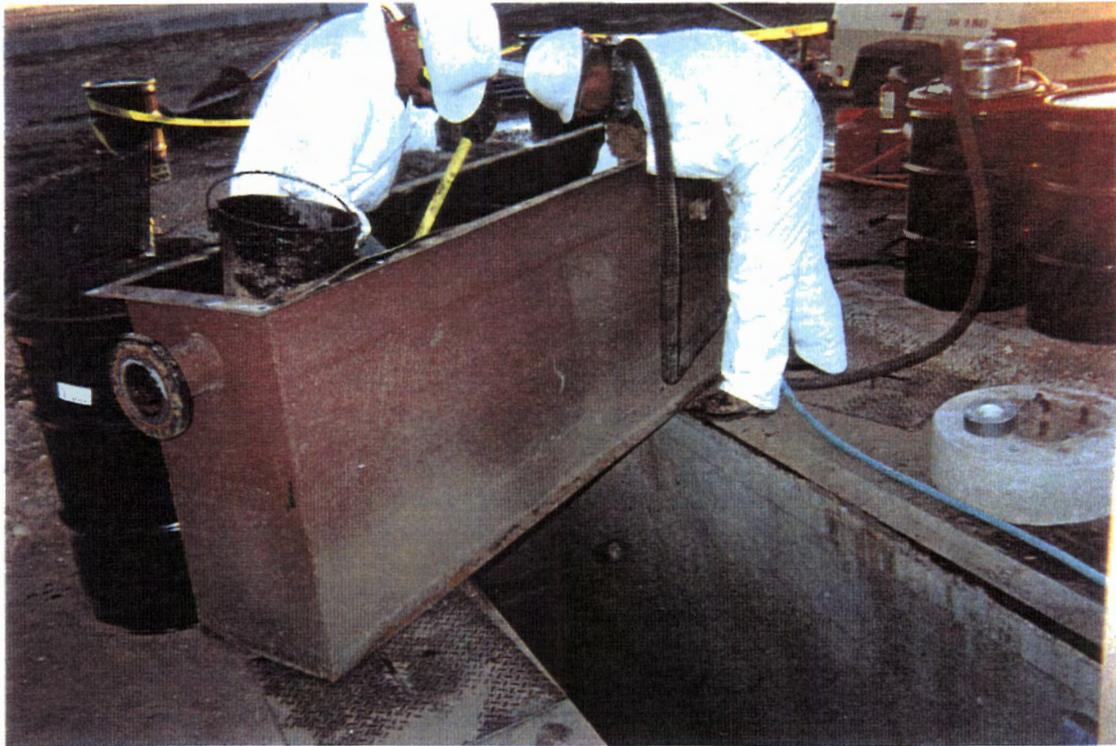
**Photograph 13:** Field Personnel Use Shovels and Scoops to Remove Sludge Prior to Pressure Washing Interior Surfaces.

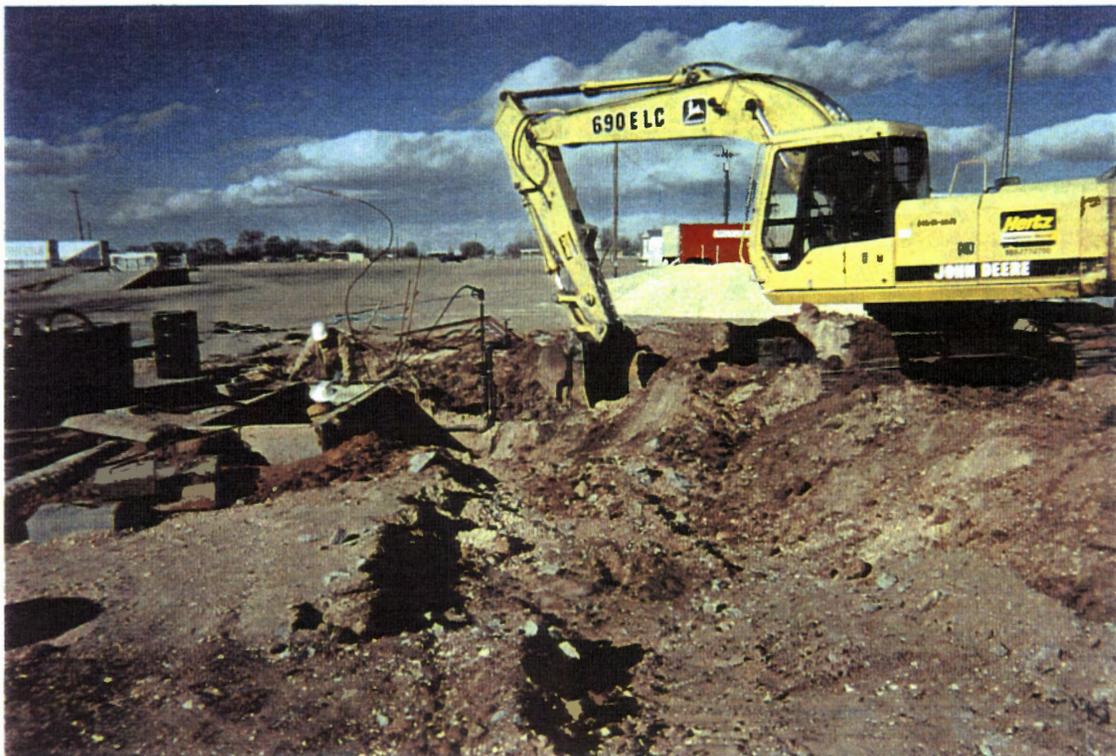
concrete O/W vault and dump pits were removed (Photograph 14) and transported to the rubble storage area.

**Photograph 14:** The Concrete O/W Separator Vault and Associated Dump Pits Are Demolished after Removal of Piping.

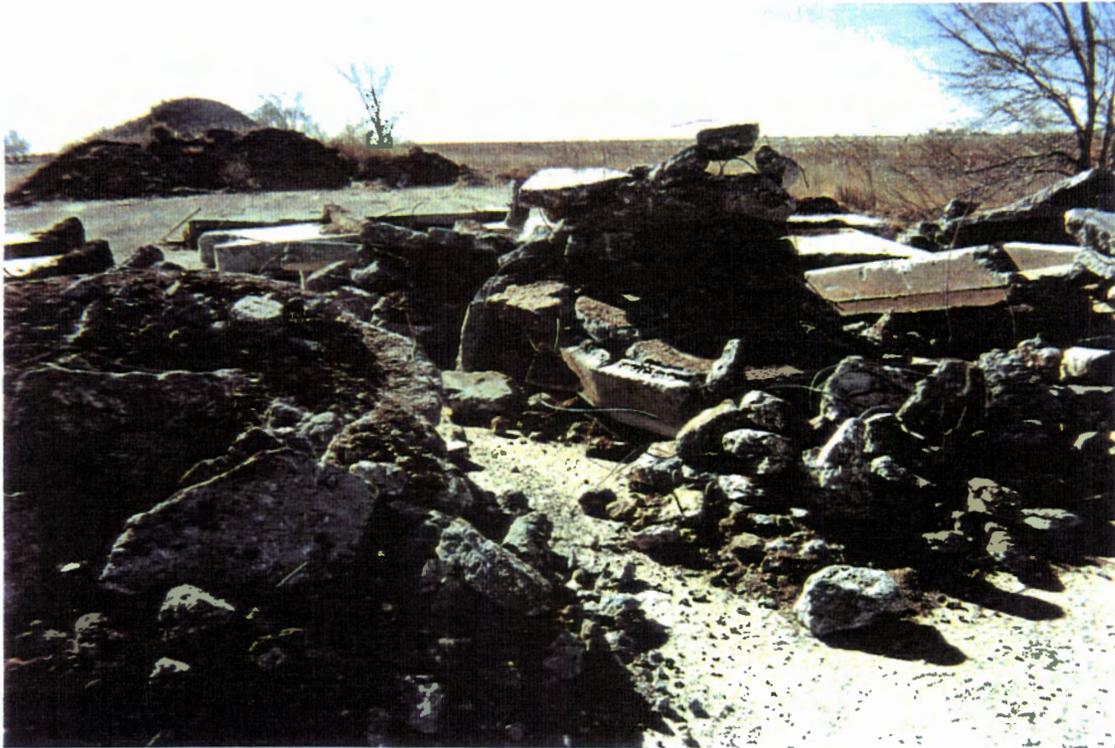
**Photograph 15:** View of Construction Rubble Stockpiled at the Designated Abandoned Airstrip.

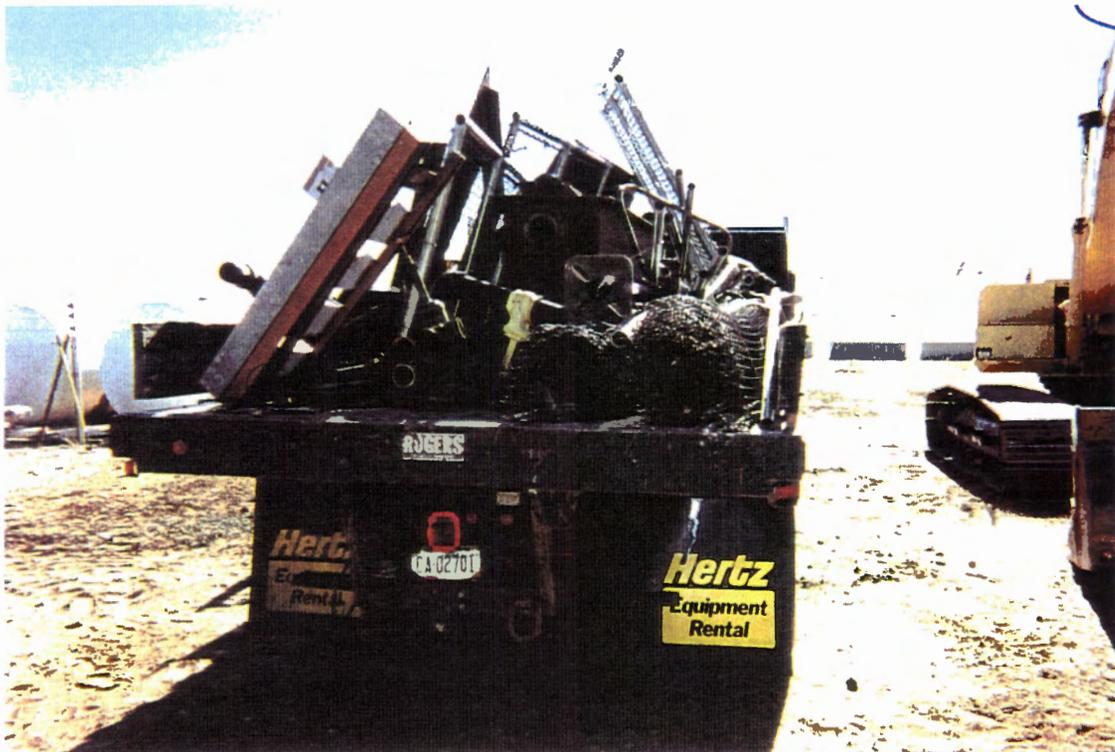
**Photograph 16:** Scrap Metal Loaded on Flatbed Truck Ready for Transport to the Scrap Metal Recycler.

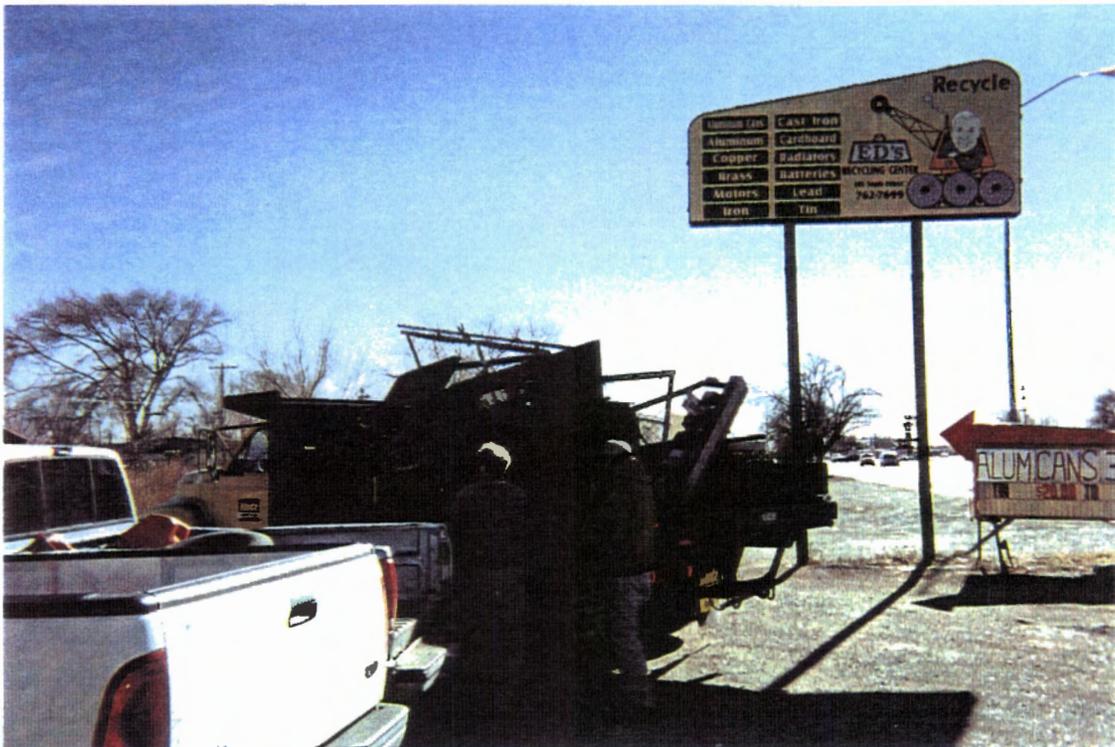
**Photograph 17:** Delivery of Scrap Metal to Ed's Recycle Center, Clovis, New Mexico.

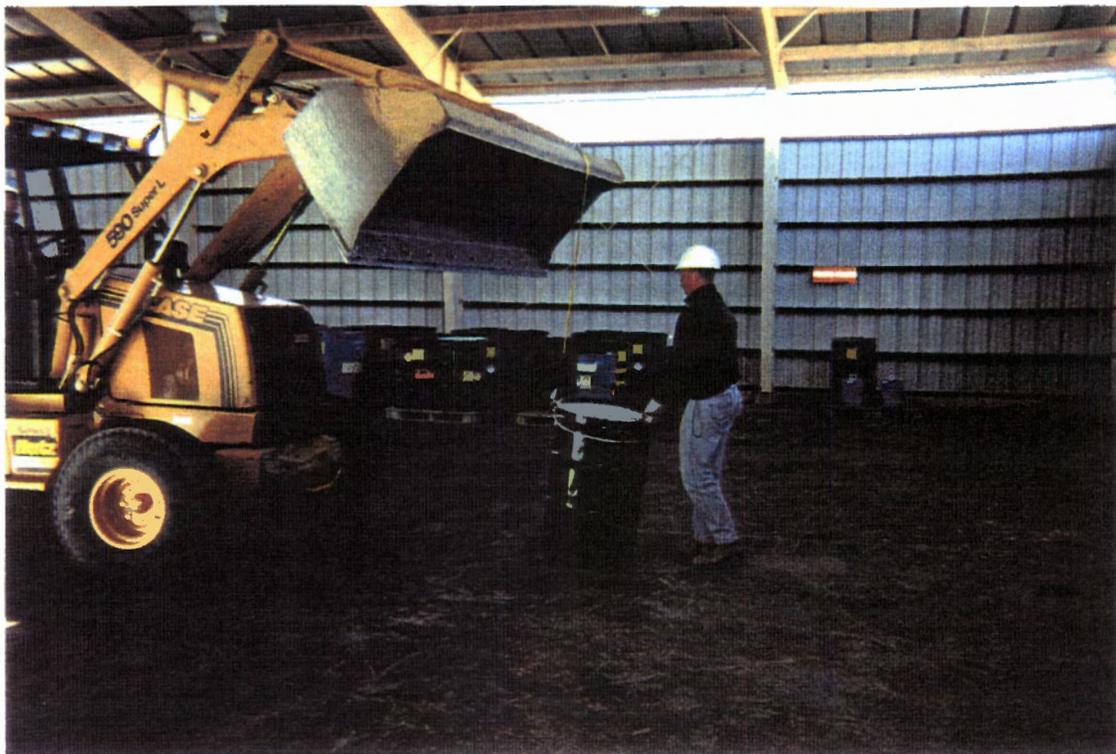
**Photograph 18:** Omegasys Personnel Unloading Drums of Decontamination and Rinse Waters, and Residual Sludges at the On-Base RCRA 90-Day Storage Facility.

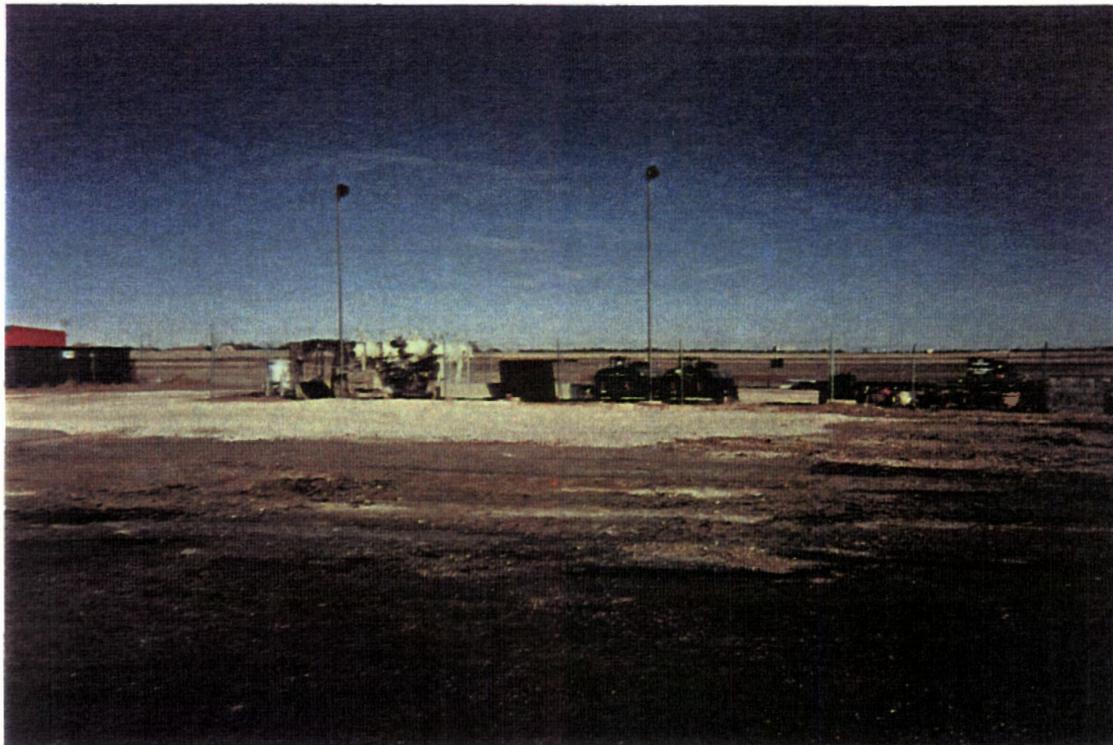
Photograph 19 shows the former site of Facility 244 after completion of removal and investigation activities. The backfilled portion is identified by the light tan area of compacted caliche, in the foreground. The storage tanks temporarily staged in an area southeast of the Facility are shown in Photograph 20.

**Photograph 19:** View of Facility 244 Location upon Completion of Removal Activities; Light Tan Area in Foreground Is Backfilled Area.

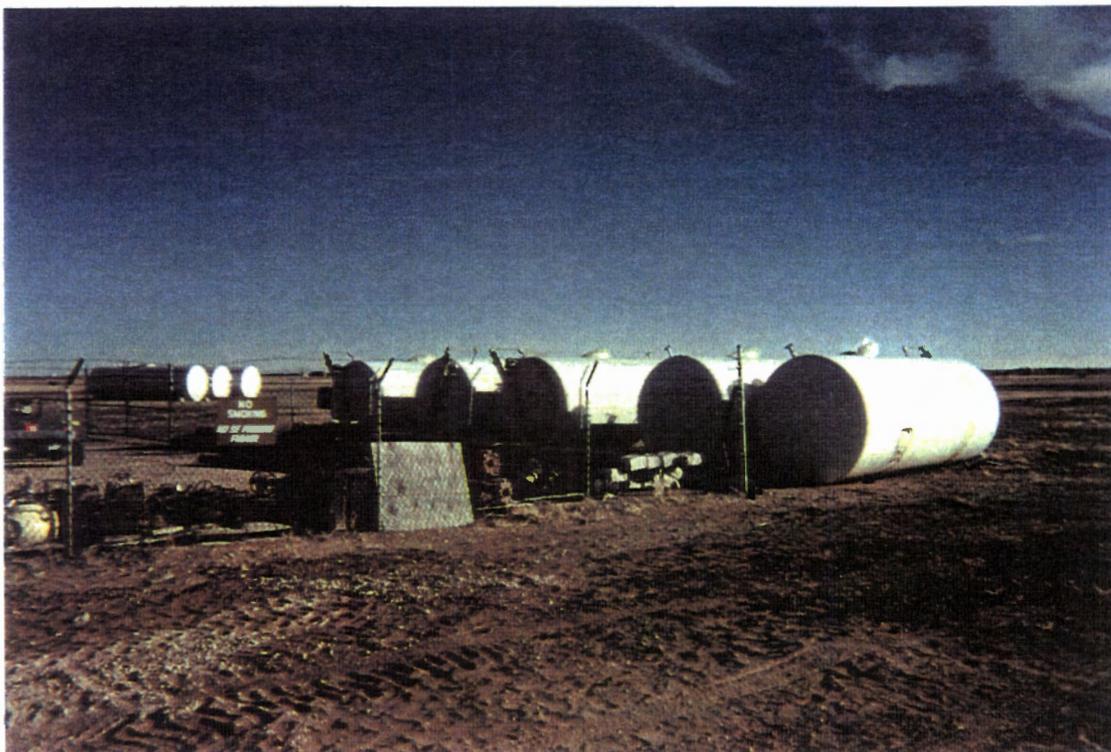
**Photograph 20:** -View of Tanks Removed from Facility 244, Temporarily Staged Prior to Sale as Surplus Material.
