CAF B 00
DEPARTMENT OF THE AIR FORCE
HEADQUARTERS 27th FIGHTER WING (ACC)
CANNON AIR FORCE BASE NEW MEXICO

**ATTACHMENT 1
NOTIFICATION OF UNAUTHORIZED DISCHARGES
AT THE GOLF COURSE POND**

ATTACHMENT 2
CORRECTIVE ACTION REPORT FOR UNAUTHORIZED DISCHARGES
AT THE GOLF COURSE POND

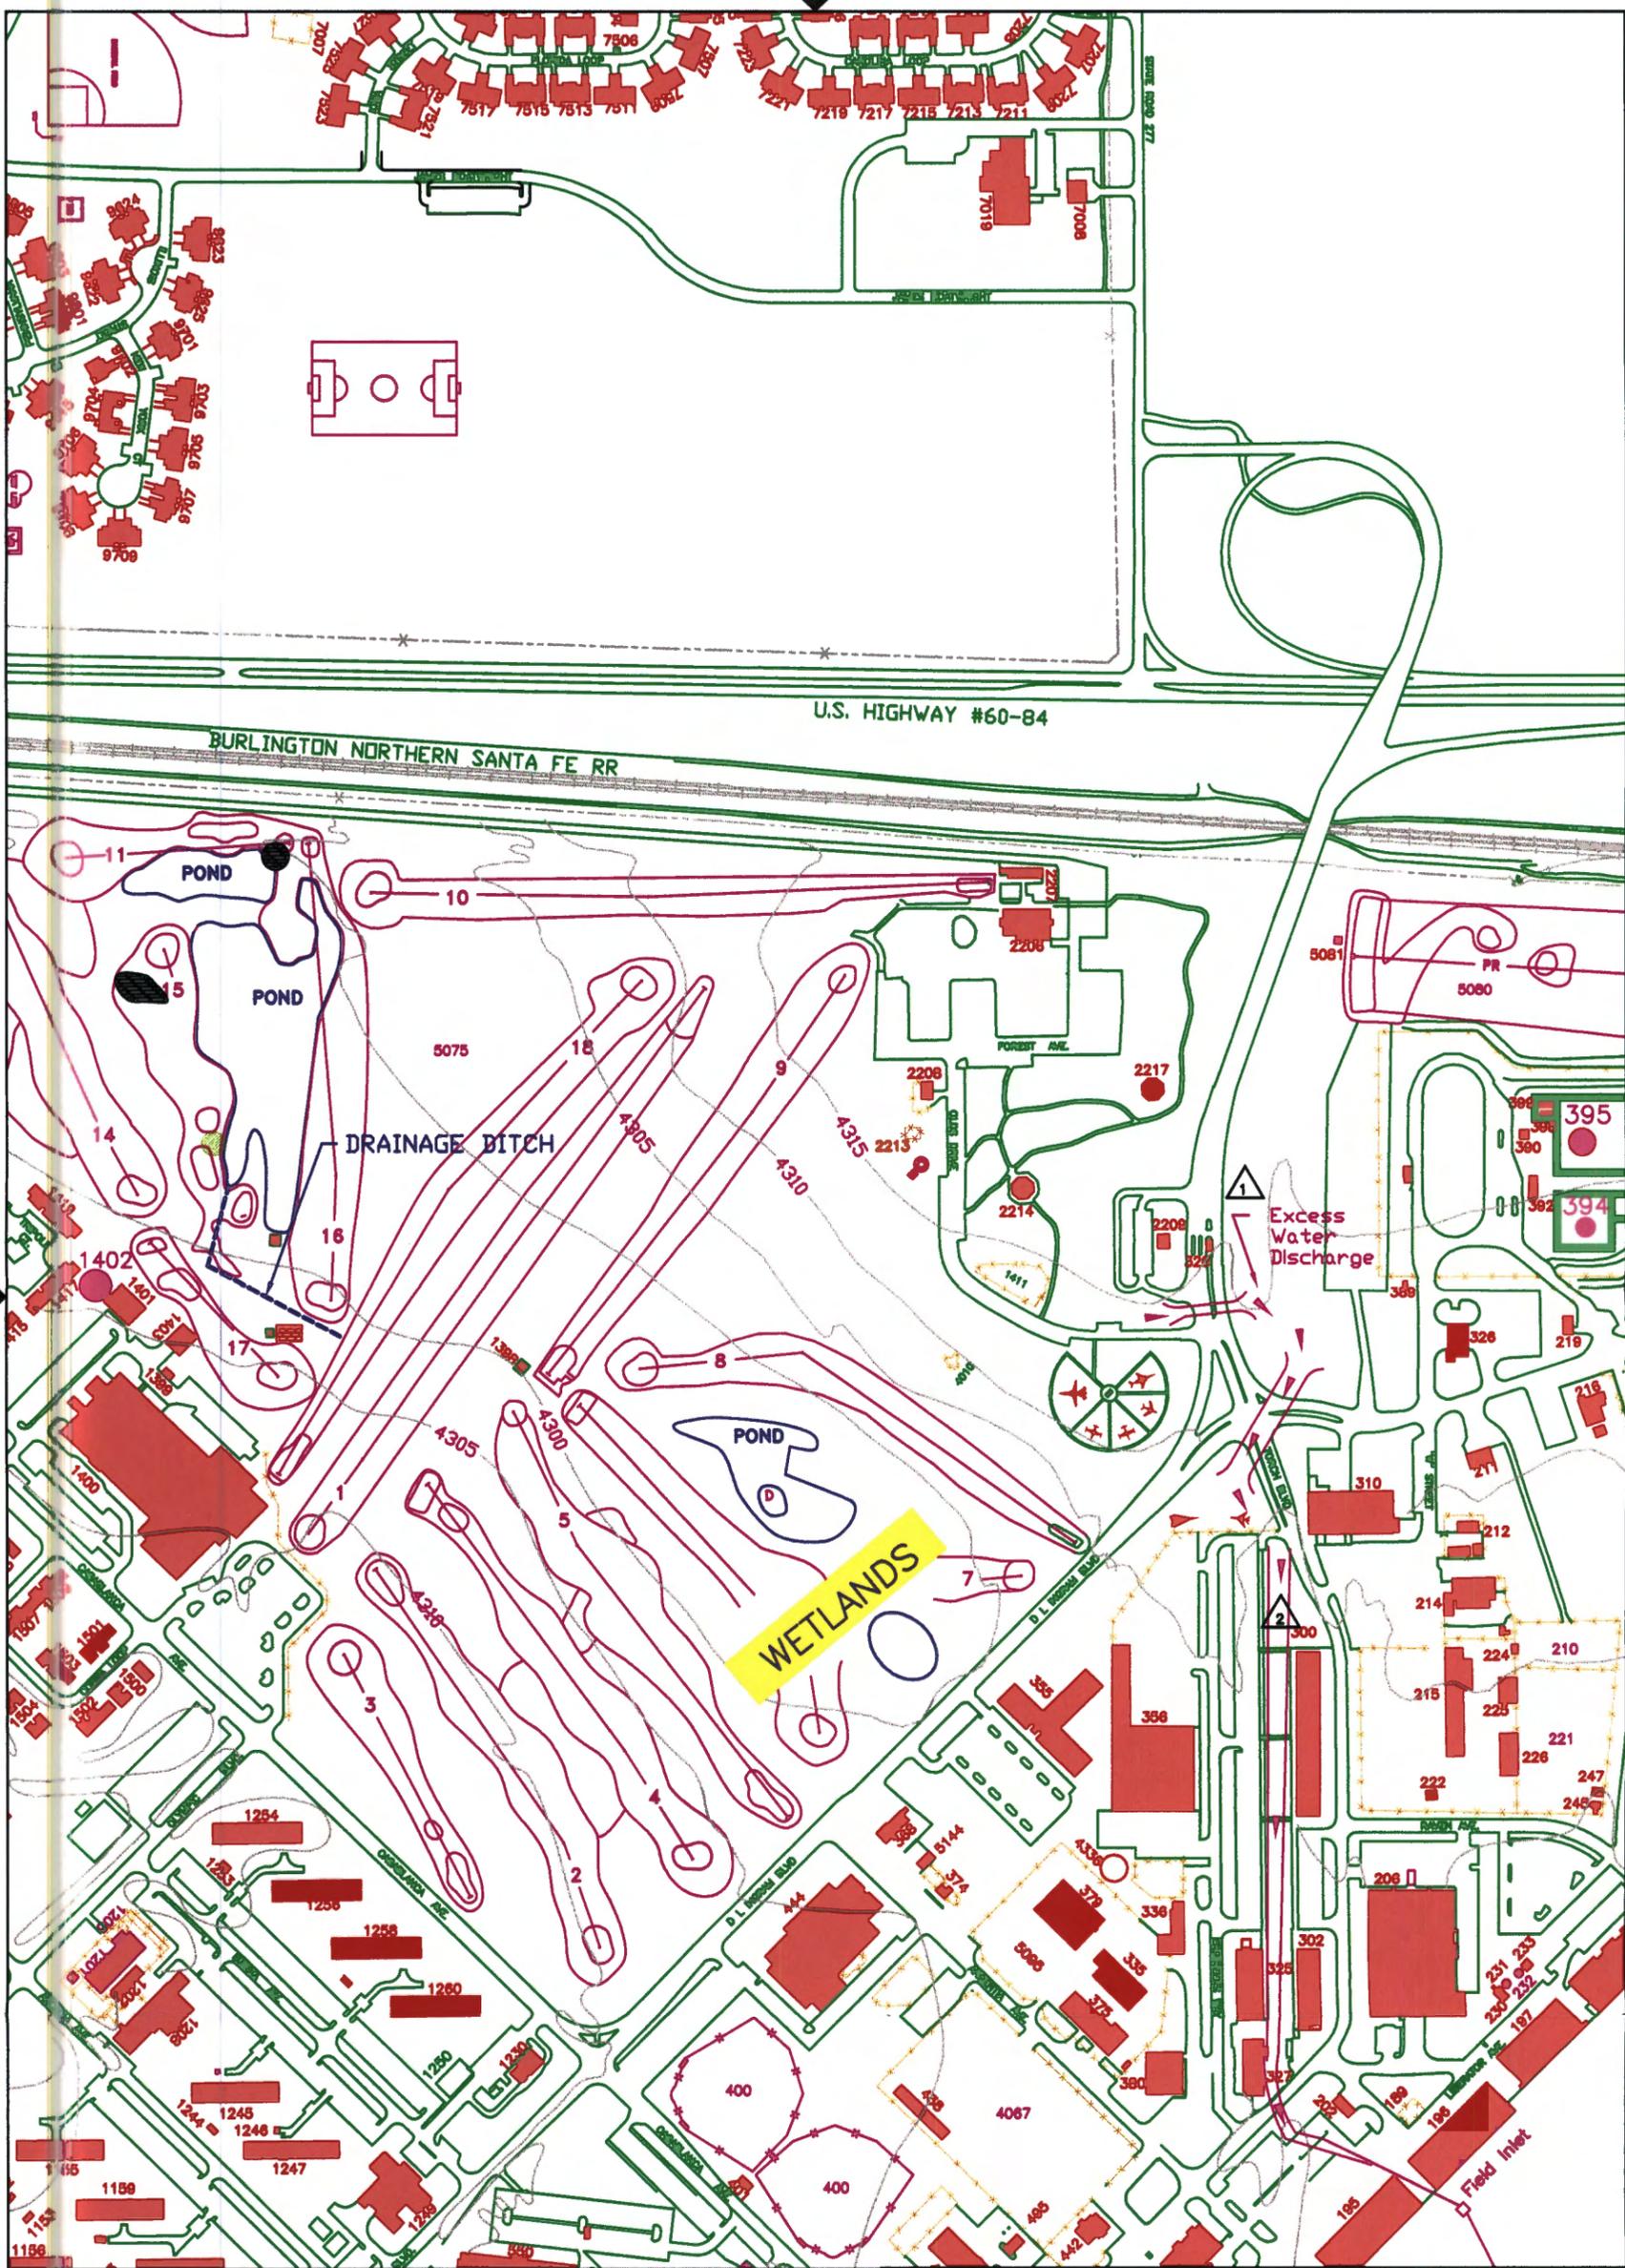
fuel approximately 20 feet to a storm drainage ditch; this ditch discharges into the golf course pond (see attached map). The source for the second incident is less obvious. It appears diesel fuel trapped beneath the ground escaped through the soil and was released when the pond level rose to the point it encroached onto the soil. The diesel fuel seemed to be concentrated near a partially vegetated mound along the 15th fairway (see attached map). It is unclear whether a past spill from mowing equipment or debris within the mound contributed to this discharge. Although under extreme and rare flooding conditions the pond has risen to the levels seen on 24 Oct 00, globules of what appears to be diesel fuel have never been observed. We suspect that released fuel from the sewage lift station may have washed up against the mound and floodwaters covering the area released fuel from this area.

2. Petroleum Migration. It appeared diesel fuel trapped beneath the ground escaped through the soil and was released when the pond level rose to the point it encroached onto the soil. The diesel fuel seemed to be concentrated near a partially vegetated mound along the 15th fairway (see attached map). It is unclear whether a past spill from mowing equipment or debris within the mound contributed to this discharge. Although under extreme and rare flooding conditions the pond has risen to the levels seen on 24 Oct 00, globules of what appears to be diesel fuel have never been observed. We suspect that released fuel from the sewage lift station may have washed up against the mound and floodwaters covering the area released fuel from this area. Cannon AFB received 2.59 inches of rain during the previous day.

Vegetated mound; location of soil and water samples
-

Sewage lift station generator
-

Location of background soil sample
-

Location of soil sample in path of excess water
-

Accumulation point of free floating petroleum

b. Sampling and Analysis. In addition to the water and soil samples collected on 24 Oct 00, Cannon AFB will obtain a soil sample within the storm drainage system that receives excess water pumped from the pond during conditions defined in the Discharge Permit. The approximate location for soil sample collection is shown on the attached map. The water samples collected on 24 Oct 00 will be analyzed for the following constituents:

A soil sample remote of the soil sample within the drainage system will be collected to establish "background" concentrations that can be compared to those within the drainage system. See the attached map for the location of this soil sample. This "background" sample will be analyzed for the above parameters.
