DEPARTMENT OF THE AIR FORCE
27TH SPECIAL OPERATIONS MISSION SUPPORT GROUP (AFSOC)
CANNON AIR FORCE BASE NEW MEXICO

SUBJECT: Approval with Modification 2012 Biennial Report

**RE: APPROVAL WITH MODIFICATION
2012 BIENNIAL GROUNDWATER MONITORING AND ANNUAL
LANDFILL INSPECTION REPORT, LF-03, LF-04, LF-05, LF-25 AND
FORMER SEWAGE LAGOONS
CANNON AIR FORCE BASE
CURRY COUNTY, NEW MEXICO
EPA ID #NM7572124454
HWB-CAFB-13-006**

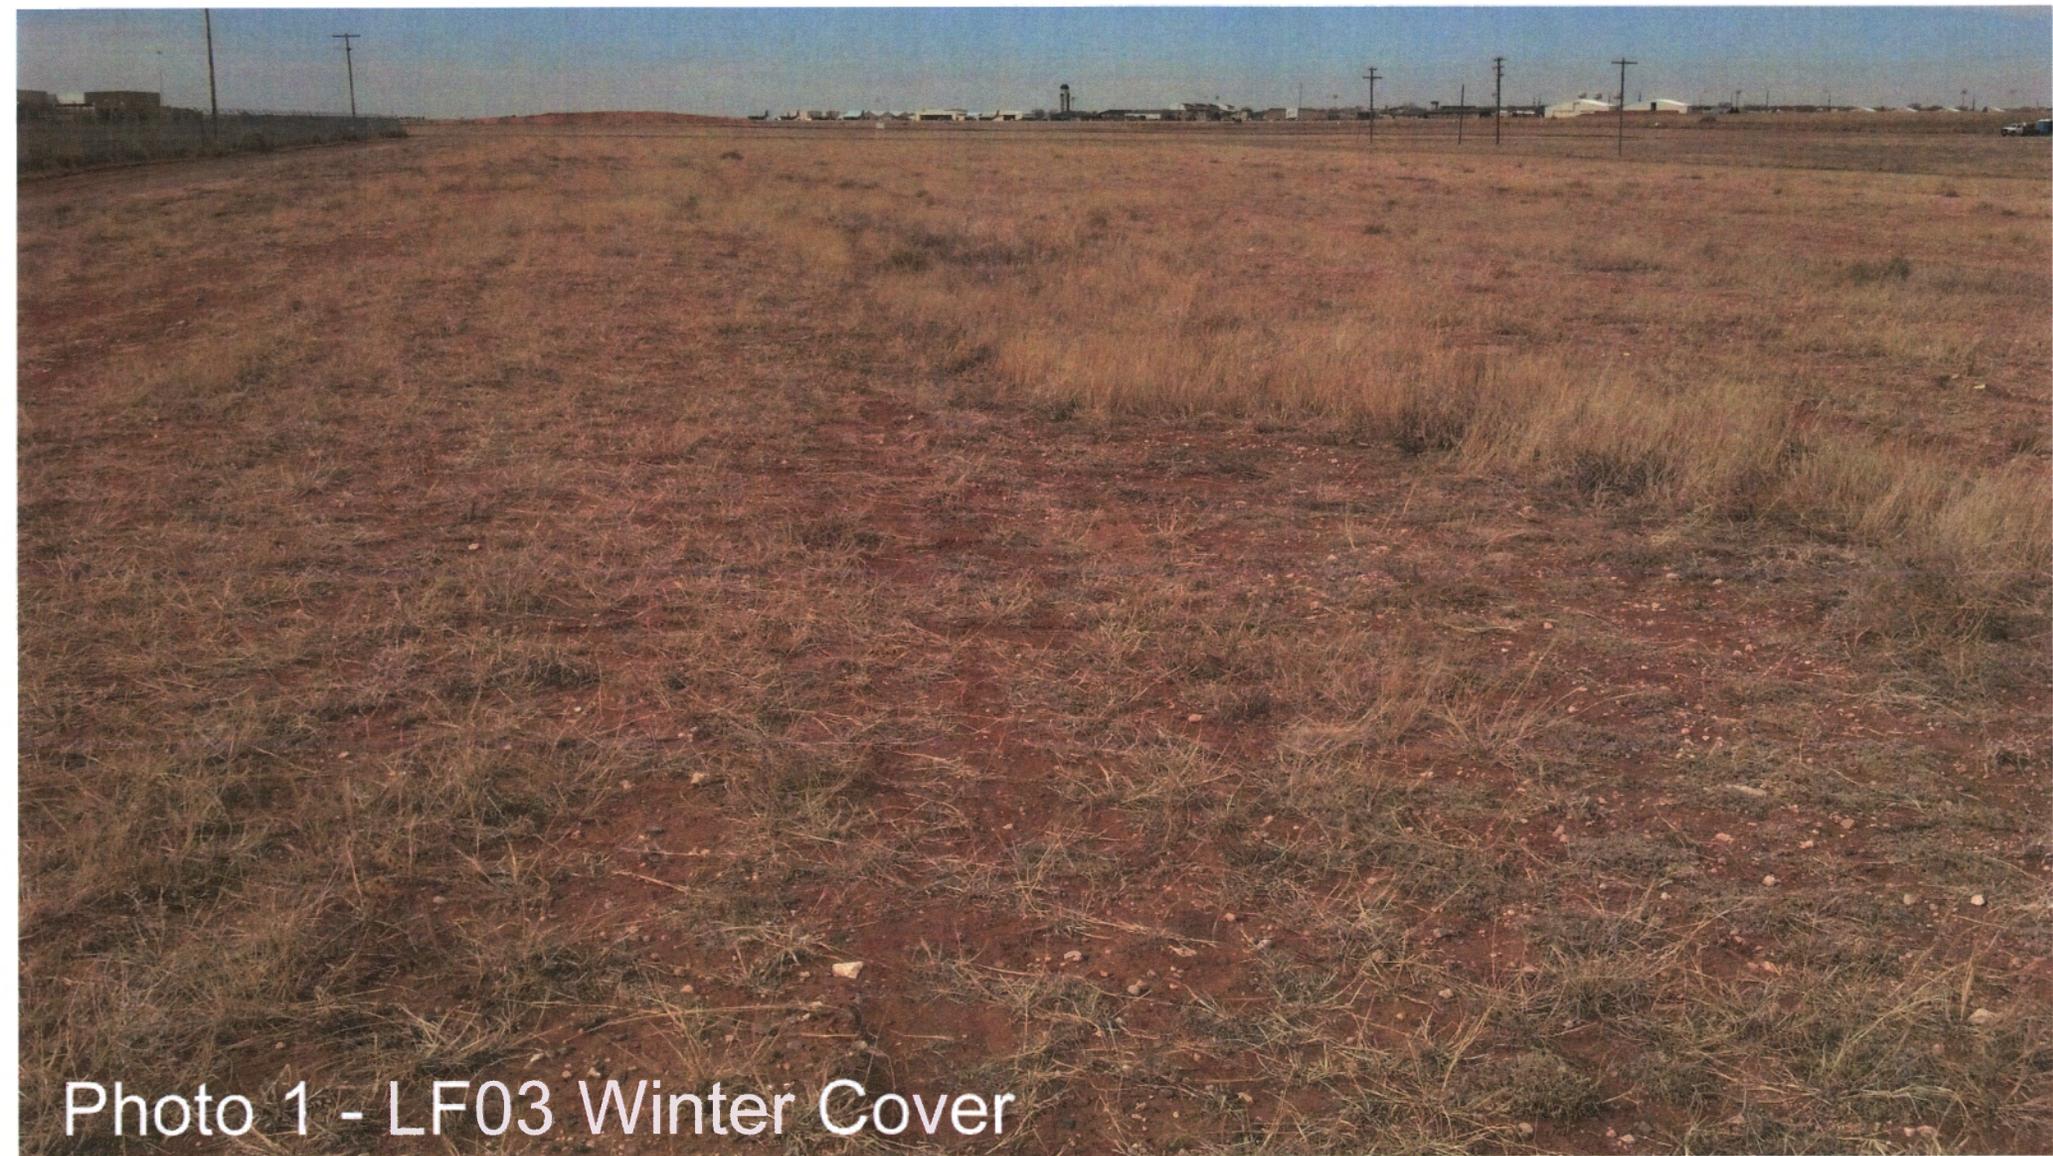
Photo 1 - LF03 Winter Cover

It is unclear if the new cap was seeded prior to the time of inspection or if there are plans for a ground cover in the future. Additionally, no silt fencing or temporary erosion prevention measures were in place to minimize wind distribution of cover material or sediment migration due to storm water.

Install a vegetative cover to maintain the integrity of the new soil cover and install erosion control measures until vegetative cover is mature. Continued annual inspections will verify that the cover system functions as designed and meets operational objectives. The need for routine maintenance or repair should be evaluated during these inspections.

CAFB Response: Natural processes have re-seeded the cover of LF-03 as shown in the attached photograph (Att. 3, Photo 1). In addition, signage was posted around LF-03 on 16 December 2013 (Att. 3, Photo 2). CAFB reports that the recommendations listed in Section 3.1.4 are complete. The 2013 required annual inspection was completed in December 2013.

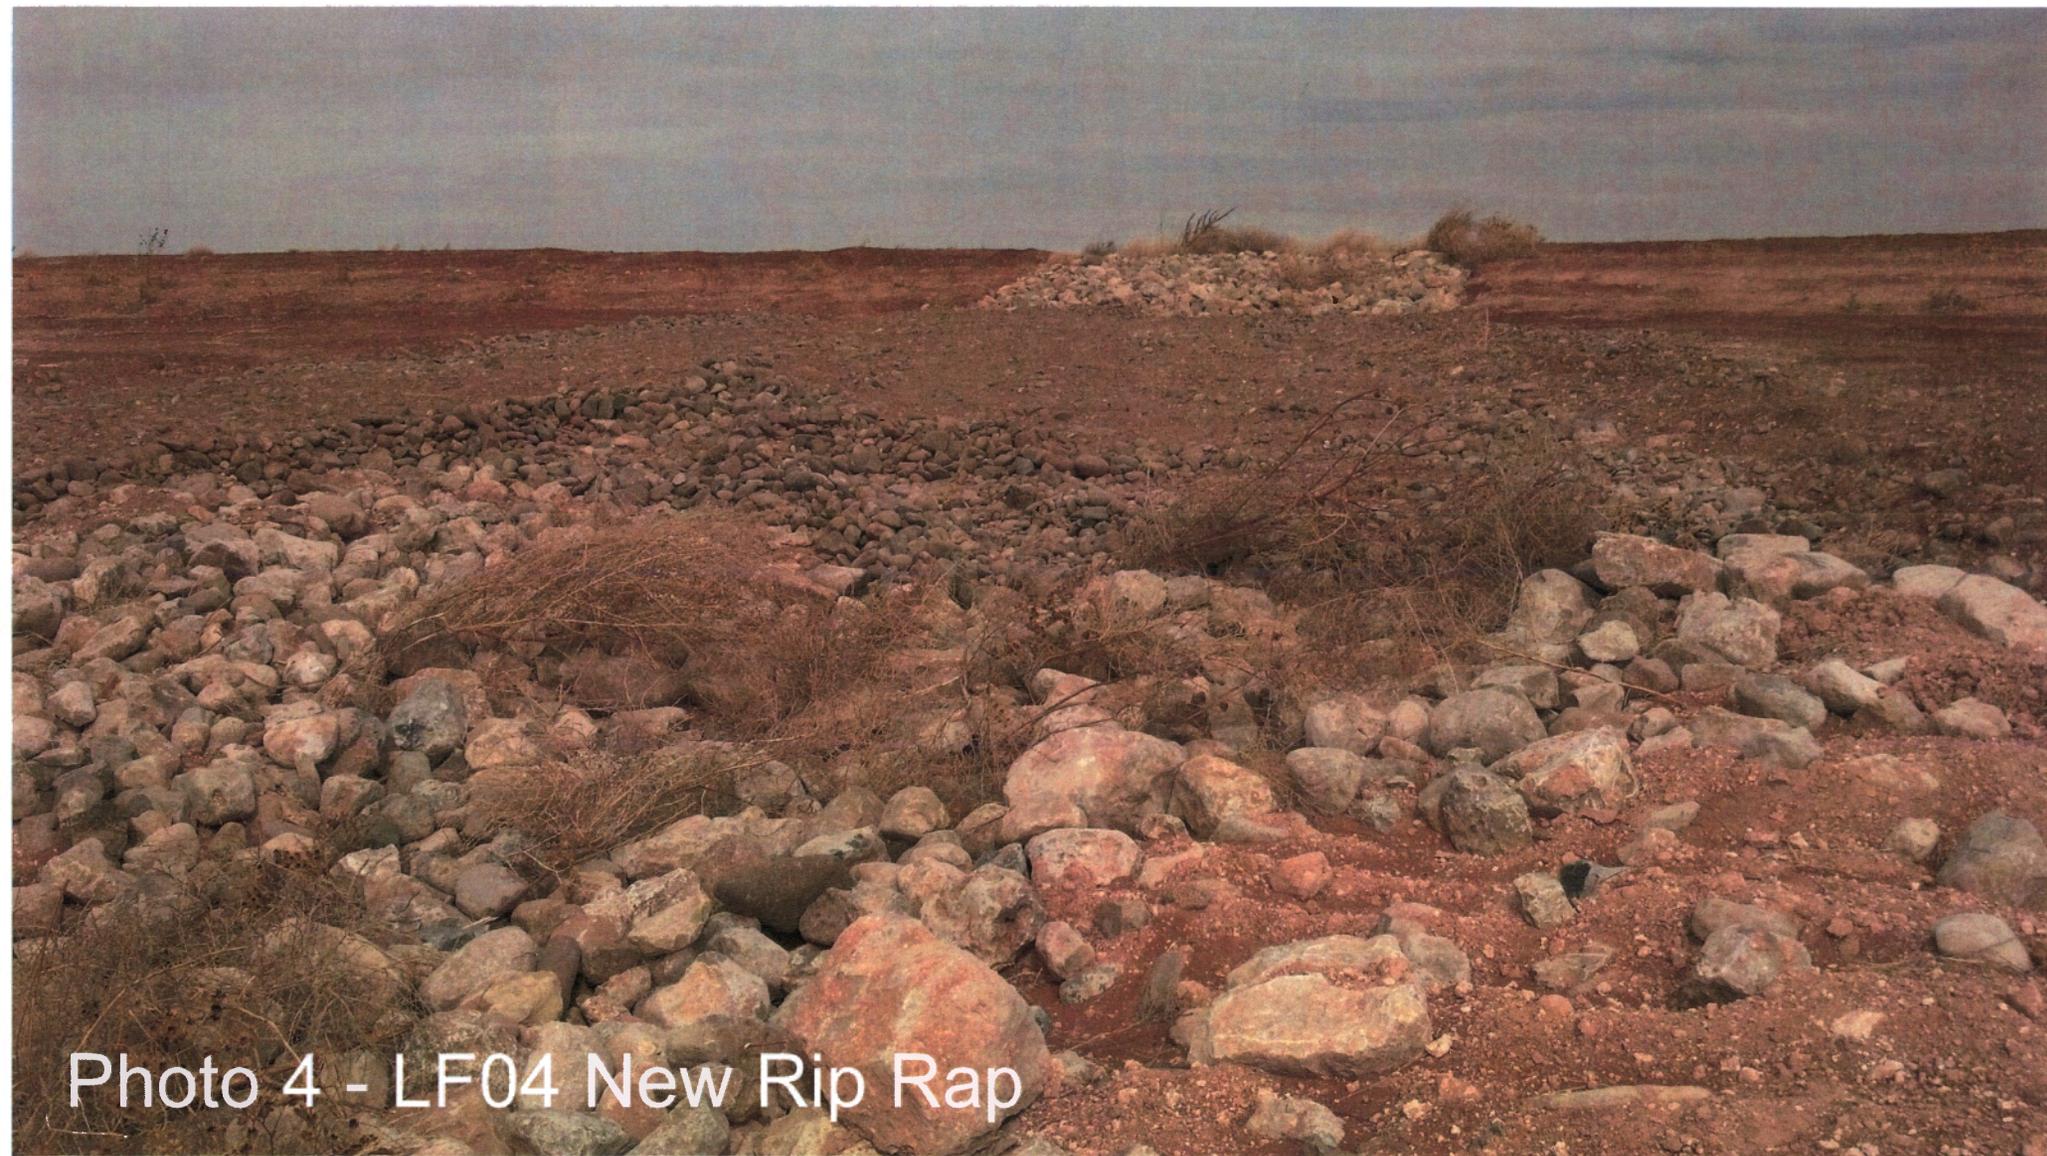
Photo 4 - LF04 New Rip Rap

It is unclear if the new cap was seeded prior to the time of inspection or if there are plans for a ground cover in the future. Additionally, no silt fencing or temporary erosion prevention measures were in place to minimize wind distribution of cover material or sediment migration due to stormwater.

Install a vegetative cover to maintain the integrity of the new soil cover and install erosion control measures until vegetative cover is mature. Continued annual inspections will verify that the cover system functions as designed and meets operational objectives. The need for routine maintenance or repair should be evaluated during these inspections.

CAFB Response: Signage was posted around LF-04 on 16 December 2013 (Att. 3, Photo 3). Erosion repairs were made to the rip-rap section of the landfill (Att. 3, Photo 4). The additional erosion control measures were met by placing soil stabilizer on the surface to prevent further erosion. CAFB is requesting an extension until June 2014 to complete the re-seeding of LF-04 to ensure appropriate temperature to support germination. The 2013 required annual inspection was completed in December 2013.
