DEPARTMENT OF THE AIR FORCE
AIR FORCE CIVIL ENGINEER CENTER

Cannon Air Force Base (AFB) initiated field work in support of the approved work plan at DP034; "Approval with modifications RCRA Facility Investigation (RFI) work plan at DP034 Revision 1", dated July 3, 2019. The geophysical survey was crucial in determining the area of the debris pit. The geophysical survey revealed the debris pit to be larger than 15 feet by 15 feet by 5 feet deep (GPR and EMI results attached for reference).

Figure 1
Geophysical Survey Results
Historical Debris Pit DP034

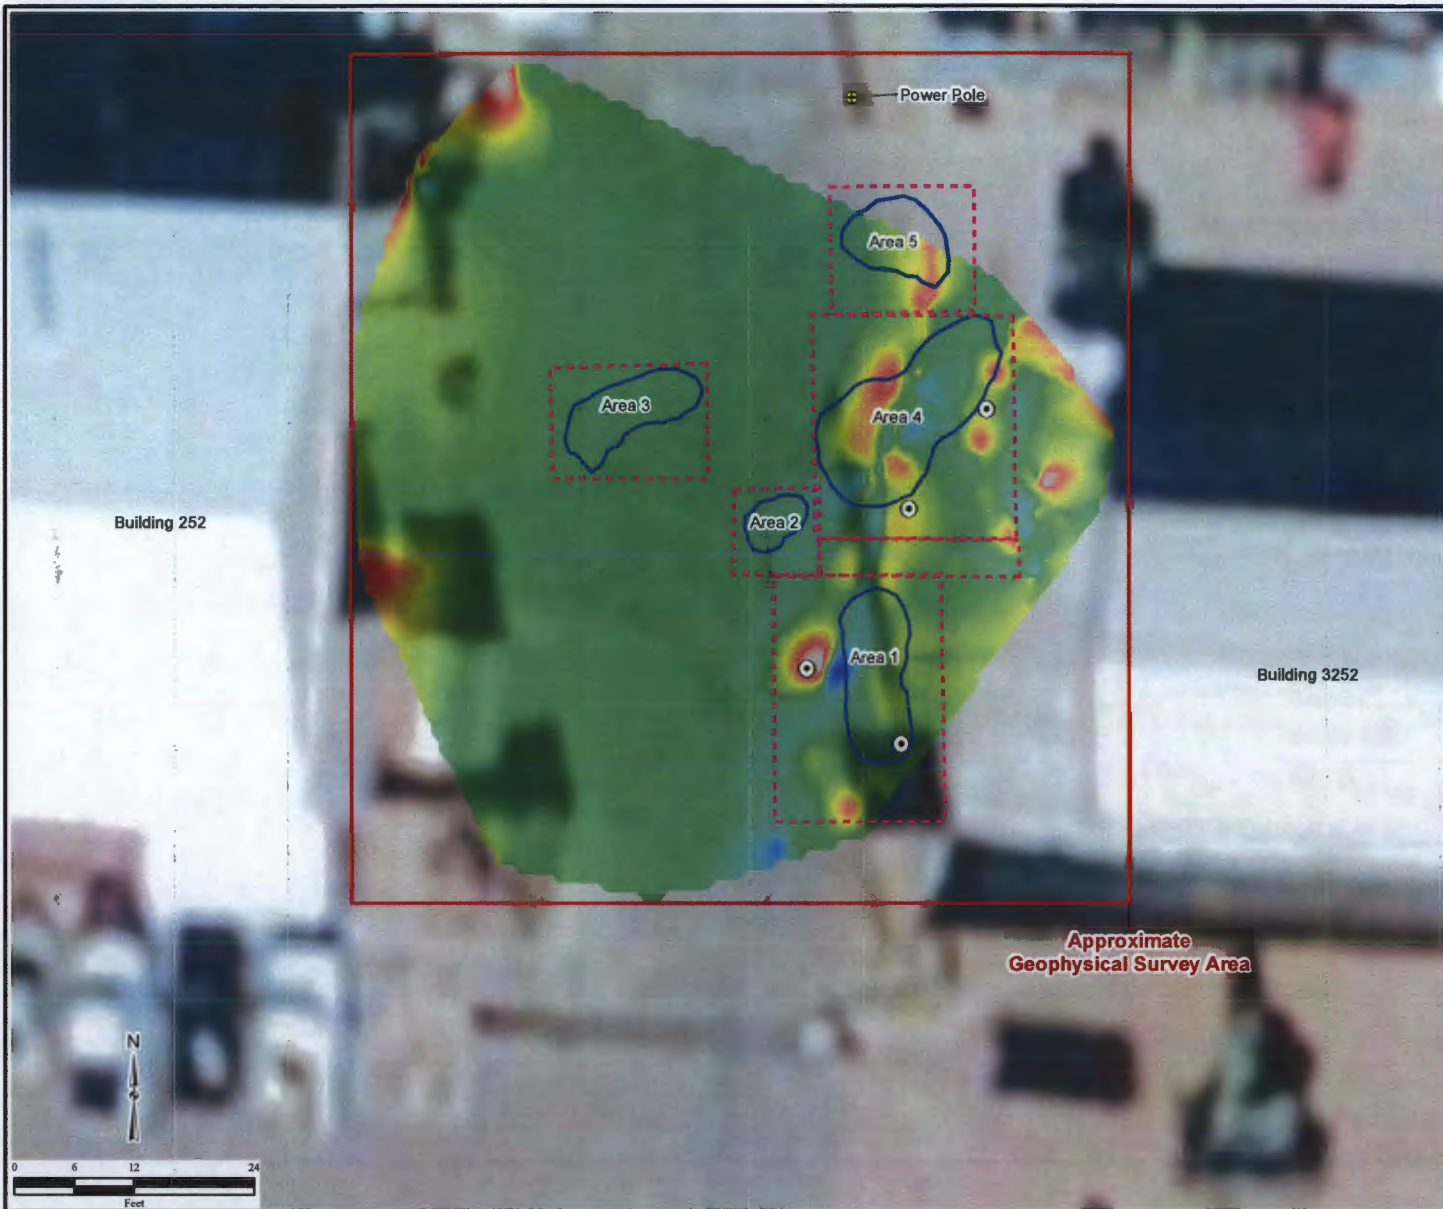
Figure 2
Geophysical Survey Results
Historical Debris Pit DP034

Pink square = possible SB location

In accordance with the approved work plan, the subsequent step is to install borings to determine the nature and extent of the potential impact to the subsurface soils in the area. After reviewing the data provided by the GPR and EMI survey, it was determined an additional 4 borings would be needed, increasing the installed borings from 6 to 10. In addition, to determine the potential existence of any additional radiological material, downhole gamma logging will be conducted at each of the borings. With NMED concurrence, the field work is estimated to commence in November for the installation of the 10 borings and downhole gamma logging.

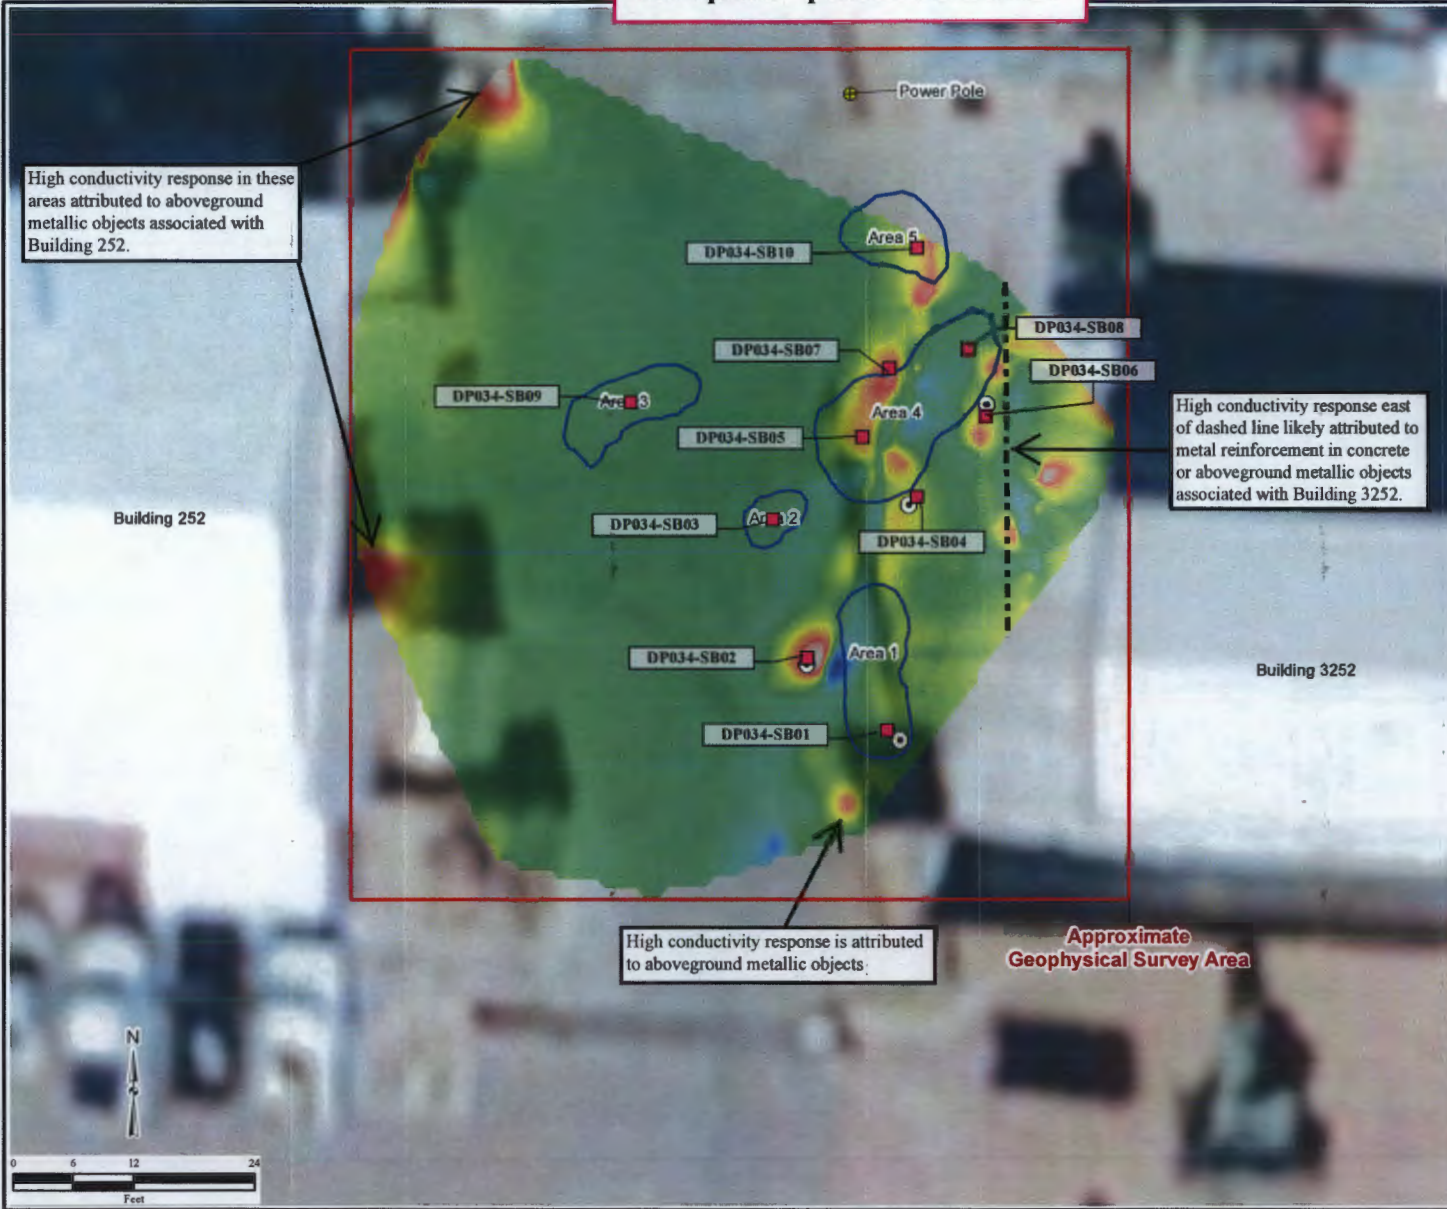
Figure 3
Geophysical Survey Results
Historical Debris Pit DP034

High conductivity response in these areas attributed to aboveground metallic objects associated with Building 252.

High conductivity response east of dashed line likely attributed to metal reinforcement in concrete or aboveground metallic objects associated with Building 3252.

High conductivity response is attributed to aboveground metallic objects.
