HWB PHOTO SHEET

Facility: Las Cruces Airport

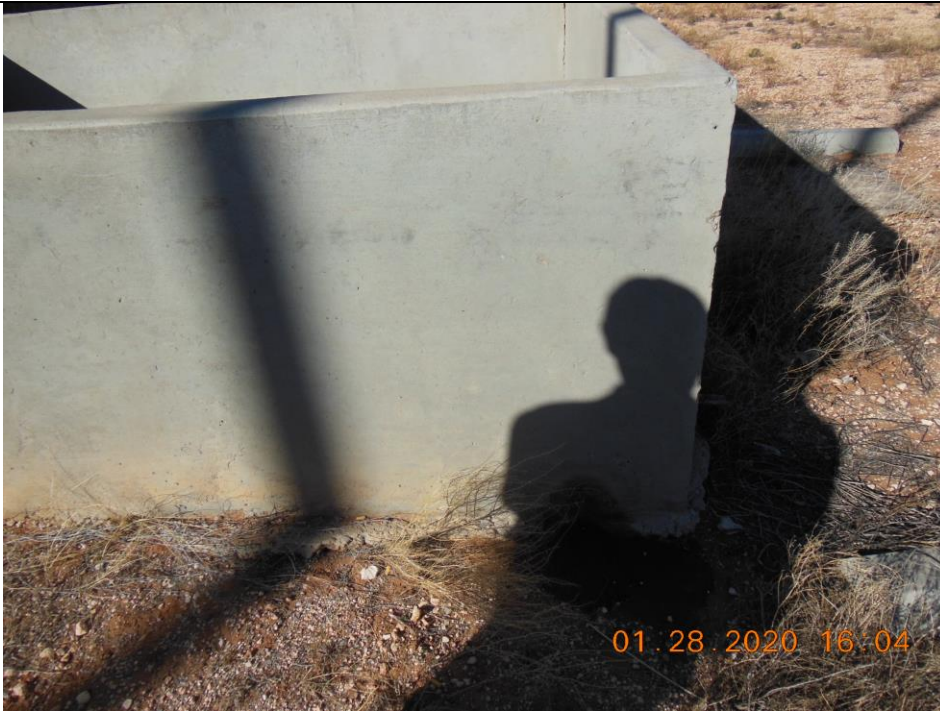
Photo #: 2766

Location: west side of Southwest Aviation hangars facing north.

Description: concrete structure used to store used oil. Used oil is leaking out of the bottom corner.

Violation(s): Failure to respond to releases of used oil. 40 CFR 279.22(d).

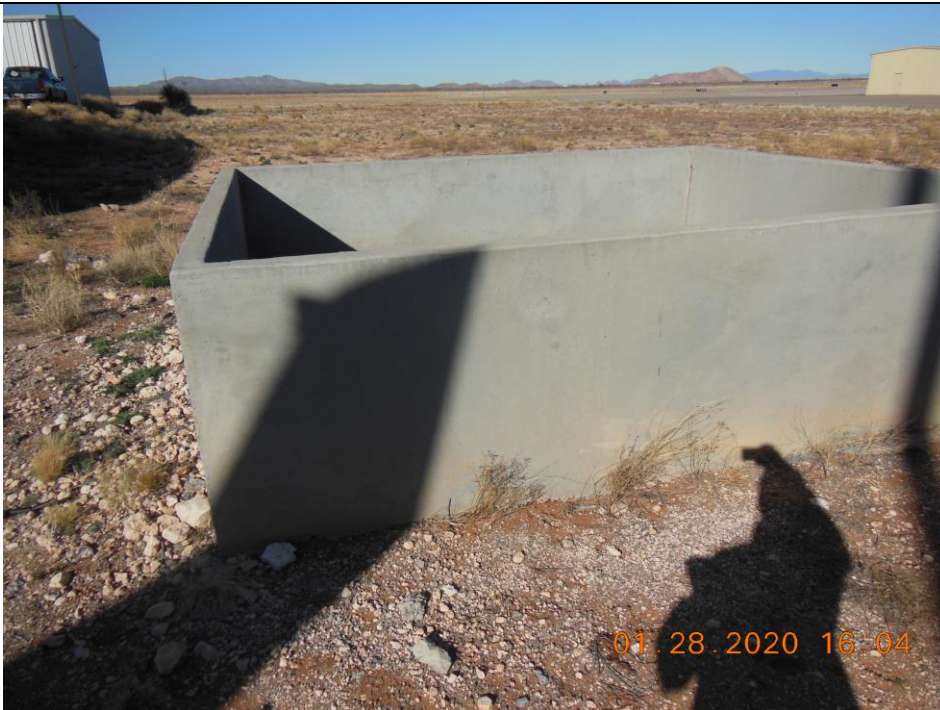
Photo #: 2767

Location: Facing north.

Description: Same as above.

Violation(s): Same as above.

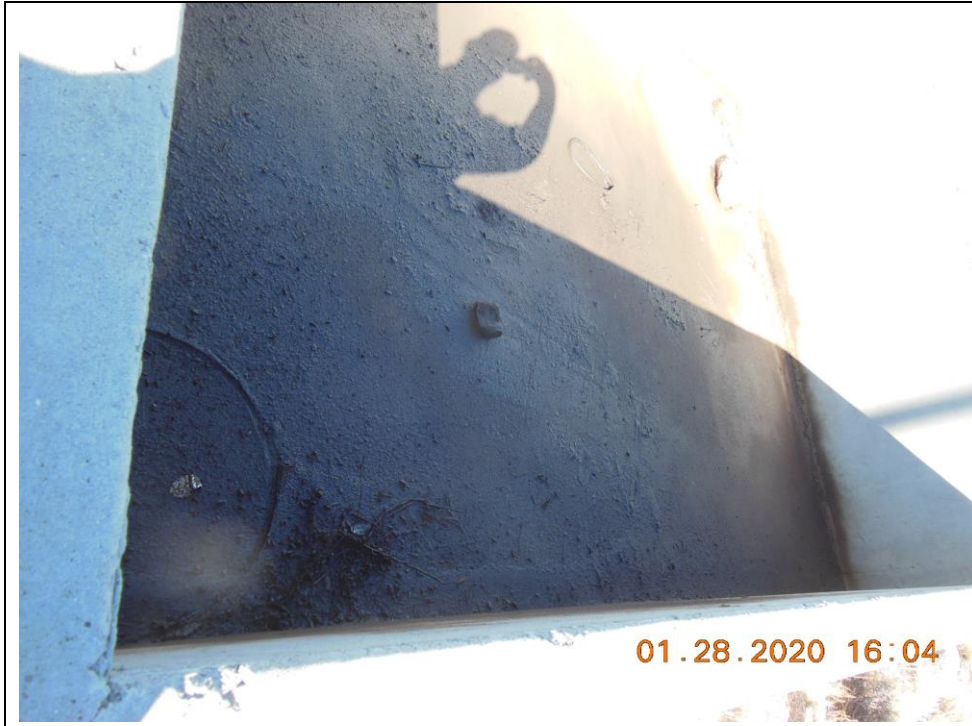
Photo #: 2768

Location: inside the concrete structure.

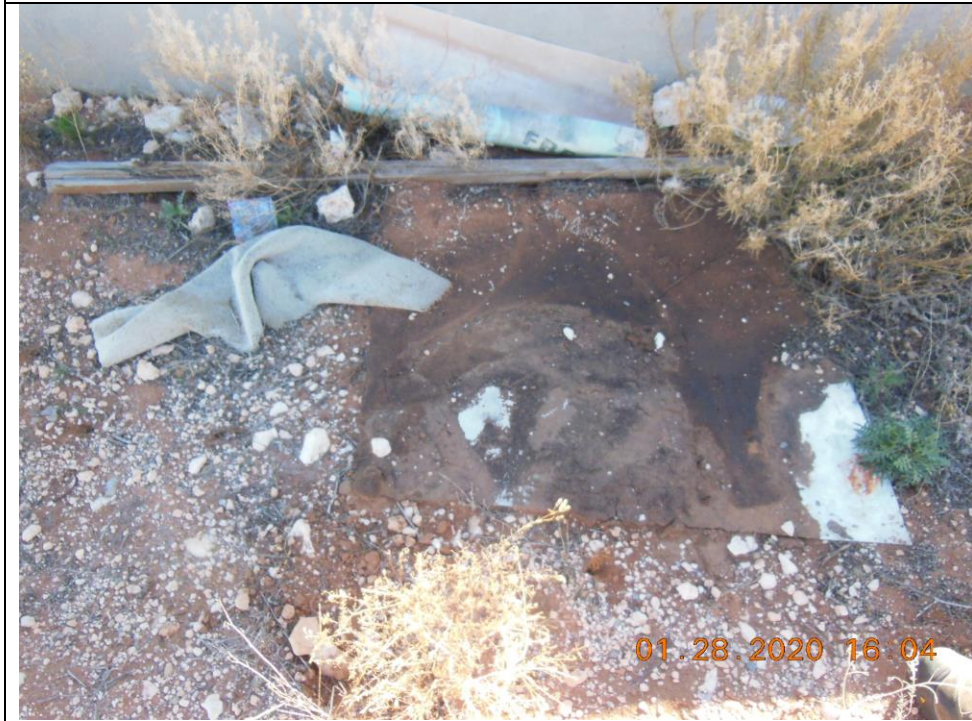
Photo #: 2770

Location: south side of concrete structure.

Description: oil contaminated debris.

Violation(s): same as above.
