On July 16, 2009 and October 15, 2009, the Directorate of Public Works, Environmental Division conducted the biannual Post-Closure Site Inspection of the Dona Ana Rubble Pit Landfill, Solid Waste Management Unit (SWMU) No.27/FTBL-012 per NMED letter dated October 30, 2007. The correspondence indicated that the following information must be included in the site inspection; observations of the final cover and side slopes, the surface water drainage system, and vegetative cover conditions. The correspondence also indicated that any damage to cover material and side slopes must be noted and repaired. Capped areas experiencing subsidence must be re-graded with additional soil as needed to maintain site drainage if subsidence has occurred. The final cover and the side slopes of SWMU-27 are in very good condition and show no subsidence. Native vegetative conditions at the landfill are very good.

SUBJECT: DPW- Environment Division EPAS Inspection.

Facility Name: SWMU-27

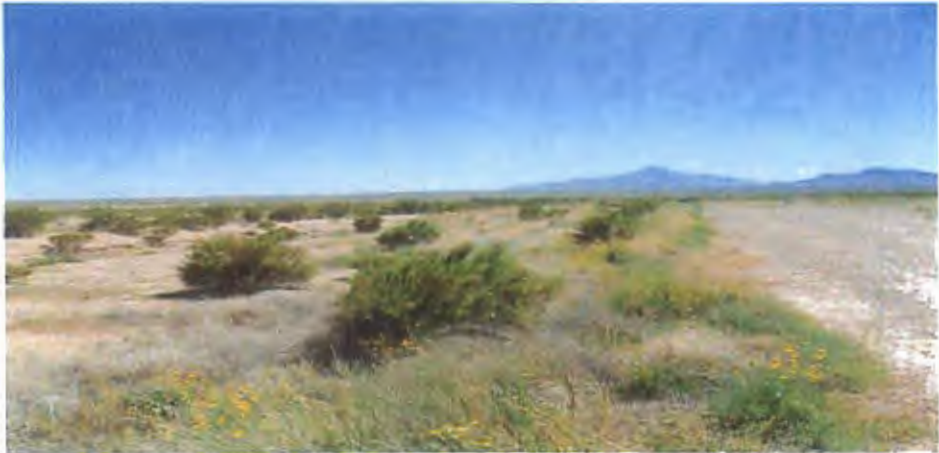
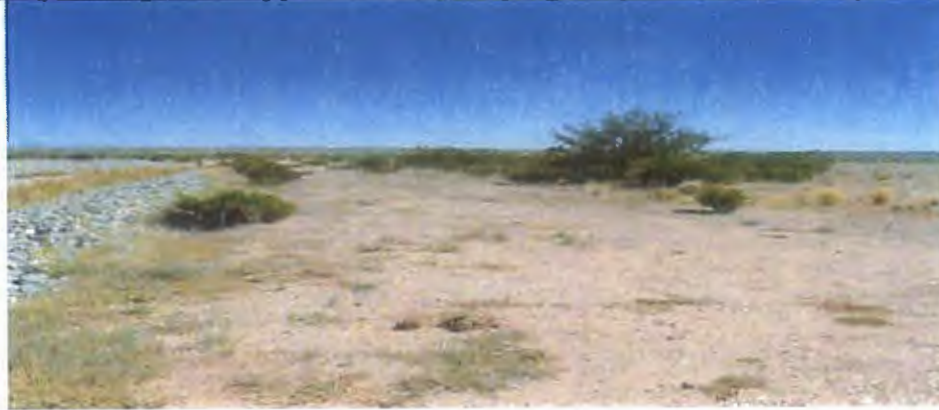
1. Positive Observation: Erosion was not found at this landfill.

2. Positive Observation: Vegetation is very healthy on the surrounding area of the landfill and on the final cover.

Observations 1 & 2	Erosion was not found at this landfill and Vegetation is very healthy
