**DEPARTMENT OF THE ARMY**  
US ARMY INSTALLATION MANAGEMENT COMMAND  
HEADQUARTERS, UNITED STATES ARMY GARRISON, FORT BLISS  
1 PERSHING ROAD  
FORT BLISS, TEXAS 79916-3803

On April 9, 2010, and on August 16, 2010, the Directorate of Public Works, Environment Division, Environmental Performance Assessment System (EPAS) team conducted the biannual Post-Closure Site Inspection of the Dona Ana Rubble Pit Landfill, Solid Waste Management Unit (SWMU) No.27/FTBL-012 per NMED letter dated October 30, 2007. The correspondence indicated that the following information must be included in the site inspection; observations of the final cover and side slopes, the surface water drainage system, and vegetative cover conditions. The correspondence also indicated that any damage to cover material and side slopes must be noted and repaired. Capped areas experiencing subsidence must be re-graded with additional soil as needed to maintain site drainage if subsidence has occurred. .

SUBJECT: DPW- Environment Division EPAS Inspection.

Facility Name: SWMU-27

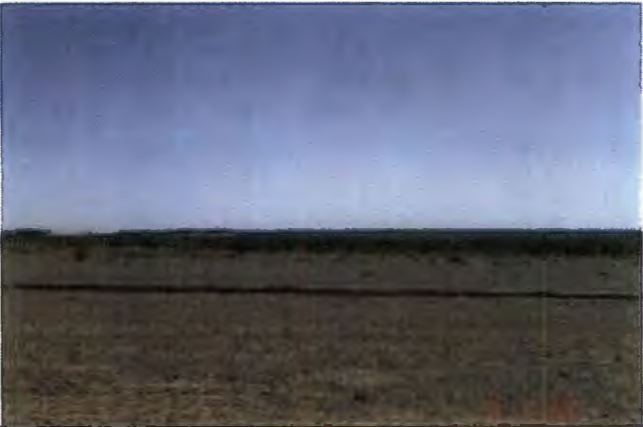
| Observation #2 | Very healthy vegetation |

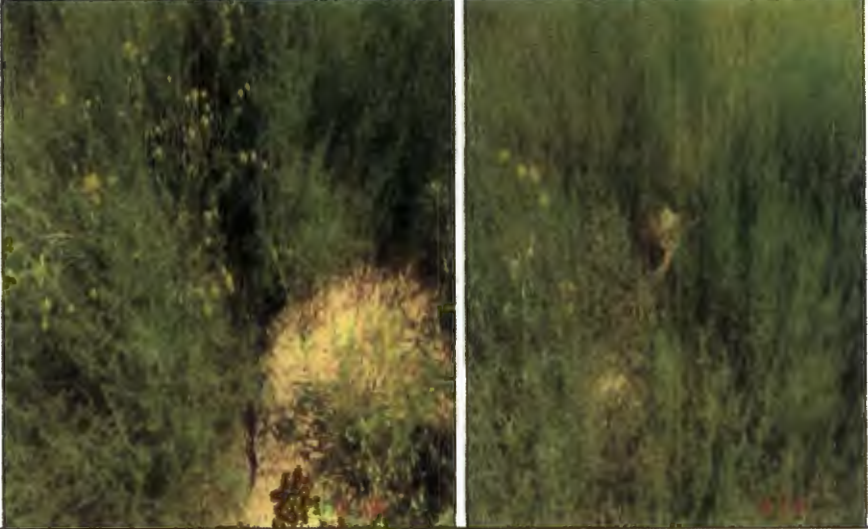
- 1. Observation:** Erosion was found on the North Side of the Landfill. Vegetation was covering erosion.
- 2. Observation:** Vegetation was very healthy in the middle and edges of the landfill.
- 3. Observation:** Fence surrounding landfill and entrance gate did not have any deficiencies.

| Observation #1 | Vegetation was covering erosion. |

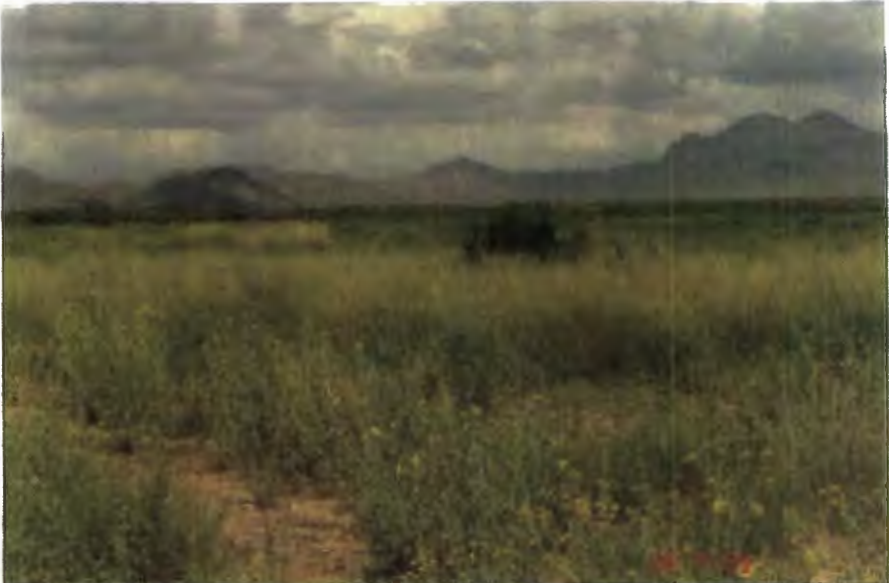
| Observation #2 | Very healthy vegetation |
