On April 28, 2011, and on November 4, 2011, the DPW-Environment Division Environmental Performance Assessment System (EPAS) team conducted the biannual Post-Closure Site Inspection of the Dona Ana Rubble Pit Landfill, Solid Waste Management Unit (SWMU) No.27/FTBL-012 per NMED letter dated October 30, 2007. The correspondence indicated that the following information must be included in the site inspection; observations of the final cover and side slopes, the surface water drainage system, and vegetative cover conditions. The correspondence also indicated that any damage to cover material and side slopes must be noted and repaired. Capped areas experiencing subsidence must be re-graded with additional soil as needed to maintain site drainage if subsidence has occurred. .

ENVIRONMENTAL PERFORMANCE ASSESSMENT

Facility Name: SWMU-27

Facility Name: Dona Ana Rubble Landfill

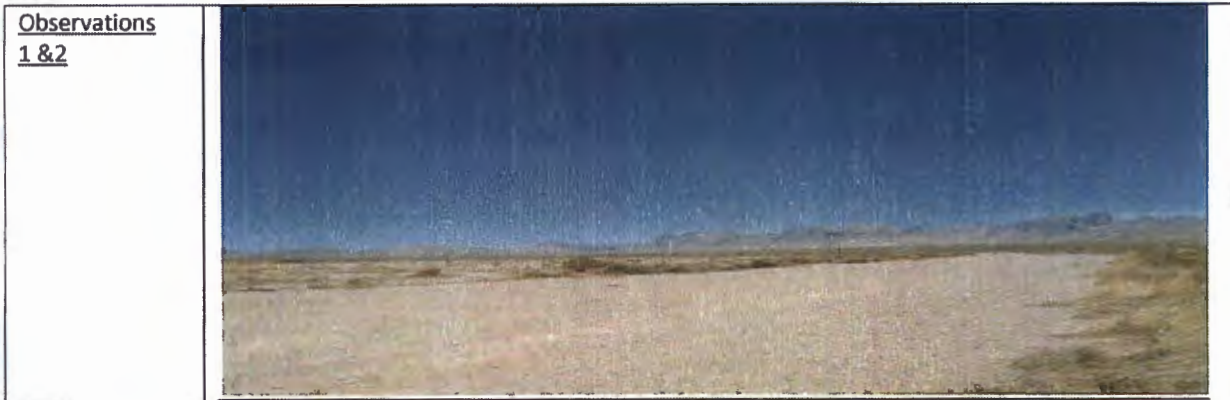
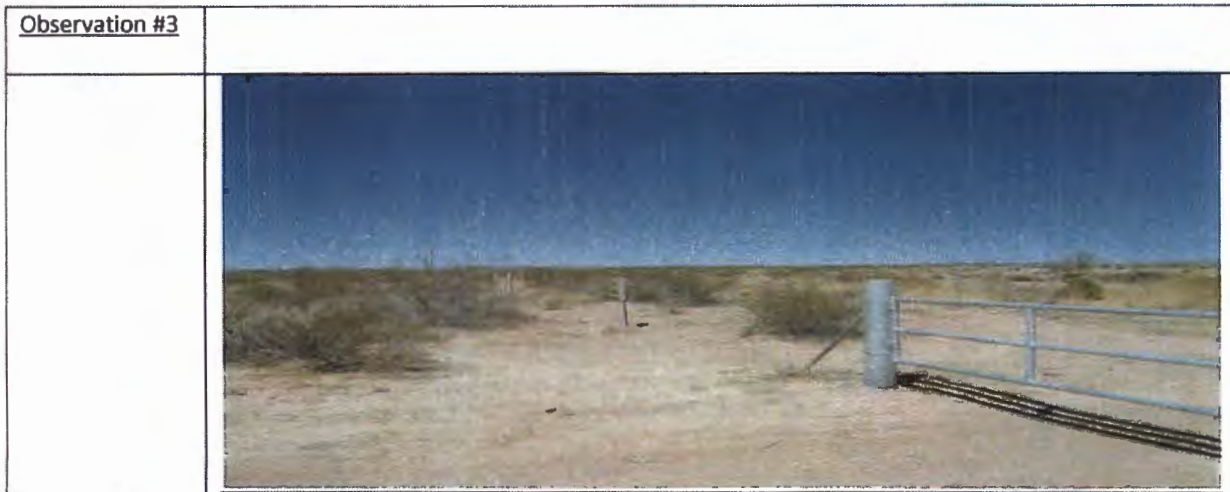
1. Positive Observation: Erosion was not found at this landfill.
2. Positive Observation: Vegetation is very healthy on the surrounding area of the landfill and on the final cover.
3. Positive Observation: Gate and fences were in good condition.

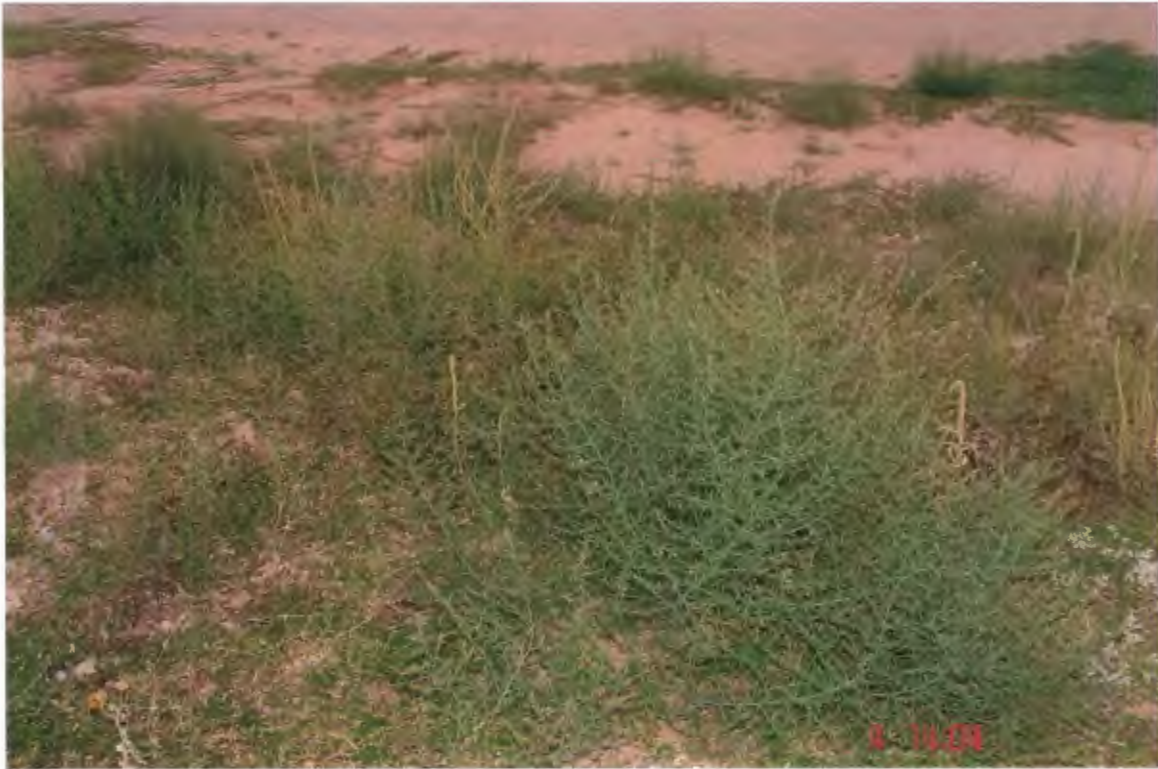
### 1. Positive Observations: On the 4 October 2011, (Before)

- A. The cap on the landfill is in very good condition.
- B. The vegetation is robust.
- C. The fence and gates are in good condition
