On April 13, 2012, the Directorate of Public Works, Environmental Division conducted the annual Post-Closure Site inspection of the McGregor Range Camp Landfill, Solid Waste Management Unit (SWMU) No. 18/FTBL-013 as per NMED letter dated June 12, 2007. The correspondence indicated that the following information must be included in the site inspection; observations of the run-on controls, landfill cover and submit photographs and descriptions of the site to NMED annually.

**McGregor Range Camp Rubble Landfill Inspection
SWMU-18/FTBL-013**

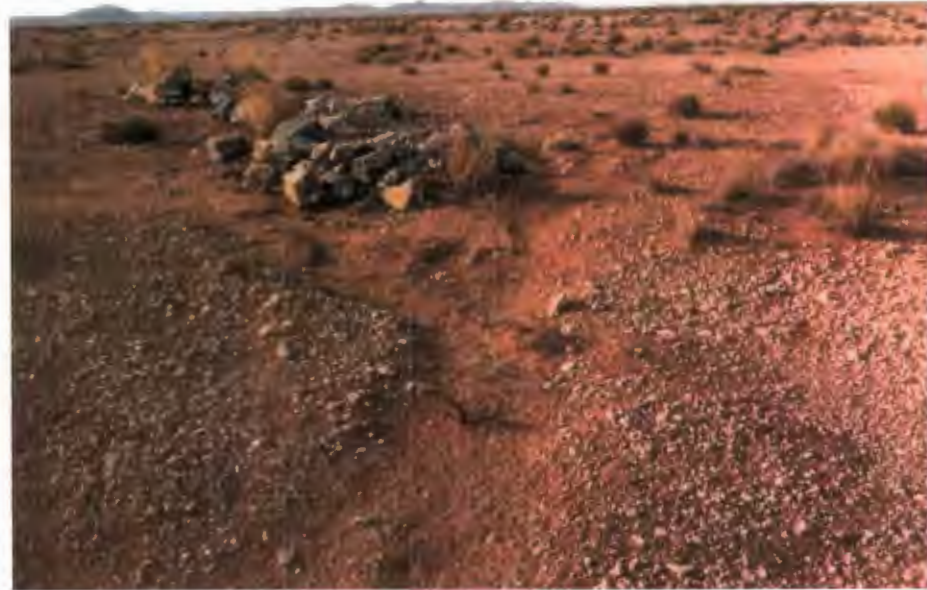
Observations #1 and #2

Observation: A small amount of erosion was found on the extreme southwest portion of SWMU-18 / FTBL-013; however there is no subsidence and/or erosion on the cover of the landfill.

Observation: Vegetation is very healthy on the surrounding area of the landfill and on the final cover.

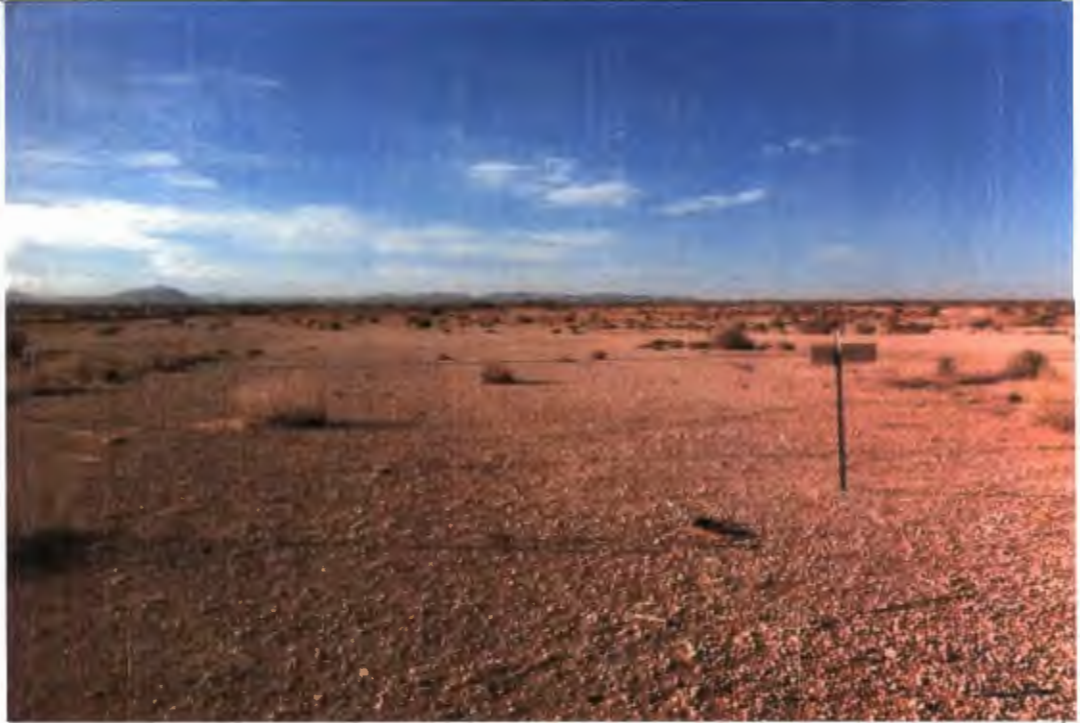
Observation #3

Signage was in good condition. The fence on the southern portion of SWMU-18 / FTBL-013 shows signs of sagging, however, in January 2013 the entire fence around this landfill will be restrung and tightened.
