On April 17, 2012, the Directorate of Public Works, Environmental Division conducted the annual Post-Closure Site inspection of the Dona Ana Range Camp Landfill, Solid Waste Management Unit (SWMU) No. 29/FTBL-011 as per NMED letter dated May 27, 2008. The correspondence indicated that the following information must be included in the site inspection: observations of the run-on controls, landfill cover and submit photographs and descriptions of the site to NMED annually.

**Dona Range Camp Sanitary Landfill Inspection  
SWMU-29/FTBL-011**

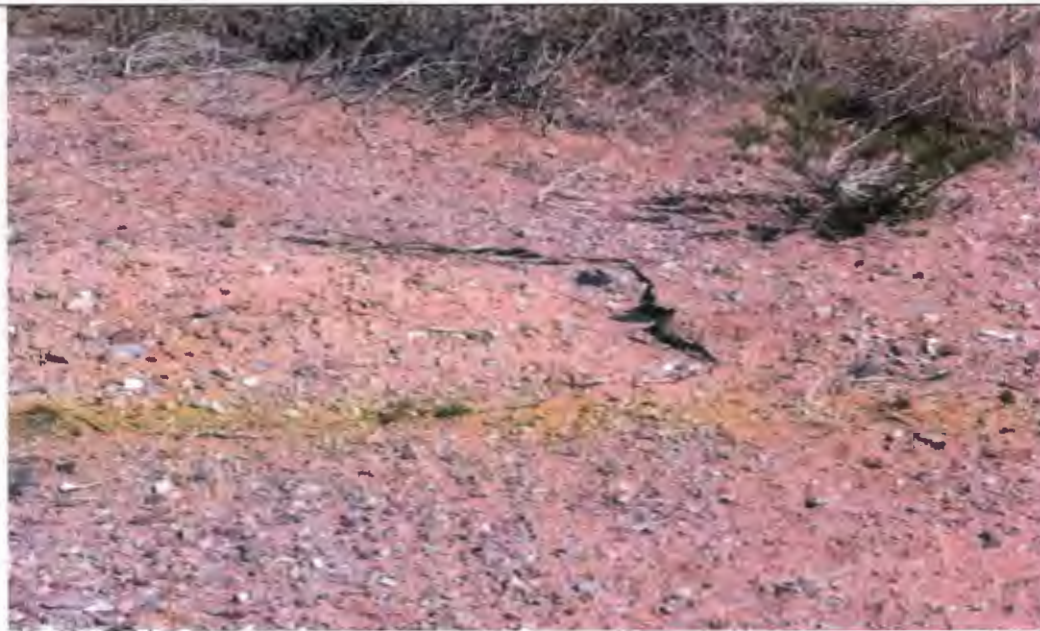
Observations #1

Observation:  
A small amount of erosion was found on SWMU-29 / FTBL-011 landfill. However this erosion is not affecting the capped area.

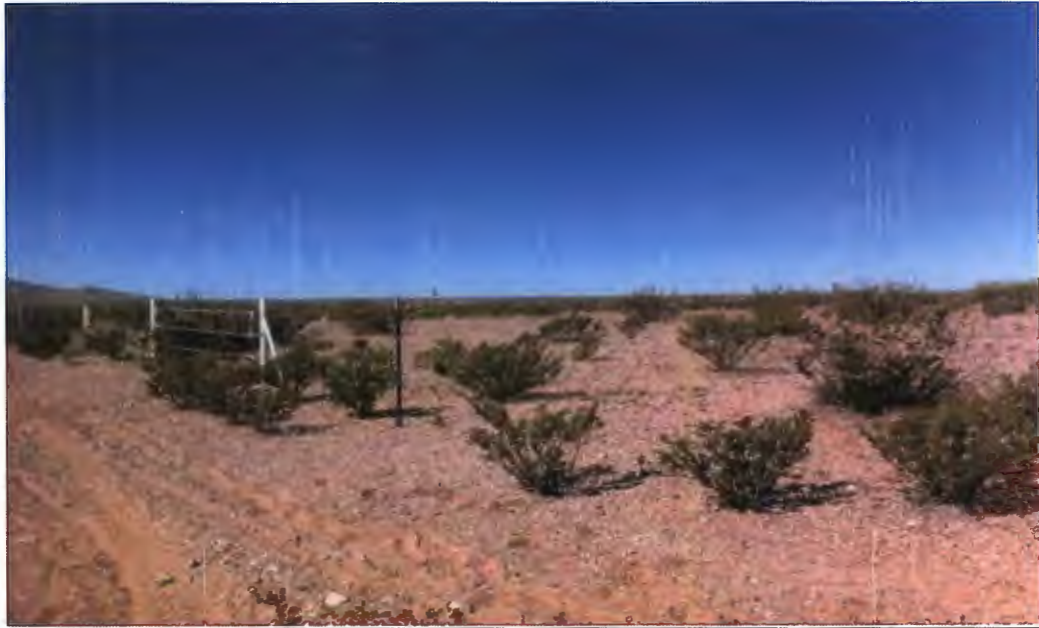
Observation #2

Observation:  
Vegetation is very healthy on the surrounding area of the landfill and on the final cover.

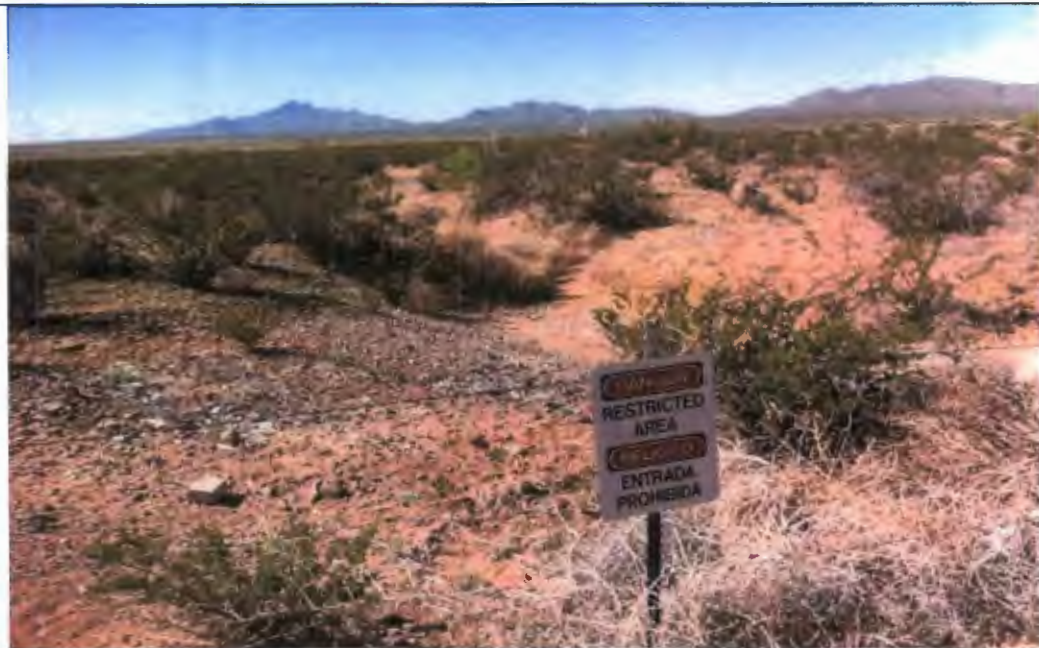
Observation #3

Observation:  
Signage and fences were in good condition
