Dona Range Camp Rubble Landfill Inspection
SWMU-27/FTBL-012

Inspection of 3-16-2012/after rainy season

Facility ID: FTBL-12

Facility Name: SWMU-27

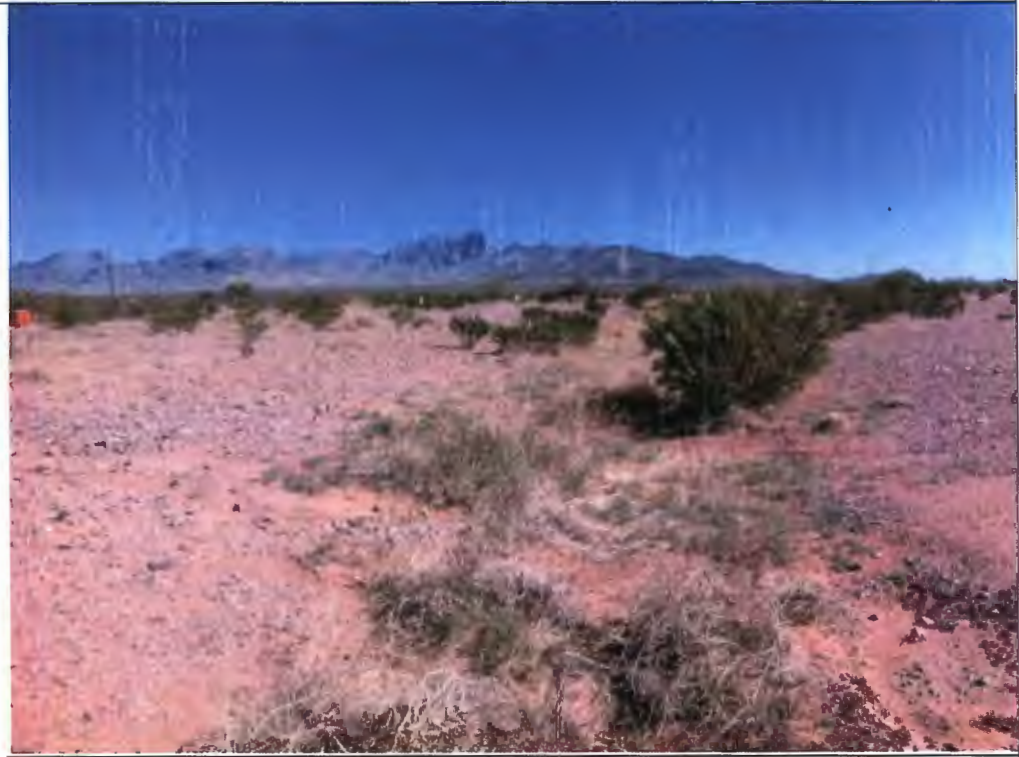
Photo #3

Erosion on the northwest portion of the Don Ana Range Camp Landfill SWMU-27 / FTBL-012.

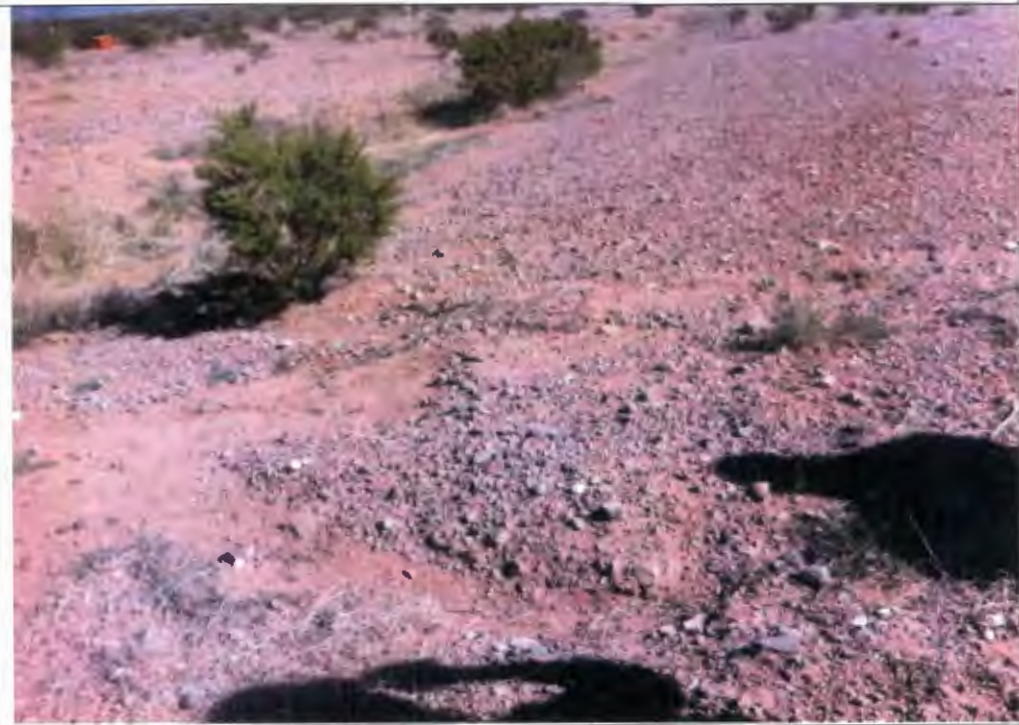
Photo #4

Erosion on the northwest portion of the Don Ana Range Camp Landfill SWMU-27 / FTBL-012.

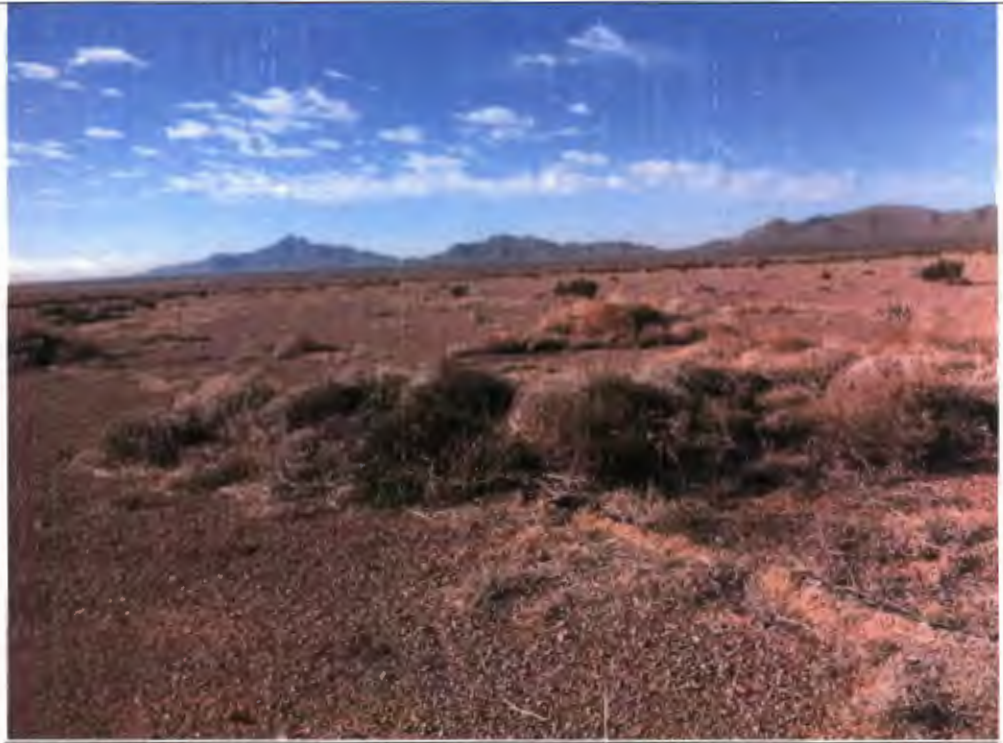
Photo #8

Vegetation is very healthy on the surrounding area of the landfill and on the final cover.
