On May 30, 2013, the Directorate of Public Works, Environmental Division conducted the annual Post-Closure Site inspection of the Dona Ana Range Camp Landfill, Solid Waste Management Unit (SWMU) No. 29/FTBL-011 as per NMED letter dated May 27, 2008. The correspondence indicated that the following information must be included in the site inspection: observations of the run-on controls, landfill cover and submit photographs and descriptions of the site to NMED annually.

Dona Range Camp Sanitary Landfill Inspection
SWMU-29/FTBL-011

Inspection Date: 05-30-2013

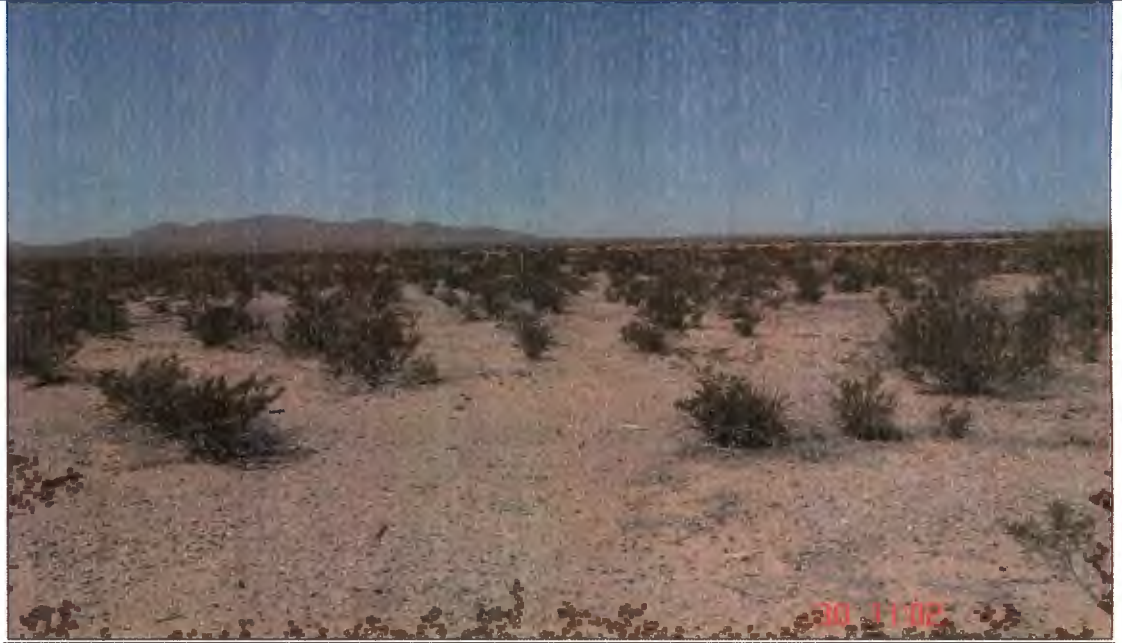
Observation #2

Looking Northwest:
Vegetation condition is healthy on the surrounding area of the landfill and the final cover.

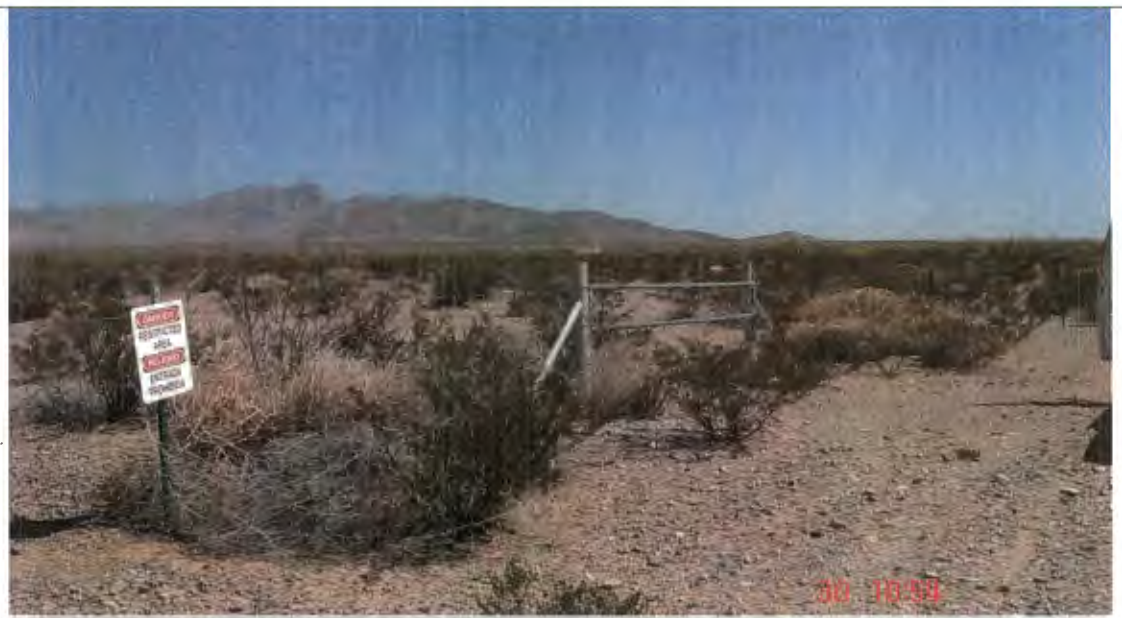
Observation #3

Looking Northwest :
Signage and fences were in good condition
