On May 30, 2013, and on September 25, 2013, the biannual inspections of the landfill were performed by the Directorate of Public Works (DPW) Environment Division. The Post-Closure Site Inspection of the Closed Dona Ana Rubble Pit Landfill #12, Solid Waste Management Unit (SWMU) No.27/FTBL-012 as per NMED letter dated October 30, 2007. The correspondence from NMED indicated that the following information must be included in the site inspection: observations of the final cover and side slopes, surface water drainage system, and vegetative cover conditions. The correspondence also indicated that any damage to cover material and side slopes must be noted and repaired. Capped areas experiencing subsidence must be re-graded with additional soil as needed to maintain site drainage if subsidence has occurred.

**Dona Range Camp Rubble Landfill Inspection
SWMU-27/FTBL-012**

Inspections of May 30, 2013

Inspection after 1 inch rain event July 31, 2013

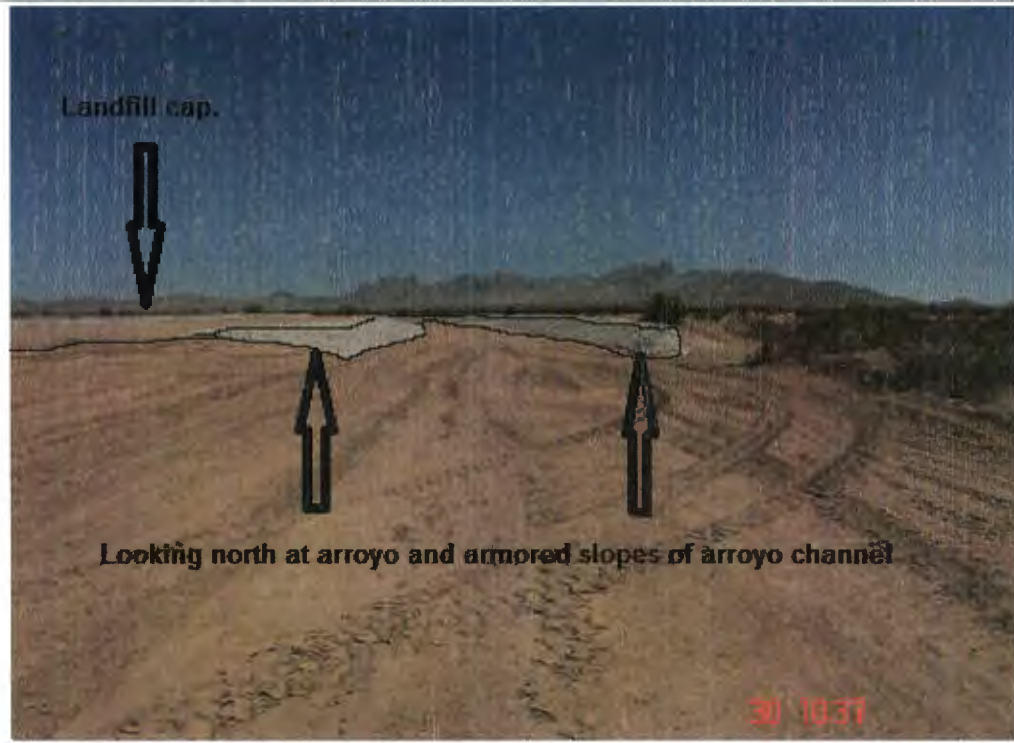
Photo #2

Looking North
The earth work
has been
completed in the
arroyo on the
eastern portion
of Landfill.

Note: Gravel
rocks placed on
side slopes of
arroyo for
protection.

SWMU-27/FTBL-
014 is to the left
in this
photograph.

Looking north at arroyo and armored slopes of arroyo channel

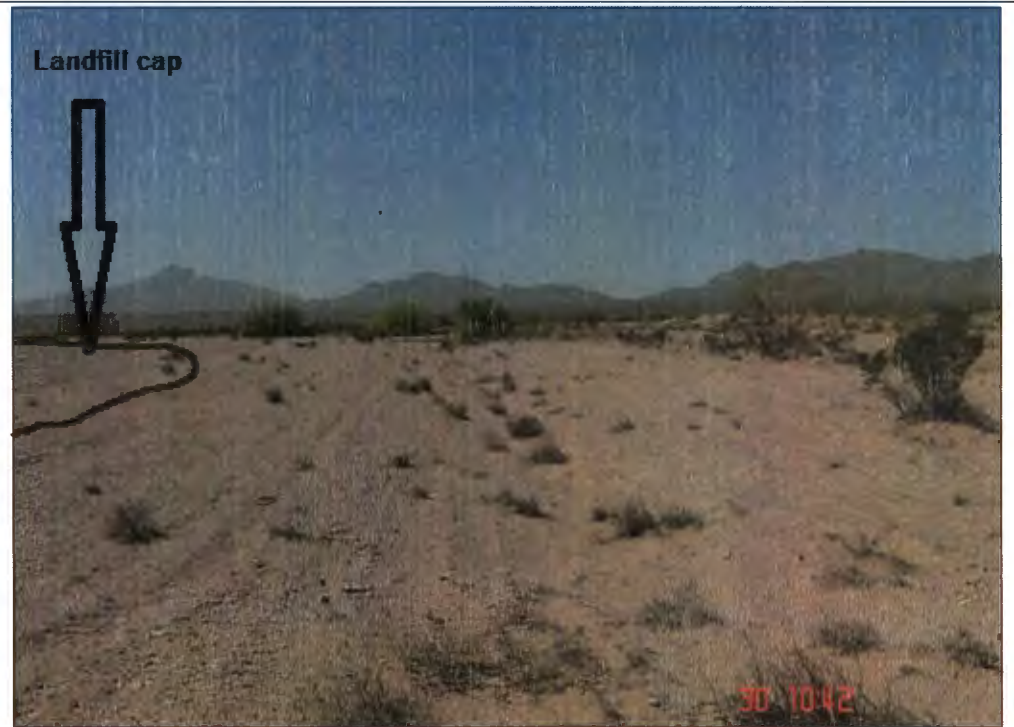
Photo #3

Looking south at
the swale, the
western portion
of Landfill is in
good condition.

Note: A small
amount of re-
grading was
completed this
past year. Also
note vegetation.

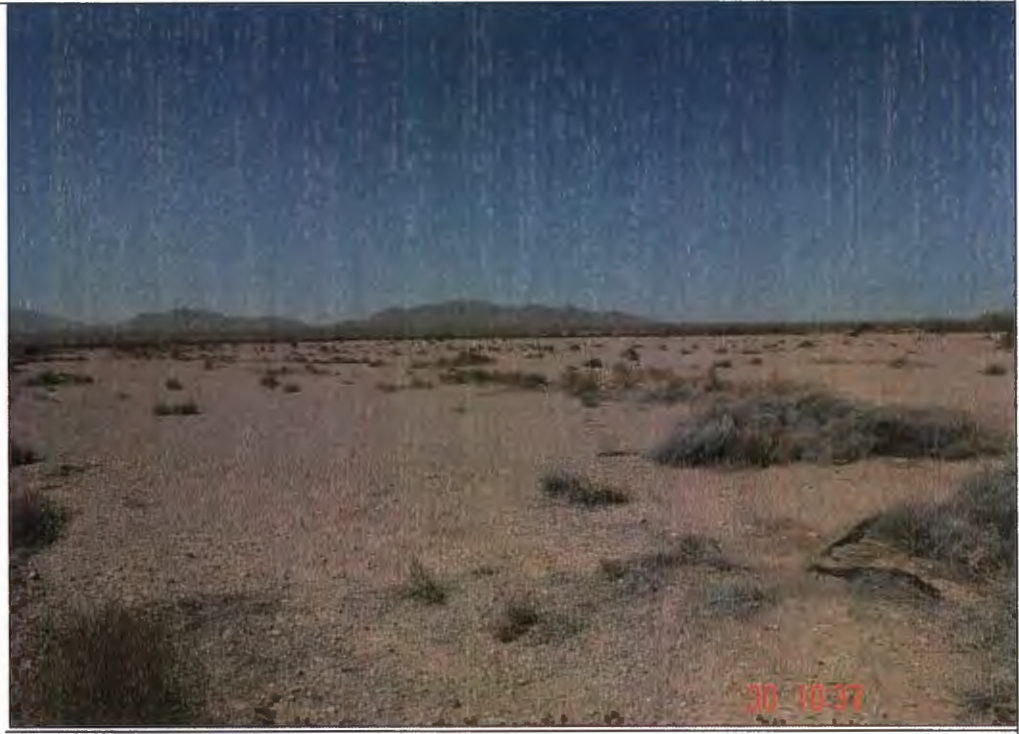
Photo #4

Looking Southwest vegetation is sparse due to the lack of precipitation during the winter and spring months

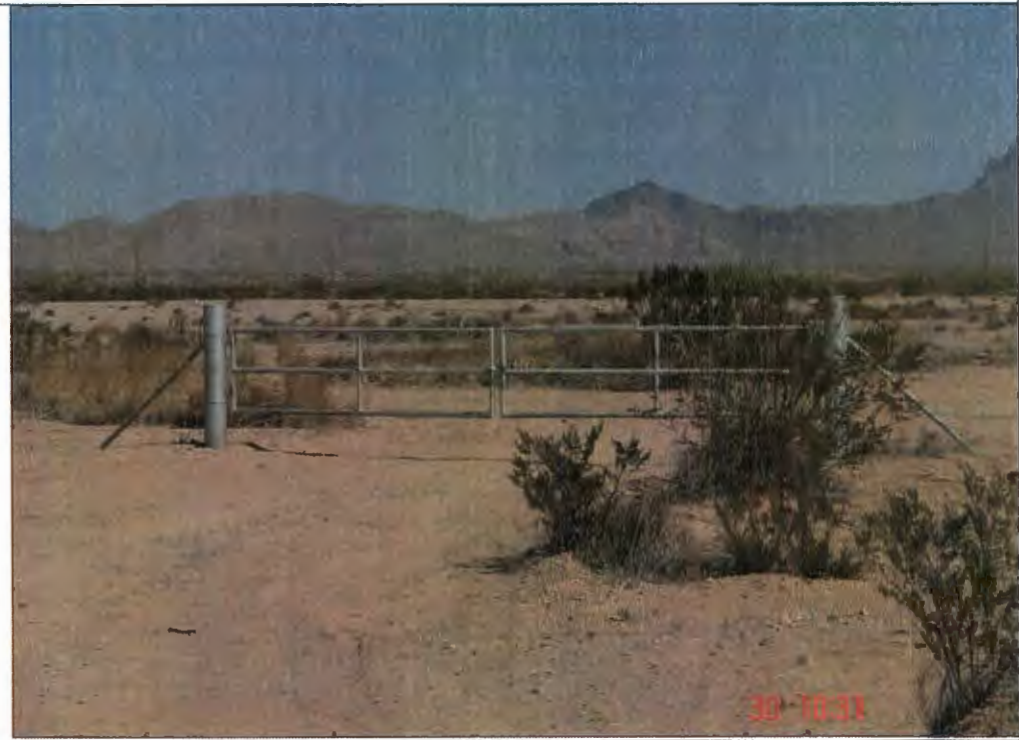
Photo #5

Looking Northwest the gate is in good condition.

Note: Sparse vegetation within the metes and bounds of landfill.

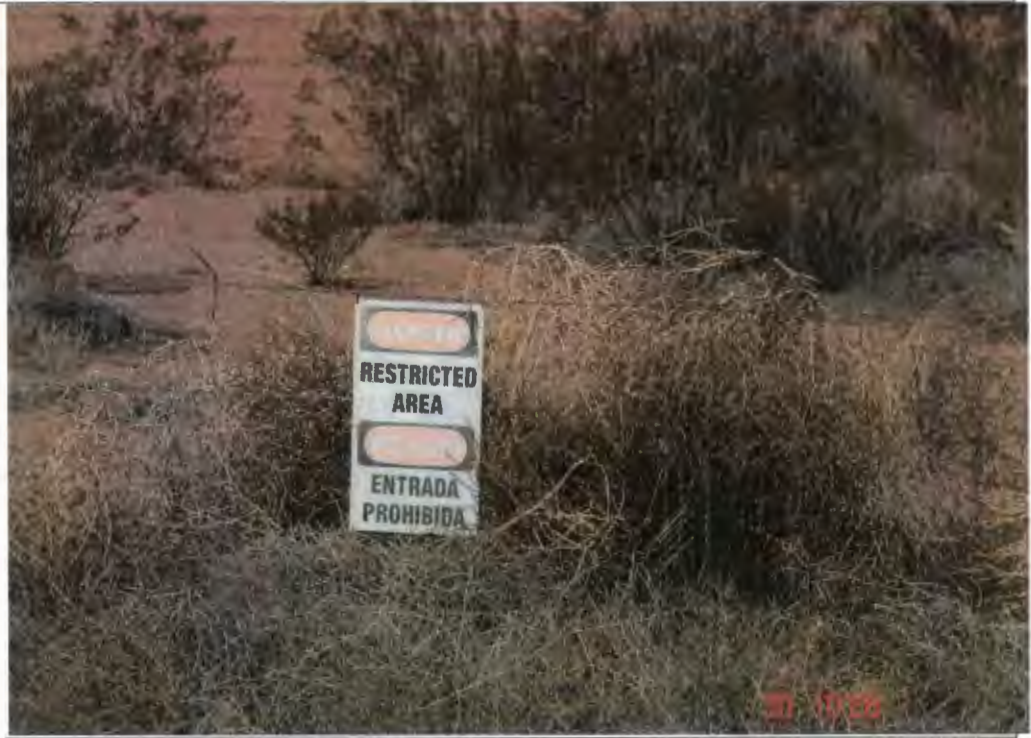
Photo #6

All signage and fencing around landfill are in good condition.

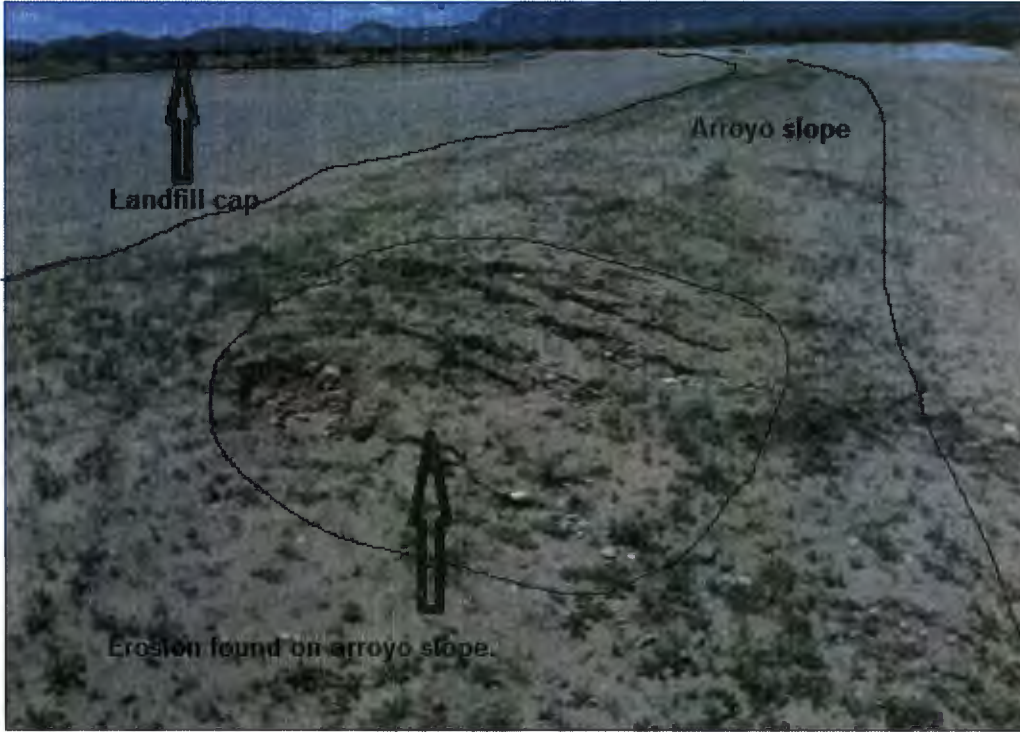
Photo #1	
<p data-bbox="203 1129 418 1375">South side slope of arroyo. Note this erosion is in the channel of the arroyo and does not affect the cap.</p> <p data-bbox="203 1417 418 1549">Note vegetation on the slope, this will help stabilize soil.</p>

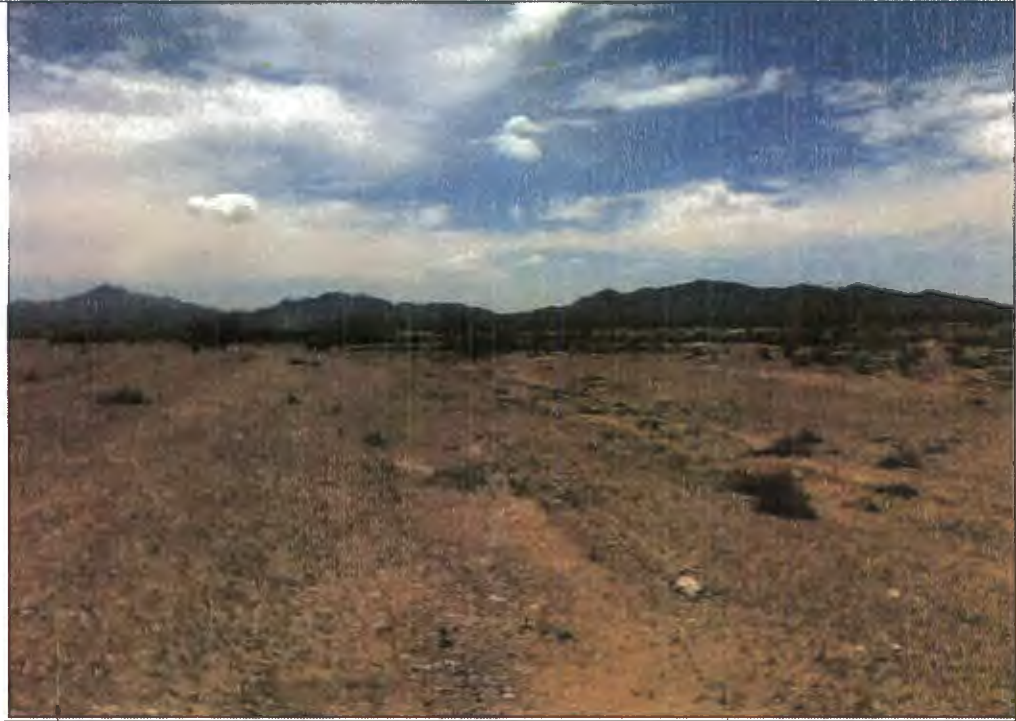
Photo #4

Looking south across landfill a minimal amount of vegetation on capped area is visible.

Note: At this time of year the vegetation is minimal, however the rainy season has begun and vegetation will begin to flourish.

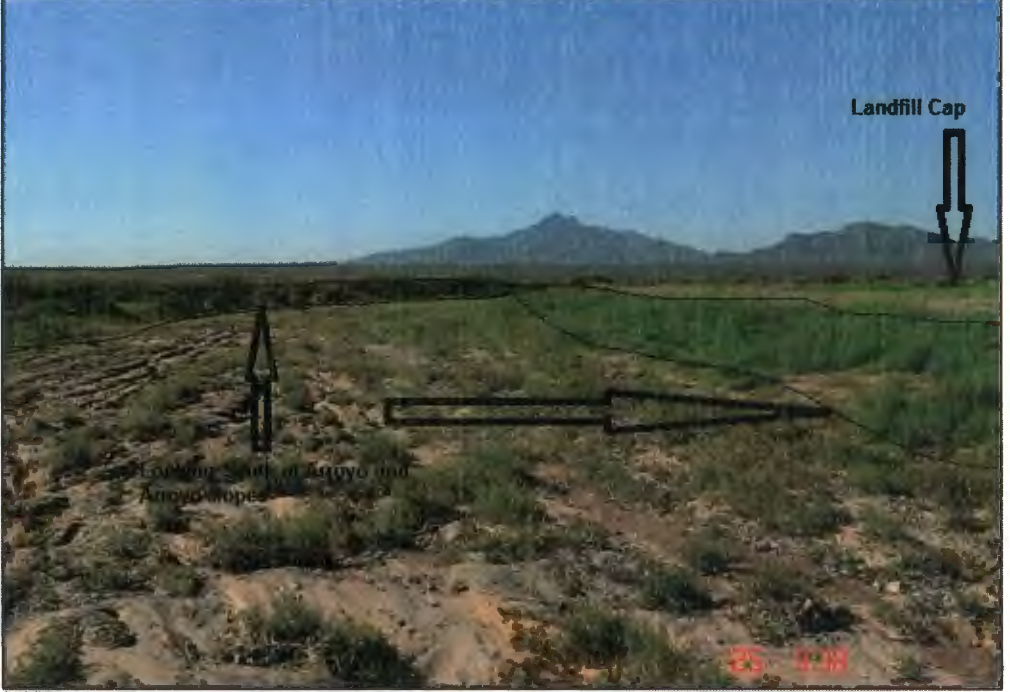
Photo #1	
<p>Looking South The earth work in the arroyo slopes in the eastern portion of SWMU-27/FTBL-012.</p> <p>Note the large amount of vegetation on the slope of the arroyo and the landfill.</p> <p>Note: SWMU-27/FTBL-014 cap is to the right in this photograph.</p>

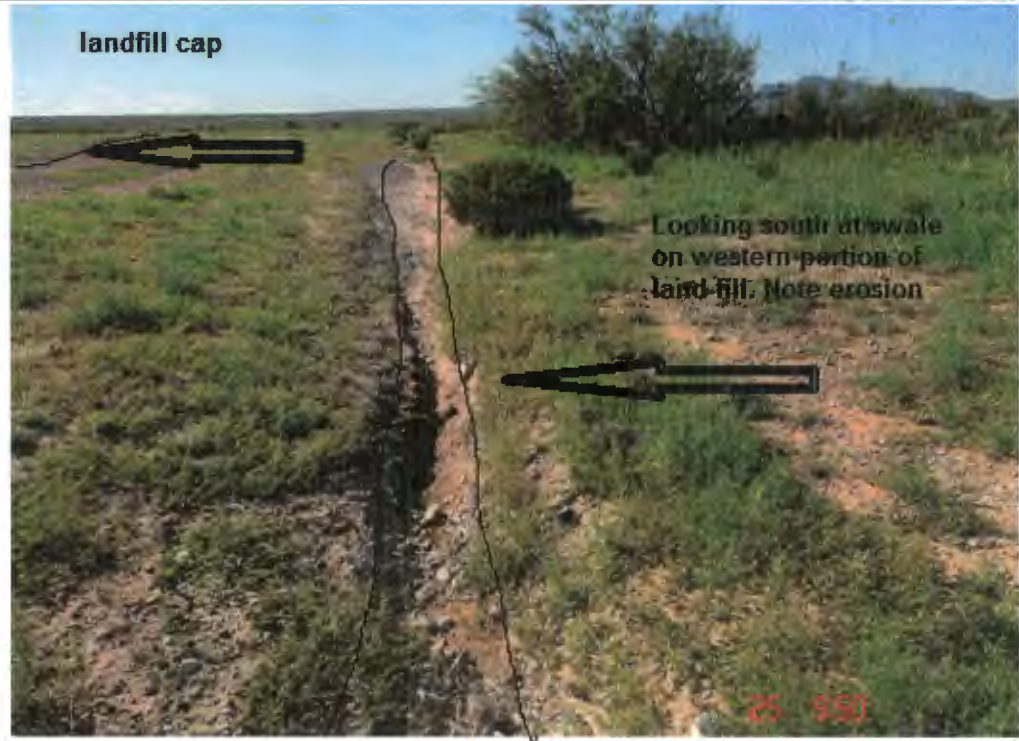
Photo #6

Looking south the swale has begun to down cut as it begins to exist the metes and bounds of the landfill, however this down cutting does not affect the cap. The swale will be repaired by next inspection.

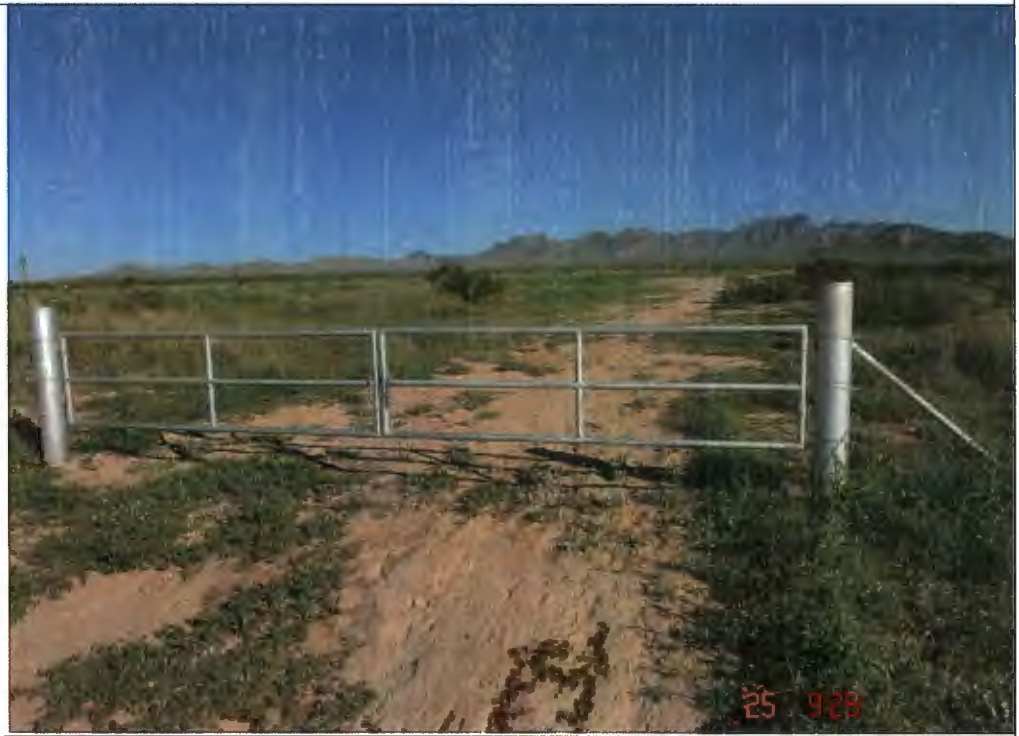
Photo #7

The gate and fencing around landfill are in good condition.

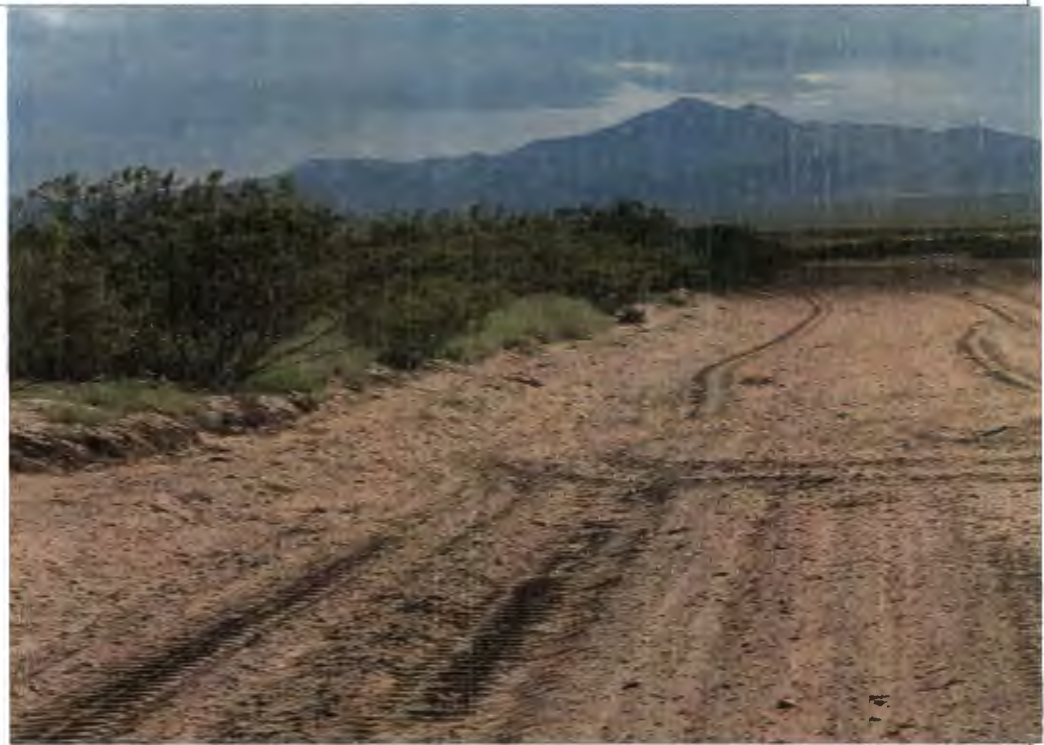
Photo #1

Looking South at completed earth work in the arroyo slopes in the eastern portion of the landfill. Photo taken on 11/6/2013.

Note: The capped area is approximately 150 feet to the right in this photograph.

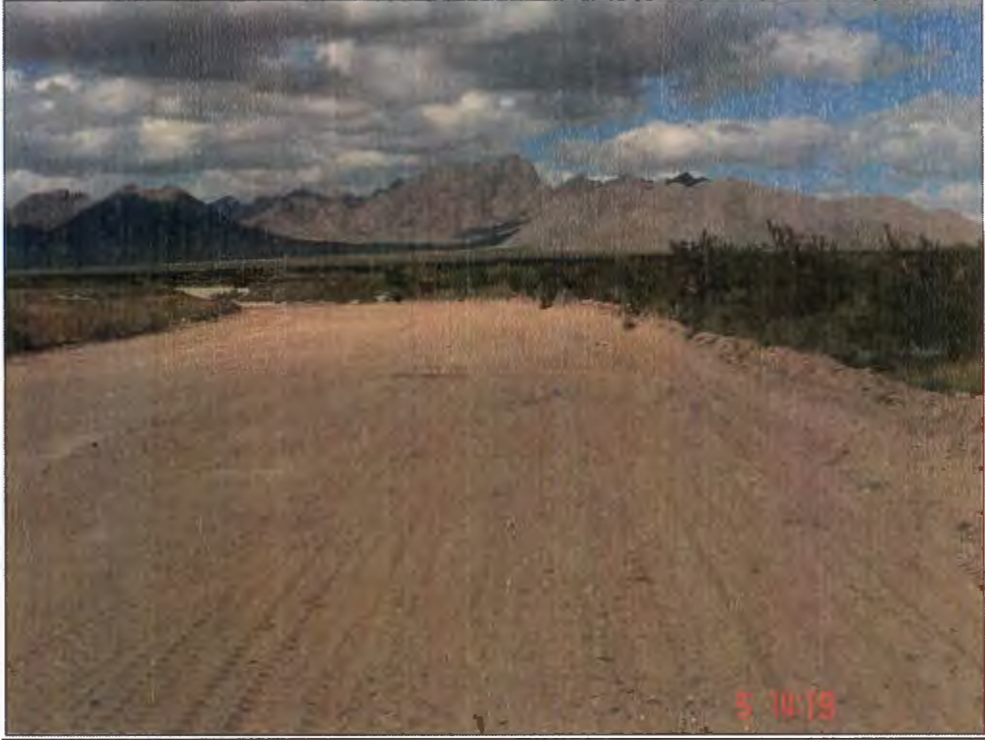
<p><u>Photo #2</u></p>

<p>Looking North The earth work has been completed in the arroyo on the eastern portion of the landfill. Photo taken on 11/6/2013.</p> <p>Note: The capped area is approximately 150 feet from the arroyo. The landfill is to the left in this photograph.</p>
