**Dona Range Camp Rubble Landfill Inspection
SWMU-27/FTBL-012**

Inspection Date: After rain even and after the rainy season:10-02-2014

Facility ID: SWMU-27/FTBL-012

Facility Name: Dona Ana Range Camp Rubble Landfill #12

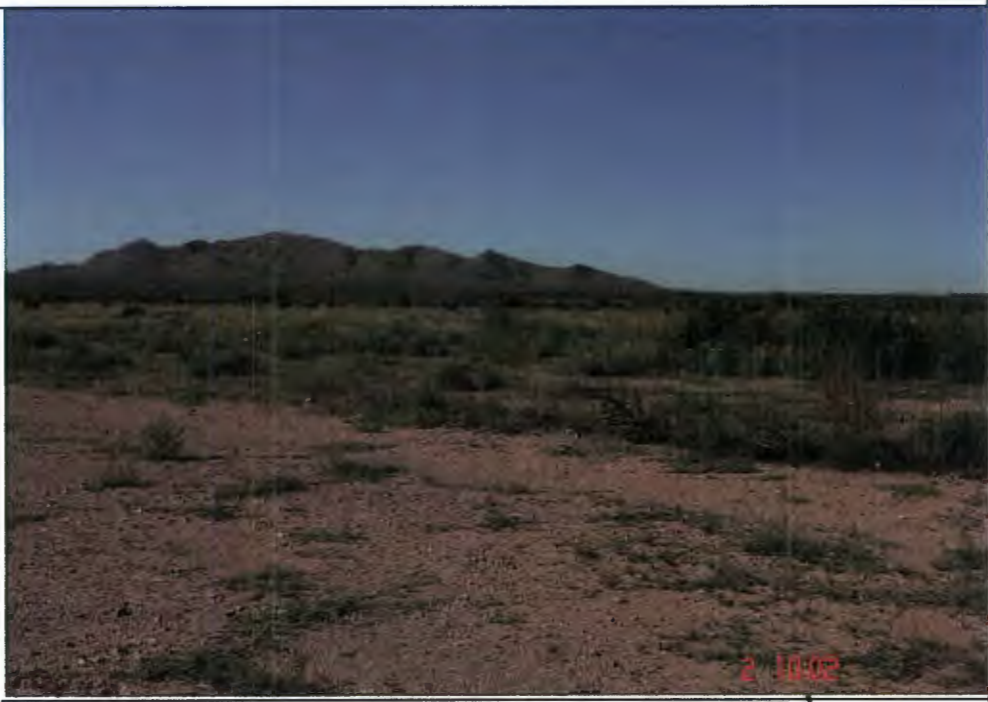
Observation #1 & 2	
<p>Observation: Looking southwest at arroyo on the east side of SWMU-27 / FTBL-012 landfill. There is no erosion present.</p> <p>Observation: Vegetation is very healthy on the surrounding area of the landfill and on the final cover.</p>
