On June 19, 2014, the Directorate of Public Works, Environmental Division conducted the annual Post-Closure Site inspection of the Dona Ana Range Camp Sanitary Landfill, Solid Waste Management Unit (SWMU) No. 29/FTBL-011 as per NMED letter dated May 27, 2008. The correspondence indicated that the following information must be included in the site inspection; observations of the run-on controls, landfill cover and submit photographs and descriptions of the site to NMED annually.

**Dona Ana Range Camp Sanitary Landfill Inspection  
SWMU-29/FTBL-011**

Inspection Date: 06-19-2014

Facility ID: SWMU-29/FTBL-11

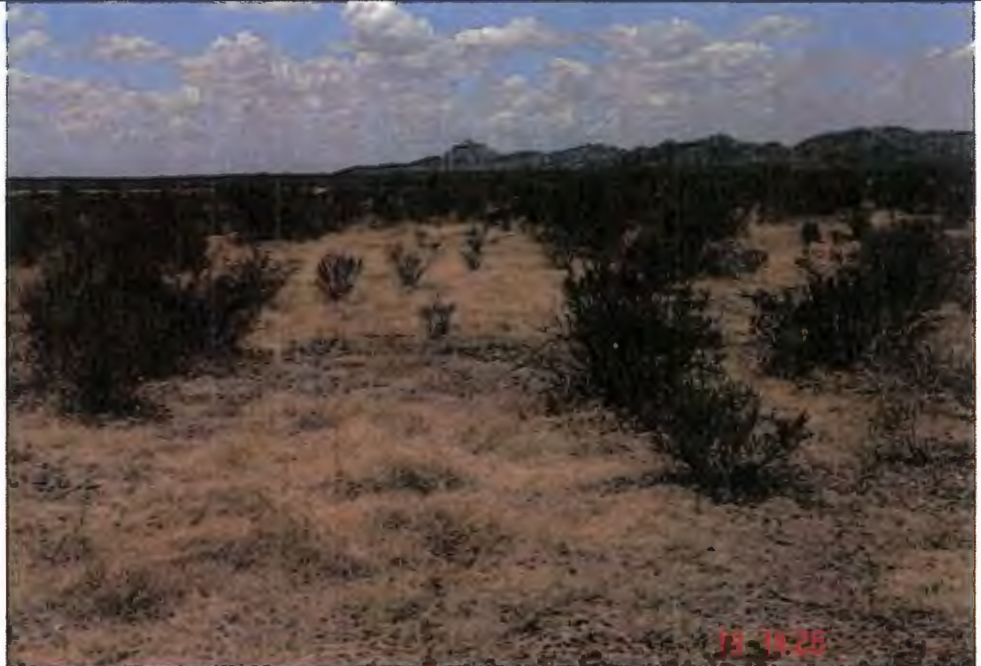
Observations #1	
Observation: Looking north across SWMU- 29 / FTBL-011 landfill.. The cover was found to be in very good condition. Note : The ground vegetation on final cover.

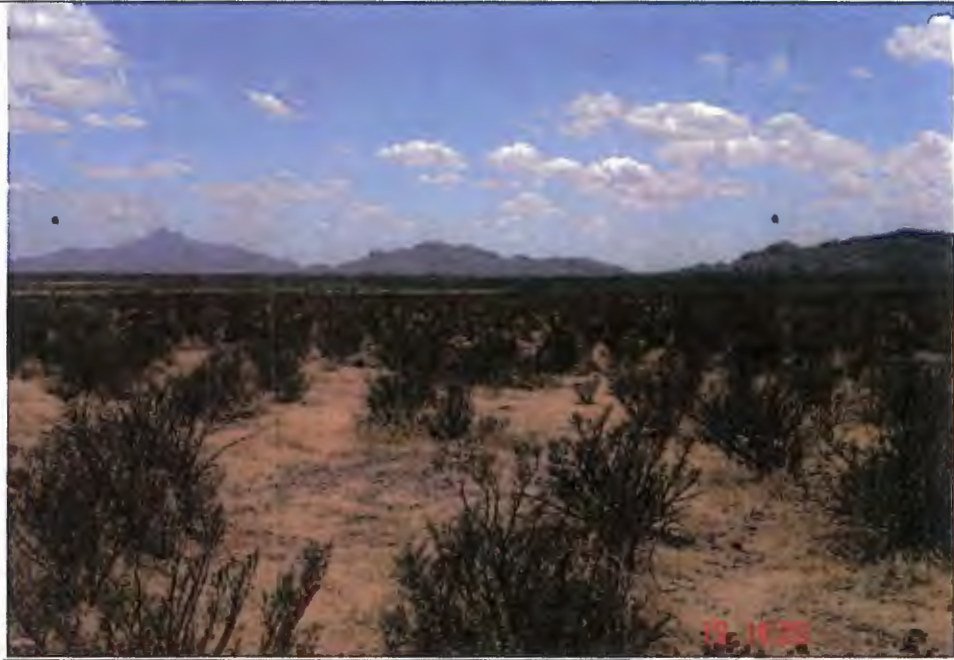
<p><b>Observation #2</b></p> <p><b>Observation:</b> Looking southwest across SWMU-29 / FTBL-011 landfill. The Vegetation is very robust on the final cover.</p>

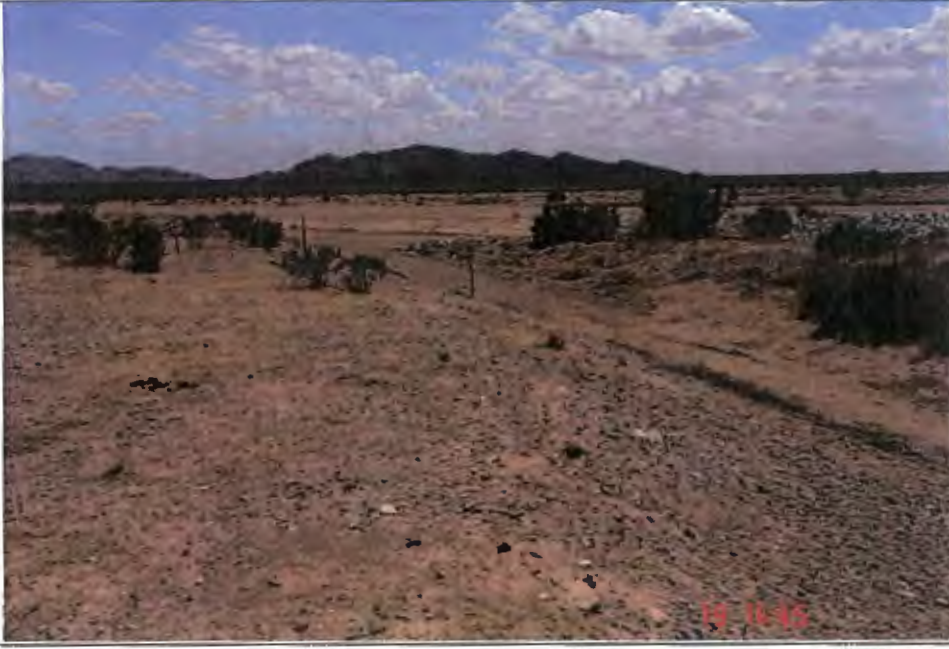
Observation #4

Observation: Looking west SWMU-29 / FTBL-011 the Run-off control to the north of the landfill is in very good condition

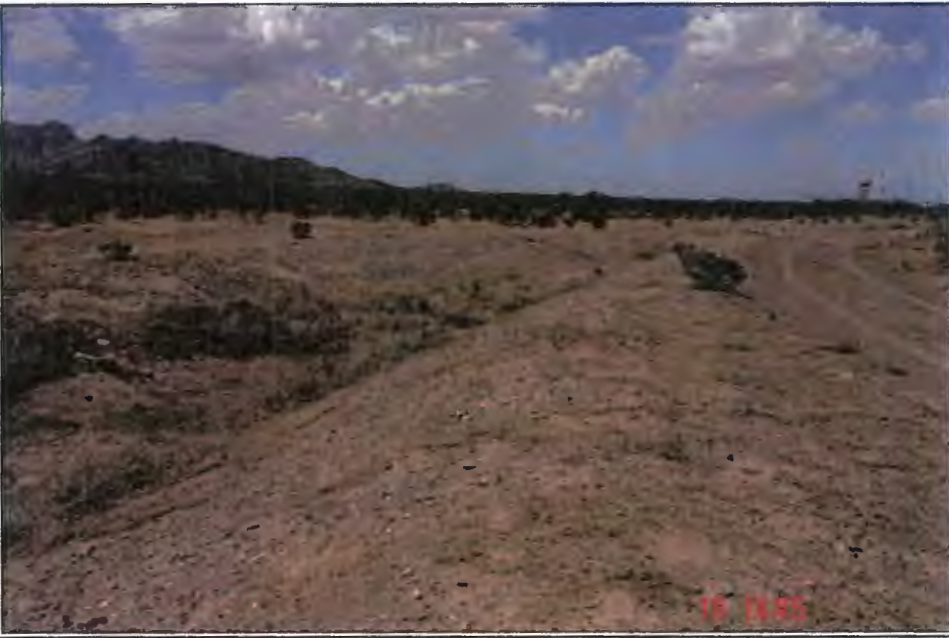
Observation #4

Observation: Looking east SWMU-29 / FTBL-011 the Run-off control to the north of the landfill is in very good condition
