On June 1, 2016, the Fort Bliss Directorate of Public Works, Environmental Division (DPW-ED) conducted the annual post-closure site inspection of the McGregor Range Camp Landfill, Solid Waste Management Unit (SWMU) 18/FTBL-013. The inspection was conducted in accordance with the requirements stated in the New Mexico Environmental Department (NMED) Hazardous Waste Bureau letter, dated June 12, 2007.

McGregor Range Camp Landfill - Inspection

SWMU-18/FTBL-013

Inspection Date: June 1, 2016

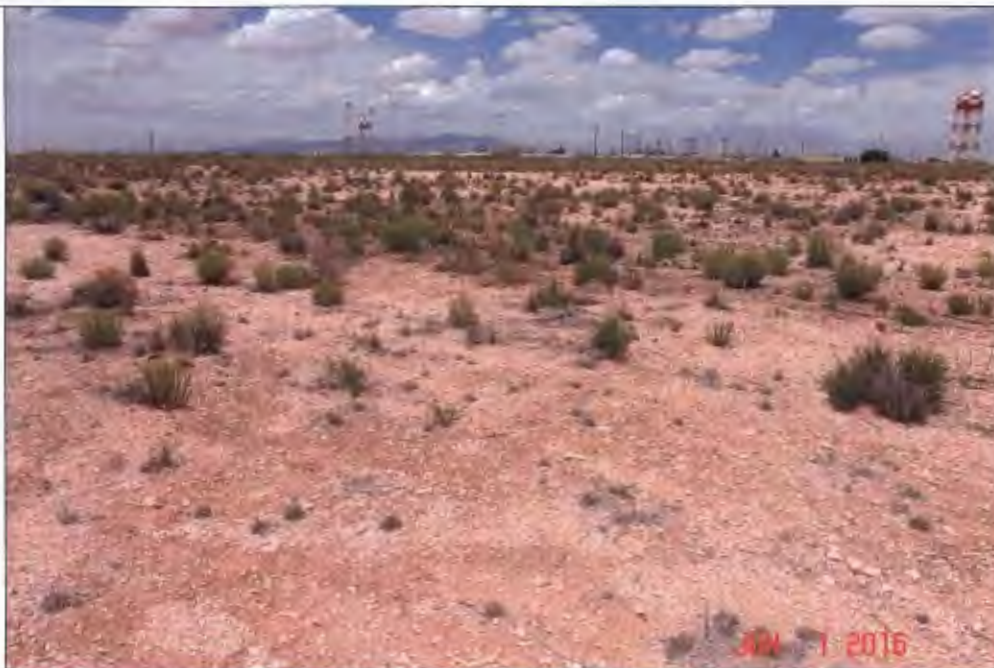
Photograph No. 1

View of landfill cap facing North.

No signs of erosion or depressions on the landfill cap. The vegetative layer was in good condition.

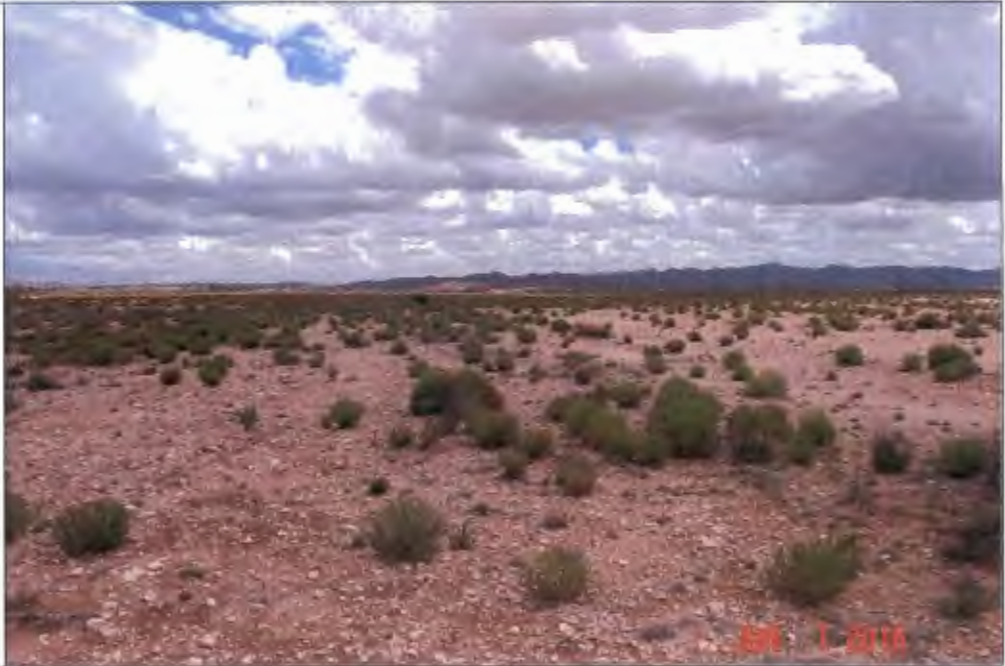
Photograph No.2

View of landfill cap facing East.

No signs of erosion or depressions on landfill cap. The vegetative layer was in good condition.

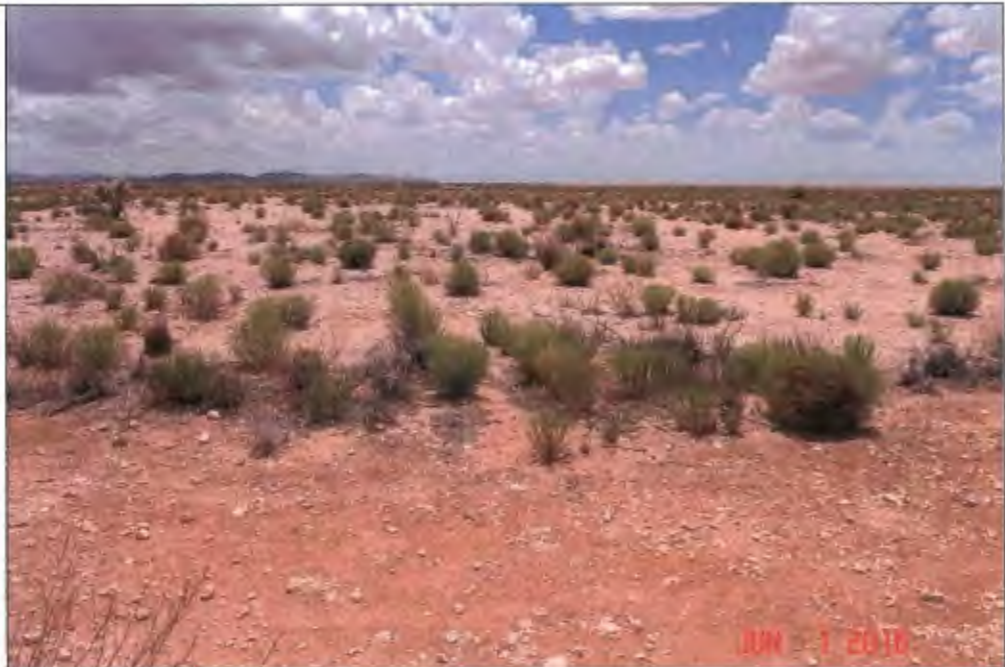
Photograph No. 3

View of landfill cap facing South.

No signs of erosion or depressions on landfill cap. The vegetative layer was in good condition.

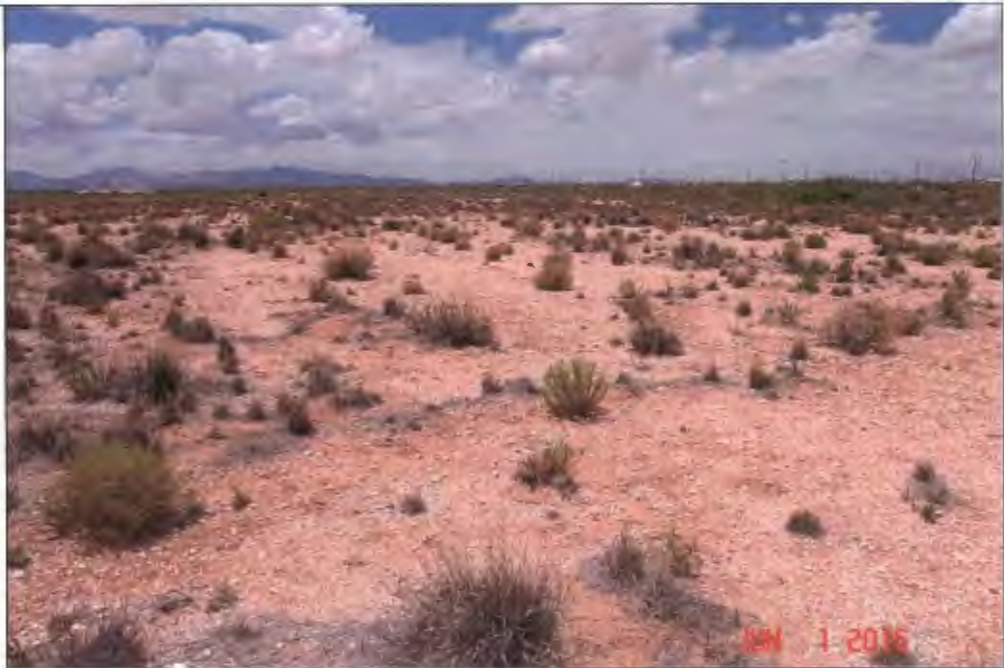
Photograph No. 4

View of landfill cap facing West.

No signs of erosion or depressions on landfill cap. The vegetative layer was in good condition.

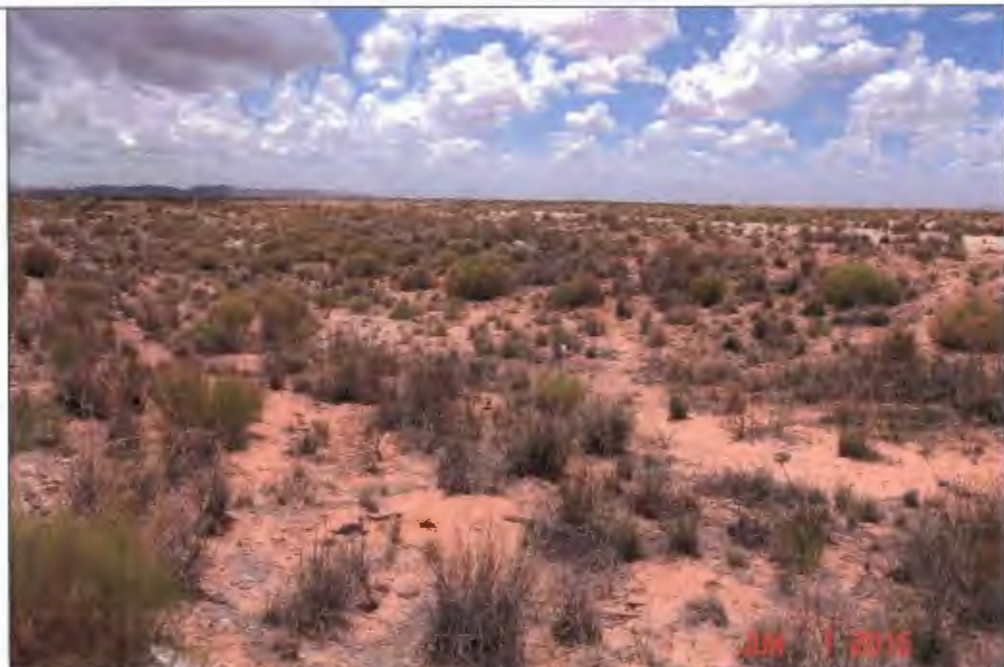
Photograph No. 5

View of arroyo facing South.

No evidence of erosion or surface depression on arroyo.

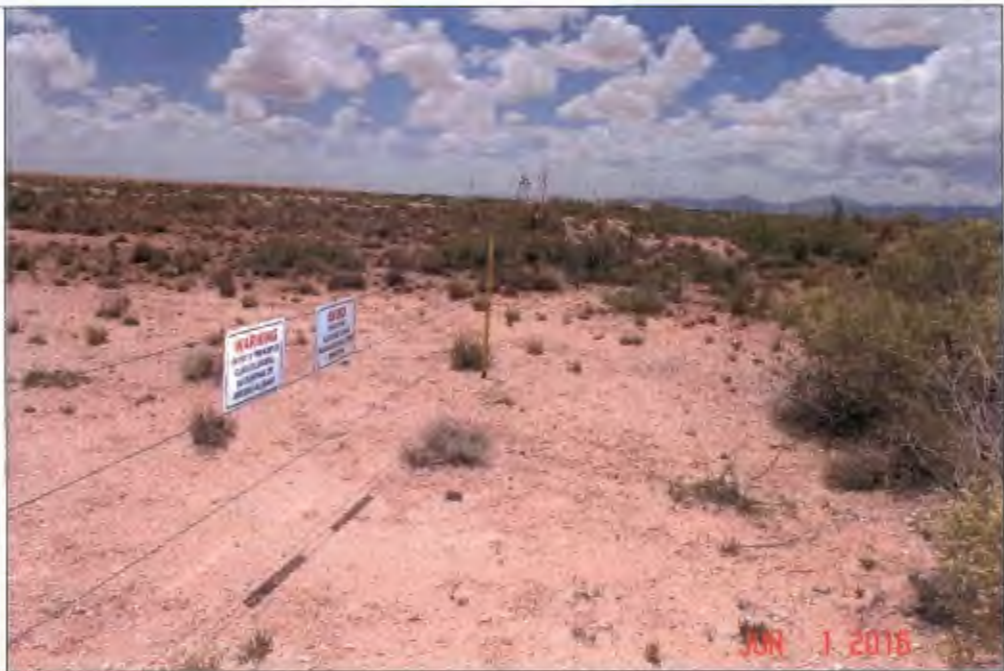
Photograph No. 6

Northern fence
facing West.

Site perimeter fence
and warning signs
remain in good
condition.

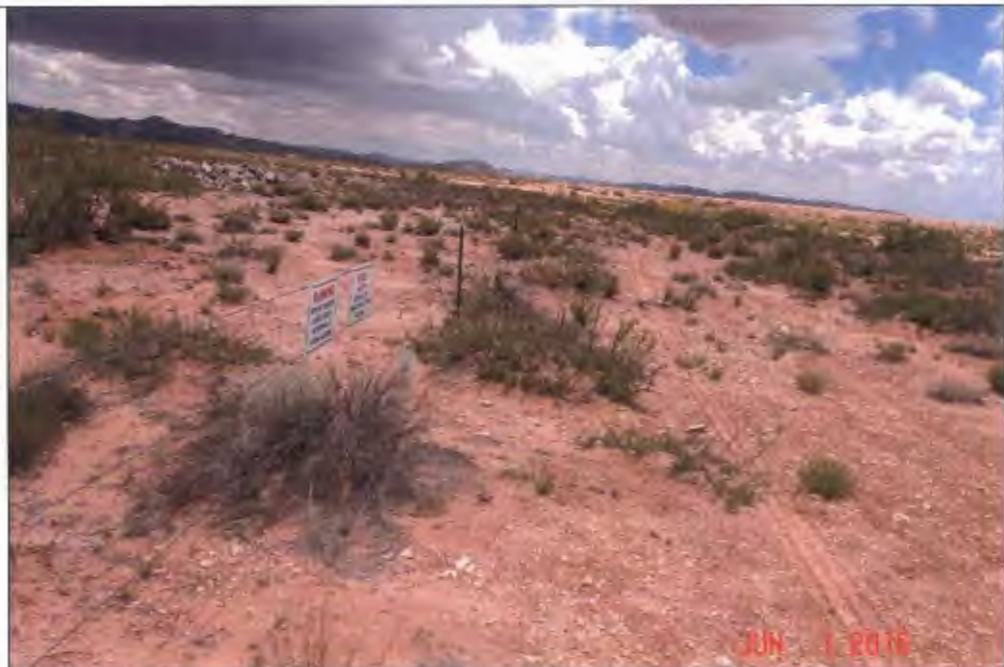
Photograph No. 7

Western fence
facing South.

Site perimeter fence
and warning signs
remain in good
condition.
