**DEPARTMENT OF THE ARMY**  
US ARMY INSTALLATION MANAGEMENT COMMAND  
HEADQUARTERS, UNITED STATES ARMY GARRISON, FORT BLISS  
1741 MARSHALL ROAD  
FORT BLISS, TEXAS 79916

On June 1, 2016, the Fort Bliss Directorate of Public Works, Environmental Division (DPW-ED) conducted the biennial post-closure site inspection of the McGregor Range Open Detonation (OD) area, Solid Waste Management Unit (SWMU) 20/FTBL-015. The inspection was conducted in accordance with the requirements stated in the New Mexico Environmental Department (NMED) Hazardous Waste Bureau letter, dated October 7, 2009.

Enclosure 2:  
McGregor Range Open Detonation Area Inspection

# McGregor Range Open Detonation (OD) Site SWMU-20/FTBL-015

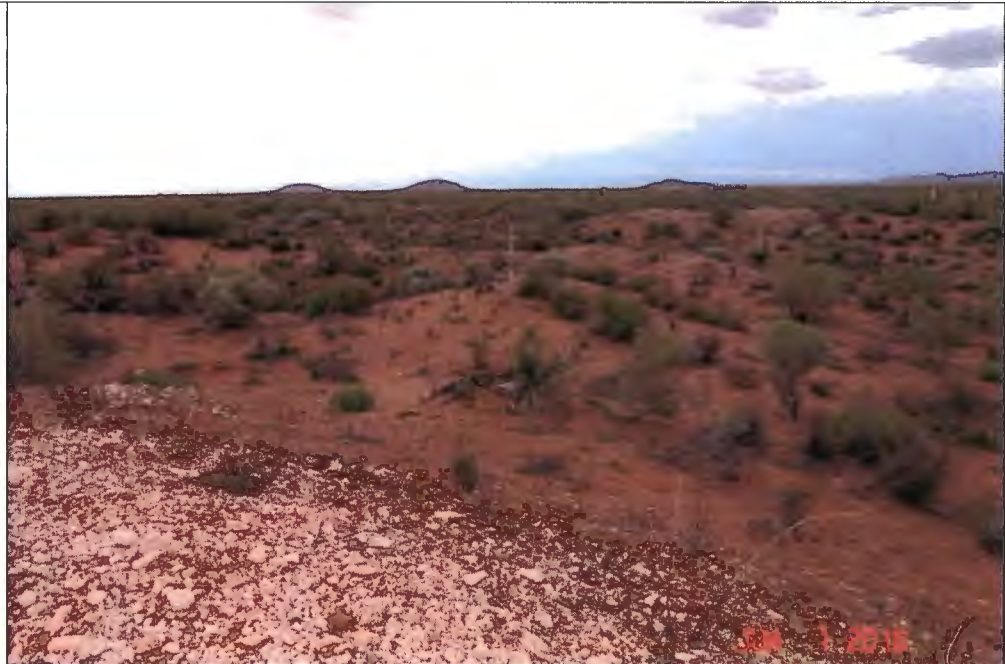
### Photograph No. 1

**SWMU-20/FTBL-015, Area A.**

No MPPEH was discovered and no signs of land erosion or depression were identified.

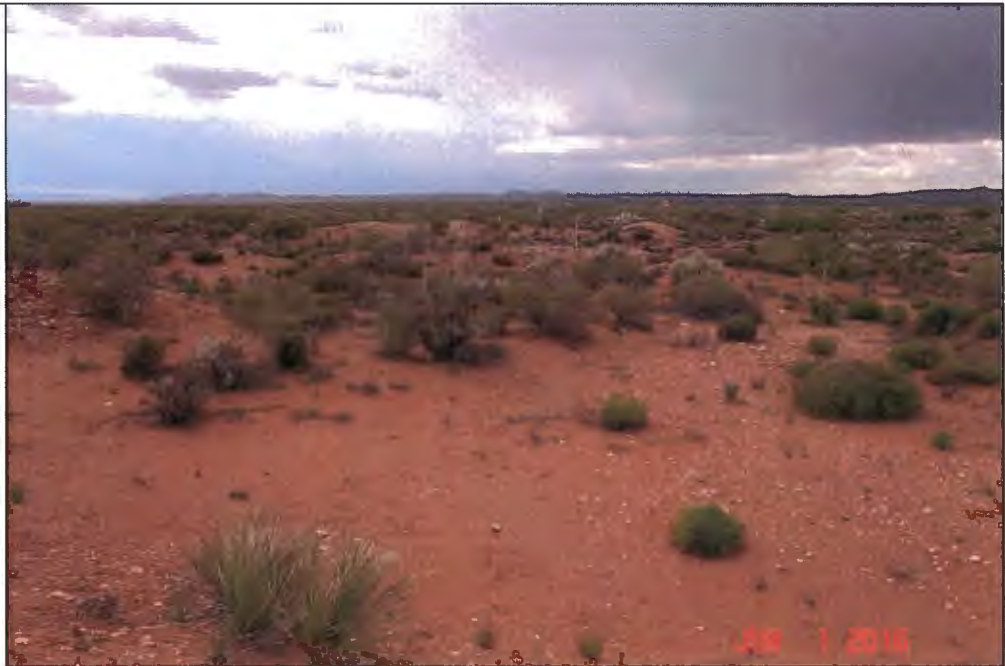
Photograph No.2

**SWMU-20/FTBL-015, Area A.**

No MPPEH was discovered and no signs of land erosion or depression were identified.

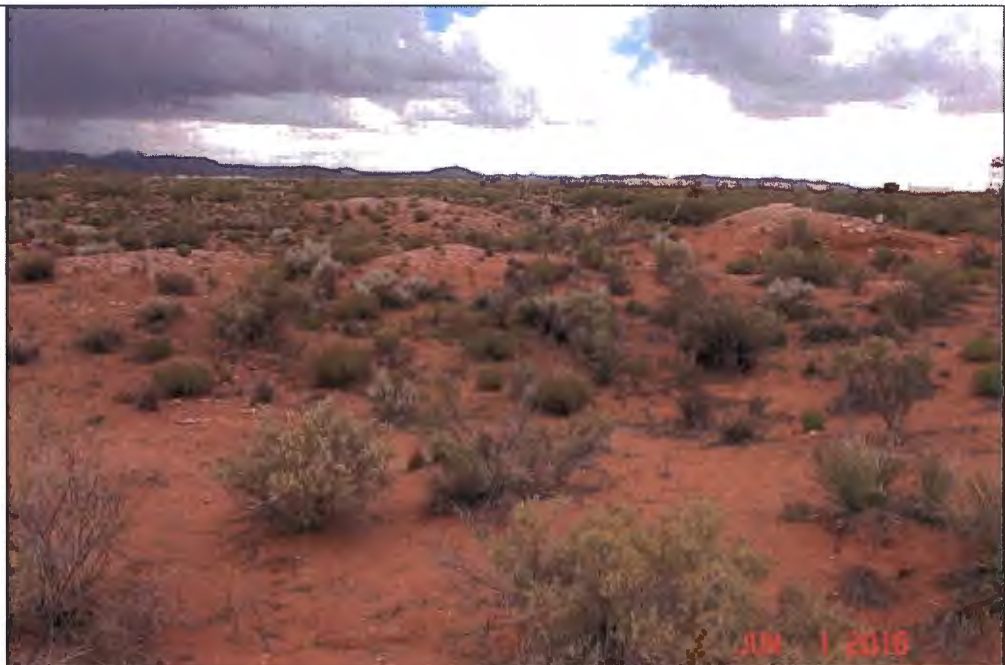
Photograph No. 3

**SWMU-20/FTBL-015, Area A.**

No MPPEH was discovered and no signs of land erosion or depression were identified.

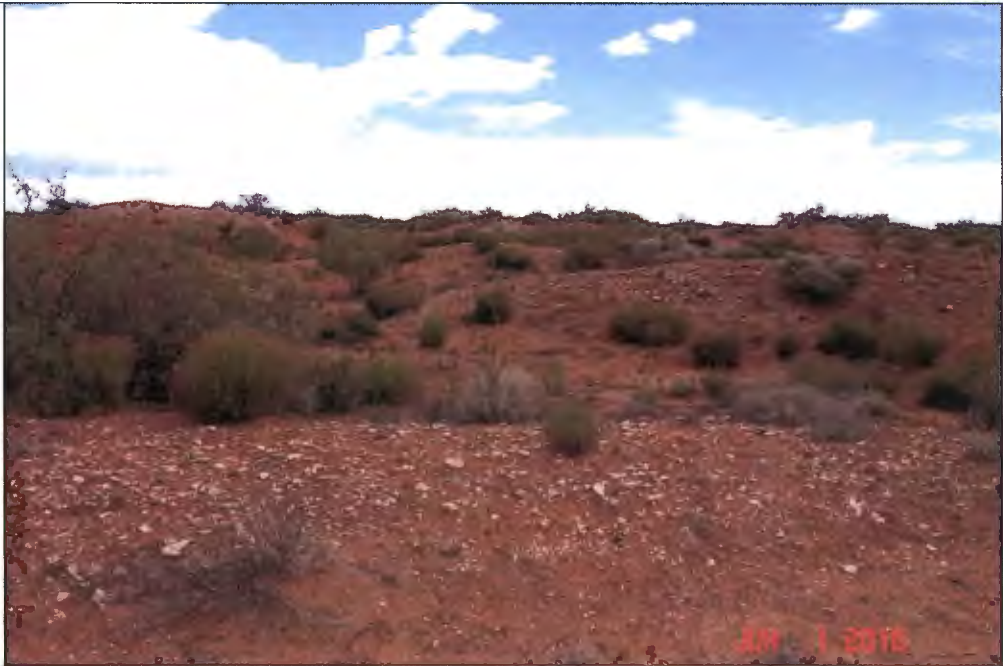
Photograph No. 4

**SWMU-20/FTBL-015, Area A.**

No MPPEH was discovered and no signs of land erosion or depression were identified.

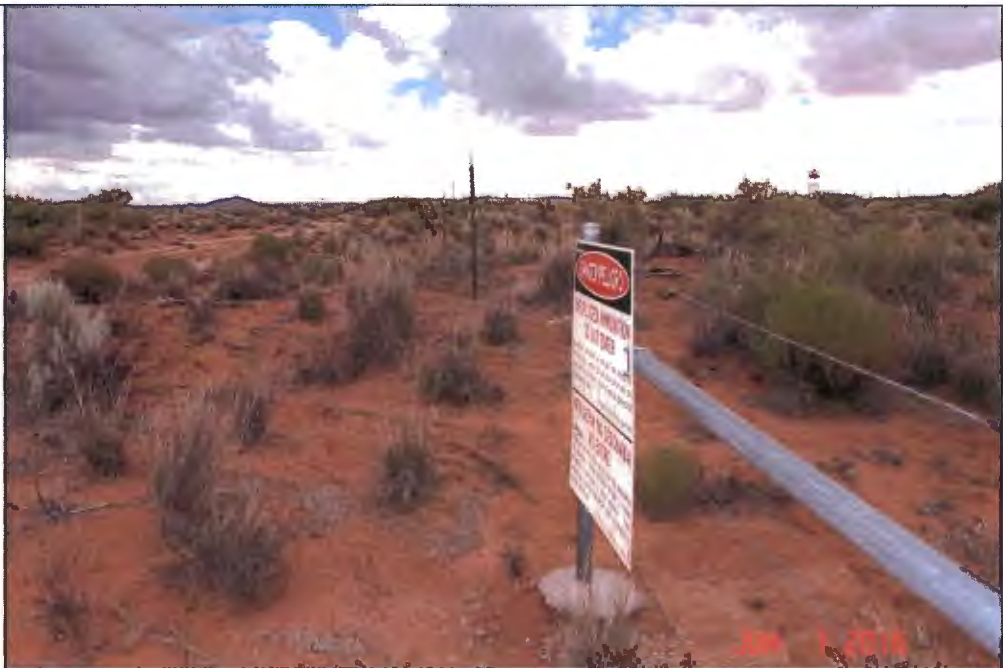
Photograph No. 5

**SWMU-20/FTBL-015, Area A.**

Site perimeter fence and warning signs were in good condition.

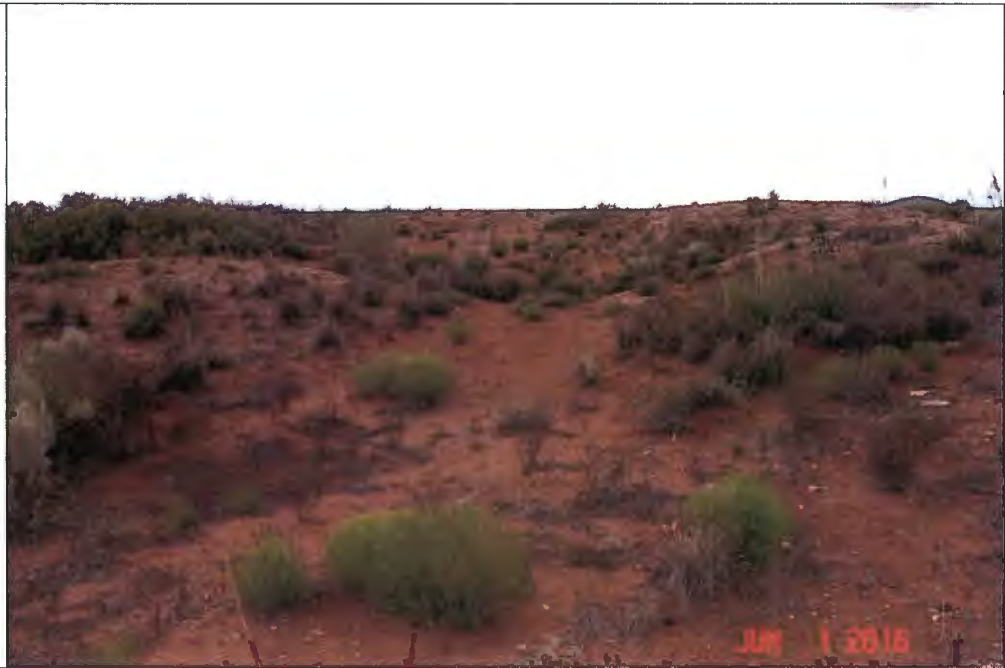
Photograph No. 6

**SWMU-20/FTBL-015, Area B.**

No MPPEH was discovered and no signs of land erosion or depression were identified.

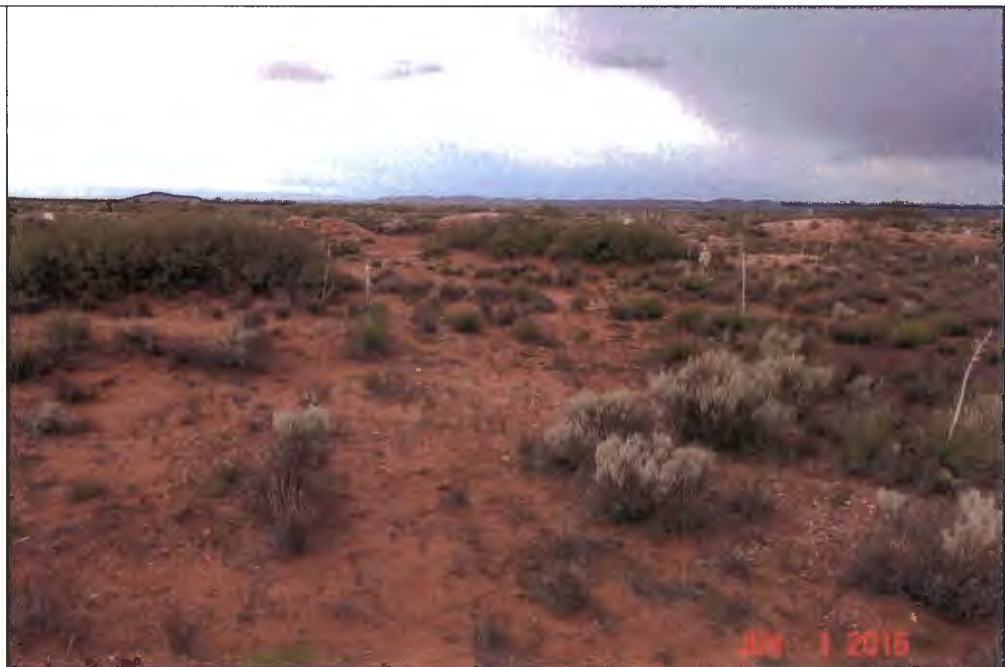
Photograph No. 7

**SWMU-20/FTBL-015, Area B.**

No MPPEH was discovered and no signs of land erosion or depression were identified.

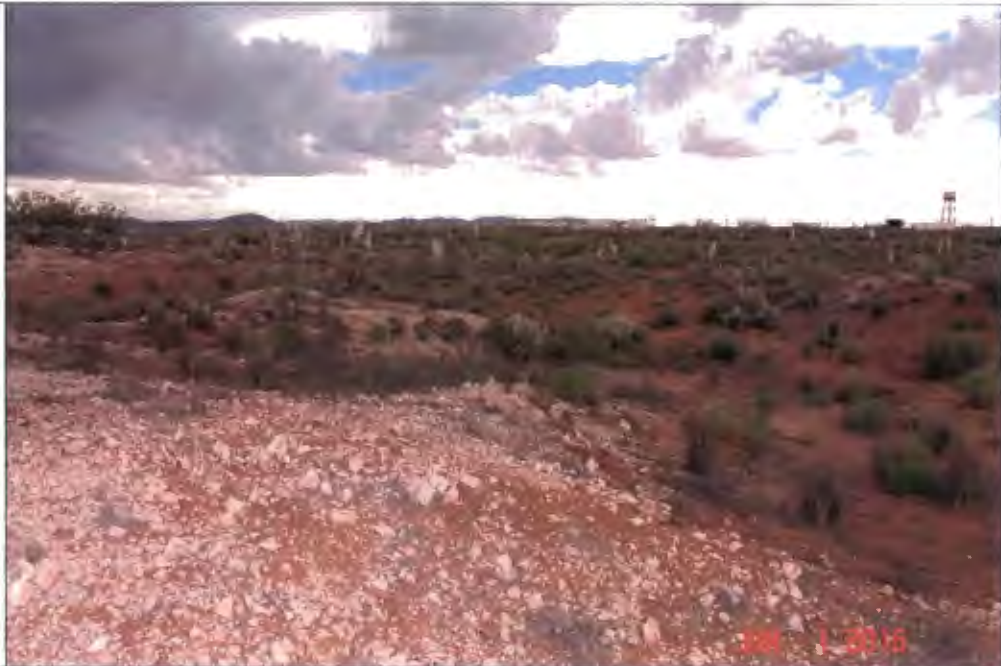
Photograph No. 8

**SWMU-20/FTBL-015, Area B.**

No MPPEH was discovered and no signs of land erosion or depression were identified.

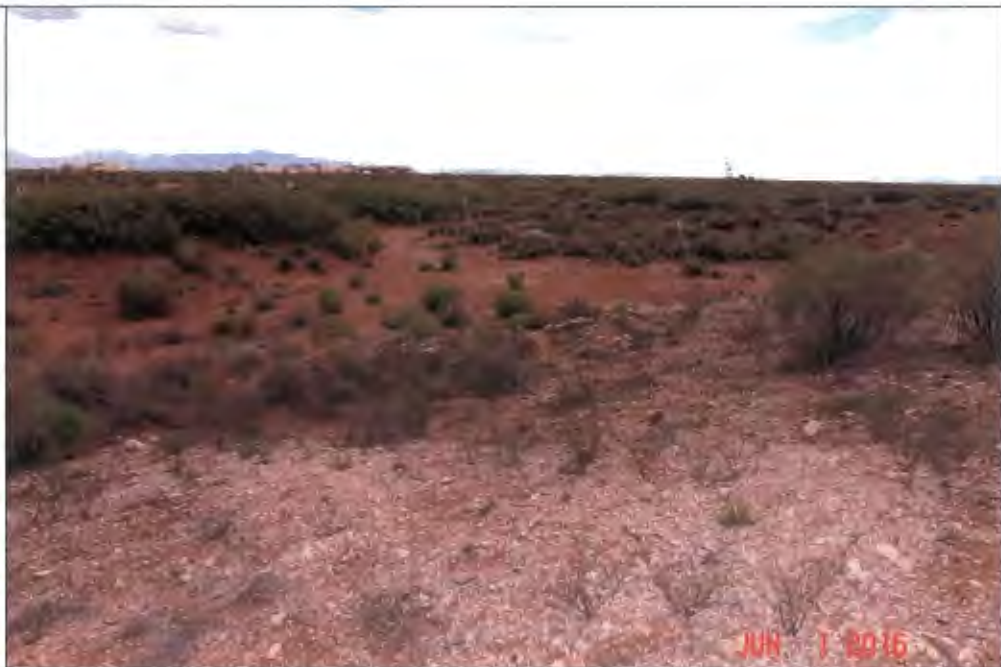
Photograph No. 9

**SWMU-20/FTBL-015, Area B.**

No MPPEH was discovered and no signs of land erosion or depression were identified.

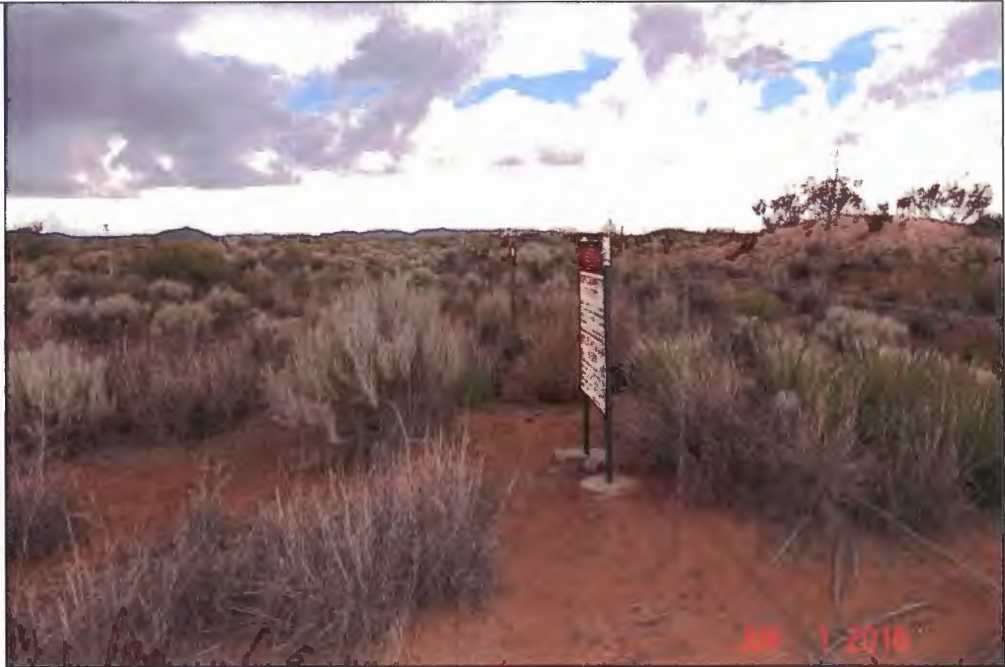
Photograph No. 10

**SWMU-20/FTBL-015, Area B.**

Site perimeter fence and warning signs were in good condition.
