RE: Submittal of Annual Post-Closure Site Inspection Report, Fort Bliss Site No. 13 (FTBL-013)/Solid Waste Management Unit 18 (SWMU-18) McGregor Range Camp Landfill, Fort Bliss, New Mexico

McGregor Range Camp Landfill – Annual Inspection

FTBL-013/SWMU-18

Inspection Date: June 7, 2017

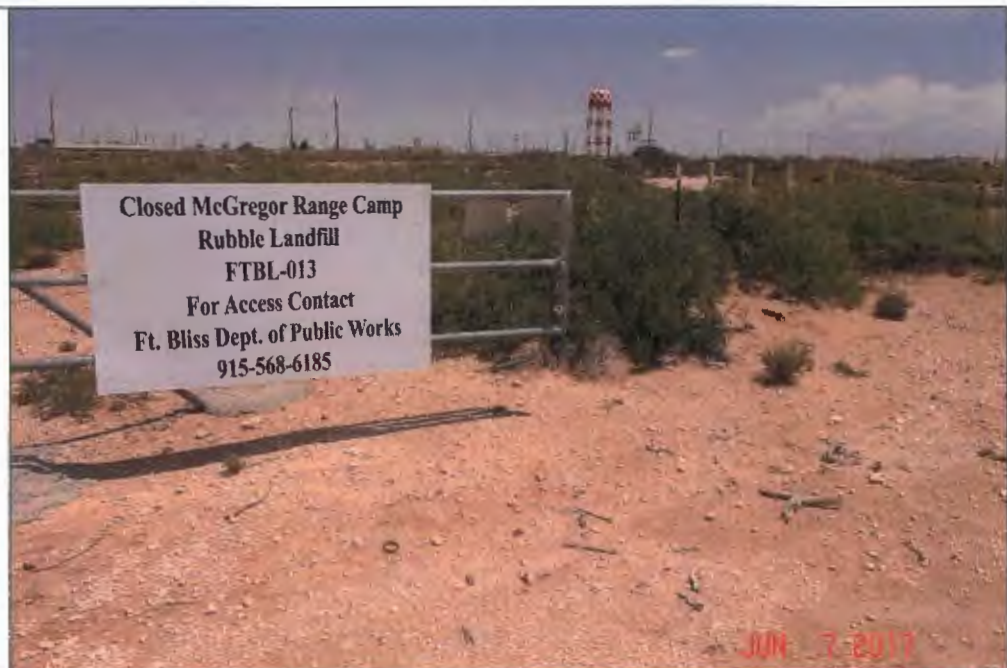
Photograph No. 1

View of landfill gate facing East.

Landfill gate and site perimeter fence were in good condition.

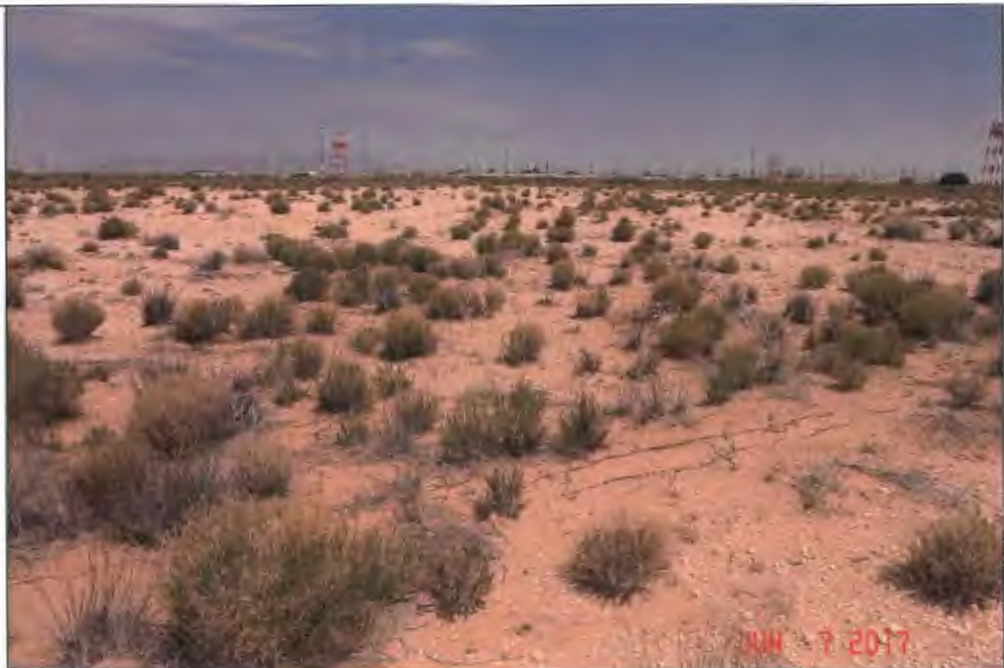
Photograph No.2

View of landfill cap facing North.

No signs of erosion or depression on landfill cap. The vegetative layer was in good condition.

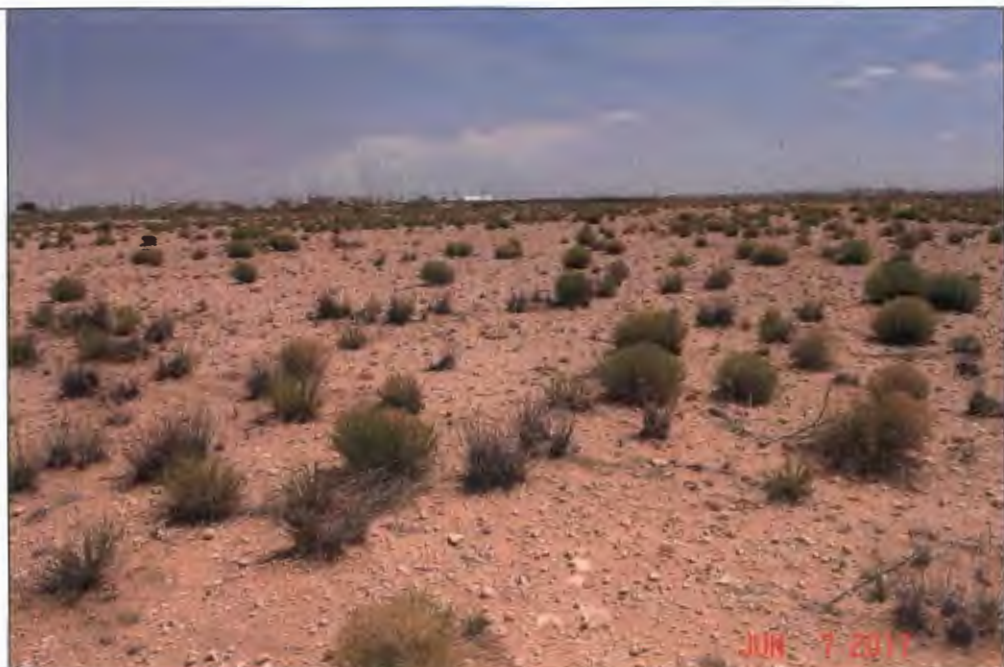
Photograph No. 3

View of landfill cap facing East.

No signs of erosion or depression on landfill cap. The vegetative layer was in good condition.

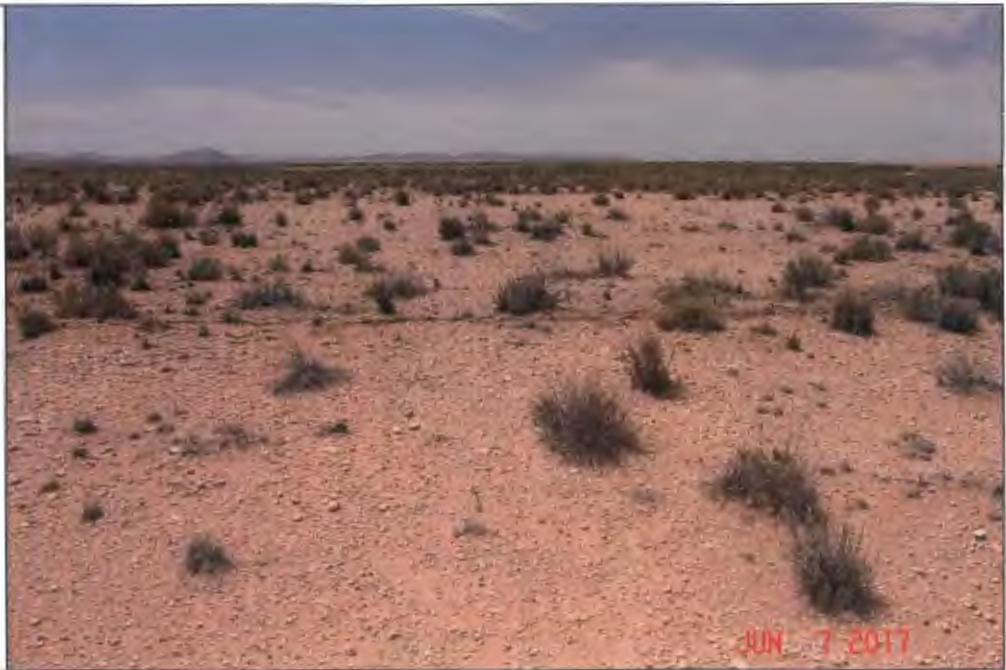
Photograph No. 4

View of landfill cap facing South.

No signs of erosion or depression on landfill cap. The vegetative layer was in good condition.

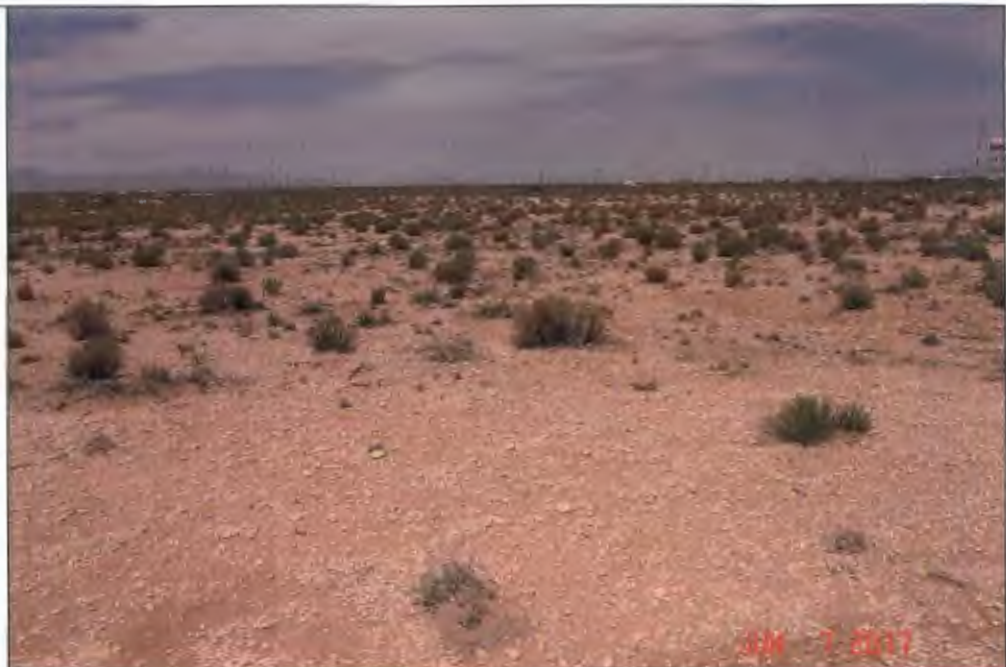
Photograph No. 5

View of landfill cap facing West.

No signs of erosion or depression on landfill cap. The vegetative layer was in good condition.

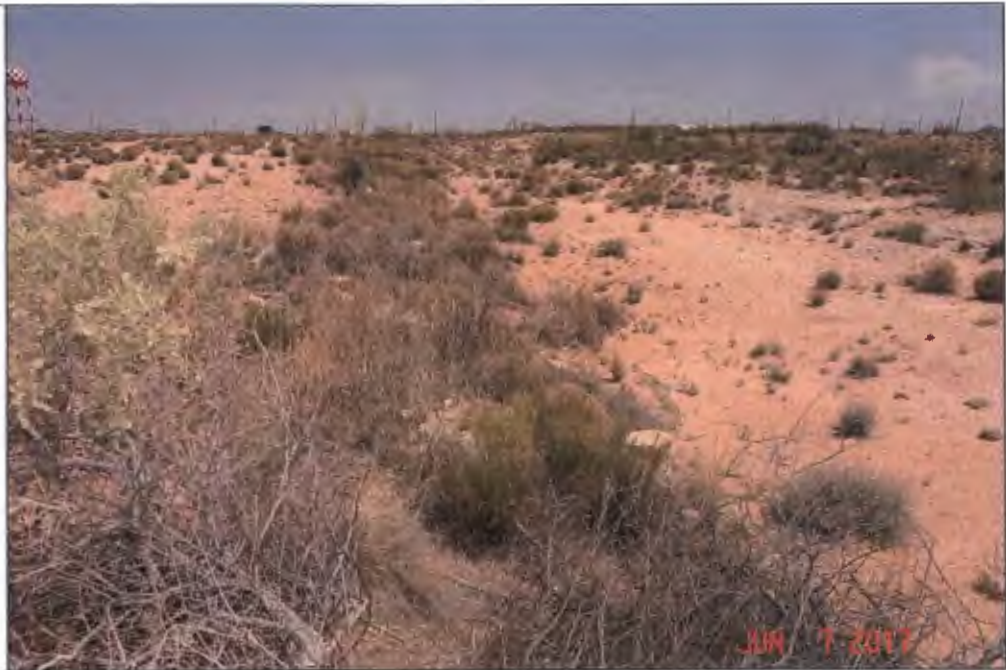
Photograph No. 6

View of arroyo facing North.

No evidence of significant erosion or surface depression on arroyo.

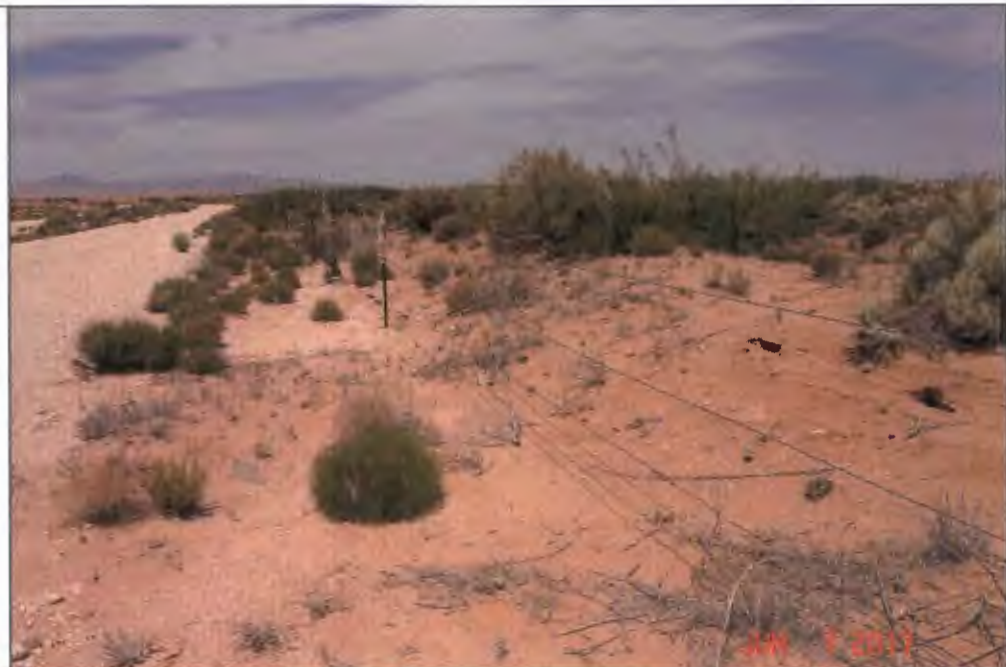
Photograph No. 7

Southern fence facing West.

Site perimeter fence and warning signs remain in good condition.

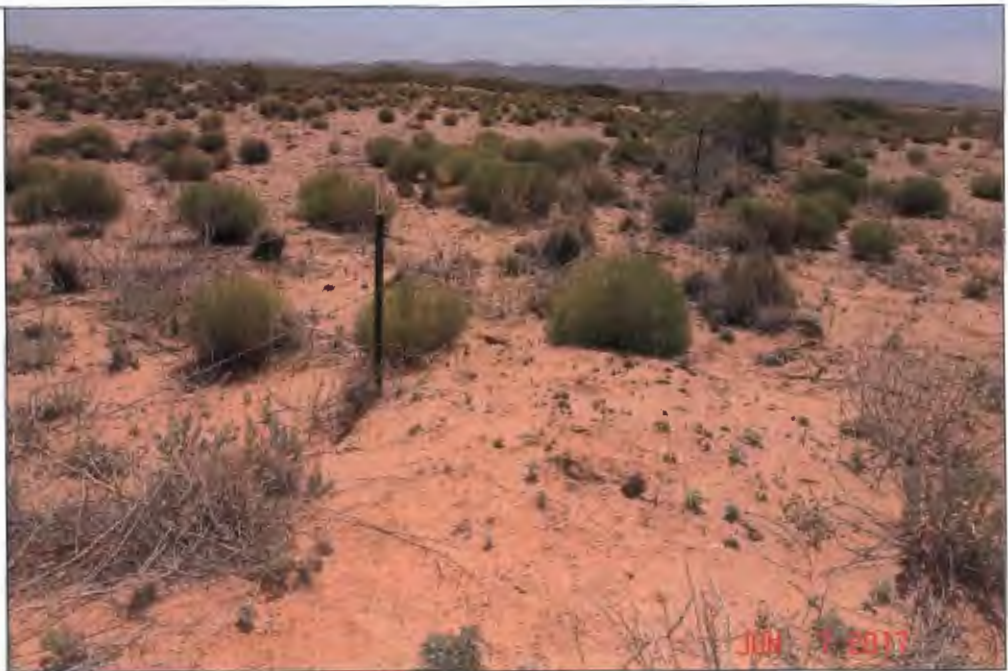
Photograph No. 8

Western fence
facing South.

Site perimeter fence
remains in good
condition.

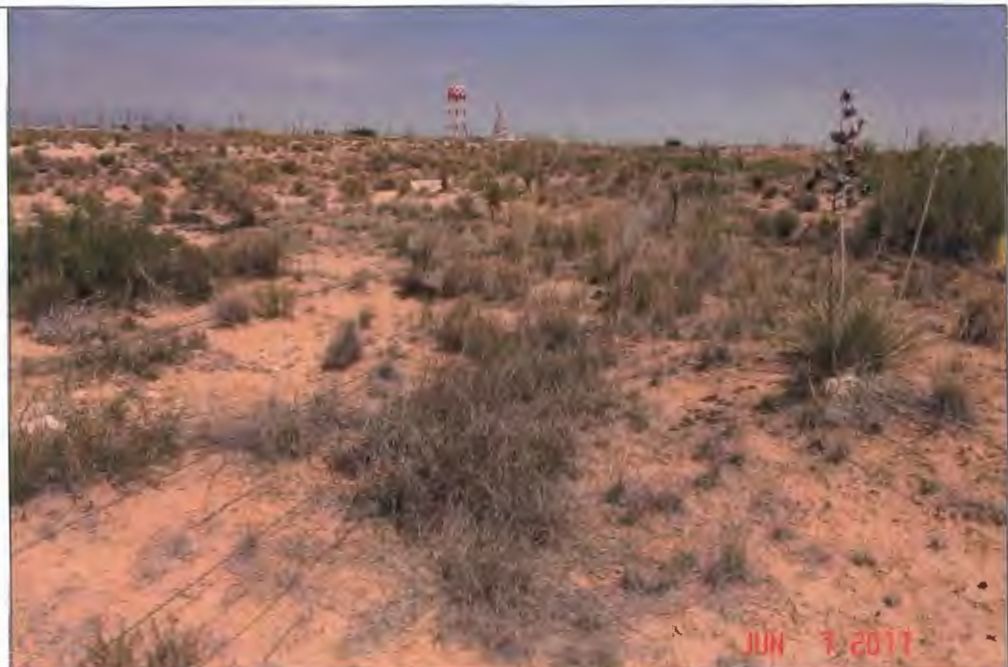
Photograph No. 9

Eastern fence facing
North.

Site perimeter fence
and warning signs
remain in good
condition.
