**DEPARTMENT OF THE ARMY**  
US ARMY INSTALLATION MANAGEMENT COMMAND  
HEADQUARTERS, UNITED STATES ARMY GARRISON, FORT BLISS  
1741 MARSHALL ROAD  
FORT BLISS, TEXAS 79916  
DEC 14 2017

RE: Submittal of Annual Post-Closure Site Inspection Reports, Fort Bliss Site No. 12 (FTBL-012)/Solid Waste Management Unit 27 (SWMU-27) Doña Ana Range Camp Rubble Landfill, Fort Bliss, New Mexico

# Doña Ana Range Camp Rubble Landfill - Pre-wet season Inspection FTBL-012/SWMU-27

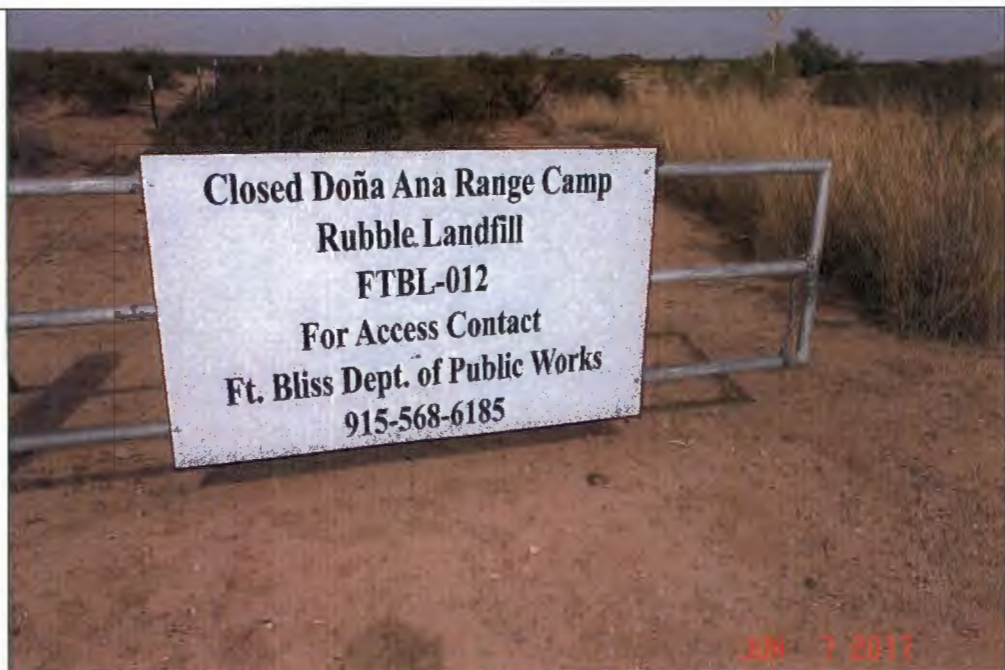
### Photograph No. 1

View of landfill gate.

Landfill gate and site perimeter fence were in good condition.

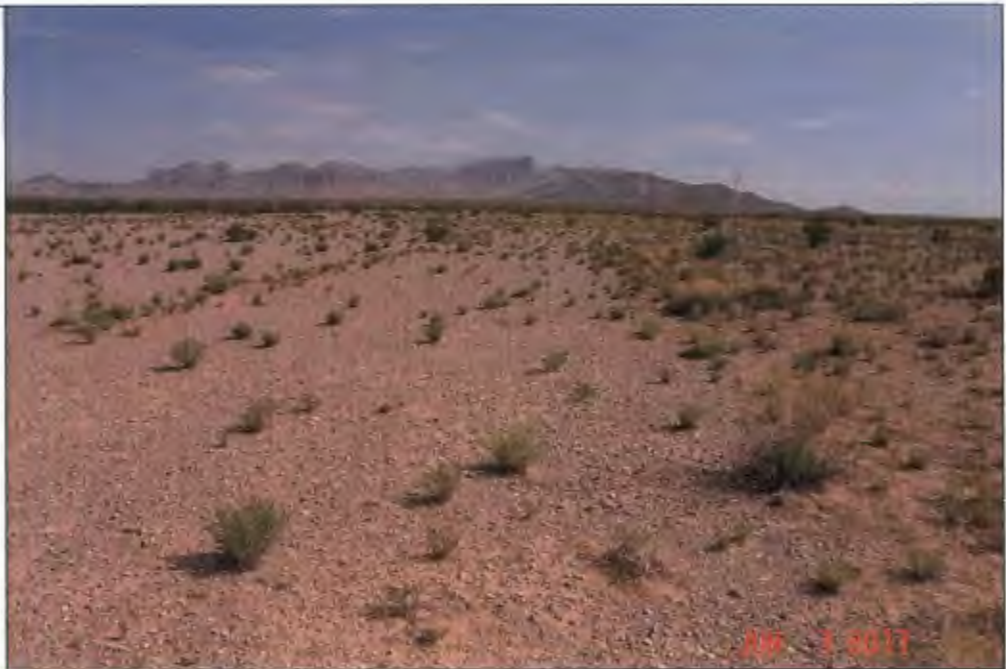
Photograph No.2

View of landfill cap facing North.

No signs of erosion or depression on landfill cap.  
Vegetative layer was in good condition.

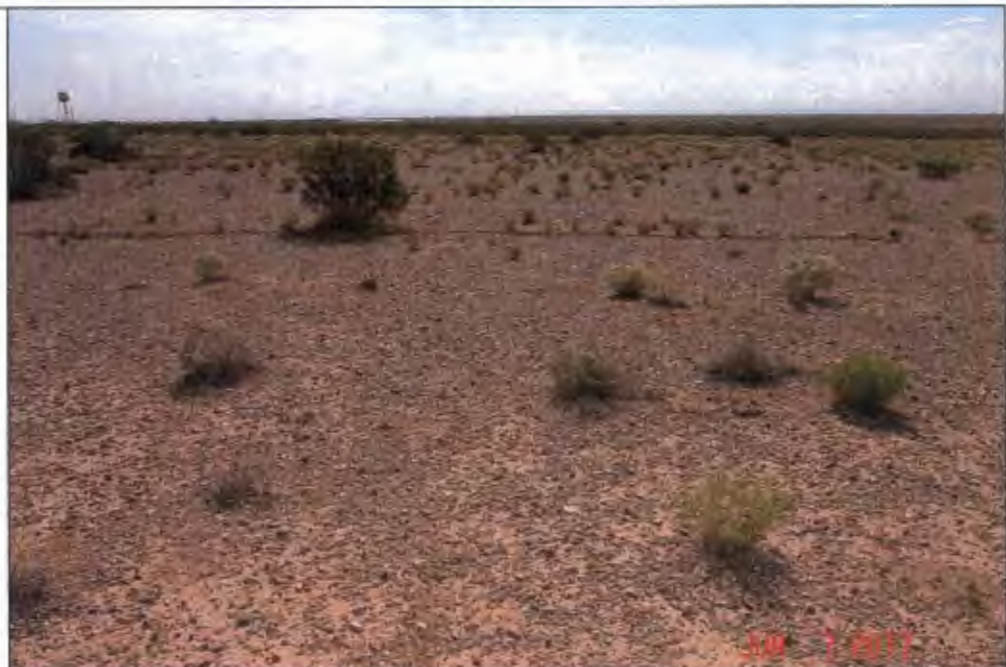
Photograph No. 3

View of landfill cap facing East.

No signs of erosion or depression on landfill cap.  
Vegetative layer was in good condition.

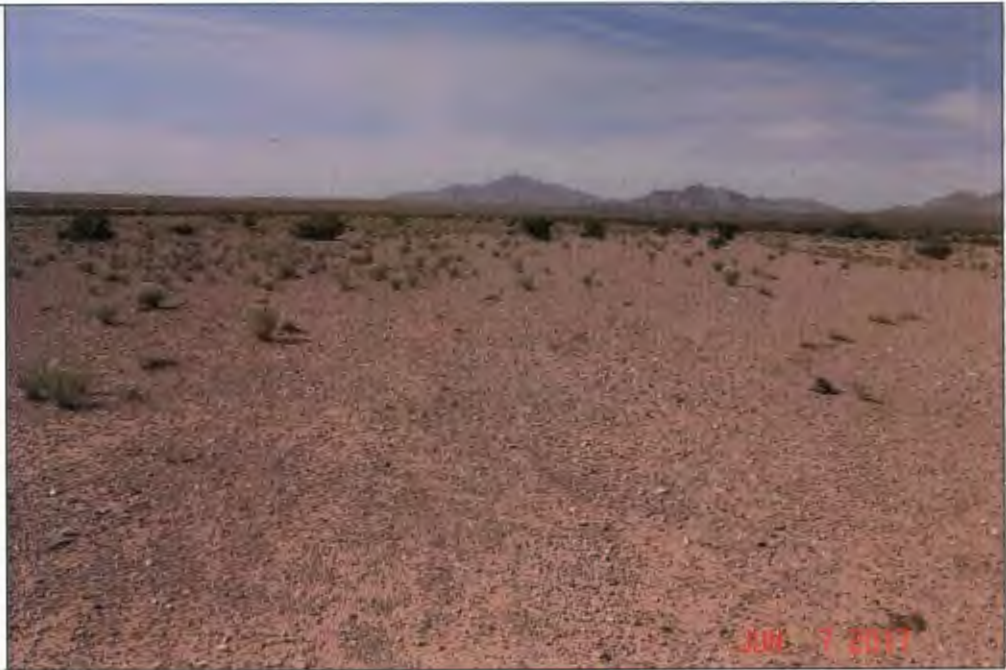
Photograph No. 4

View of landfill cap facing South.

No signs of erosion or depression on landfill cap.  
Vegetative layer was in good condition.

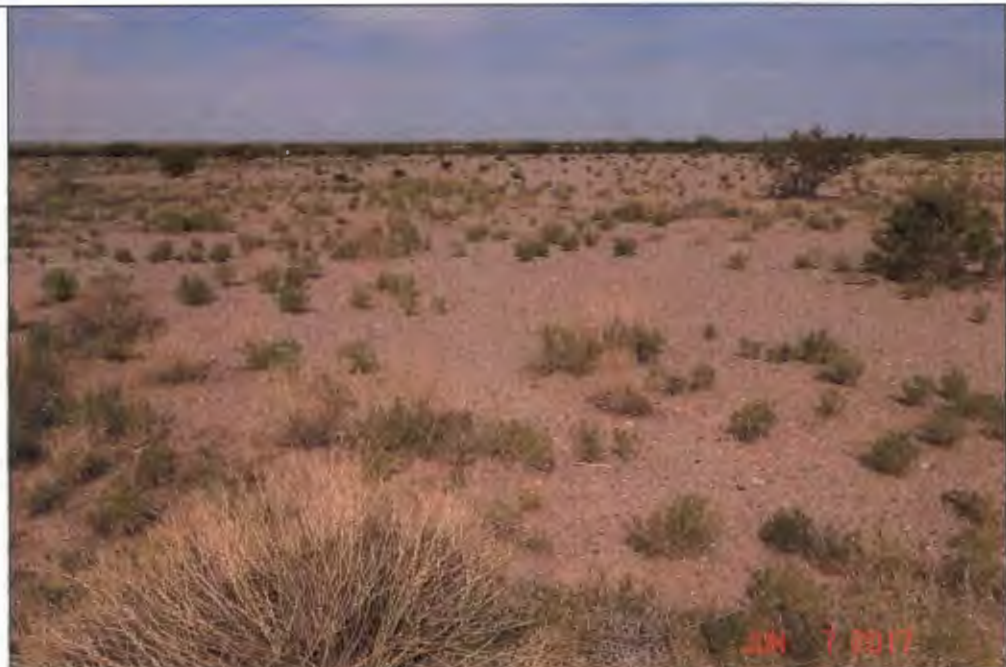
Photograph No. 5

View of landfill cap facing West.

No signs of erosion or depression on landfill cap.  
Vegetative layer was in good condition.

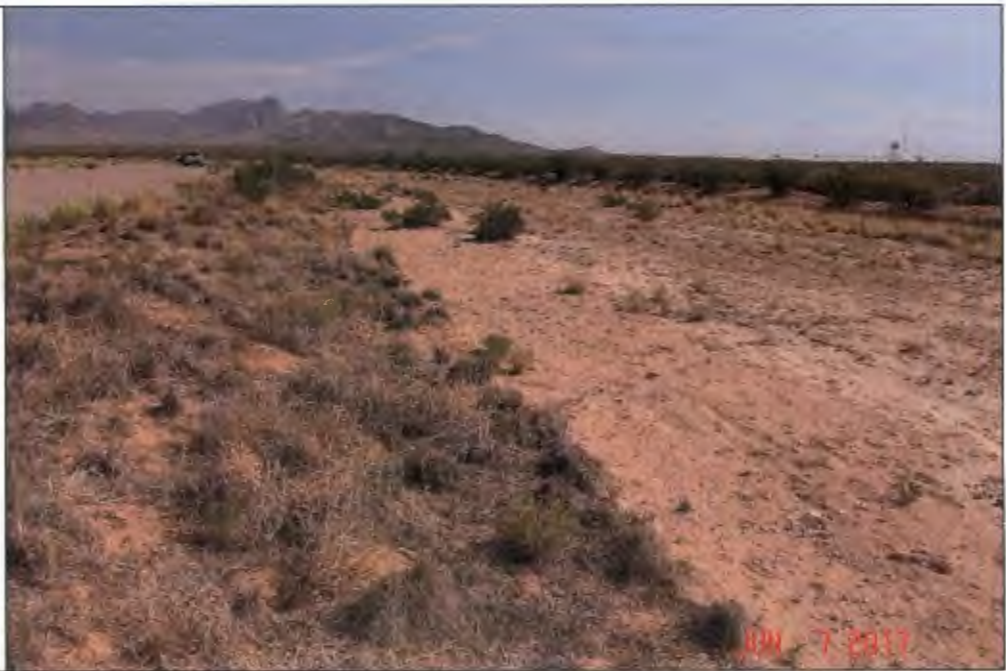
Photograph No. 6

View of arroyo facing North.

No sign of significant erosion caused by water runoff on arroyo.

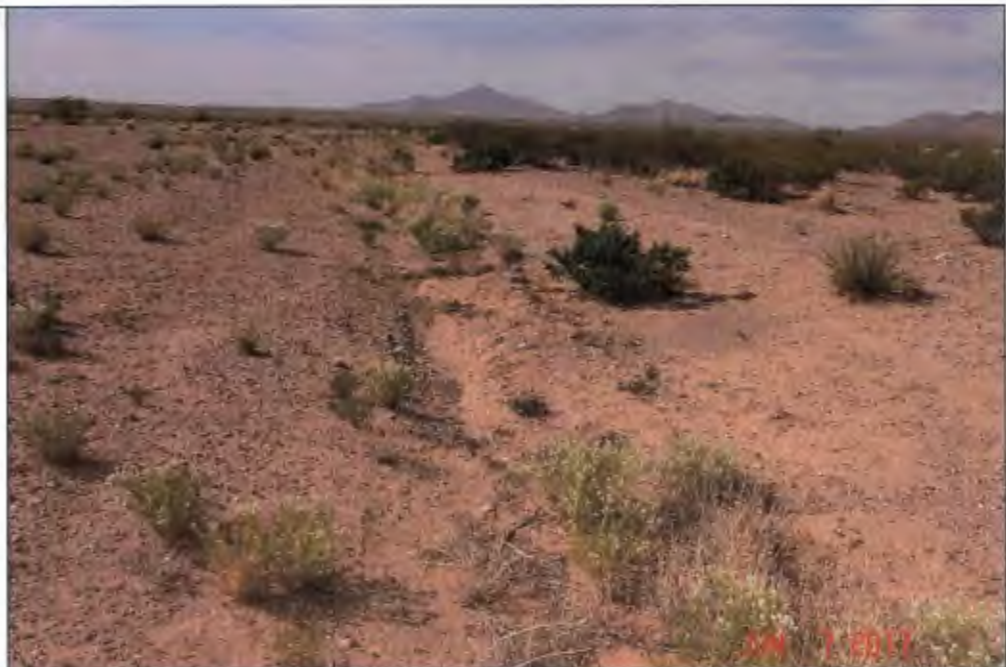
Photograph No. 7

View of swale facing South.

No sign of significant erosion caused by water runoff on drainage swale.

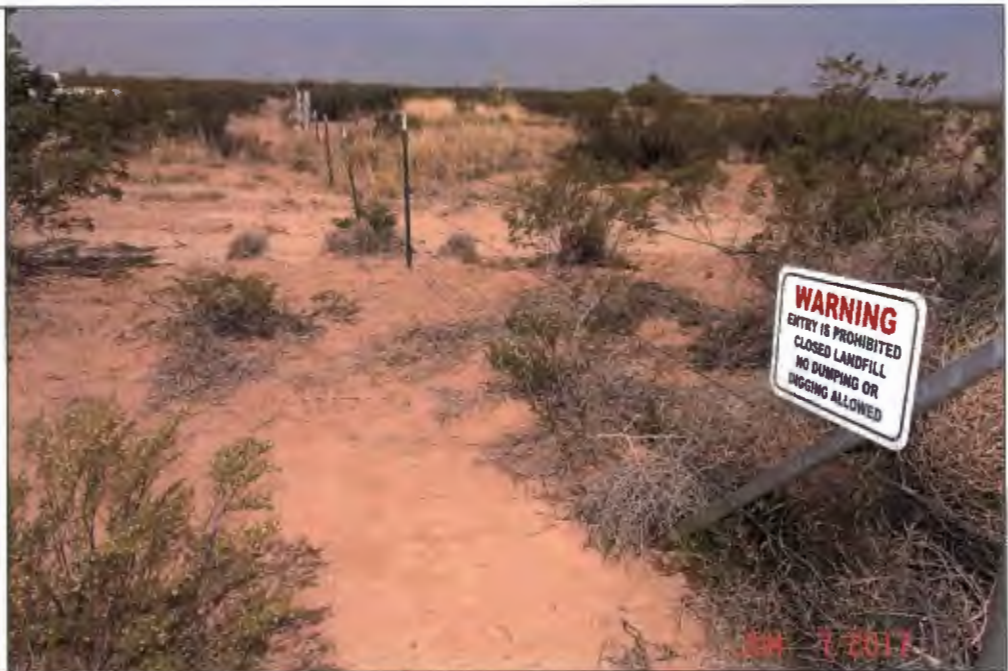
Photograph No. 8

View of Southern fence facing West.

Site perimeter fence and warning signs were in good condition.

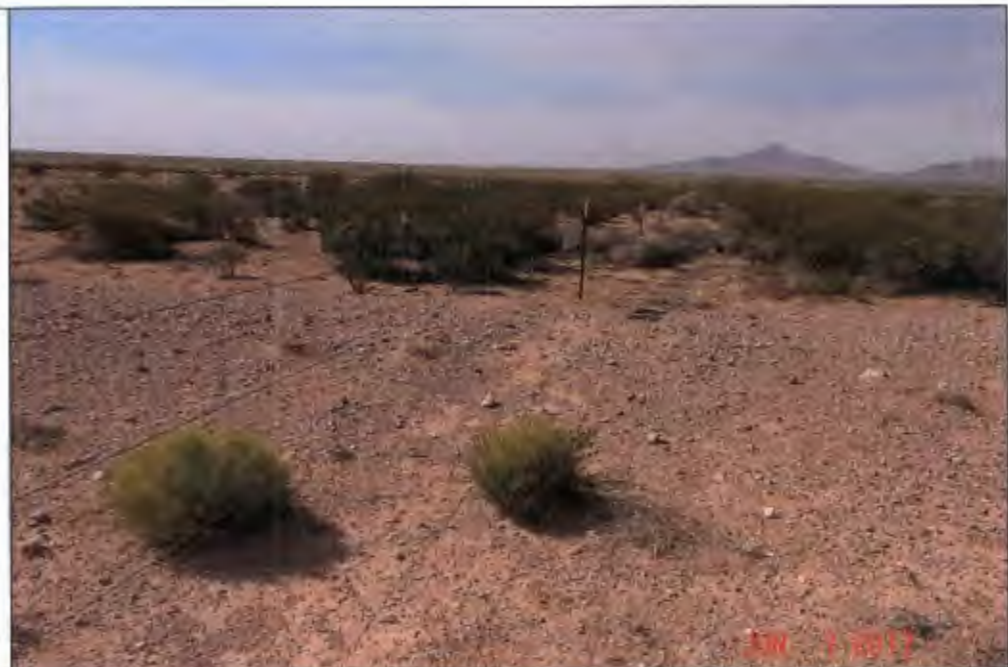
Photograph No. 9

View of Western fence facing South.

Site perimeter fence and warning signs were in good condition.

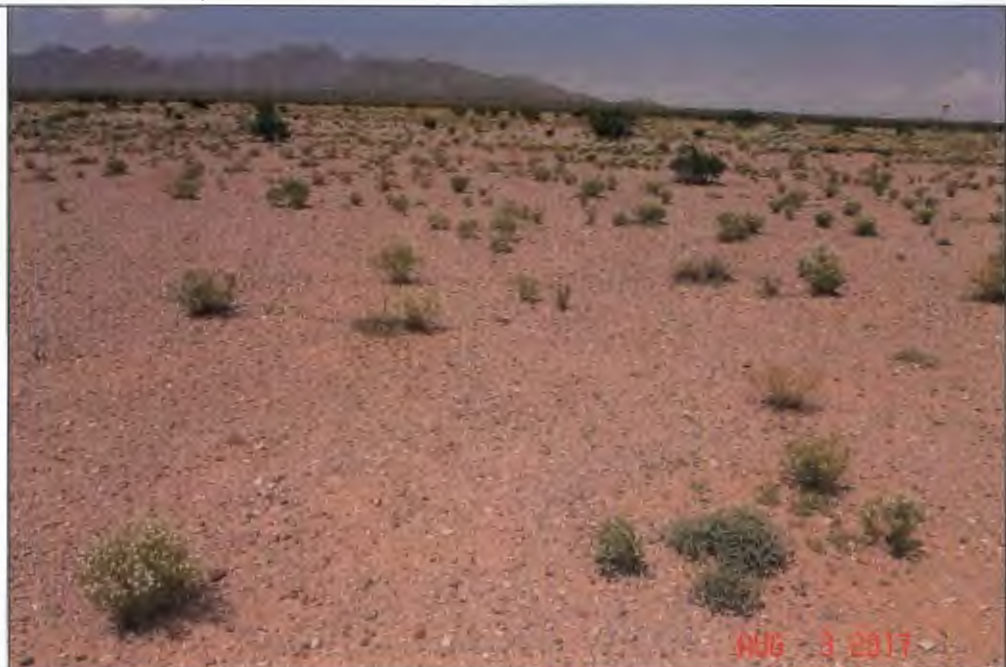
### Photograph No. 1

View of landfill cap facing North.

No signs of erosion or surface depression resulting from the rain event.

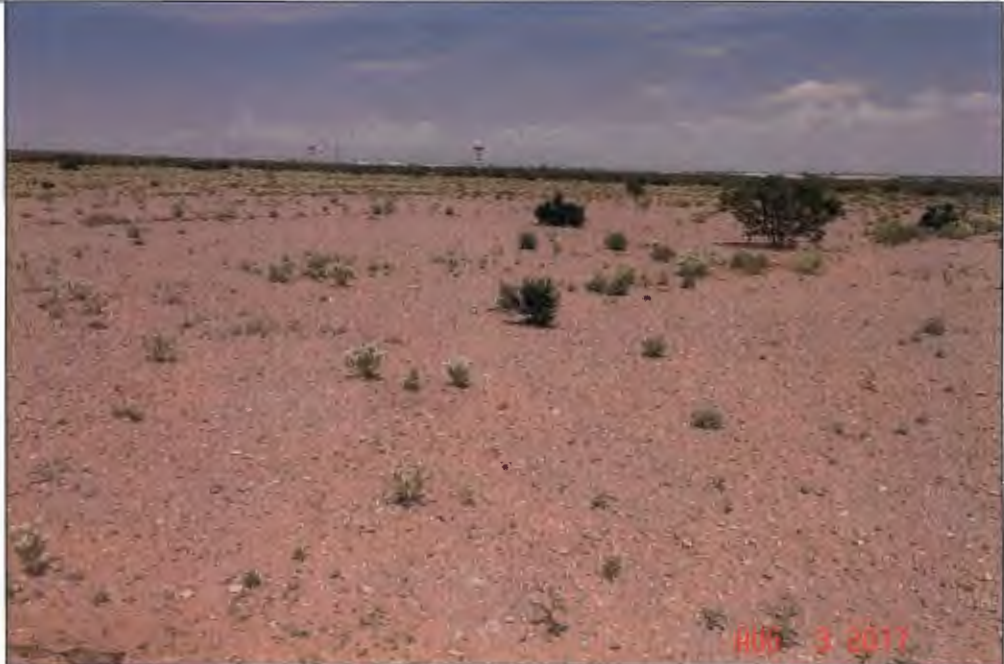
Photograph No.2

View of landfill cap  
facing East.

No signs of erosion  
or surface  
depression resulting  
from the rain event.

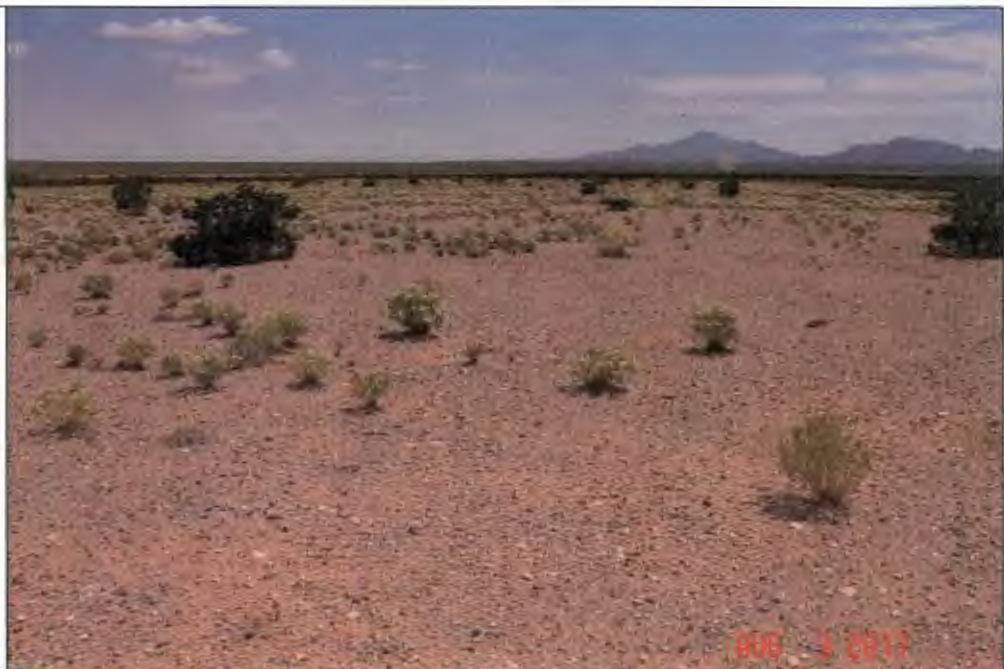
Photograph No. 3

View of landfill cap  
facing South.

No signs of erosion  
or surface  
depression resulting  
from the rain event.

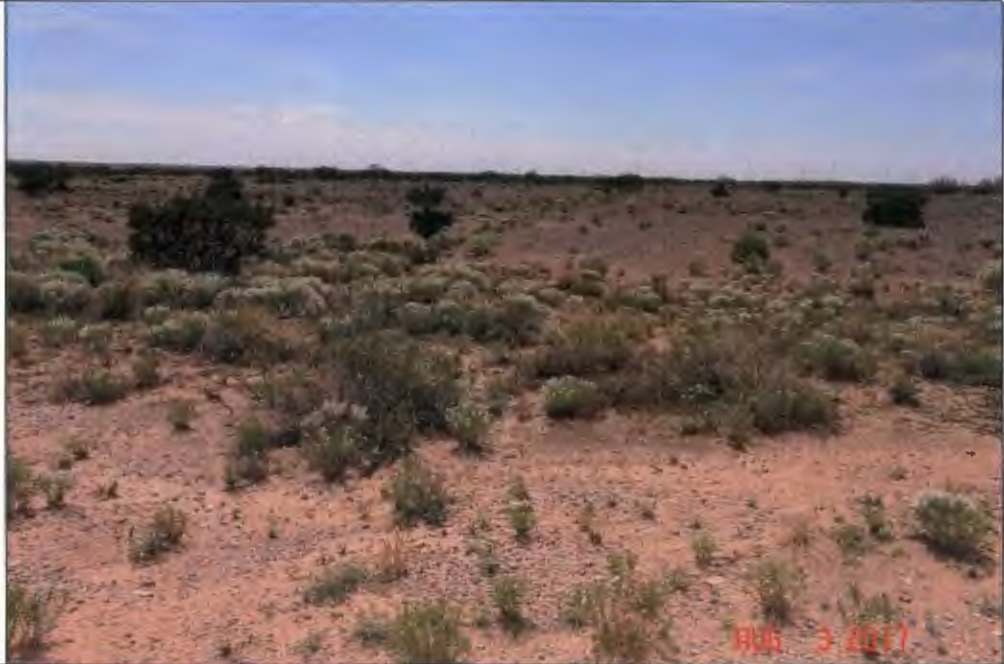
Photograph No. 4

View of landfill cap facing West.

No signs of erosion or surface depression resulting from the rain event.

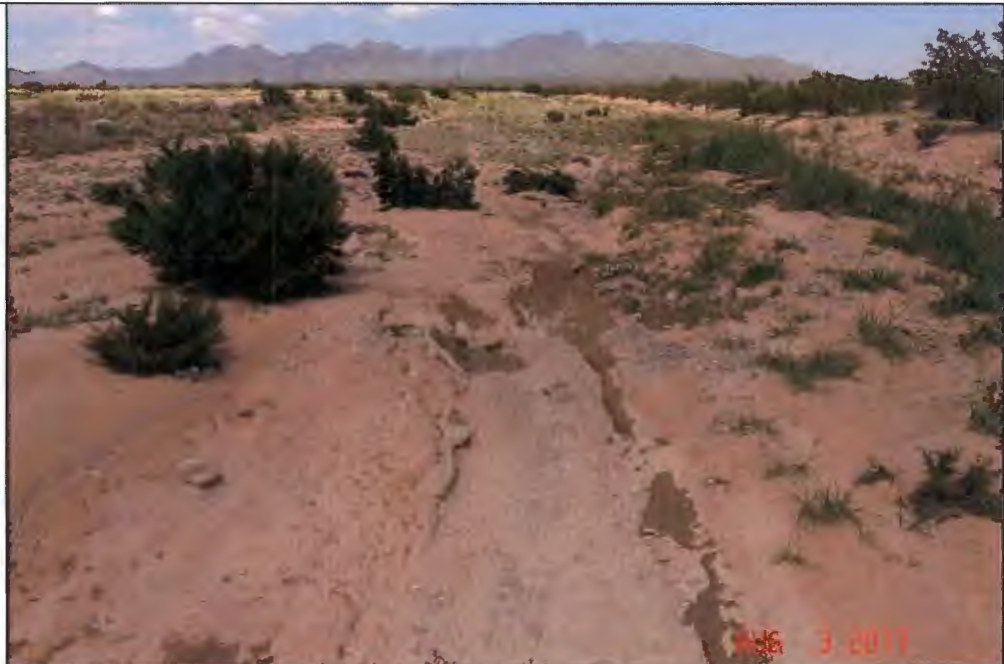
Photograph No. 5

View of arroyo facing North.

No signs of significant erosion or surface depression on arroyo resulting from the rain event.

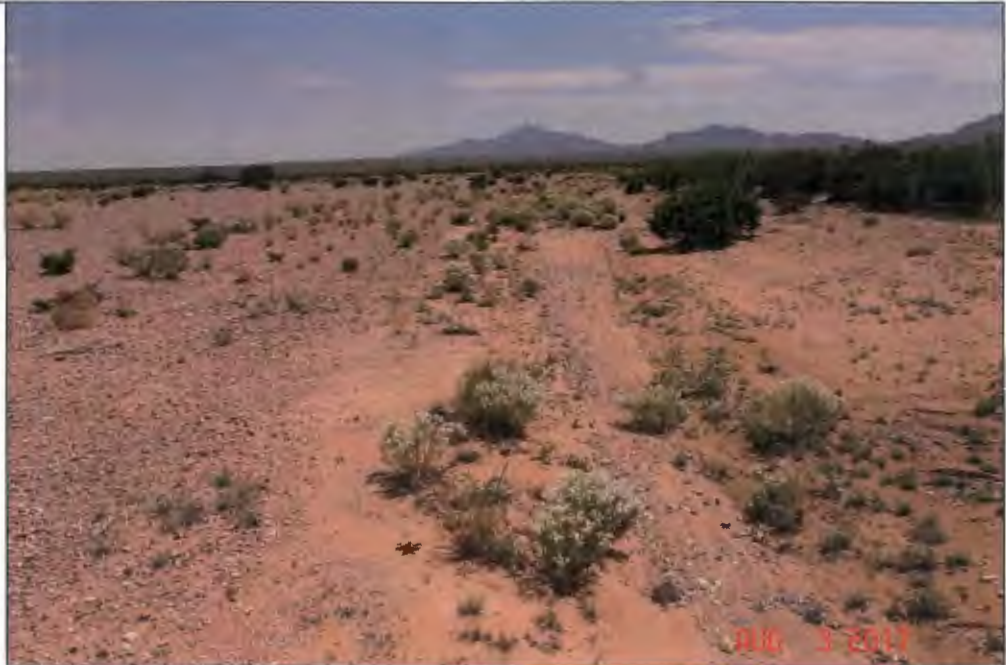
Photograph No. 6

View of swale facing South.

No signs of significant erosion or surface depression resulting from the rain event.

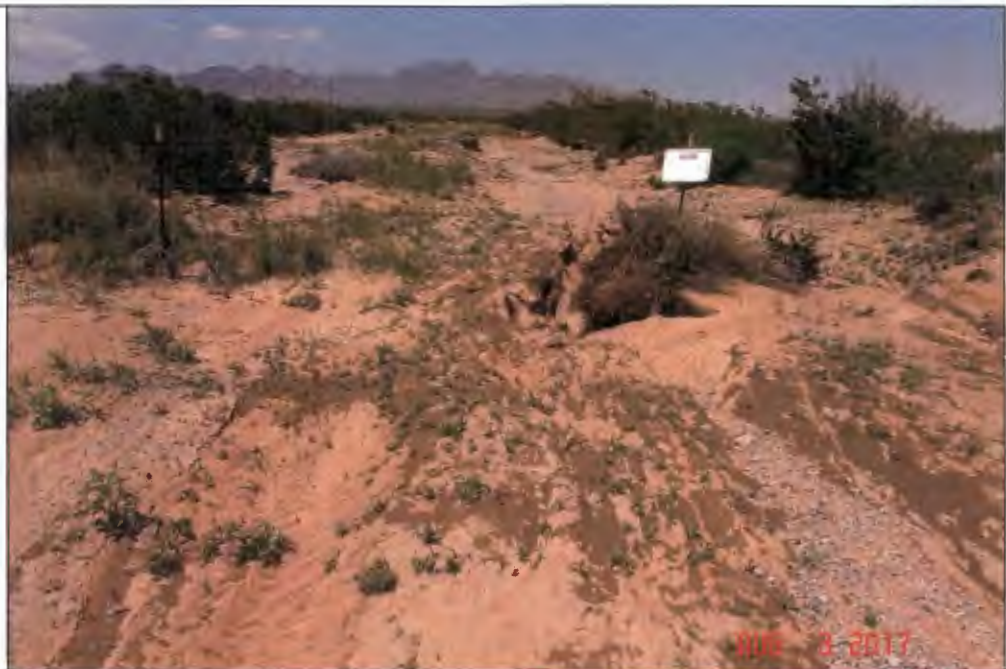
Photograph No. 7

View of arroyo facing North.

Drainage system (arroyo) on the South side of the site showed significant erosion. Debris obstructed water flow during rain event.

On November 13, 2017, the aforementioned eroded section of the arroyo was repaired by filling with dirt and rocks. Additionally, a fence post situated in the middle of the arroyo, which obstructed flow during rain events causing significant erosion and trenching, was removed. The fence section was then reinforced by installing an additional fence post on each edge of the arroyo (Enclosure 5).

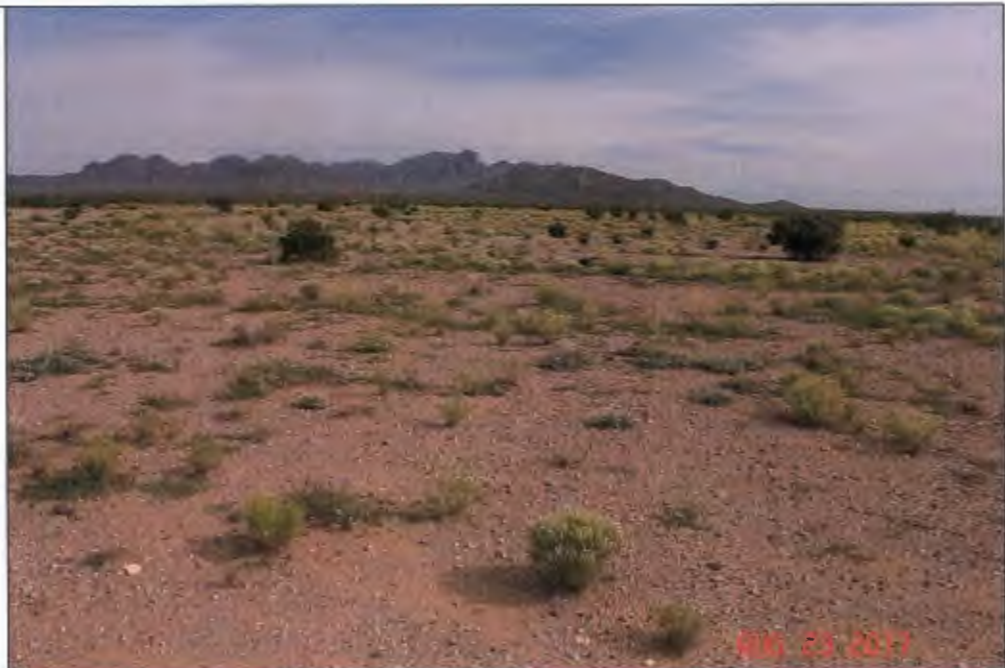
### Photograph No. 1

View of landfill cap facing North.

No signs of erosion or surface depression resulting from the rain event.

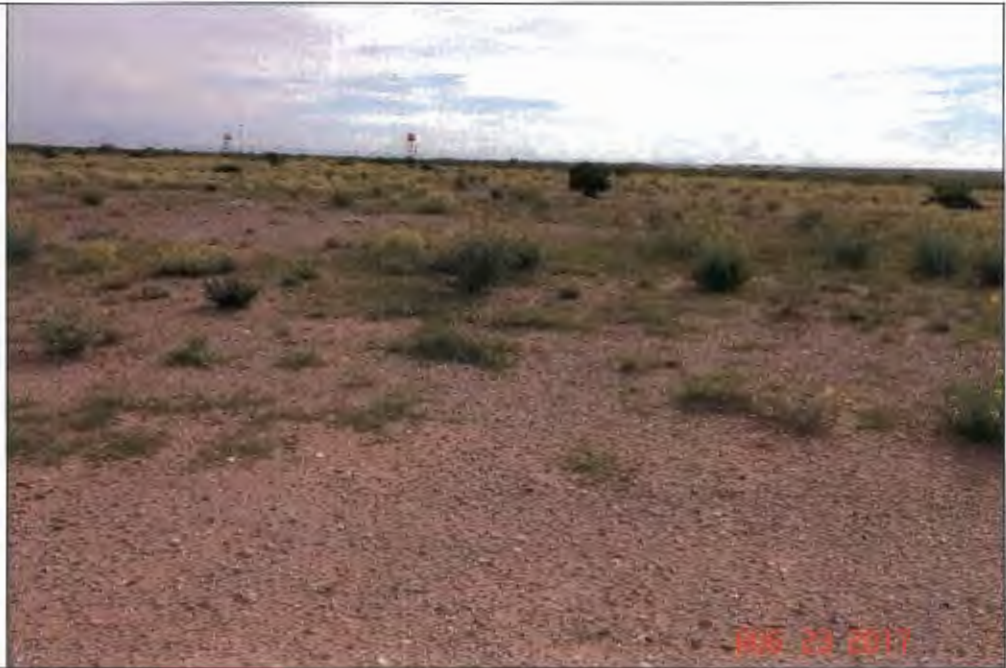
Photograph No.2

View of landfill cap facing East.

No signs of erosion or surface depression resulting from the rain event.

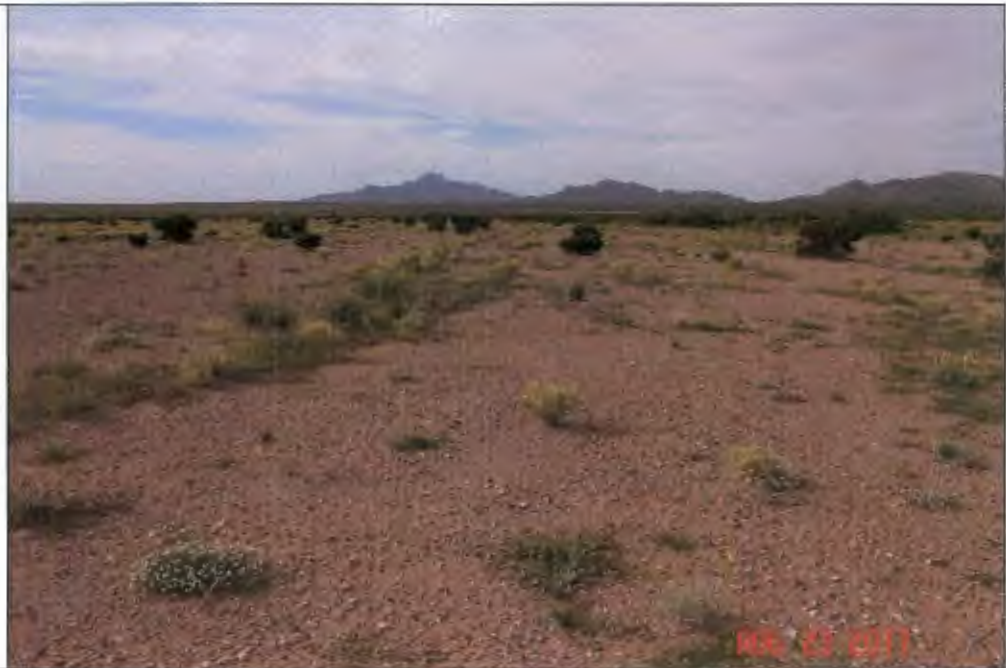
Photograph No. 3

View of landfill cap facing South.

No signs of erosion or surface depression resulting from the rain event.

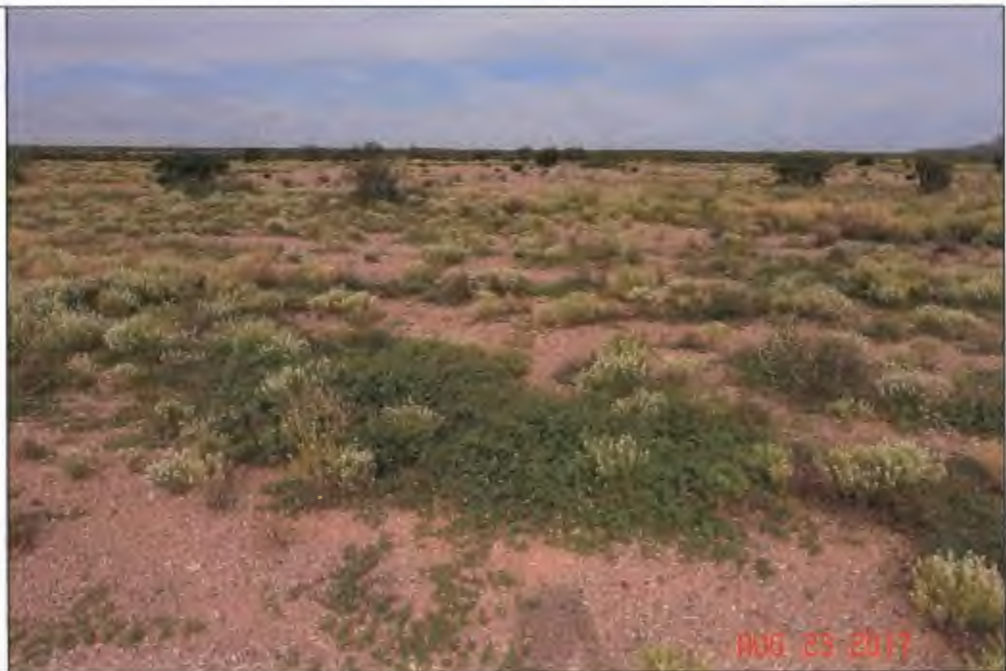
Photograph No. 4

View of landfill cap facing West.

No signs of erosion or surface depression resulting from the rain event.

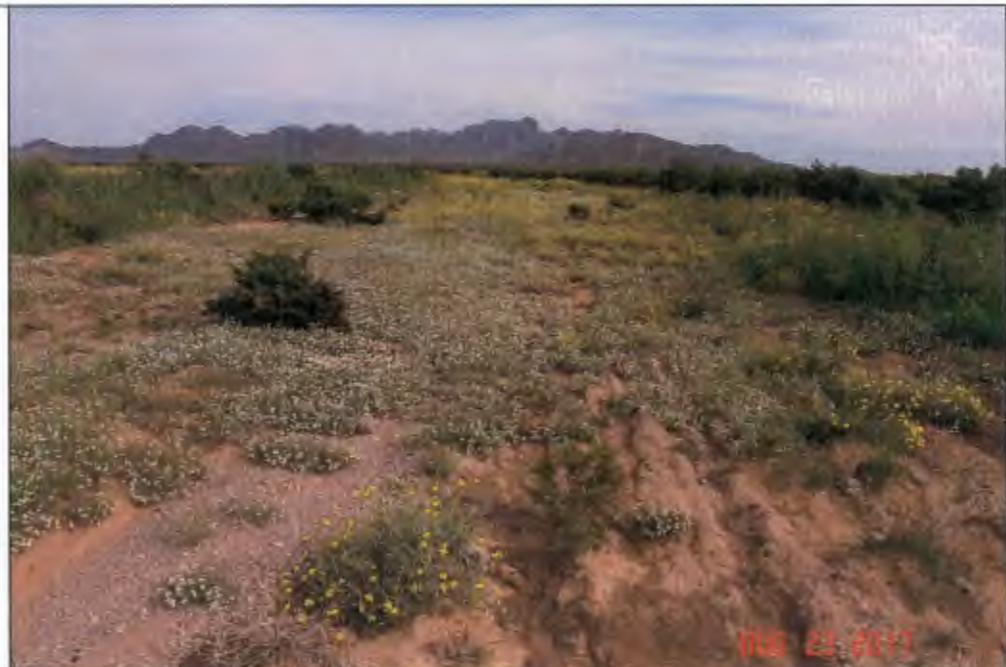
Photograph No. 5

View of arroyo facing North.

No signs of significant erosion on arroyo resulting from the rain event.

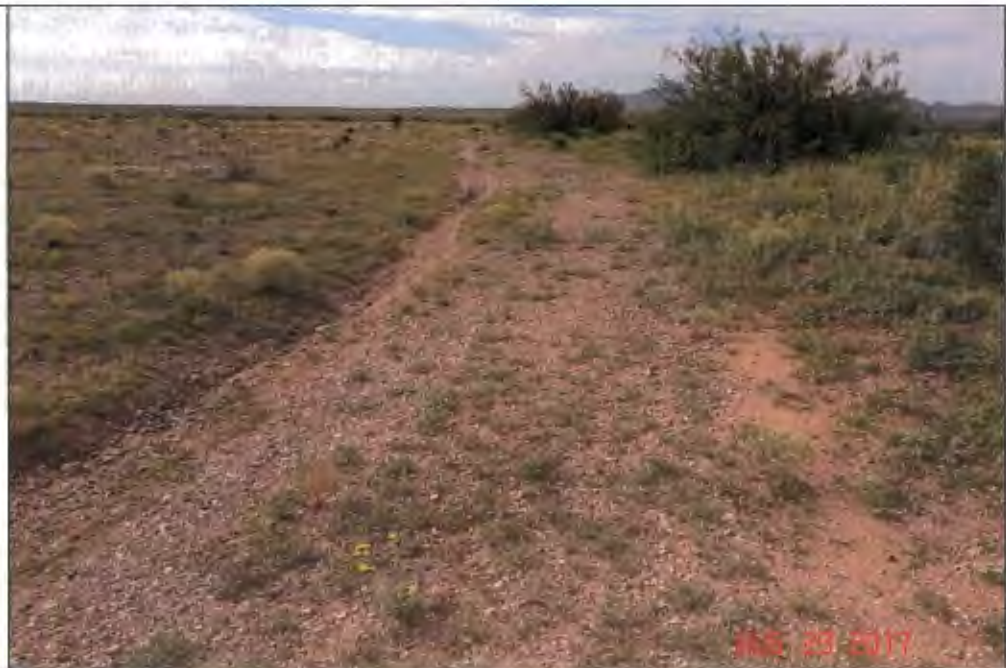
Photograph No. 6

View of swale facing South.

No signs of significant erosion or surface depression resulting from the rain event.

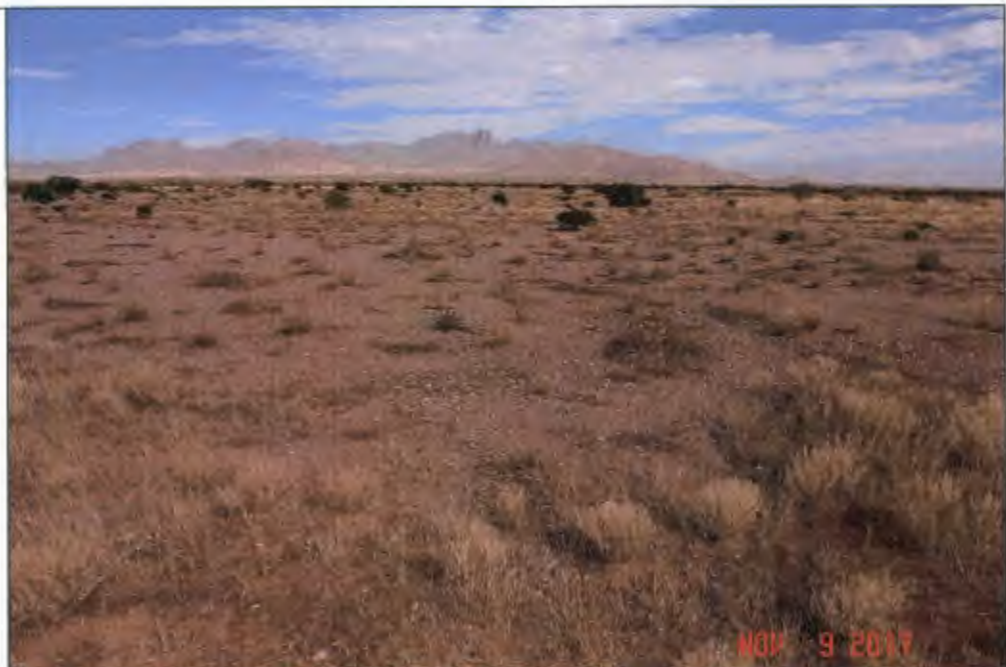
### Photograph No. 1

View of landfill cap facing North.

No signs of erosion or depression on landfill cap.  
Vegetative layer was in good condition.

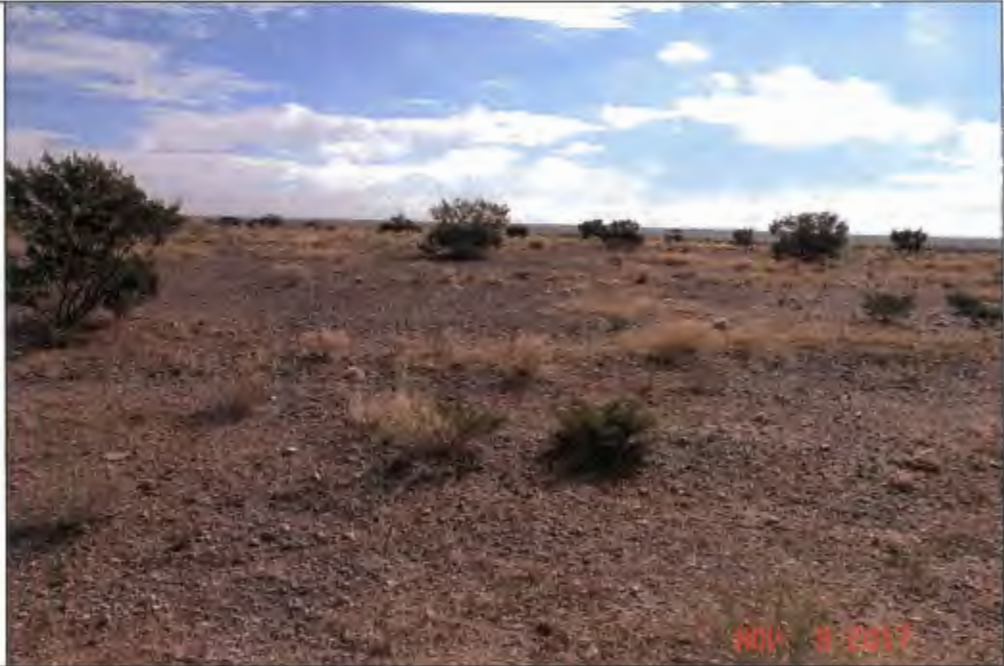
Photograph No.2

View of landfill cap facing East.

No signs of erosion or depression on landfill cap.  
Vegetative layer was in good condition.

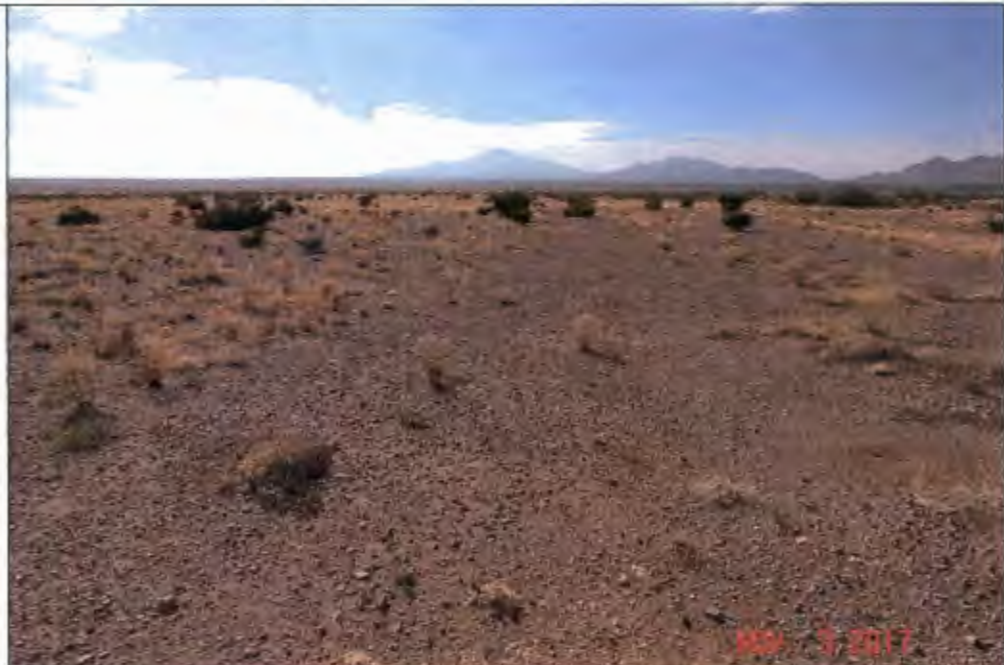
Photograph No. 3

View of landfill cap facing South.

No signs of erosion or depression on landfill cap.  
Vegetative layer was in good condition.

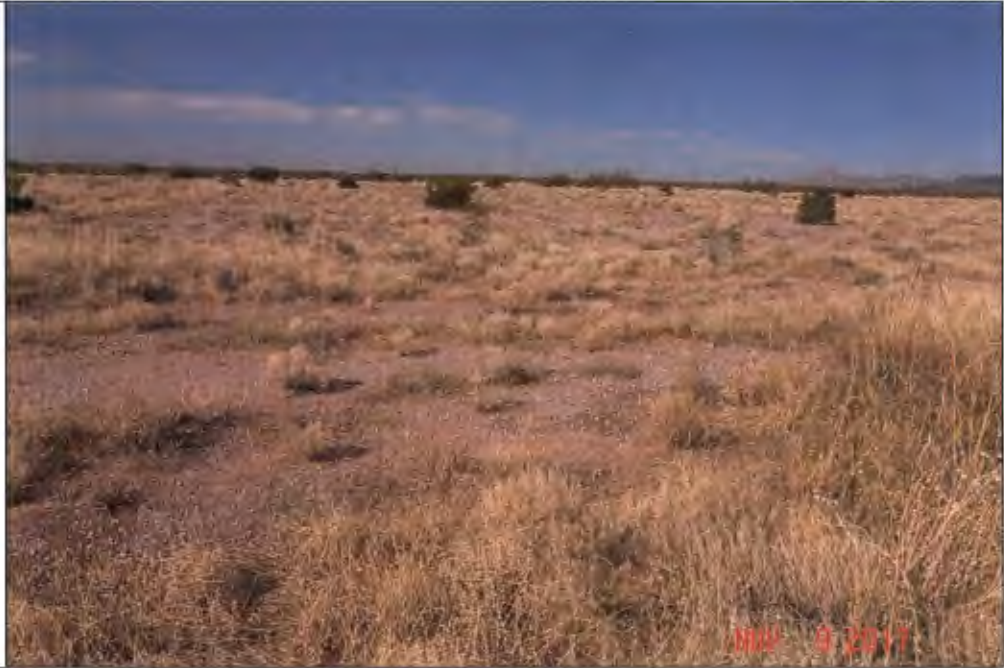
Photograph No. 4

View of landfill cap facing West.

No signs of erosion or depression on landfill cap.  
Vegetative layer was in good condition.

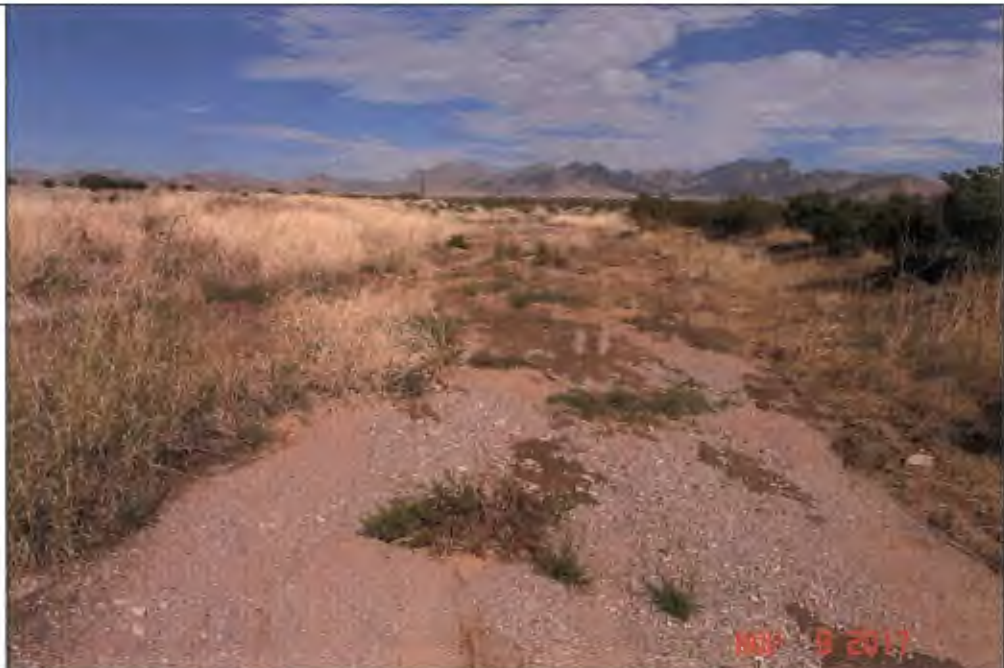
Photograph No. 5

View of arroyo facing North.

No sign of significant erosion caused by water runoff on arroyo.

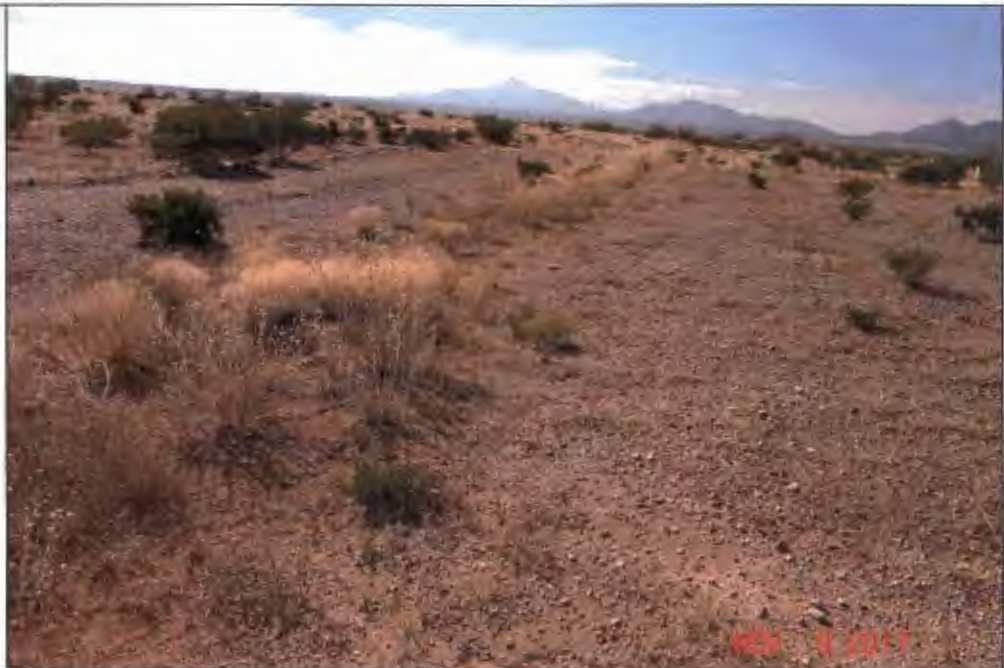
Photograph No. 6

View of swale facing South.

No sign of significant erosion caused by water runoff on drainage swale.

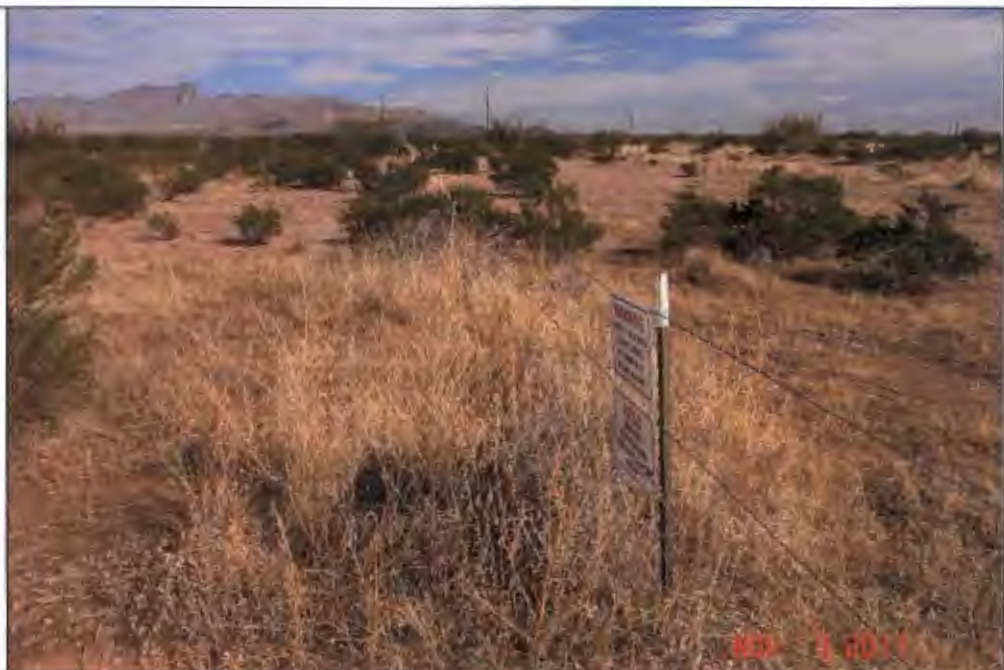
Photograph No. 7

View of Western fence facing North.

Site perimeter fence and warning signs were in good condition.

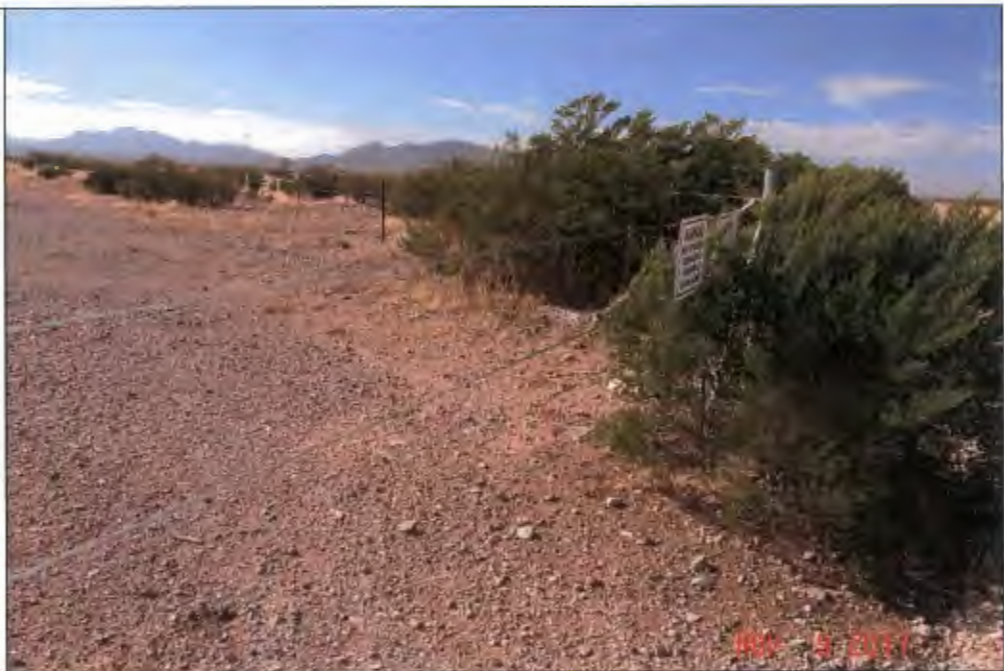
Photograph No. 8

View of Northern  
fence facing West.

Site perimeter fence  
and warning signs  
were in good  
condition.

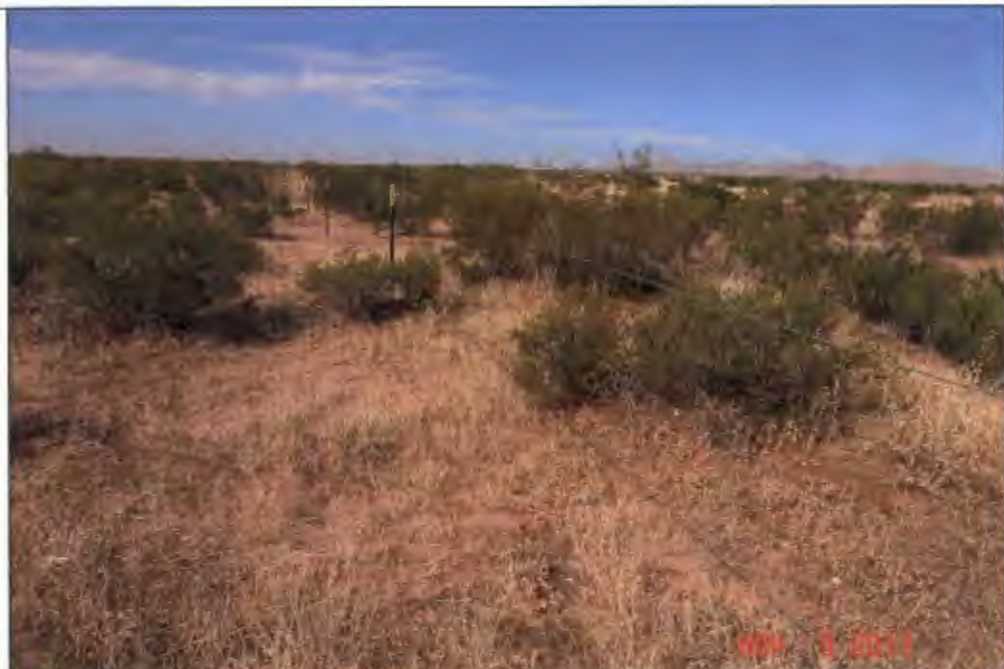
Photograph No. 9

View of Southern  
fence facing West.

Site perimeter fence  
in good condition.

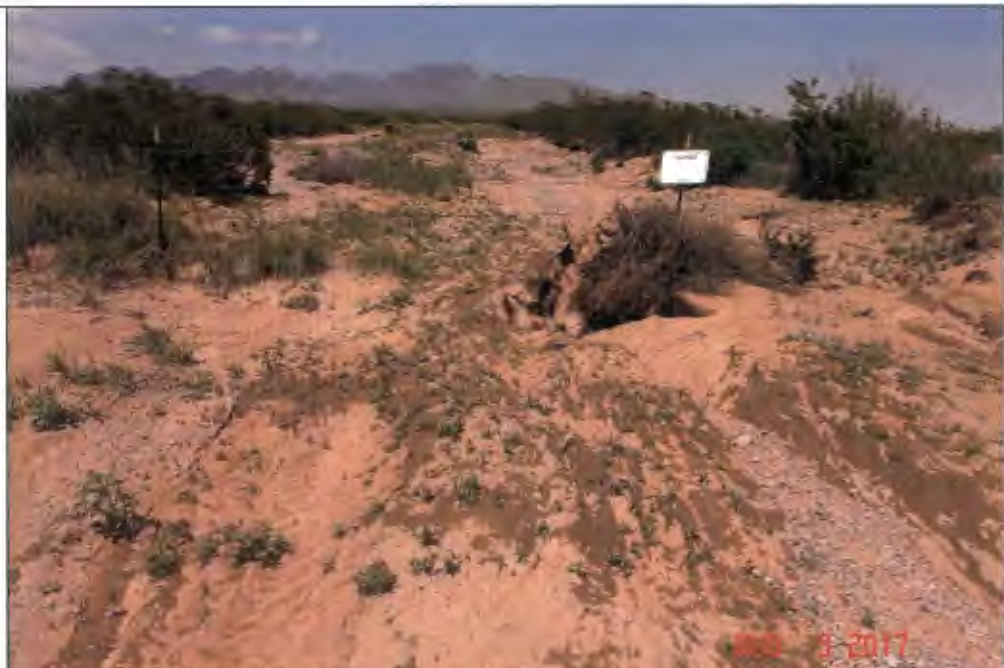
### Photograph No. 1

View of arroyo facing North.

Drainage system (arroyo) on the South side of the site showed significant erosion. Debris obstructed water flow during rain events. Identified during the site inspection conducted August 3, 2017.
