**DEPARTMENT OF THE ARMY**  
US ARMY INSTALLATION MANAGEMENT COMMAND  
HEADQUARTERS, UNITED STATES ARMY GARRISON, FORT BLISS  
1741 MARSHALL ROAD  
FORT BLISS, TEXAS 79916  
DEC 14 2017

RE: Submittal of Annual Post-Closure Site Inspection Reports, Fort Bliss Site No. 12 (FTBL-012)/Solid Waste Management Unit 27 (SWMU-27) Doña Ana Range Camp Rubble Landfill, Fort Bliss, New Mexico

# Doña Ana Range Camp Rubble Landfill - Pre-wet season Inspection FTBL-012/SWMU-27

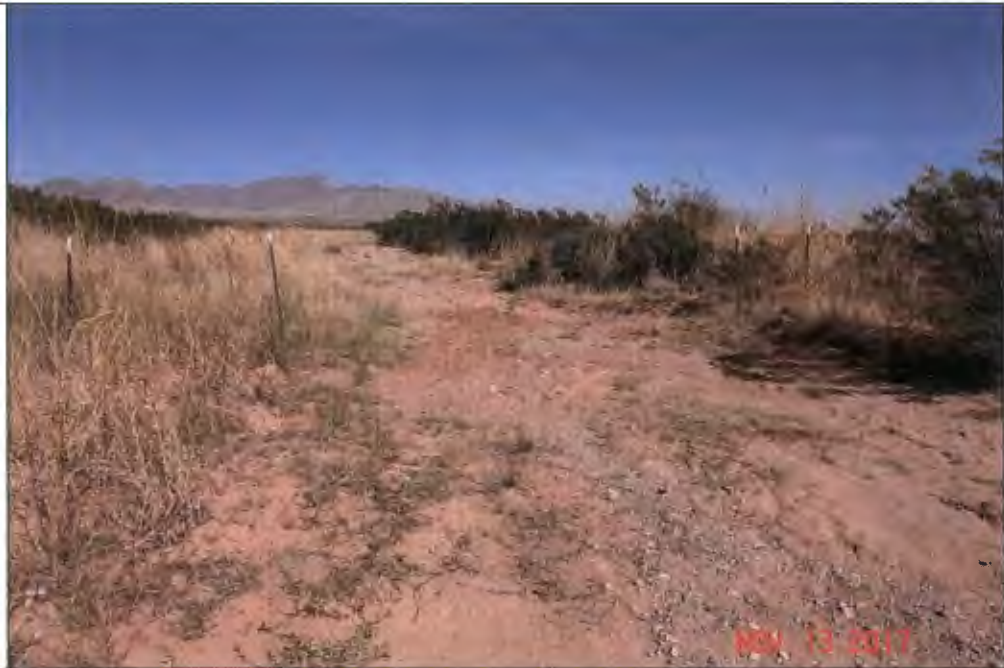
Photograph No.2

View of arroyo facing North.

Eroded section of the arroyo was repaired by filling with dirt and rocks

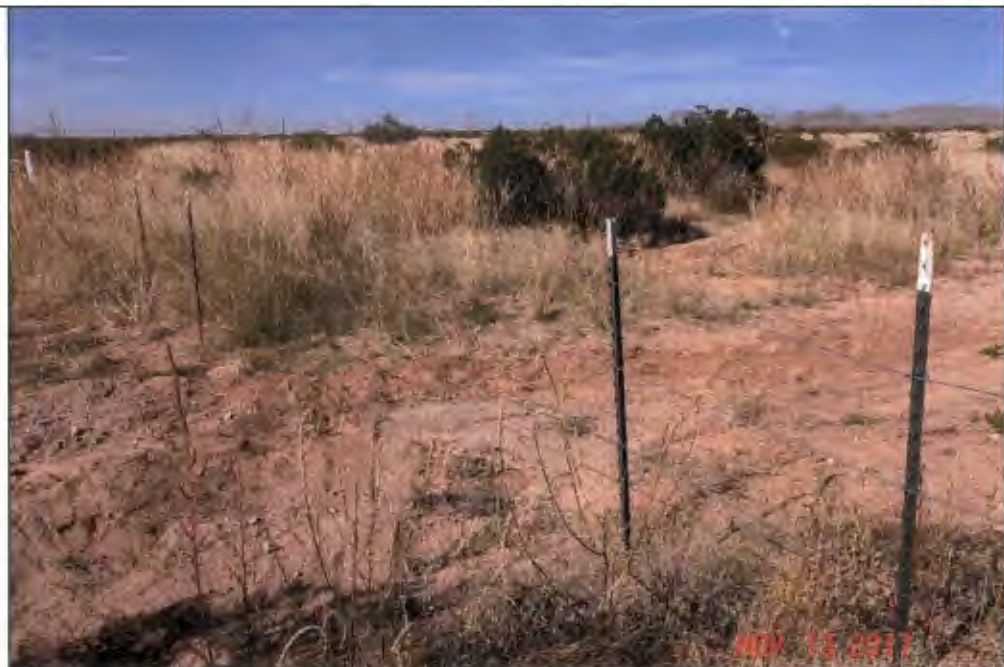
Photograph No. 3

View of reinforced fence facing West.

The fence post situated in the middle of the arroyo, which obstructed flow during rain events, was removed. The fence section was reinforced by installing an additional fence post on each edge of the arroyo.
