RE: Submittal of Annual Post-Closure Site Inspection Report, Fort Bliss Site No. 11 (FTBL-011)/Solid Waste Management Unit 29 (SWMU-29) Doña Ana Range Camp Sanitary Landfill, Fort Bliss, New Mexico

Doña Ana Range Camp Sanitary Landfill – Annual Inspection FTBL-011/SWMU-29

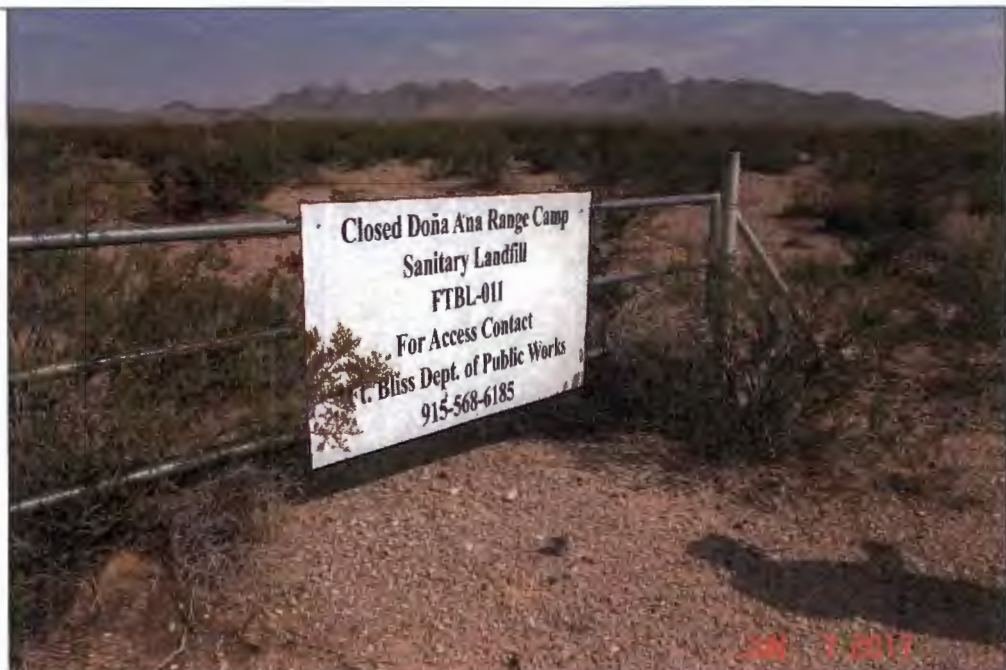
Photograph No. 1

View of landfill gate facing North.

Landfill gate and site perimeter fence were in good condition.

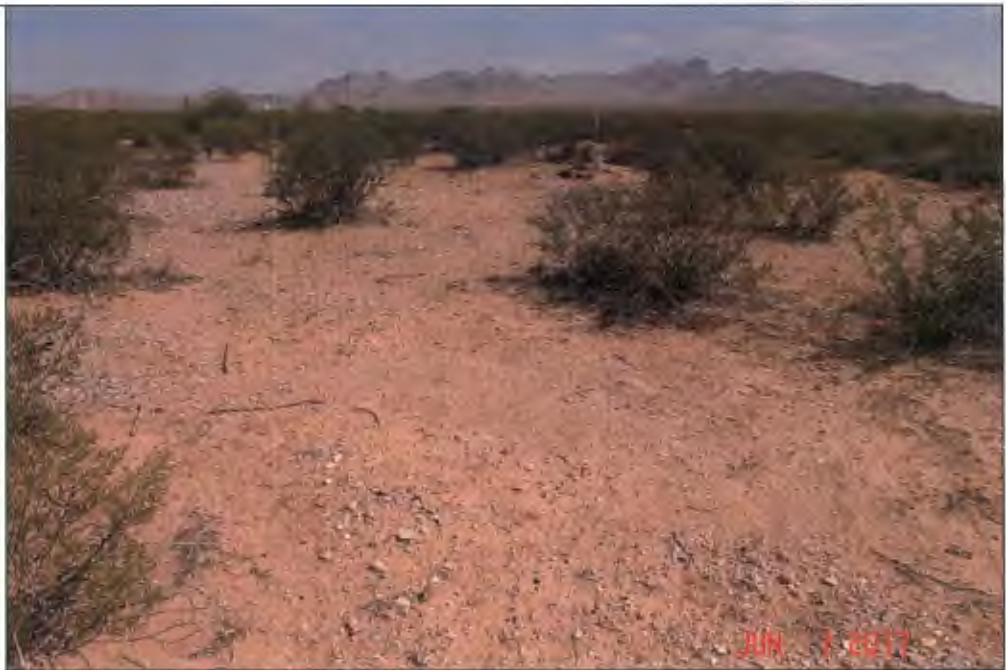
Photograph No.2

View of landfill cap facing North.

No signs of erosion or depression on landfill cap.
Vegetative layer was in good condition.

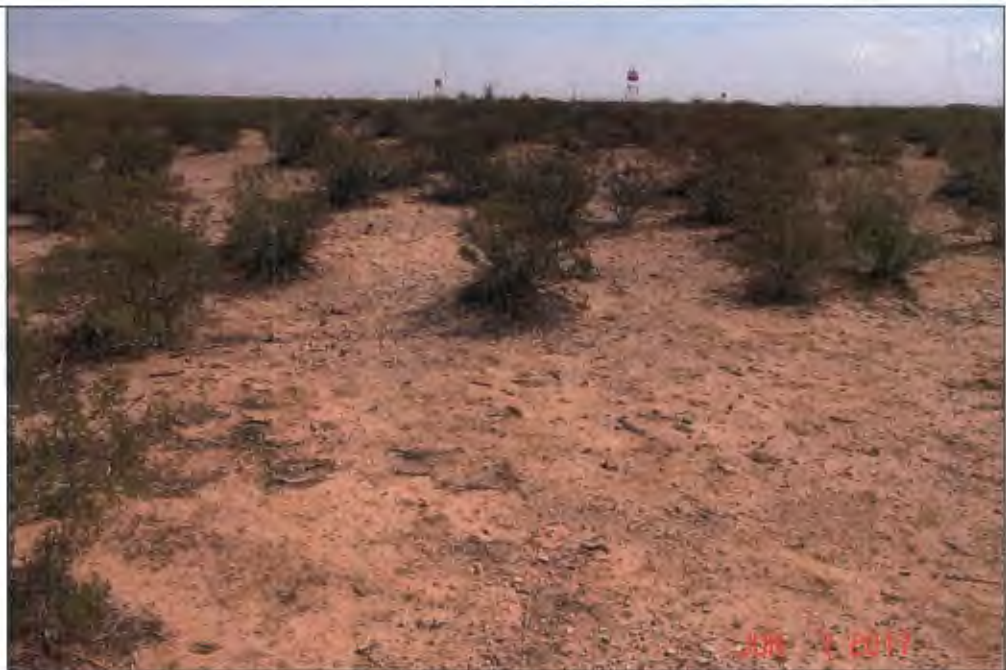
Photograph No. 3

View of landfill cap facing East.

No signs of erosion or depression on landfill cap.
Vegetative layer was in good condition.

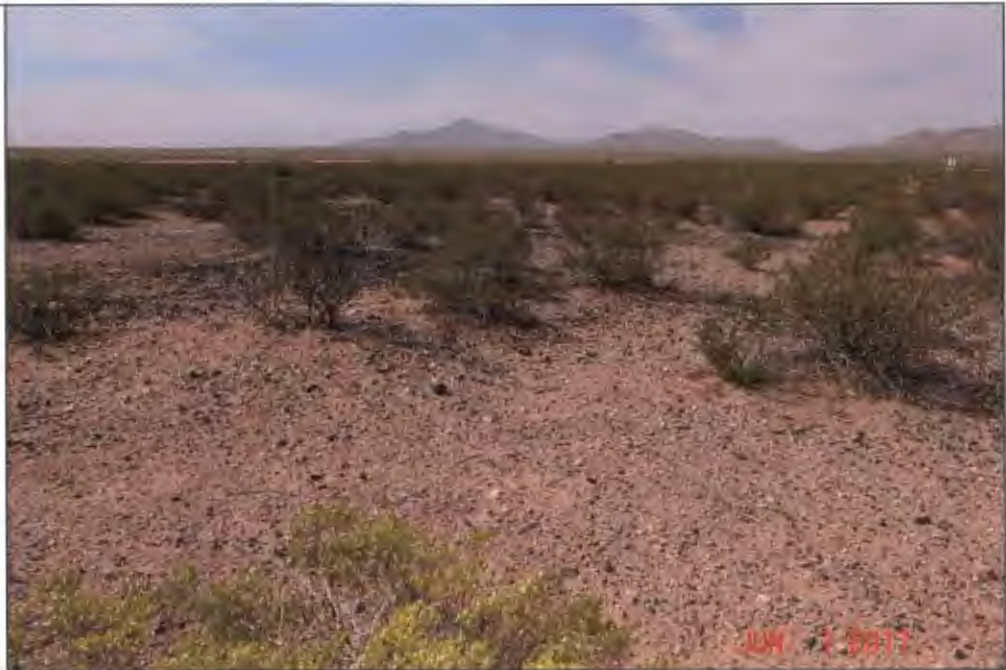
Photograph No. 4

View of landfill cap facing South.

No signs of erosion or depression on landfill cap.
Vegetative layer was in good condition.

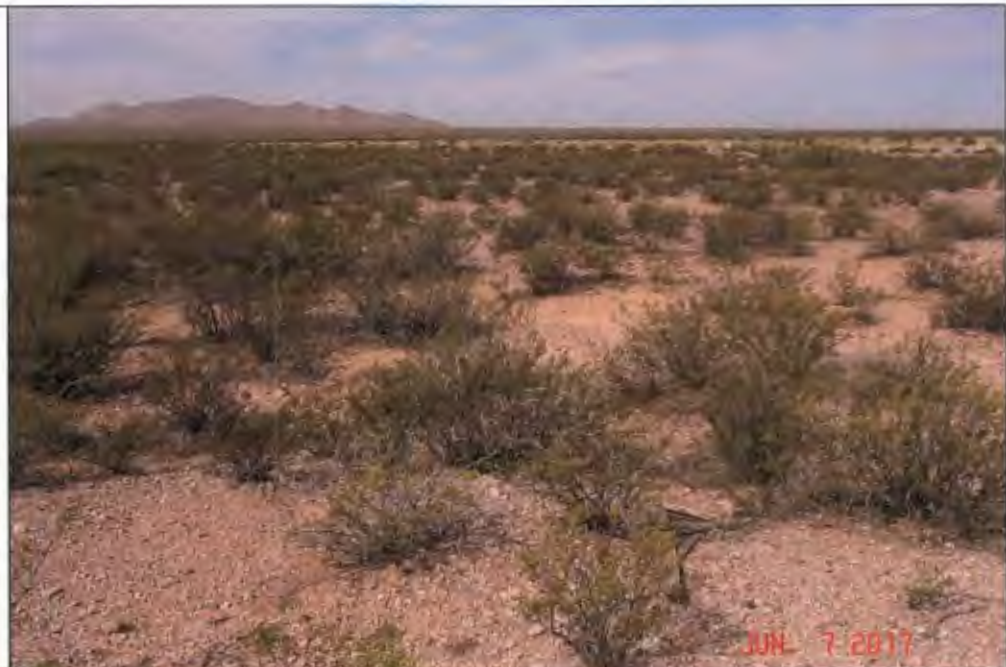
Photograph No. 5

View of landfill cap facing West.

No signs of erosion or depression on landfill cap.
Vegetative layer was in good condition.

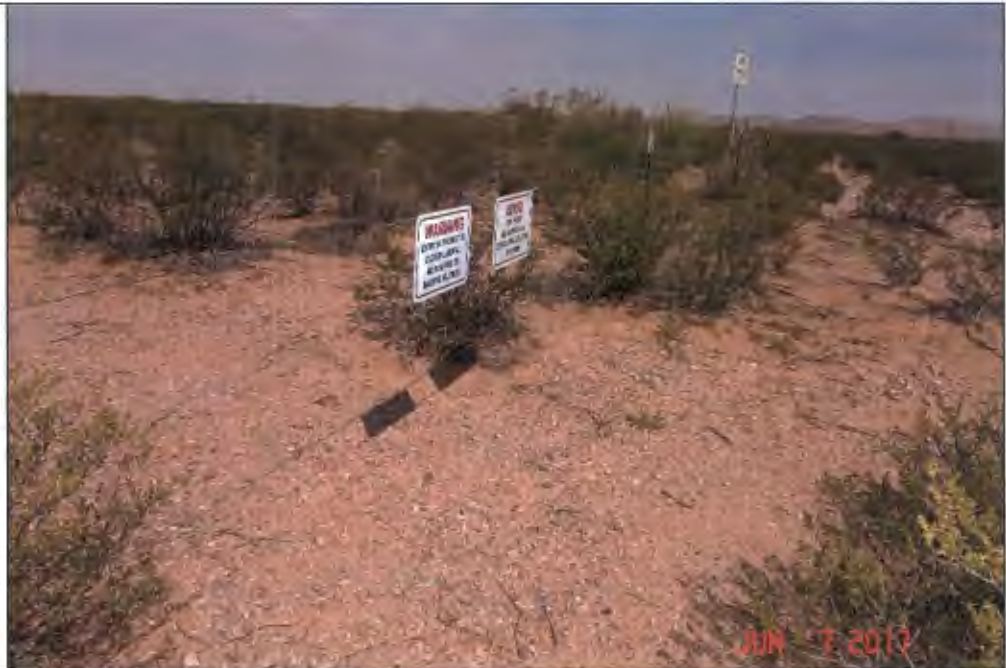
Photograph No. 6

View of Western fence facing South.

Site perimeter fence and warning signs were in good condition.

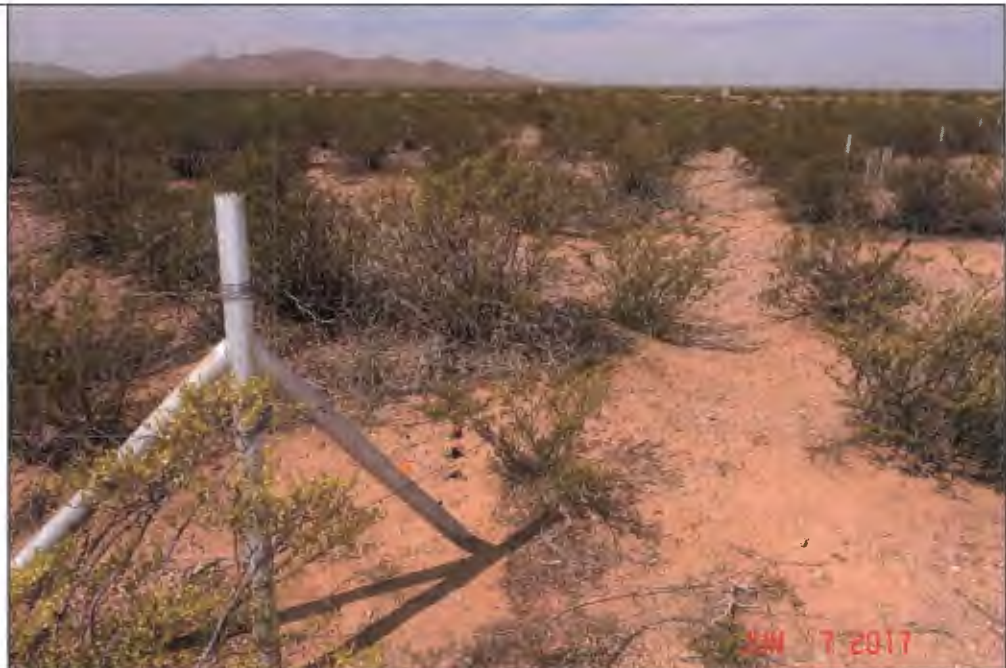
Photograph No. 7

View of Northern fence facing West.

Site perimeter fence and warning signs were in good condition.
