RE: Submittal of Annual Post-Closure Site Inspection Report, Fort Bliss Site No. 13 (FTBL-013)/Solid Waste Management Unit 18 (SWMU-18) McGregor Range Camp Landfill, Fort Bliss, New Mexico

McGregor Range Camp Landfill – Annual Inspection

FTBL-013/SWMU-18

Inspection Date: October 24, 2018

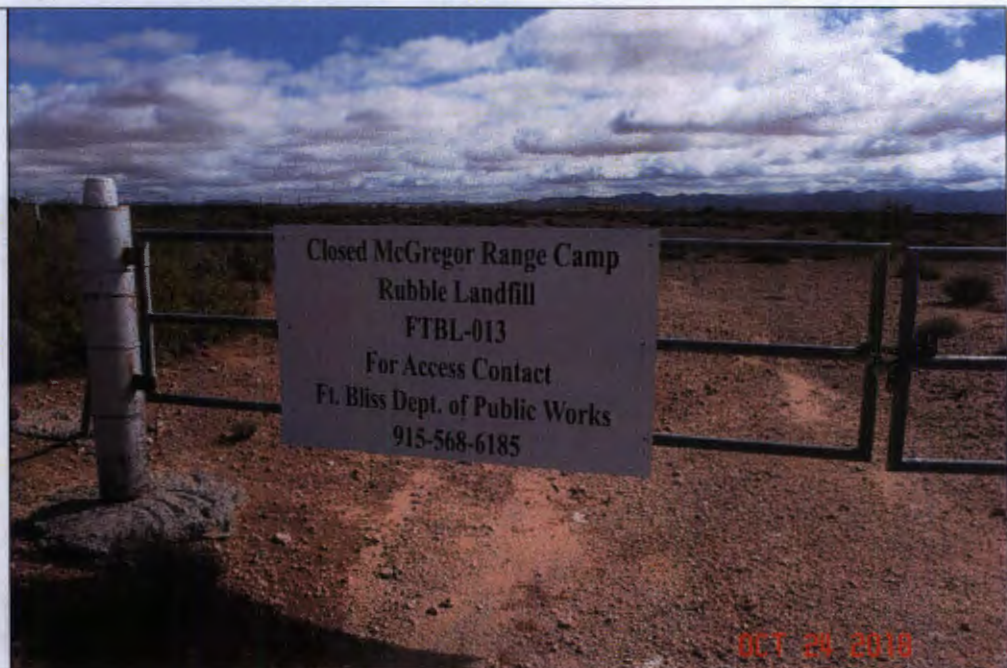
Photograph No. 1

View of landfill gate facing Southeast.

Landfill gate and site perimeter fence remain in good condition.

Lock and chain remain in good condition and functioning properly.

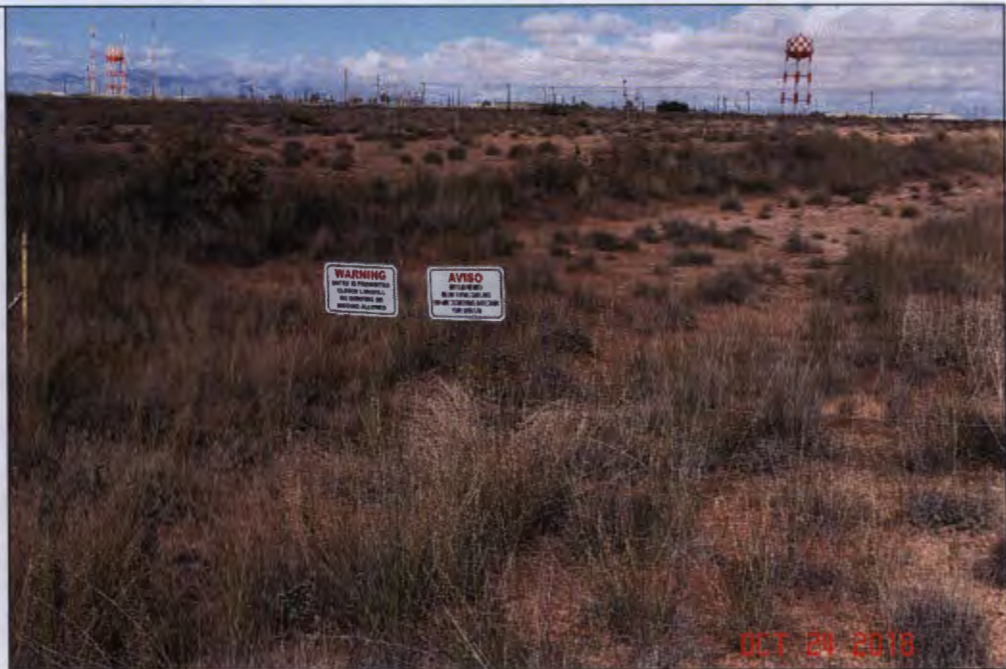
Photograph No.2

View of landfill cap facing North.

No signs of erosion or depression on landfill cap.

The vegetative layer remains in good condition.

West – East fencing and signage remain in good condition.

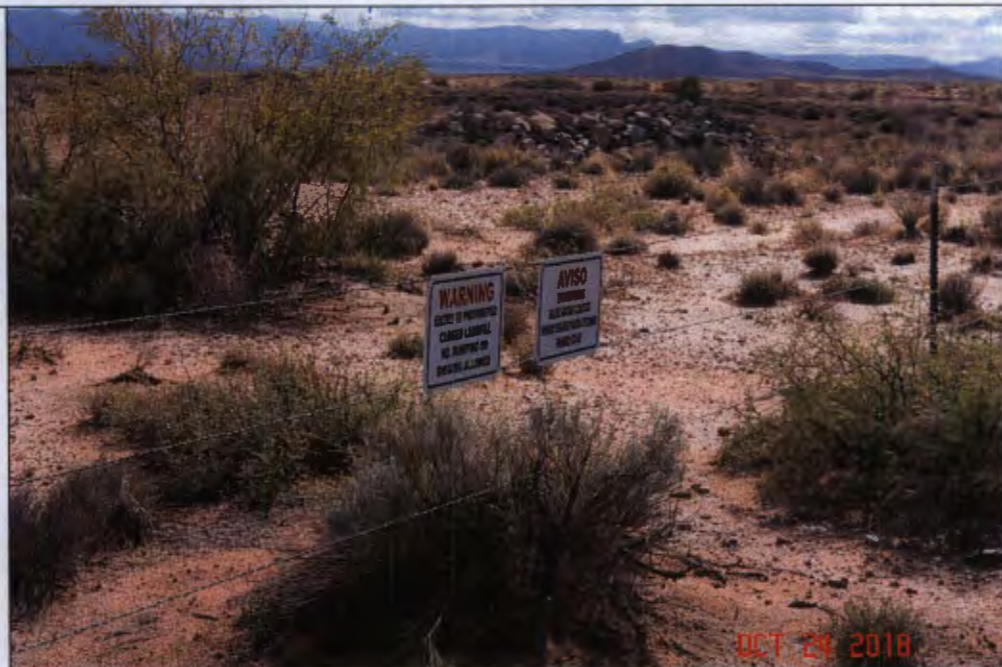
Photograph No. 3

View of landfill cap and fence facing South.

No signs of erosion or depression on landfill cap.

The vegetative layer remains in good condition.

Fence and signage remain in good condition.

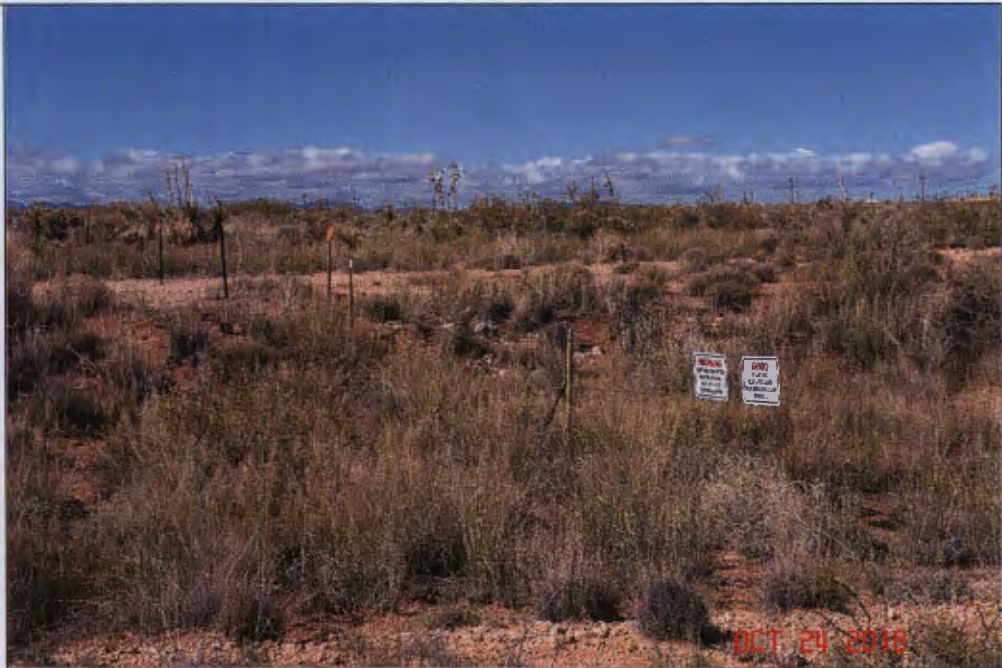
Photograph No. 4

View of landfill cap facing South.

No signs of erosion or depression on landfill cap.

The vegetative layer remains in good condition.

NW-SE fencing and signage remain in good condition.

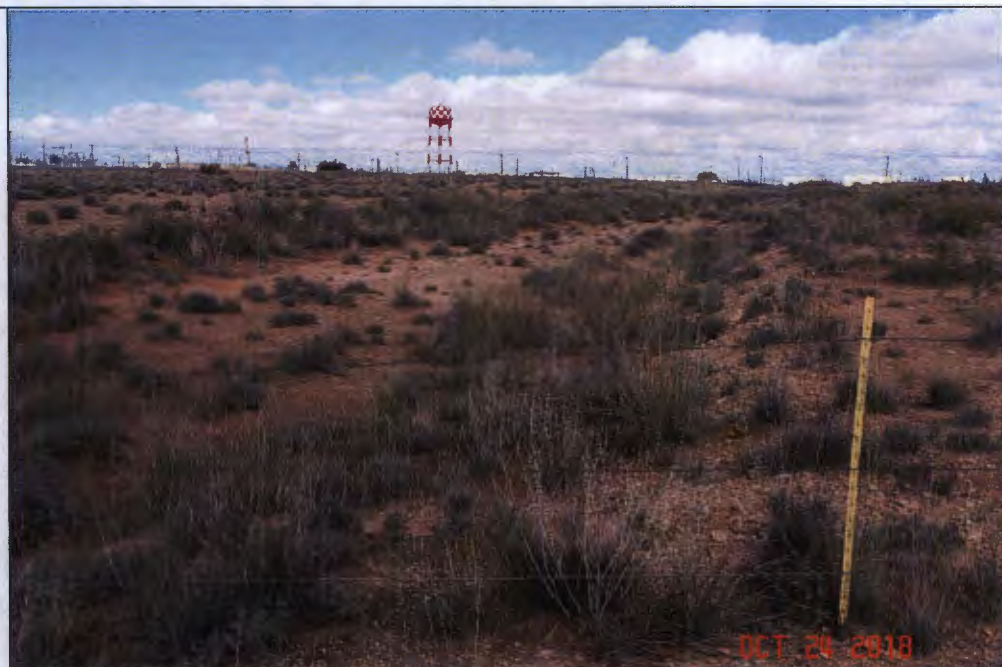
Photograph No. 5

View of landfill cap facing Northeast.

No signs of erosion or depression on landfill cap.

The vegetative layer remains in good condition.

Eastern fencing and signage remain in good condition.

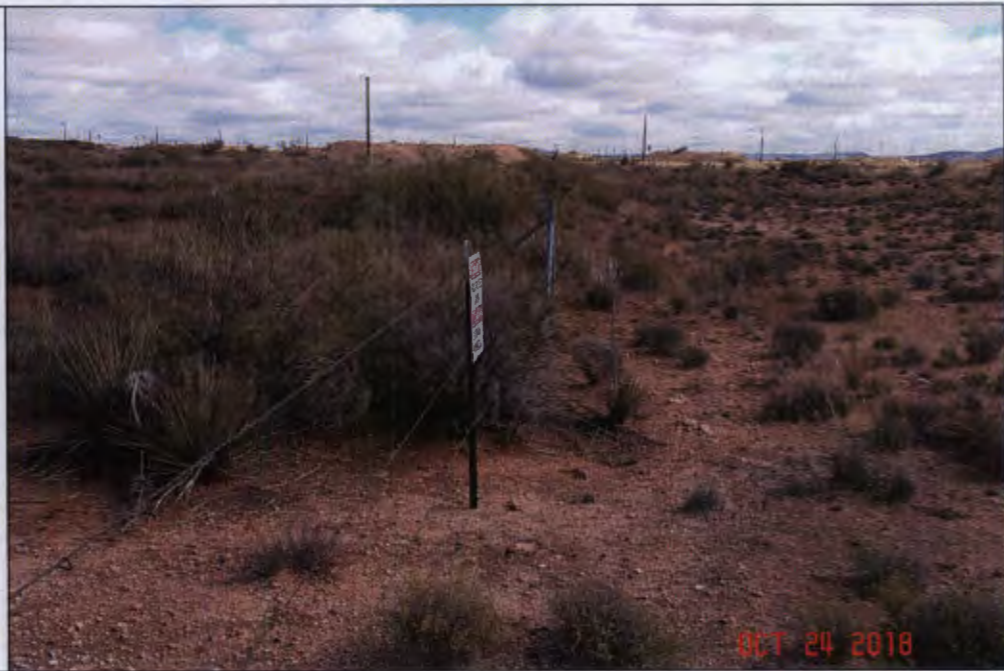
Photograph No. 6

Eastern fence and signage remain in good condition.

No evidence of significant erosion.

Vegetative layer remains in good condition.

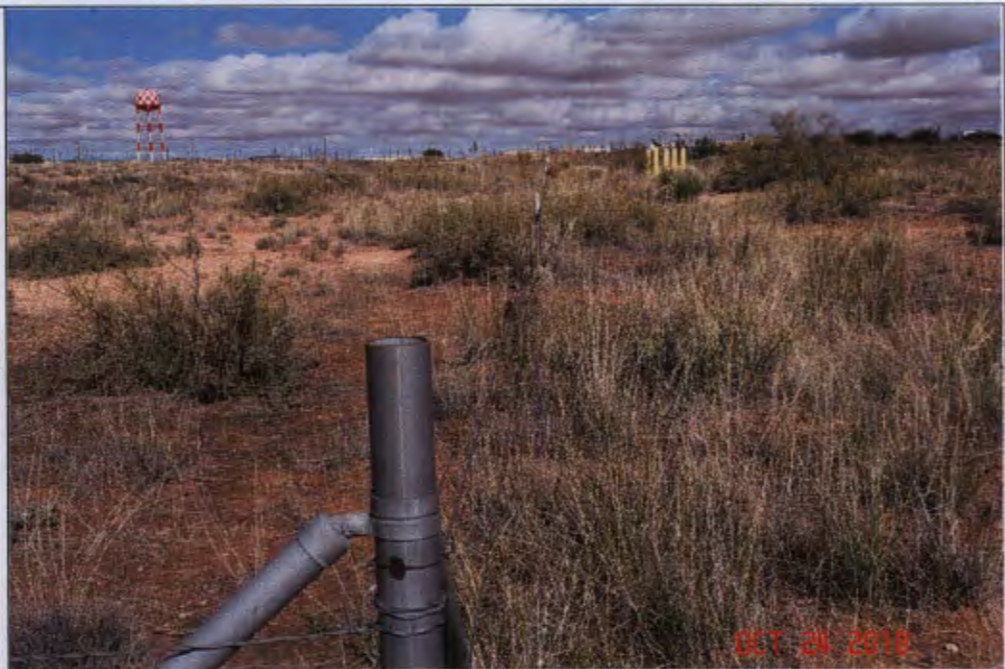
Photograph No. 7

Southern fence facing North.

Site perimeter fence remains in good condition.

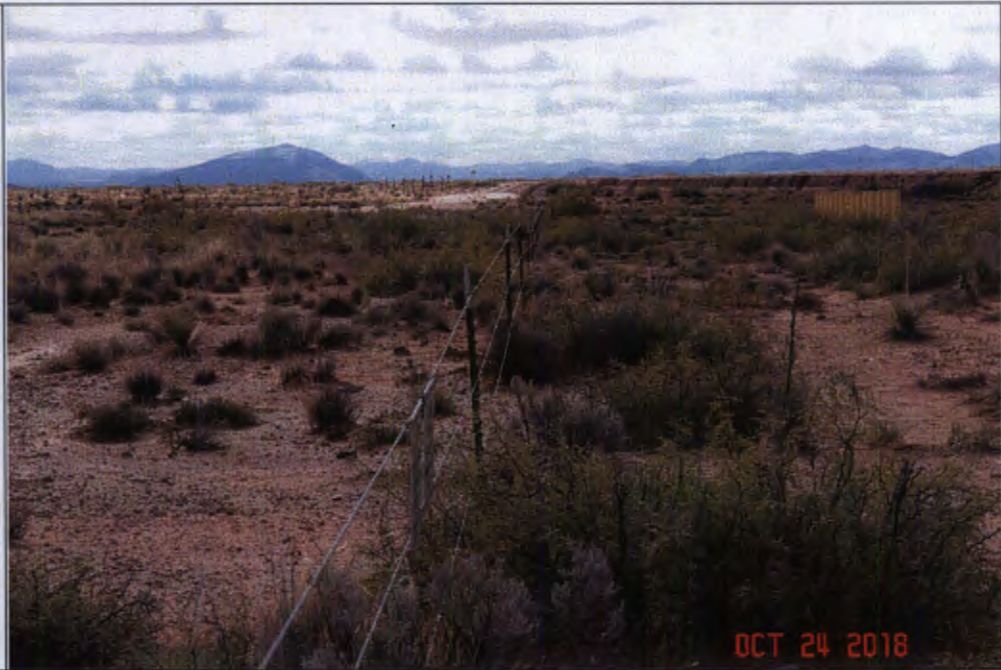
Photograph No. 8

Western fence
facing South.

Site perimeter fence
remains in good
condition.
