RE: Submittal of Annual Post-Closure Site Inspection Report, Fort Bliss Site No. 11 (FTBL-011)/Solid Waste Management Unit 29 (SWMU-29) Doña Ana Range Camp Sanitary Landfill, Fort Bliss, New Mexico

Doña Ana Range Camp Sanitary Landfill – Annual Inspection SWMU-29/FTBL-011

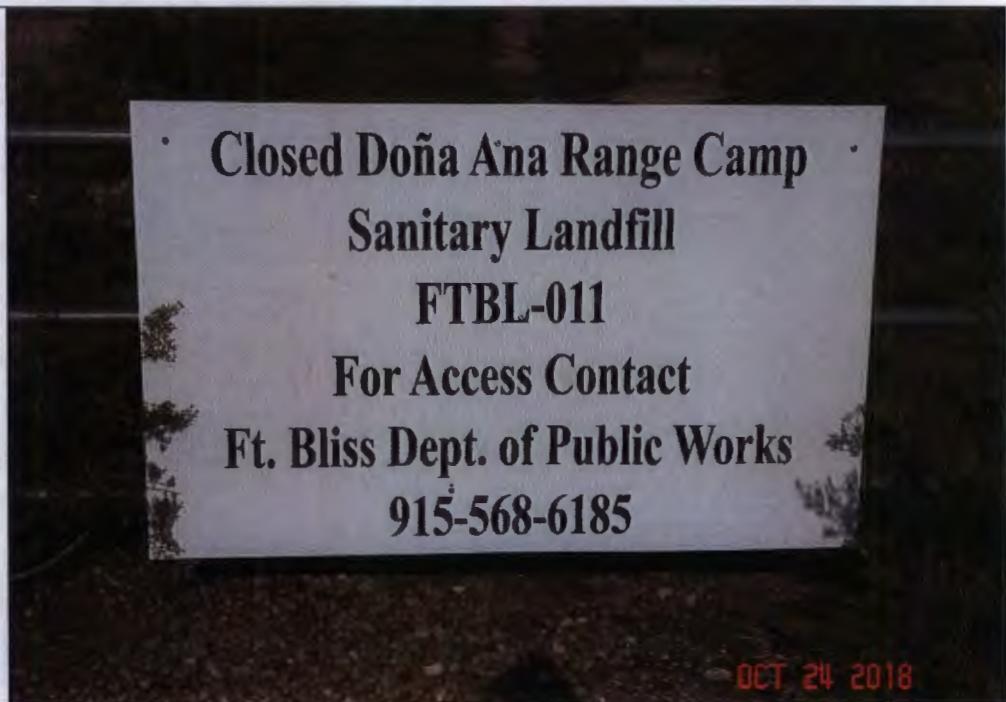
Photograph No. 1

Landfill gate and sign due North.

Gate lock works properly.

Site perimeter fence and signage remain in good condition.

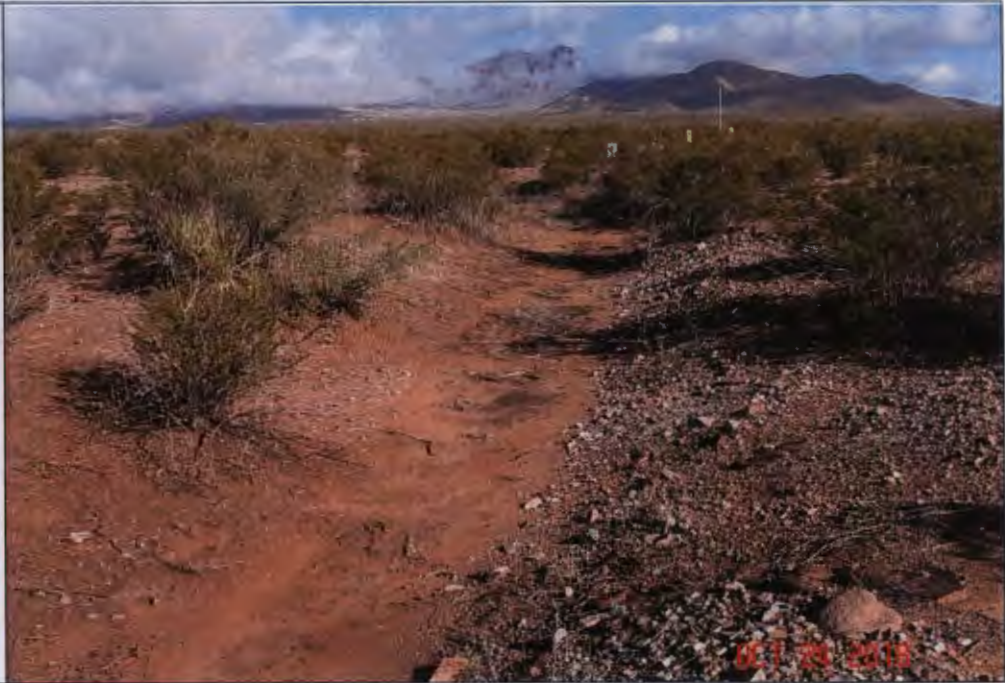
Photograph No.2

View of landfill cap facing North.

No signs of erosion or depressions on landfill cap.

Vegetative layer is in good condition.

Swale remains in good condition. No obstructions present and slopes remain intact.

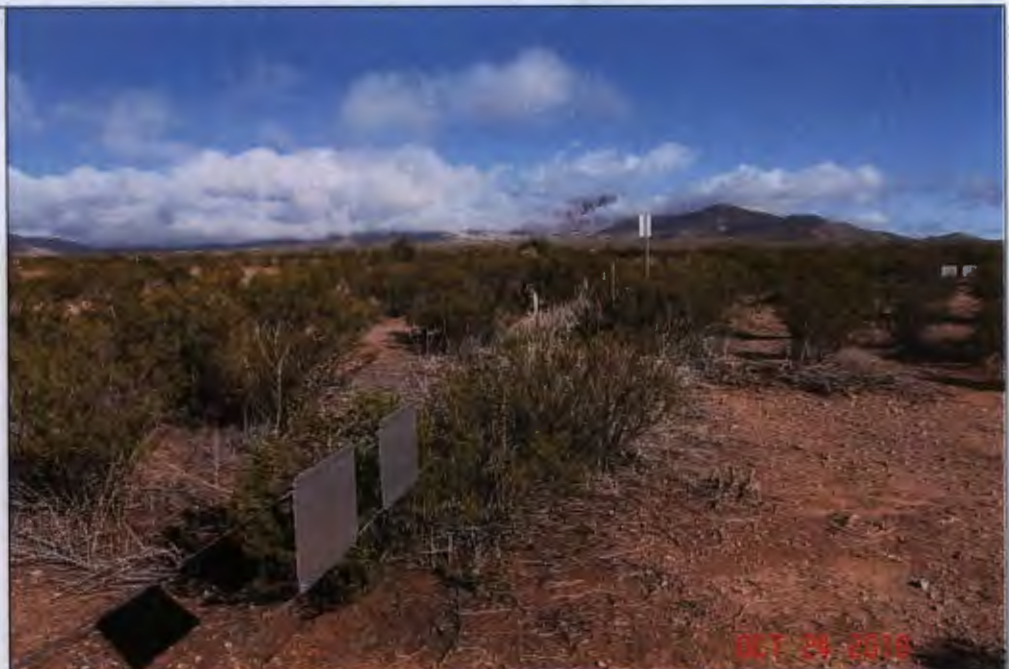
Photograph No. 3

View of landfill cap facing East.

No signs of erosion or depressions on landfill cap.

Vegetative layer is in good condition.

NW-SE fencing and signage remain in good condition.

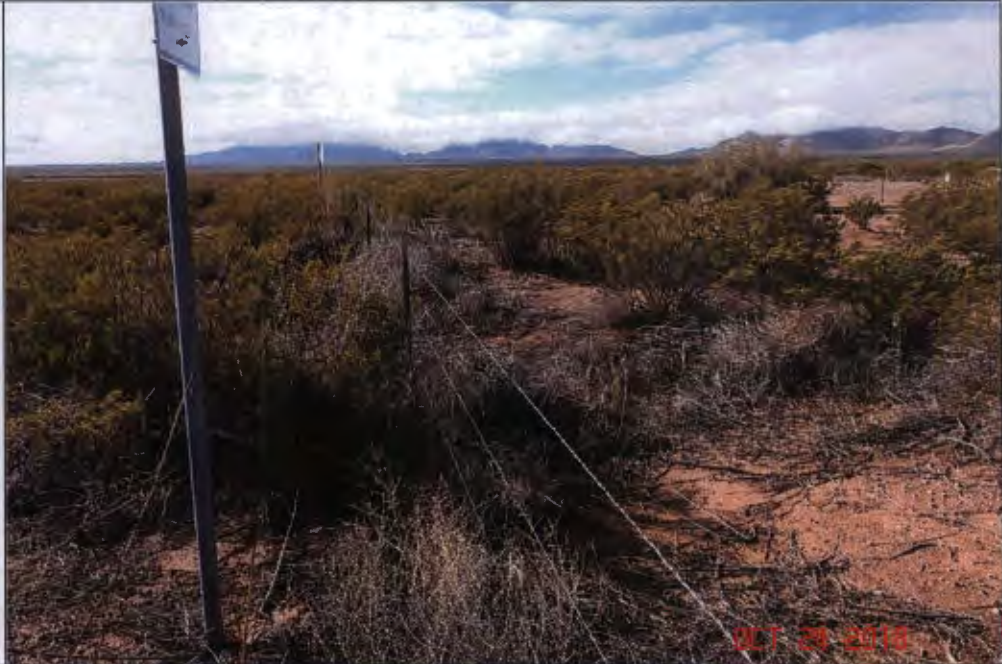
Photograph No. 4

View of landfill cap facing South.

No signs of erosion or depressions on landfill cap.

Vegetative layer is in good condition.

Fencing and signage remain in good condition.

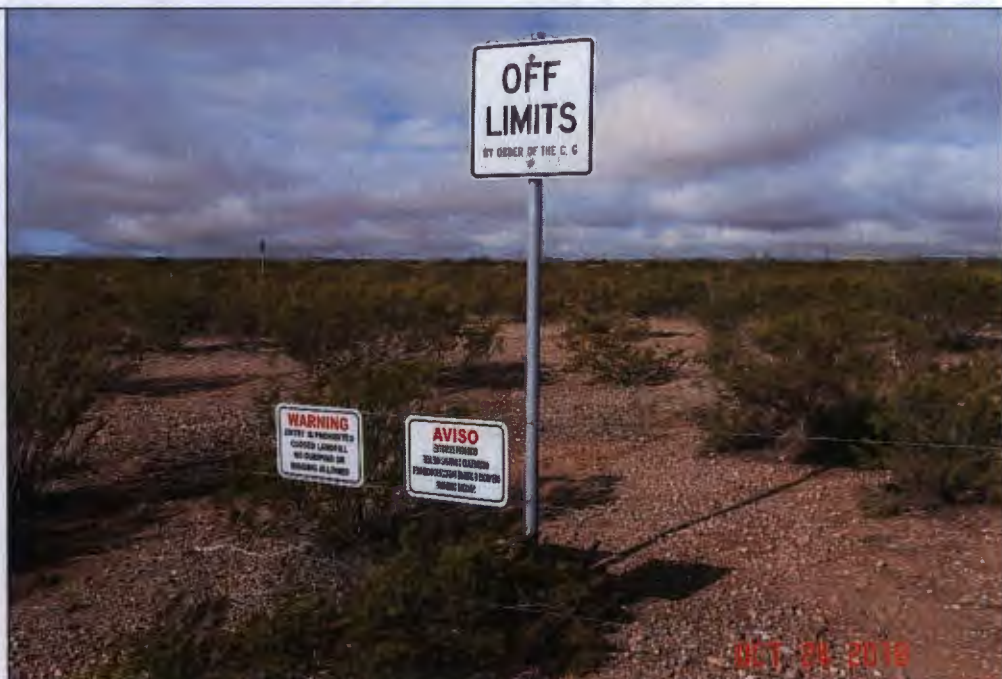
Photograph No. 5

View of landfill cap facing West.

Site perimeter fence and warning signs remain in good condition.

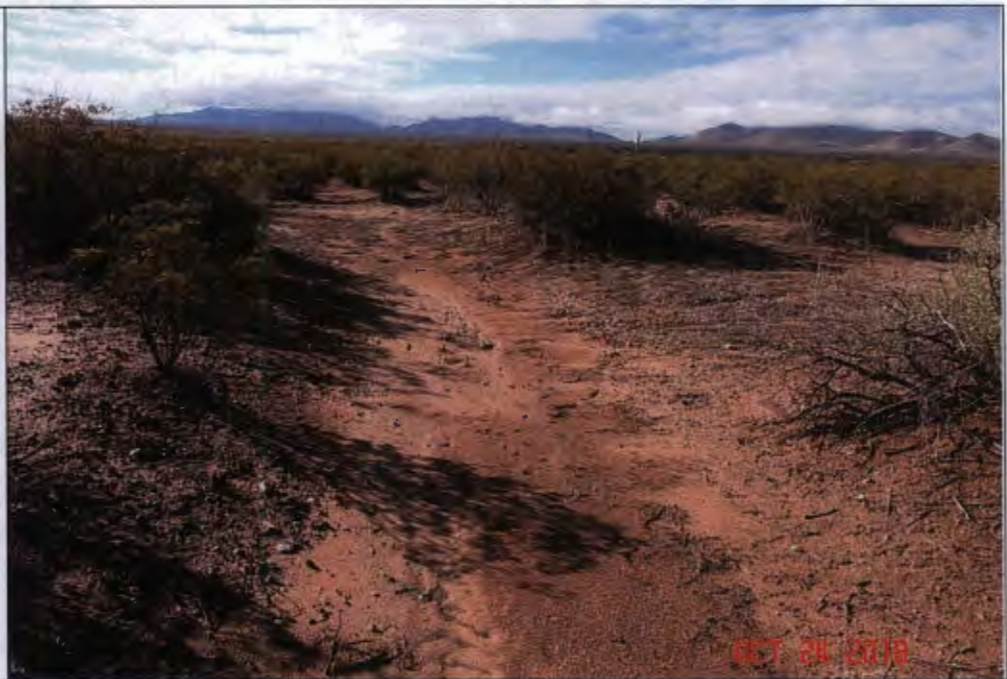
Photograph No. 6

View of swale trending South.

Swale is in good condition. No obstructions are present and slopes remain intact.
