DEPARTMENT OF THE AIR FORCE

HEADQUARTERS 833D COMBAT SUPPORT GROUP (TAC)

Pollution Incident Report

EMERGENCY NOTIFICATION REPORT
(RE: 40 CFR 265.56(j)(1-7))

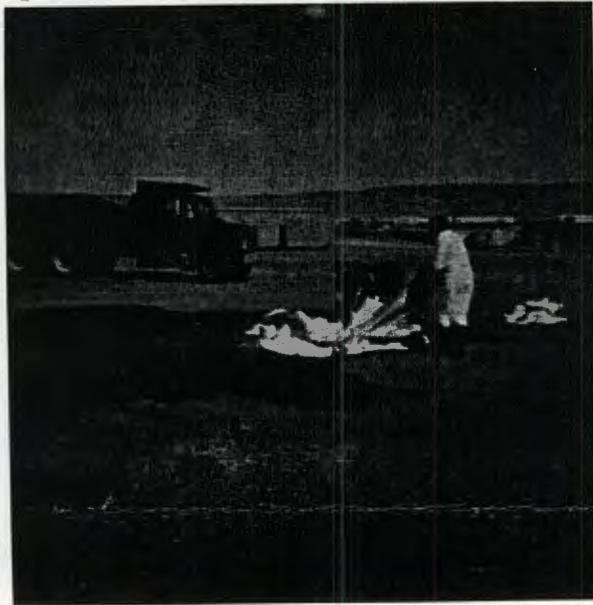
SPILL CLEAN-UP, Bldg 906,
MOBSS, 6 Mar 90

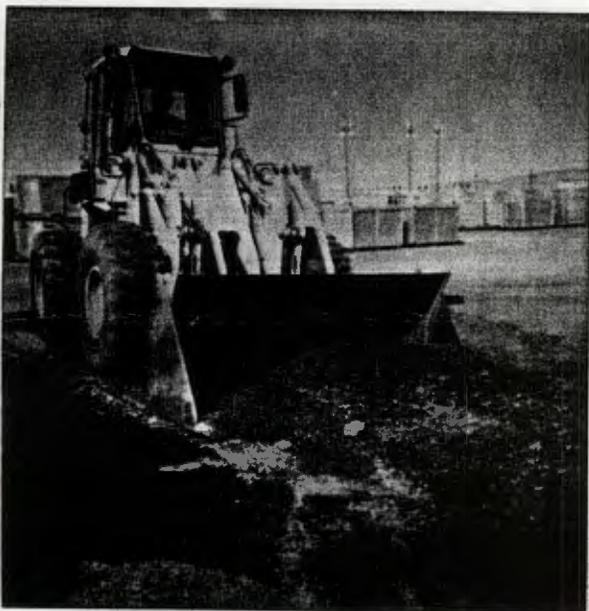
SPILL CLEAN-UP, Bldg 906, MOBSS
6 Mar 90

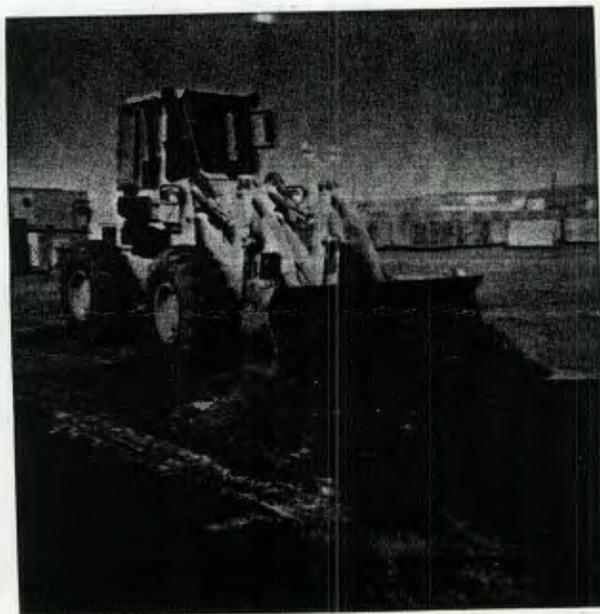
SPILL CLEAN-UP, BLDG 906
MOBSS, 6 MAR 90

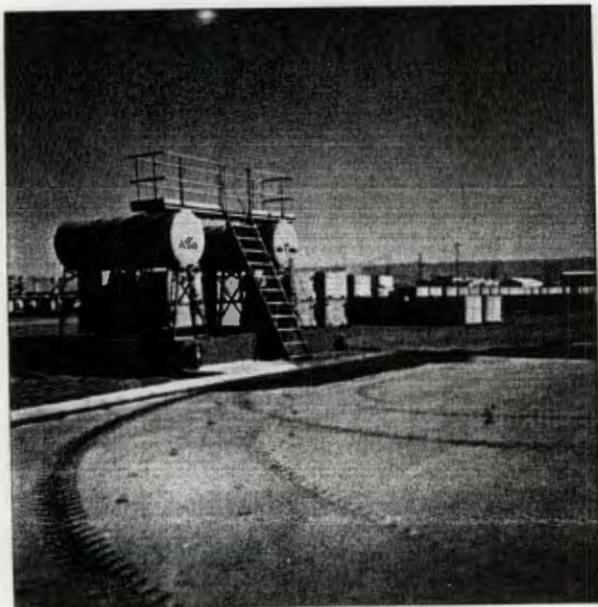
7. Cause of spill, description of response, estimated quantity and disposition of recovered material: On 7 Mar 1990, at approximately 0930 hrs, Sgt Gregory Seely, MOBSS, noticed seepage from the plug of a 1000 gallon above ground diesel fuel tank. When he attempted to tighten the plug, it detached from the tank. The tank had been filled earlier on the morning of 7 Mar with 950 gallons of diesel. When the plug detached from the facility, Sgt Seely immediately contacted the Base Fire Department (FD). The FD received the call at 0936 and arrived on scene at 0941. FD personnel plugged the tank and stopped the spill. The FD contacted the Base Environmental Coordinator for clean-up requirements. The Ch, Operations, Major Sunada, requested the Spill Response Trailer be moved to the spill location. Absorbent materials were placed on the asphalt and gravel areas to collect the floating diesel. Absorbent material was collected in 55 gallon drums and will be manifested as a hazardous waste. Approximately 6" of contaminated gravel and soil were removed from the contaminated area; this equated to approximately 25 cu yds. This material was then taken to the lined and bermed Base hydrocarbon recovery area at the sanitary landfill to dry out and to allow microbial degradation of the hydrocarbon materials. Based on the removal of visible contamination, the fact the gravel and soil ground surface is very hard in this area, providing for little migration of the diesel fuel to the subsurface, and knowledge of microbial degradation of hydrocarbon materials in soils, it is believed the management of diesel contaminated absorbent and soils was protective of human health and the environment. The base has concern some fuel was trapped under the hardstand. It is believed some fuel migrated between the edge of the gutter and edge of the hardstand. The base will provide a follow-up letter when action is taken to correct this problem. Due to evaporation and other complexities of this spill, it is difficult to estimate percentage of material recovered.

1000 gal tank on right - Plug
Popped out - caused spill

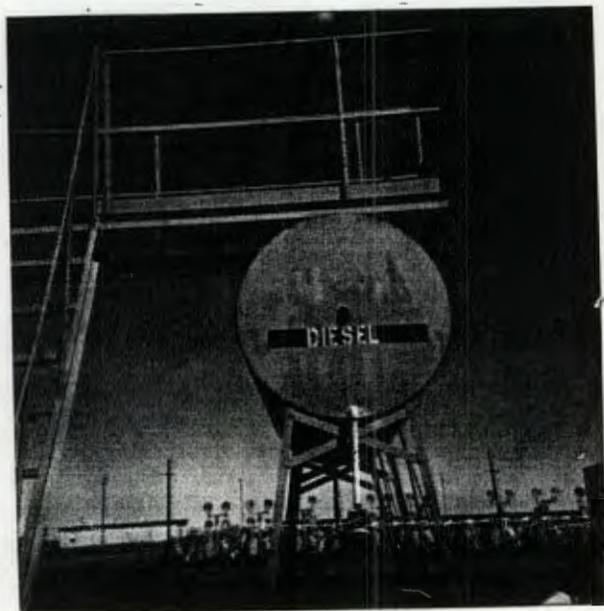
Plugged Tank, Bldg 906,
MOBSS 6 Mar 90

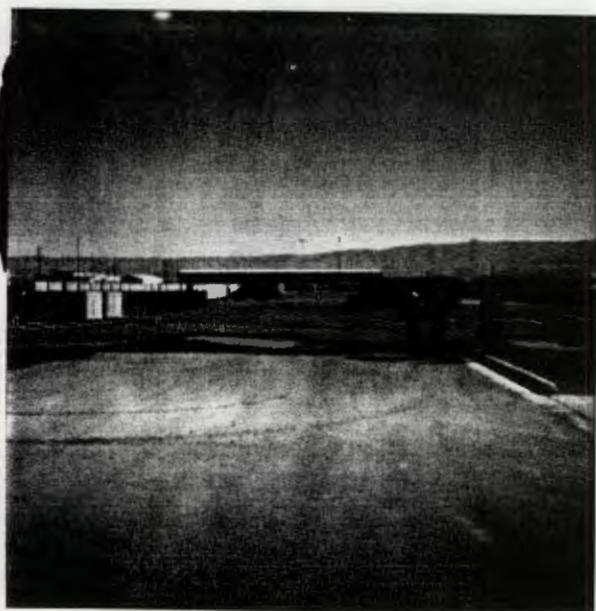
SPILL, ESTIMATED 400 gal
Diesel, Bldg 906, 6 Mar 90
