SUBJECT: SWMU 141 No Further Action Proposal Information, Draft Final PA/SI Report,
Section 5

Section 5

SITE SD-27—PAD 9 WASHRACK AREA

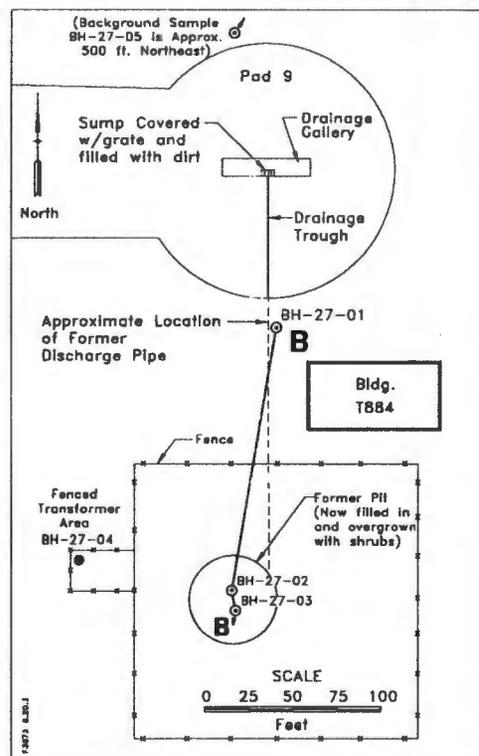
Figure 5-1 Site SD-27 Features

Site features are illustrated in Figure 5-1. The pad is in fair condition, exhibiting some cracks mainly along concrete seams. The sump in the middle of the pad

is filled with soil and has plants growing in it. The drainage gallery from the sump to the southern edge of the pad is filled with dirt. It is not known whether the dirt in the sump and drainage gallery is underlain by concrete, or whether runoff drained through a pipe or a lined or unlined ditch.

The area of the former pit is now surrounded by a slightly damaged wire-mesh fence and is overgrown with bushes and small trees, most of which were removed for this investigation. An abandoned transformer is located adjacent to the fence west of the former pit. The abandoned transformer is surrounded by a chain-link fence. The ground around the abandoned transformer is stained.

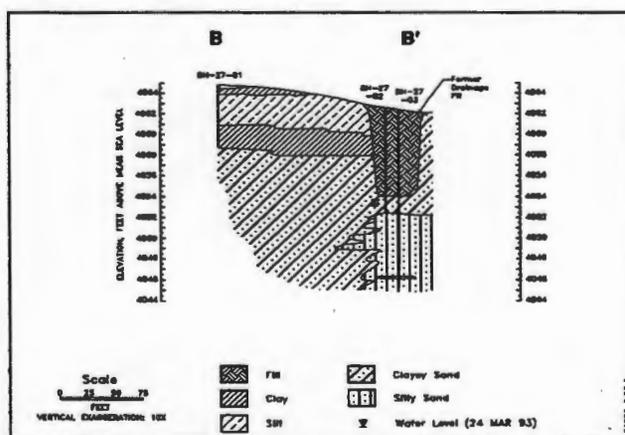
Figure 5-2 Site SD-27 Geologic Cross Section

To correlate and interpret the site stratigraphy, cross section B-B', shown in Figure 5-2, was constructed from boring logs for Site SD-27. Figure 5-1 shows the location of the cross section. Site lithology consists primarily of silt interbedded with lenses of clay and sandy clay. In the vicinity of the former waste disposal pit, shown in Figure 5-1, fill material was encountered at a depth of 8 ft. A clayey sand unit with caliche underlies the pit.

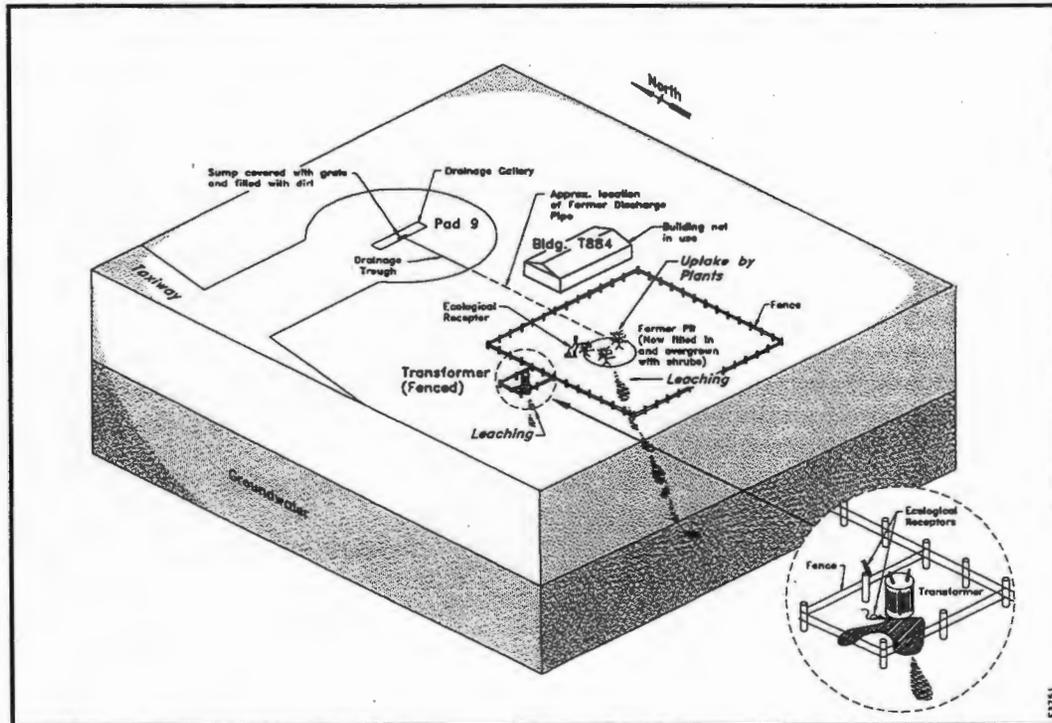
Figure 5-3 Site SD-27 Conceptual Site Model

Figure 5-3 depicts possible contaminant migration and exposure pathways for both human and ecological receptors. The constituents detected in site soils could migrate through the environment via several different mechanisms. Volatilization is likely to be minimal, given the semivolatile nature of PCBs, and the fact that the fuel hydrocarbon contamination is at the base of the former pit and is buried. Fugitive dust generation, which can transport contamination to ambient air, is of minimal concern because radioactivity was detected at levels comparable to background, the surface area of PCB contamination is very small, and the petroleum hydrocarbons detected at the site are buried.

is no known area where surface water runoff from the site collects, and the only surface contamination at the site is a very small area of PCB-contaminated soil. Infiltration and percolation of contaminants to groundwater are the most likely modes of contaminant transport at this site. The sample in which petroleum hydrocarbons were detected was taken from below the water table. However, groundwater is nonpotable and does not discharge anywhere near the site.
