DEFENSE LOGISTICS AGENCY

SUBJECT: Memorandum For Record, Spill at Bldg 1024

SPILL RESPONSE FORM

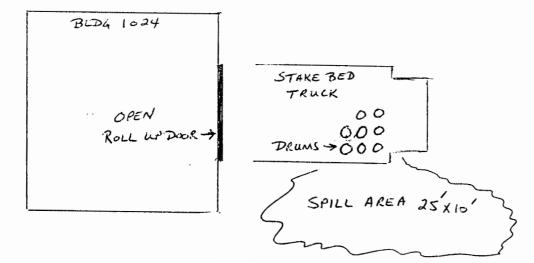
Sketch of Spill Site (if more room is needed, turn to the back of the page to complete the sketch.)

4. Location of Spill: BLDG 1024 LOADING PAD

Probable Cause of Spill: VAPOR PRESSURE BUILD UP IN OPEN HEAD 17E DEUM

Type III >10 ft. in diameter _____ Stable ____ Expanding ___X
