DEPARTMENT OF THE AIR FORCE
HEADQUARTERS 377TH AIR BASE WING (AFMC)
CERTIFIED MAIL: P 143 078 406
RETURN RECEIPT REQUESTED

**FINAL NO FURTHER ACTION DOCUMENT
SWMU 8-6
SILVER RECOVERY
UNIT BUILDING 1000 (WP-47)**

September 25, 1996

**FINAL NO FURTHER ACTION DOCUMENT
SWMU 6-14
SEWAGE EFFLUENT TRANSMISSION LINE
(ST-51)**

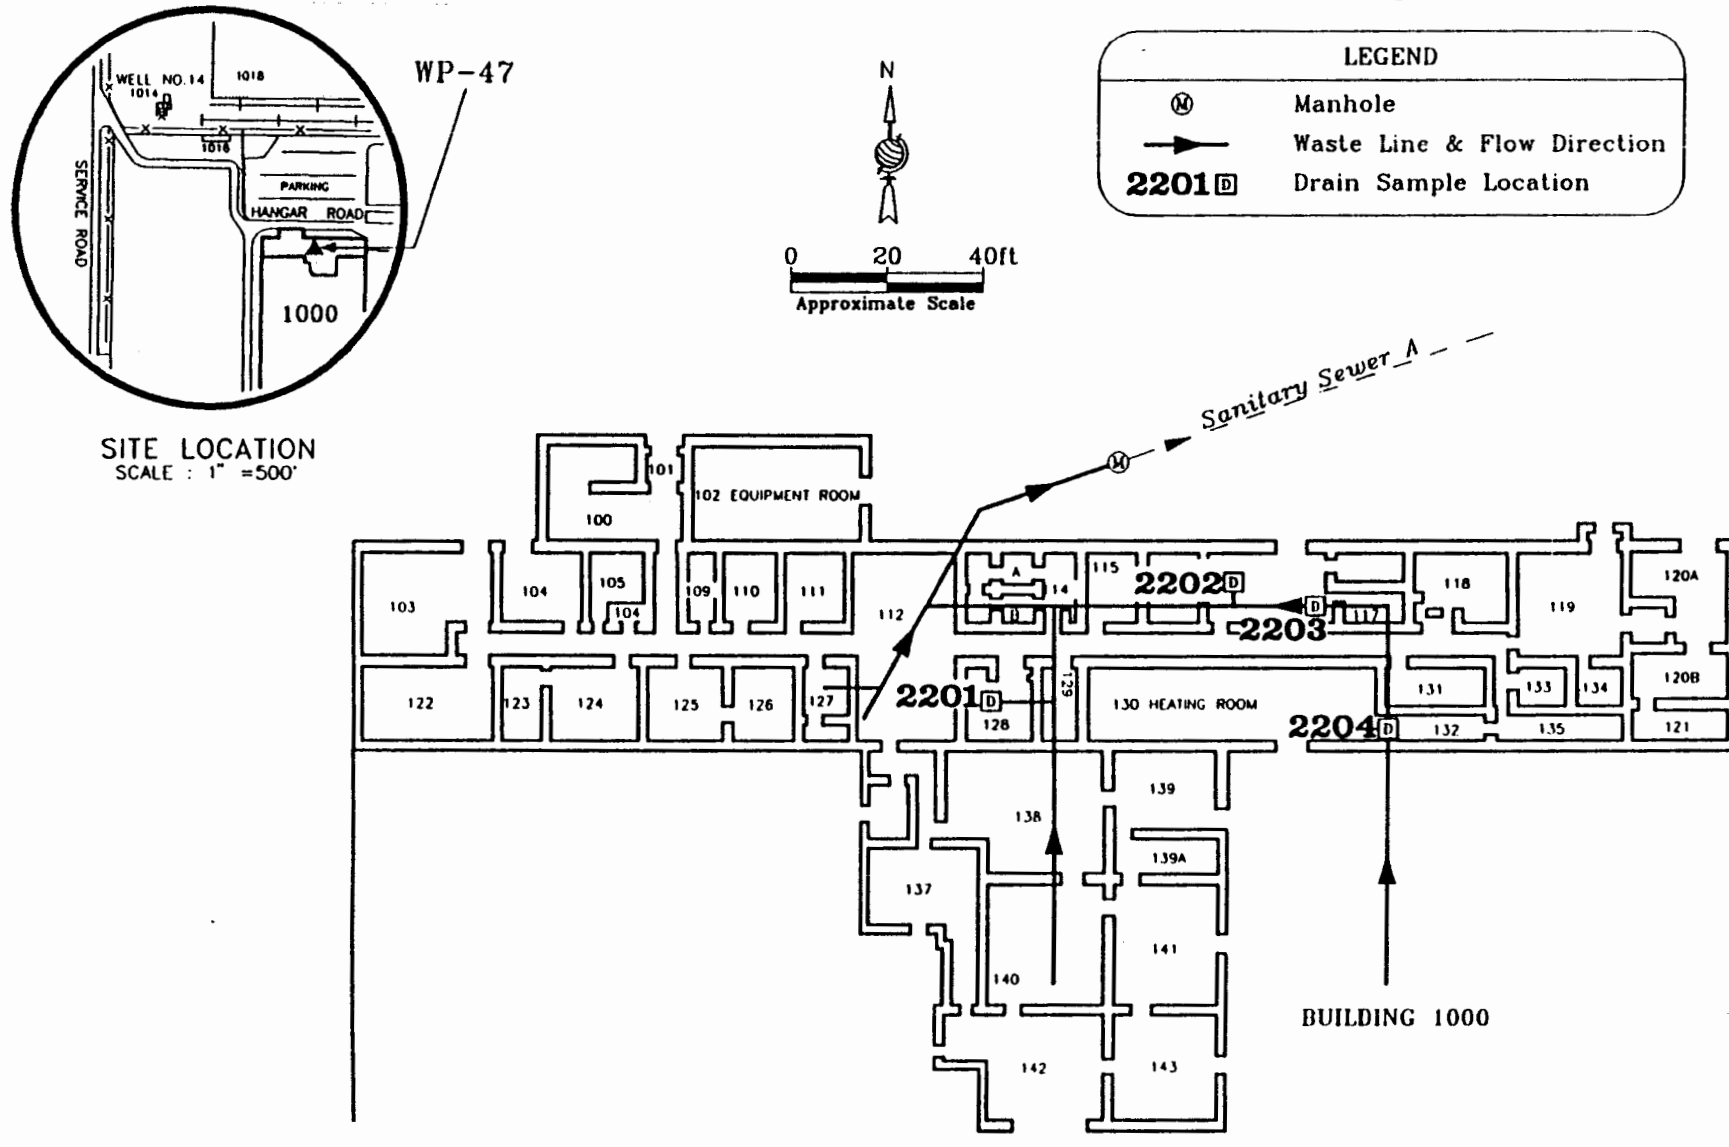
Figure 2-1 Site WP-47, Silver Recovery Unit, Building 1000, Kirtland AFB (Halliburton NUS Corporation, 1995a)

Appendix II RFI, sediment samples were collected from the traps in each of the four floor drains in September 1993. The sediment sample locations are shown on Figure 2-1 and are designated as 2201, 2202, 2203 and 2204. During the Stage 2C RFI, soil samples were collected on December 27, 1994, through borings drilled through the floor slab adjacent to the drain lines, to determine the presence or absence of soil contamination. The United States Environmental Protection Agency (EPA) reviewed the Appendix II Stage 2B RFI and by correspondence letter dated 30 May 1995, the EPA agreed with KAFB's recommendation for NFA at the site, but recommended continued monitoring (KAFB, 1995).

During the Stage 2B investigation, silver was detected above the Human Health Risk-Based (HHRB) action level of 400 mg/kg in the sediment samples collected from the drains at locations 2201 and 2202 (Figure 2-1). Silver was detected at 412,000 and 241,000 mg/kg in the sediment sample and replicate sample, respectively, from location 2201. The silver concentration in the sediment at sample location 2202 was detected at 6330 mg/kg.

Silver was also detected in the aqueous samples from 2202 and 2203 and the replicate sample at 2201 (Figure 2-1). Concentrations ranged from 0.00065 to 0.0072 mg/l. These concentrations are below the HHRB action level of 0.05 mg/l and also below the Secondary Maximum Contaminant Level (SMCL) of 0.1 mg/l. No drains were receiving wastewater at the time of sampling in September 1993.

Based on these analytical findings, an interim corrective measure was undertaken to remove the silver contaminated sediments/water. This corrective measure involved hydro-jetting the affected drains and removing the affected sediments/water with a vacuum truck.

The drains associated with the silver recovery unit at Building 1000, SWMU 8-6, were cleaned out on March 9, 1996, using hydro-jetting equipment and a vacuum truck to collect the effluent. Approximately 1950 gallons of effluent were generated during the cleaning effort. Most of the effluent water, approximately 1700 gallons, was top discharged to the sanitary sewer. The remaining effluent and sludge, approximately 230 gallons, was containerized in 55 gallon drums at the field office. This effort was conducted in accordance with the *Work Plan for Interim Corrective Measures* by Halliburton NUS Corporation (1995c). Jeff Johnston and Karin Crandall of Halliburton NUS Corporation were on-site to supervise the cleaning effort. Mr. Rooter Plumbing and Atlas Pumping Service in Albuquerque, New Mexico, provided the subcontractor support for the drain cleaning services. A project to refurbish the walls and floors in these rooms includes plugging and abandonment of the drains and is scheduled for completion in late 1996.

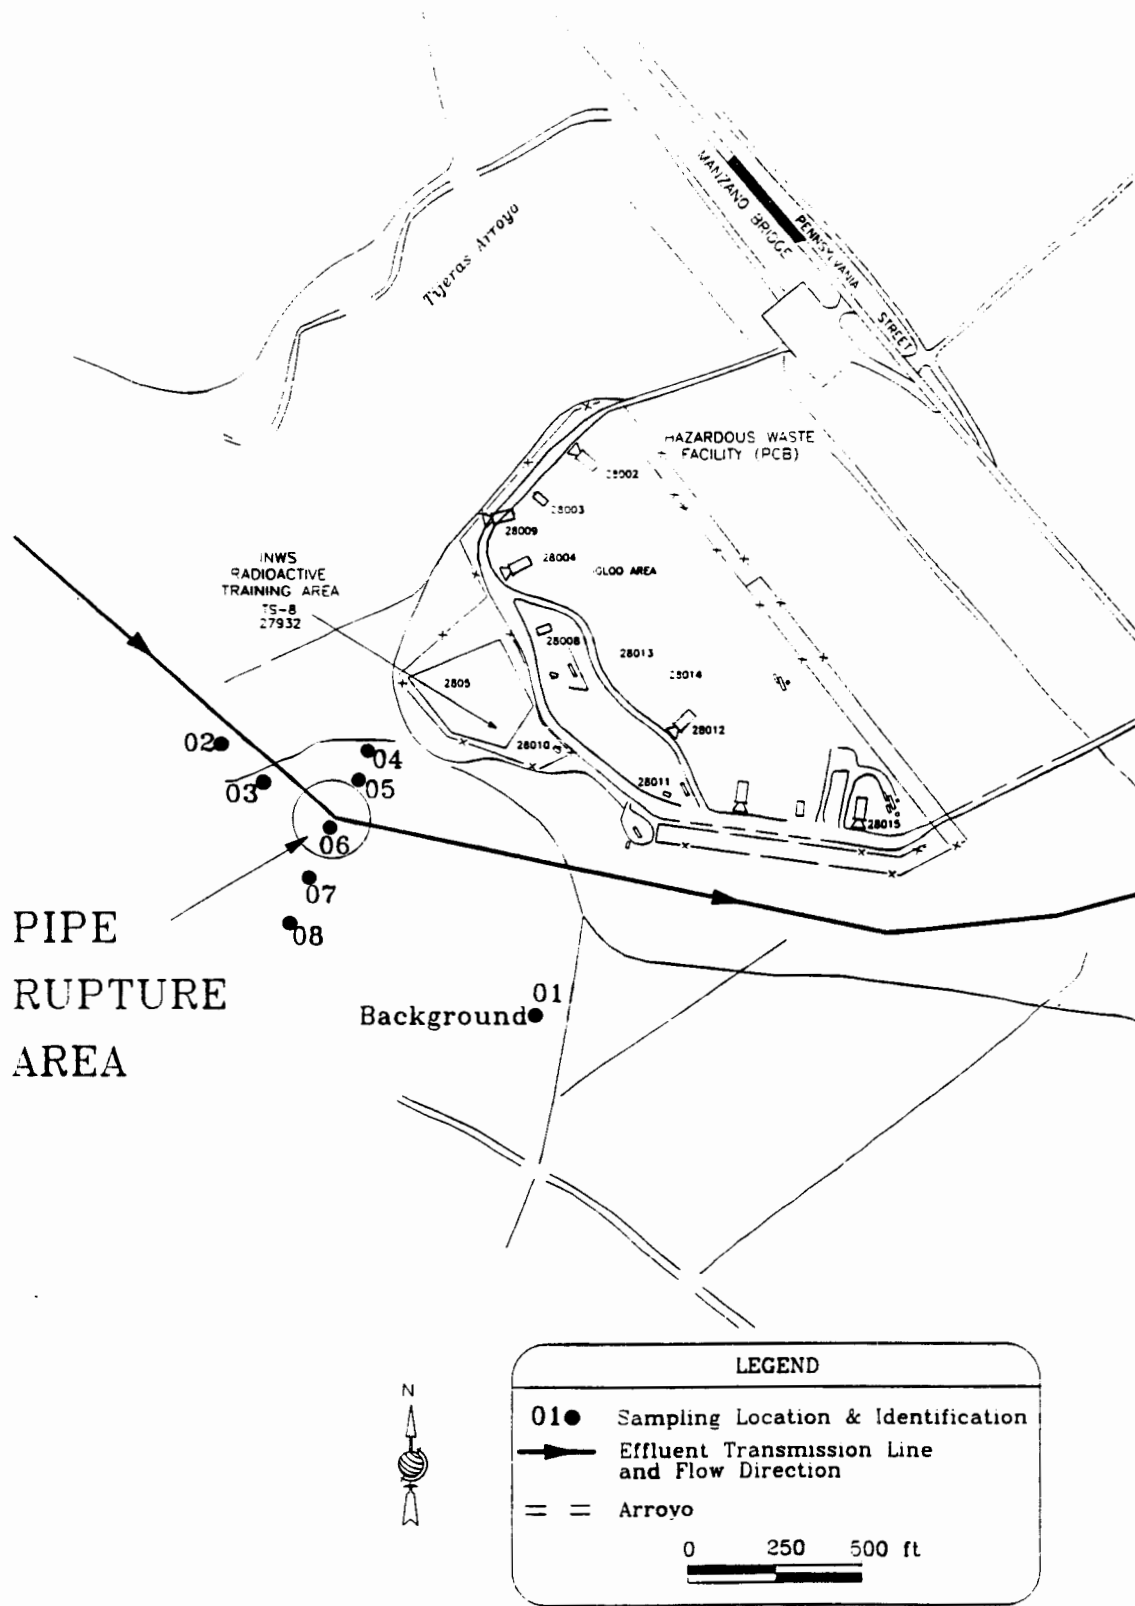
Figure 2-2 Soil Sampling Locations at SWMU 6-14, Sewage Effluent Transmission Line (ST-51) (Halliburton NUS, 1995)

During the Halliburton NUS Corporation (1995) investigation, eight boreholes were hand-augered in the vicinity of the ST-51 pipeline rupture area (Figure 2-2) to assess the affected area. Soil samples were collected from these boreholes at a depth from 10 to 11 feet below the ground surface. The samples were analyzed for volatile organic compounds (VOCs), semi volatile organic compounds (SVOCs), metals, total petroleum hydrocarbons (TPH), nitrate, and soil moisture. The analytical results from this sampling effort showed no residual evidence of a contaminant release at the subject location. No TPH, VOCs, or SVOCs above background or action levels were found; however, nitrate was detected in each sample but was below the human health-risk based (HHRB) action level at concentrations ranging from 2.8 mg/kg to 28 mg/kg. The background concentration for nitrate was detected at 18 mg/kg. Arsenic, beryllium, and manganese were the only metals detected at concentrations exceeding HHRB action levels. These concentrations appear to be naturally occurring throughout KAFB.
