**KIRTLAND AIR FORCE BASE
ALBUQUERQUE, NEW MEXICO**

**FINAL – CORRECTIVE ACTION REPORT FOR SEWER
RELEASE OF NITRATE AT MANHOLE-13 AFFECTING
BULK FUELS FACILITY GROUNDWATER
MONITORING WELLS KAFB-106005, KAFB-106009,
AND KAFB-106012R**

April 2017

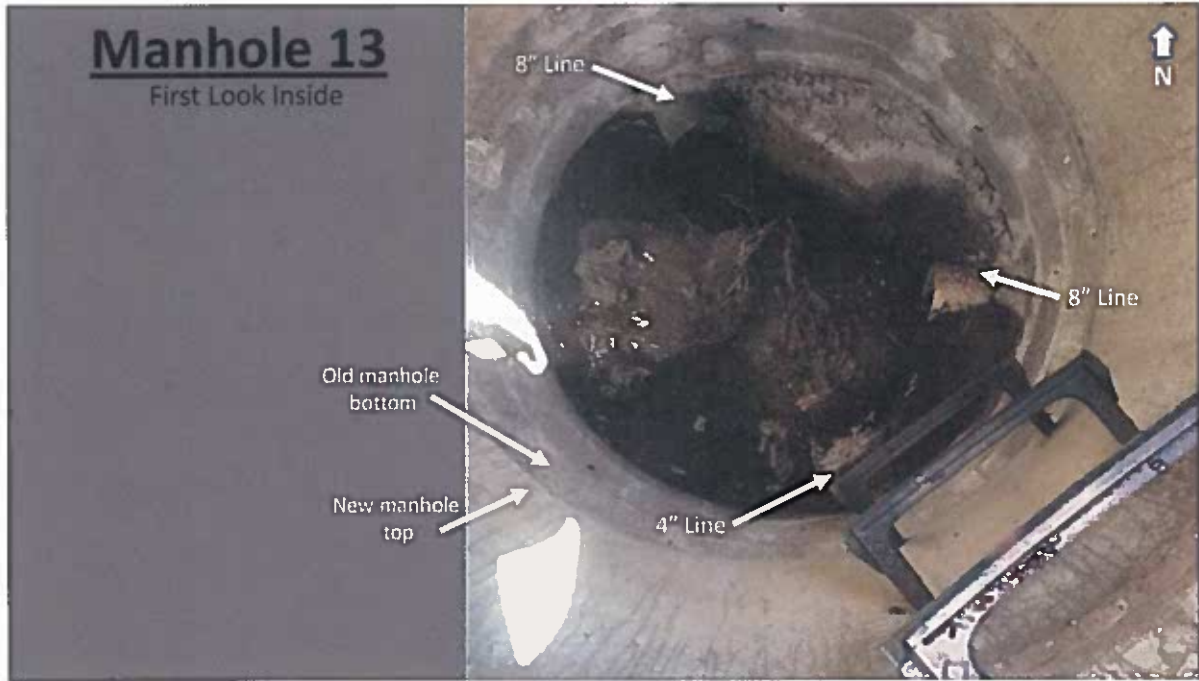
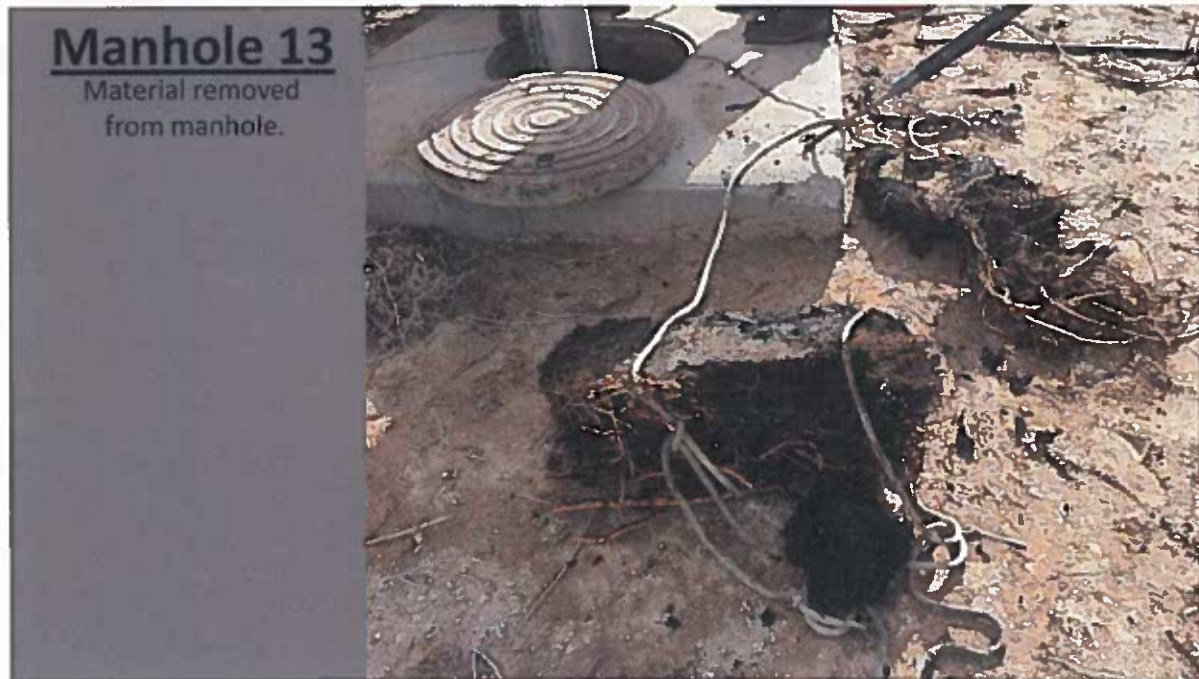
Manhole 13

Upon investigation, manhole-13 (MH-13) was found to have been compromised with tree roots invading the bottom of the manhole structure and causing leakage of sewer water. To address the sewer leak, MH-13 and approximately 10-20 feet (ft) of connective piping will be fully removed and replaced. Sampling of affected BFF groundwater monitoring wells KAFB-106005, KAFB-106009, and KAFB-106012R will continue on a quarterly basis until concentrations demonstrate reduction of total nitrate below MCL of 10 mg/L.

View of roots growing into the manhole from the outside of the manhole (about 6' bgs).

A work order has been submitted to Kirtland AFB Civil Engineering base maintenance contractor to completely replace MH-13 and about 10-20 ft of connecting pipe in all three directions. This action will inhibit further tree root invasions into the manhole structure. BFF groundwater monitoring program will continue sampling KAFB-106005, KAFB-106009, and KAFB-106012R wells to demonstrate reduction of total nitrate below the MCL of 10 mg/L.

During the time of investigation, the top half of MH-13 had been reconstructed, and the bottom half of the manhole was still the original structure. It is unknown why the top half was reconstructed. Thus, in order to ensure that tree roots do not invade the manhole structure or sewer lines in the near future, the entire manhole structure will be removed and replaced, along with 10-20 ft of connecting pipe. The target date for replacement of manhole is July 2017.

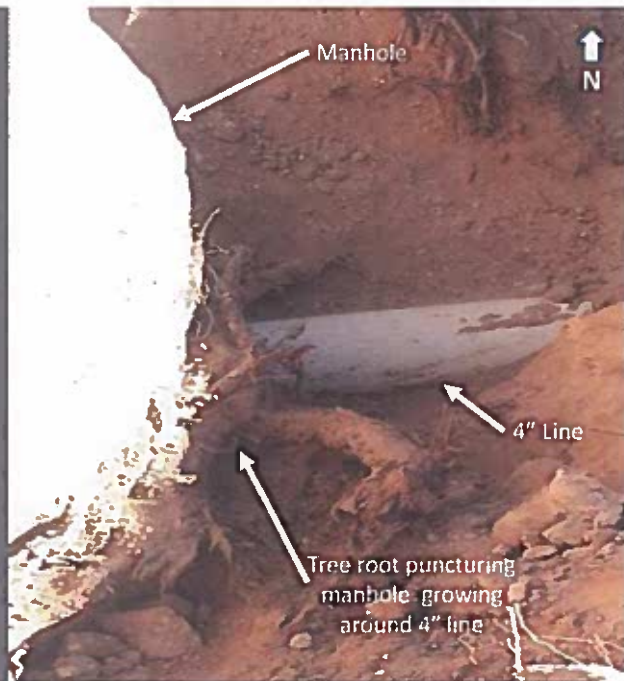
Inside 4" Line

Groundwater monitoring wells KAFB-106005, KAFB-106009, and KAFB-106012R have shown total nitrate concentrations that continued to increase with time. As a result, base maintenance contractor camera inspected the main pipeline parallel to Randolph Road (Rd) (approximately 700 ft of line) and was unable to find any issues with this line. A further investigation was performed to find the source of nitrate increases in BFF wells by inspecting manholes along Randolph Rd. It was discovered in March 2017 that MH-13 was in a state of disrepair as a result of tree roots that had compromised the bottom of the manhole structure (Appendix A). Additionally, the pipelines associated with MH-13 were inspected and determined not to be compromised (Appendix A).

Image is from video inspection looking upstream (south) 1.1' from the manhole.
