DEPARTMENT OF THE AIR FORCE
377TH AIR BASE WING (AFGSC)

Attached please find the *Effluent Conveyance Line Integrity Testing Report of the Groundwater Treatment System*. This procedure has been prepared to summarize the testing performed to ensure compliance with Condition 15 of the Discharge Permit DP-1839 associated with the discharge of treated water from the groundwater treatment system at ST-106/SS-111.

**EFFLUENT CONVEYANCE LINE INTEGRITY TESTING SUMMARY
FROM THE GROUNDWATER TREATMENT SYSTEM TO KAFB-7
APRIL 4, 2018**

EFFLUENT LINE INTEGRITY TESTING REPORT
OF THE GROUNDWATER TREATMENT SYSTEM
BULK FUELS FACILITY
SOLID WASTE MANAGEMENT UNIT ST-106/SS-111
KIRTLAND AIR FORCE BASE, NEW MEXICO

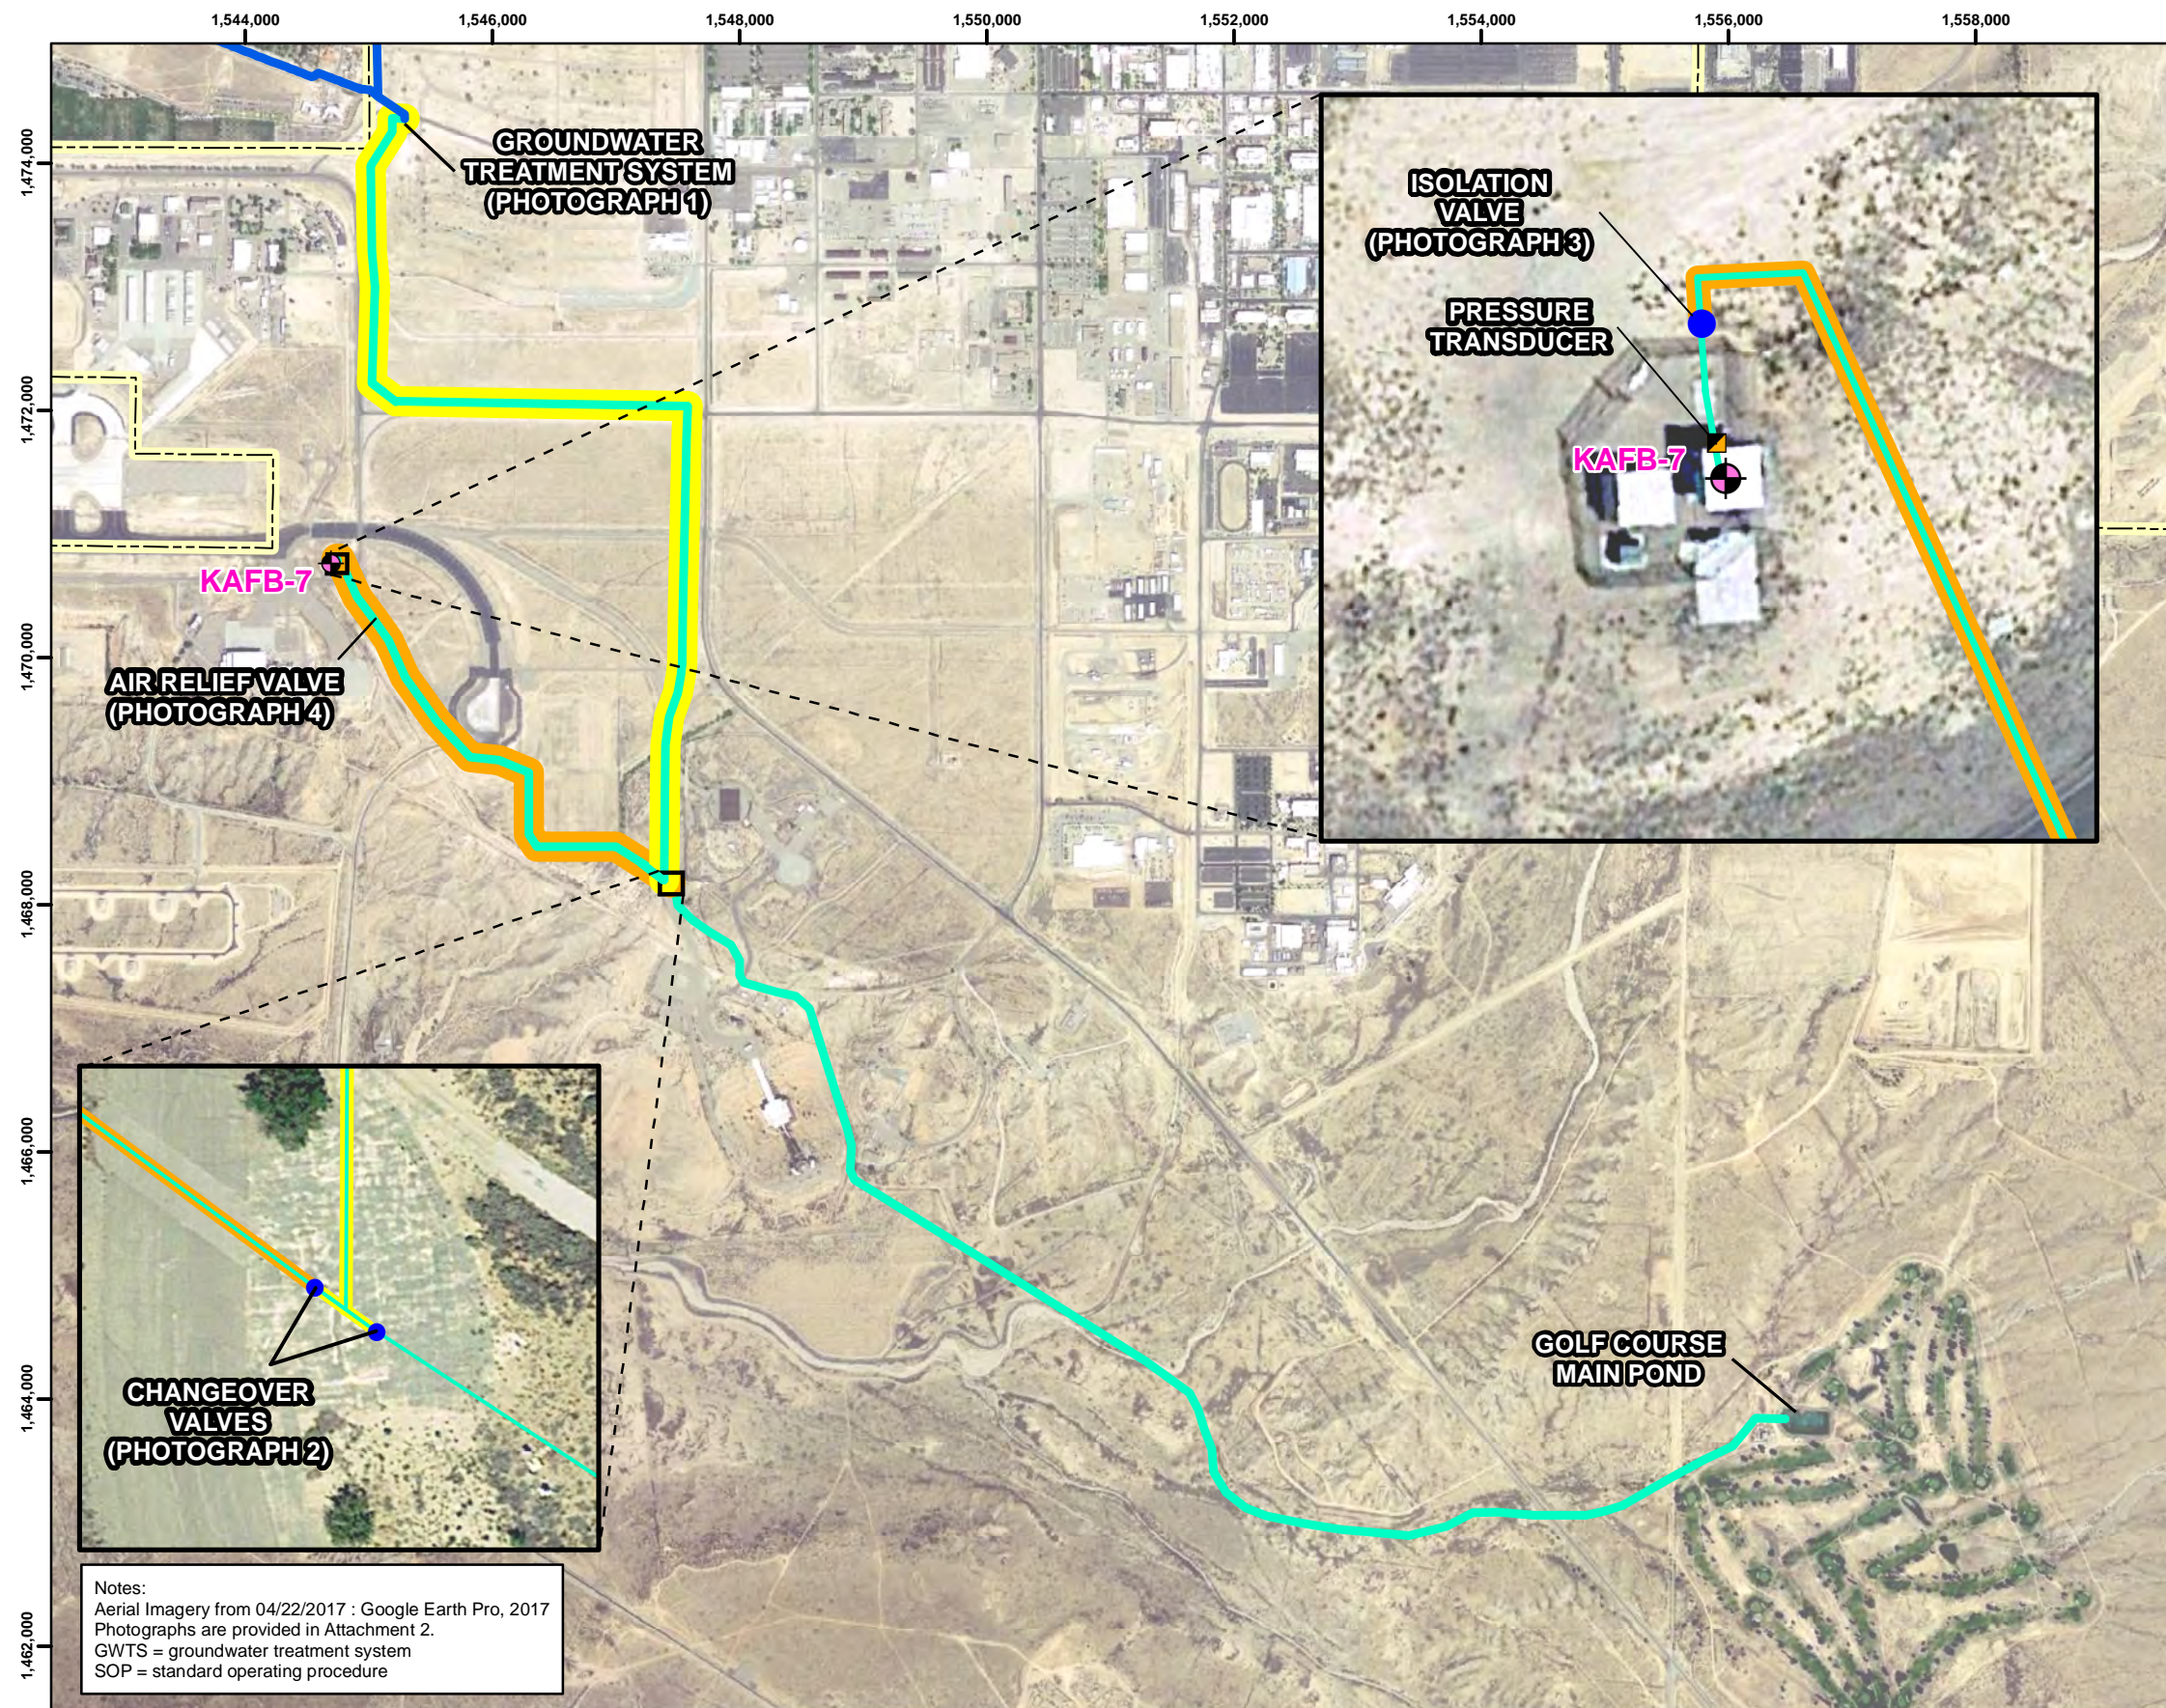
FIGURE 1

approximately 25 minutes before the testing was aborted and there was minimal indication of pressure loss from the line. The section of line will be retested (Figure 1) following repairs to the KAFB-7 injection system.

Prior to starting the second test, the conveyance line pressure was relieved to the Tijeras Arroyo Golf Course main pond. Once the pressure had been relieved, the second test was initiated on the conveyance line between the GWTS facility and the changeover valves (Figure 1). Hydrostatic testing of this section was completed within the SOP specifications. The hydrostatic test on this section began with the 30-minute expansion makeup period initiated at 1130. Makeup water was added at two intervals during this period at 1145 and 1155. The initial pressure reading of 50.00 psi was collected at 1200 and successive readings were collected at 5-minute intervals thereafter until 1300. The pressure versus time profile is provided in Figure 2. The final pressure reading collected was 49.12 psi, resulting in an overall loss of pressure of 0.88 psi, or less than 2 percent (%) of the initial pressure. This 2% difference in pressure is within the acceptable range of $\pm 30\%$ as provided in the SOP specifications (USACE, 2018). No leaks were observed along any of the exposed piping. The field testing form is provided in Attachment 1, and a photographic log is provided in Attachment 2.

EFFLUENT CONVEYANCE LINE TEST
SECTION AND ISOLATION VALVES

1. The section of conveyance line piping from the GWTS to the changeover valves was hydrostatically tested in conformance with the SOP and found acceptable.
2. The section of the conveyance line pipe from the changeover valves to KAFB-7 held pressure, but could not be tested in full conformance with the SOP due to faulty seating of the isolation valve upstream of the V-smart valve and possible damage to the V-smart valve if the test was continued.
3. The section of the conveyance line pipe from the changeover valves to KAFB-7 should be re-tested following completion of repairs to the V-smart valve assembly.

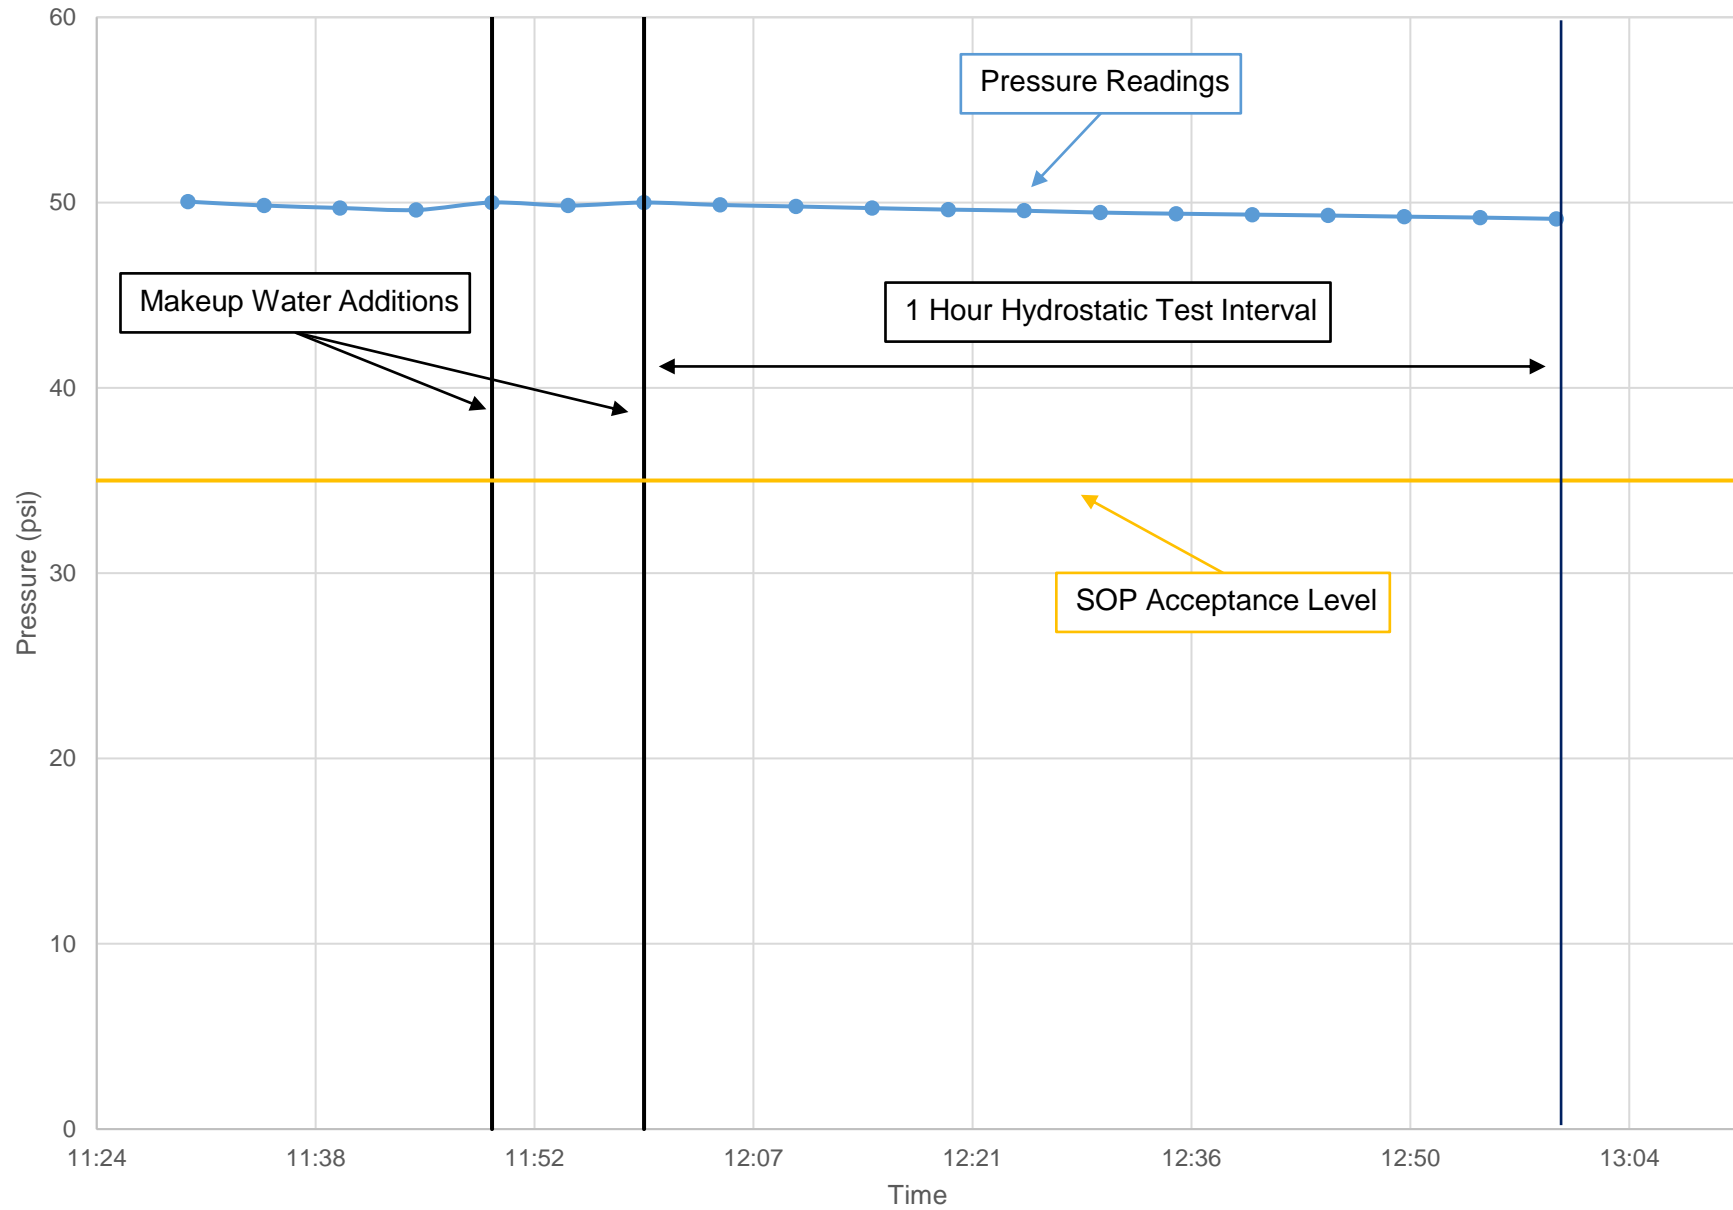
Figure 2. Periodic Hydrostatic Test Readings

Initial pressure reading after 30-minute makeup period: 50.05^{psi} makeup, 50.00^{psi} initial.

Pressure reading after 1 hour: 49.12^{psi}

Difference in pressure: 0.88^{psi}

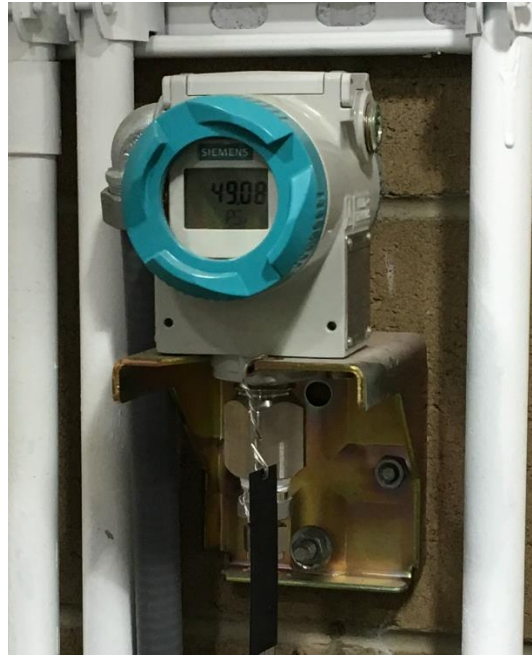
Location: Effluent Pipe Tree at the GWTS (Photograph 1 on Figure 1)
Description: Effluent Pressure Gauge at 13:10 (Post Test)
Date: April 04, 2018

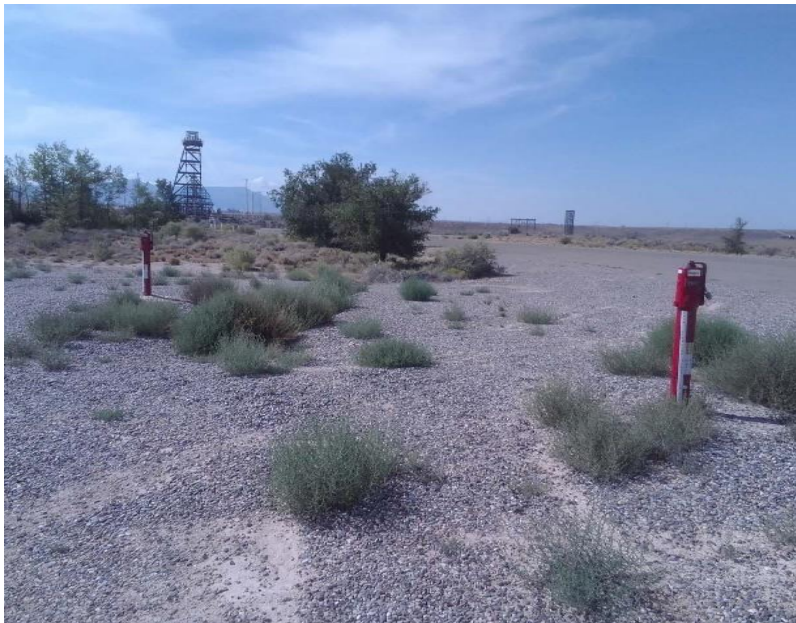
Location: Changeover Valves (Photograph 2 on Figure 1)
Description: Post Indicators for the Changeover Valves
Date: April 04, 2018

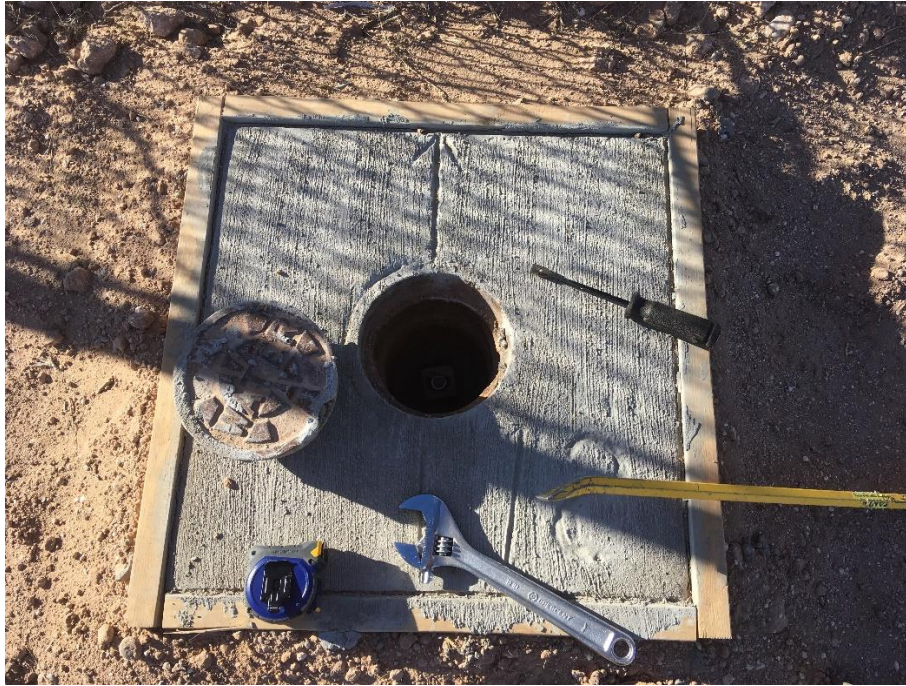
The entire effluent conveyance line between the GWTS facility and KAFB-7 was isolated and hydrostatically pressurized up to 50 pounds per square inch (psi). After initial pressurization, the KAFB-7 well head was visually inspected for leaks during the 30-minute makeup period. During the inspection, the KAFB-7 well head pressure transducer, located downstream of the effluent isolation valve (Figure 1), was reading 56 psi indicating that the isolation valve was not functioning properly. It is believed that the valve malfunction was caused by fine sediment buildup within the valve seat causing the valve to remain open.

Are there any leaks present? KAFB-7 isolation valve could not be sealed.

Additional testing comments: Pressure detected downstream of KAFB-7 isolation valve. Test could not be completed.

Location: KAFB-7 (Photograph 3 on Figure 1)
Description: Newly Installed Isolation Valve
Date: April 04, 2018

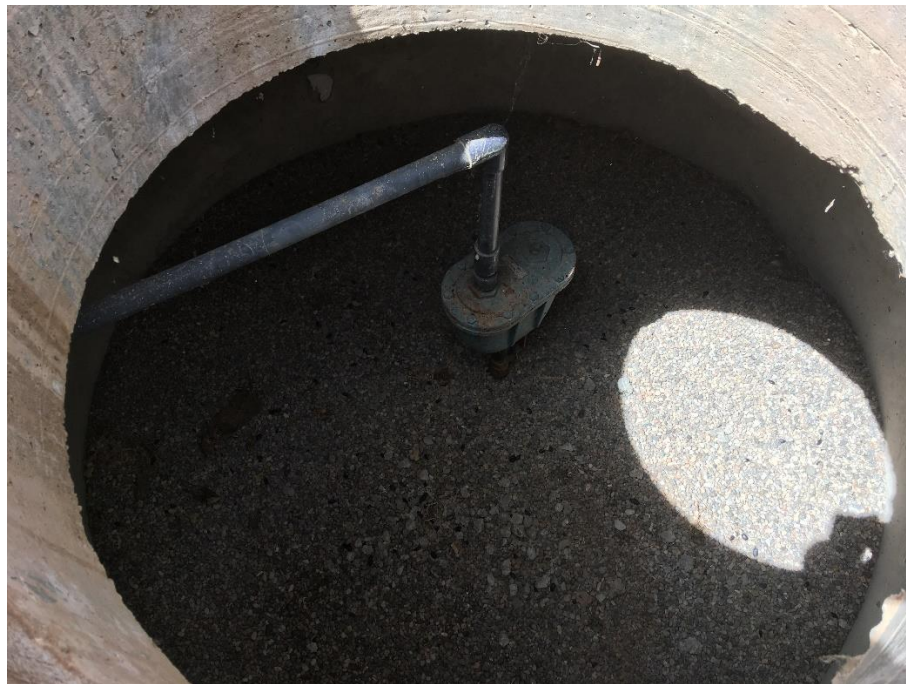
Location: Along Effluent Conveyance Line (Photograph 4 on Figure 1)
Description: Air Relief Valve
Date: April 04, 2018
