TO: John Kieling, Prog. Mgr., DOE Facilities, HRMB
THRU: James H. Davis, Ph.D., Chief, SWQB *JHD*
THRU: *JK* Glenn Saums, Prog. Mgr., SWQB
FROM: *BH* Barbara Hoditschek, Env. Spec., SWQB
DATE: July 6, 1999
SUBJECT: Surface Water Quality Bureau Final Report On 3011 RCRA Grant: The Oversight of Los Alamos National Laboratory Removal Activity

**New Mexico Environment Department-Surface Water Quality Bureau Final Report
For The 3011 RCRA Grant:
The Oversight of Los Alamos National Laboratory Removal Activity**

Submitted to the NMED-Hazardous and Radioactive Materials Bureau, July 2, 1999

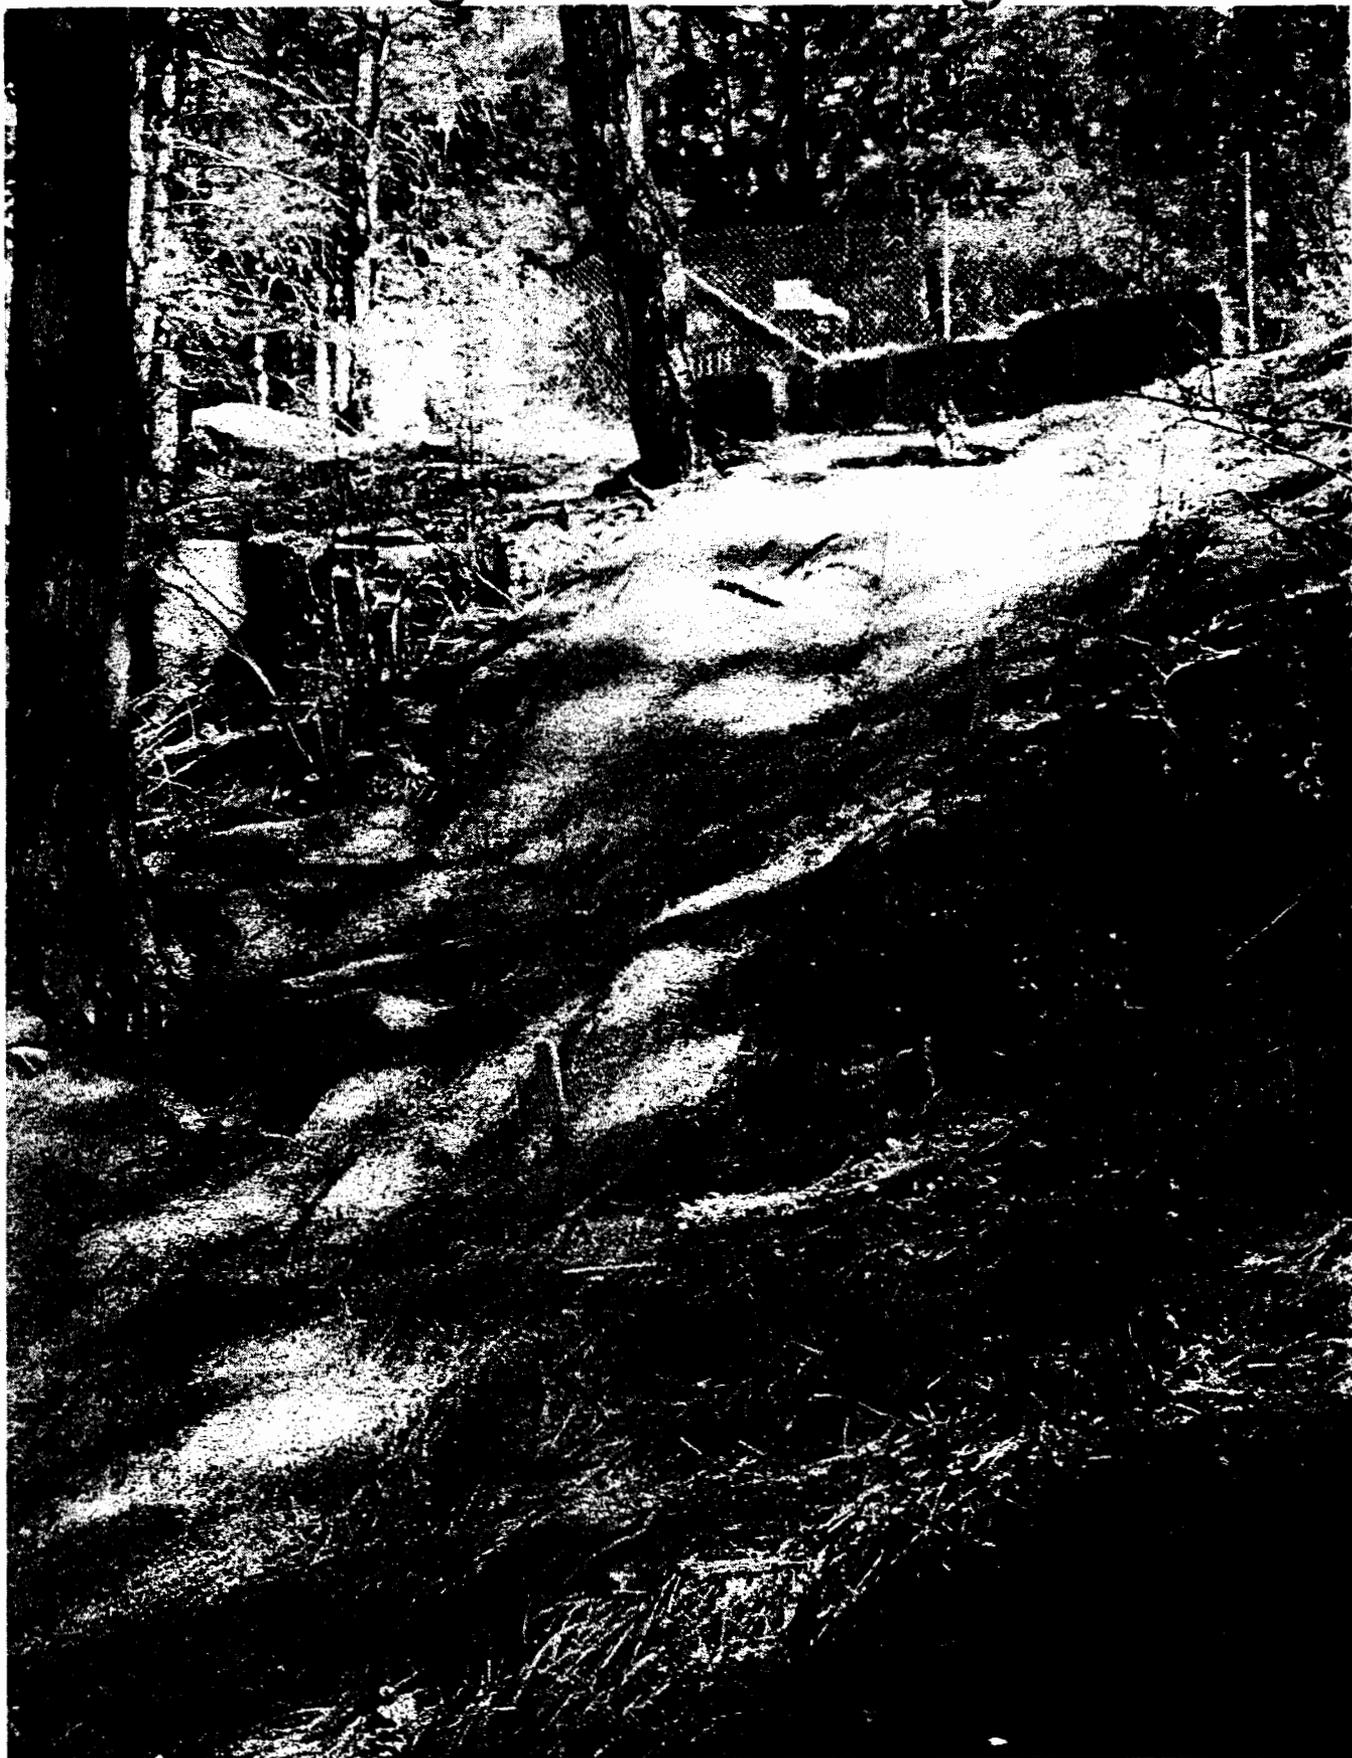
**PRS 1-001(f) - Hillside 140/Uranium (H)
Jute mat controlling potential surface erosion**

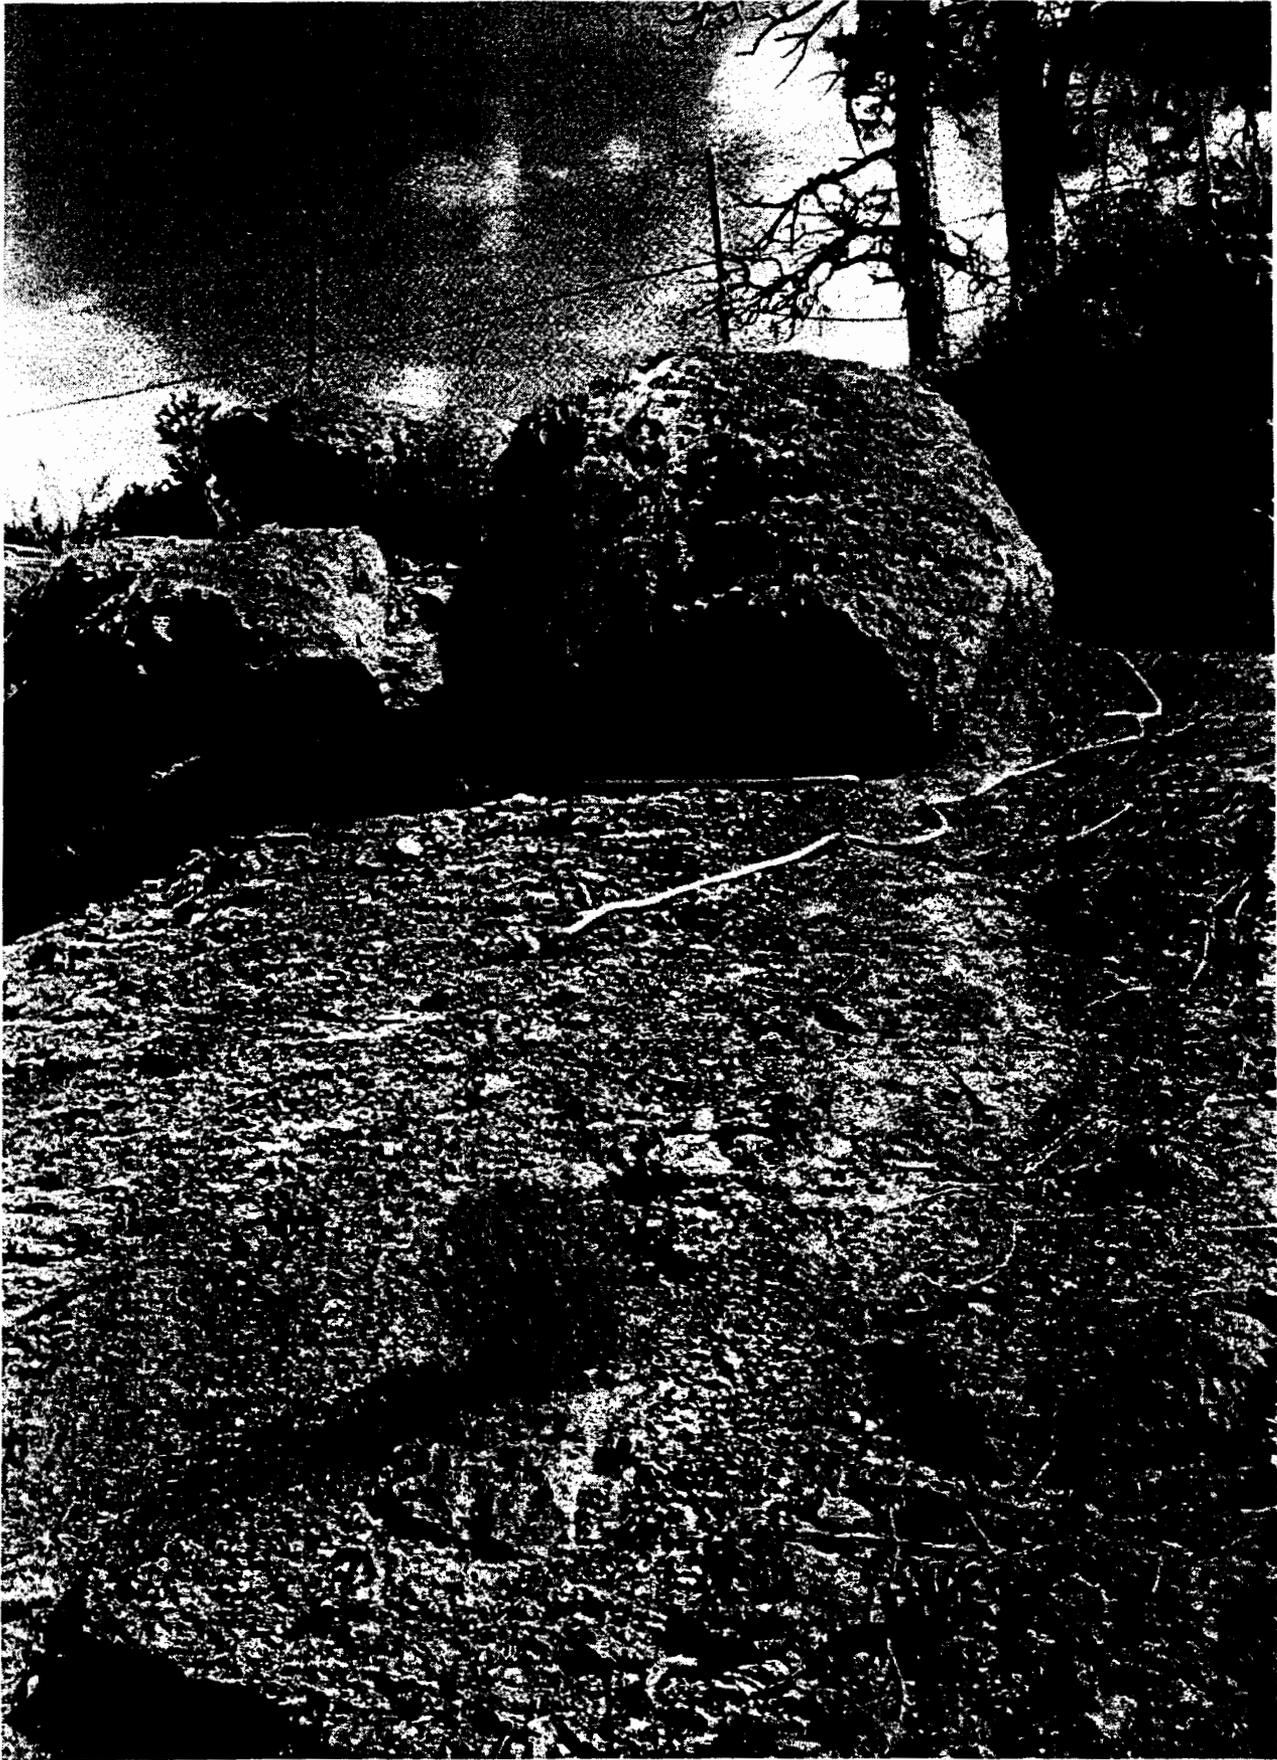
PRS 1-003(d) Can Dump Site (paint pool) - Before cleanup

The removal of the empty paint cans from the lower area was accomplished with minimal, if any, disturbance of the vegetation or topsoil and, therefore, required no site restoration upon completion of the field activities.

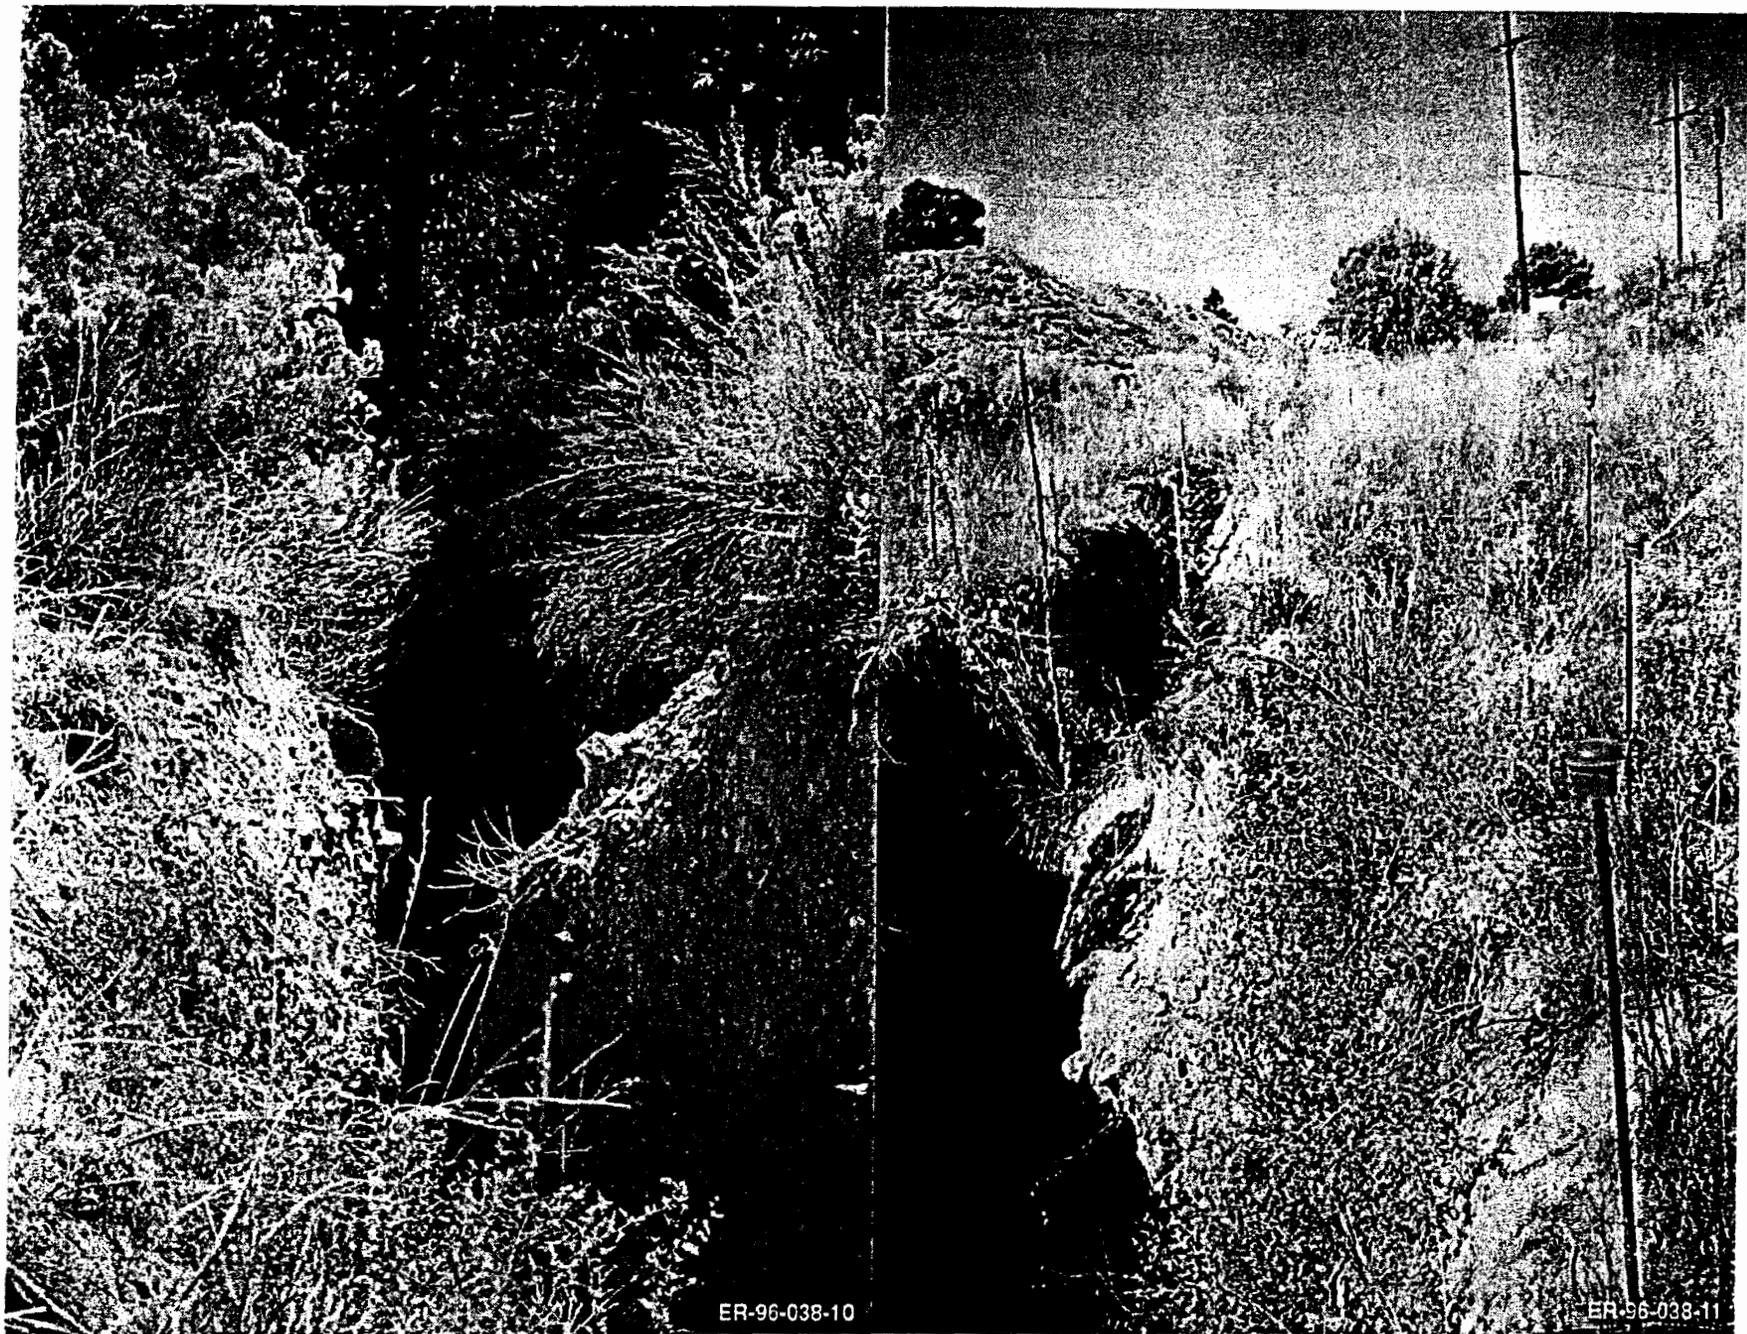
TA-35 - Severe gullying

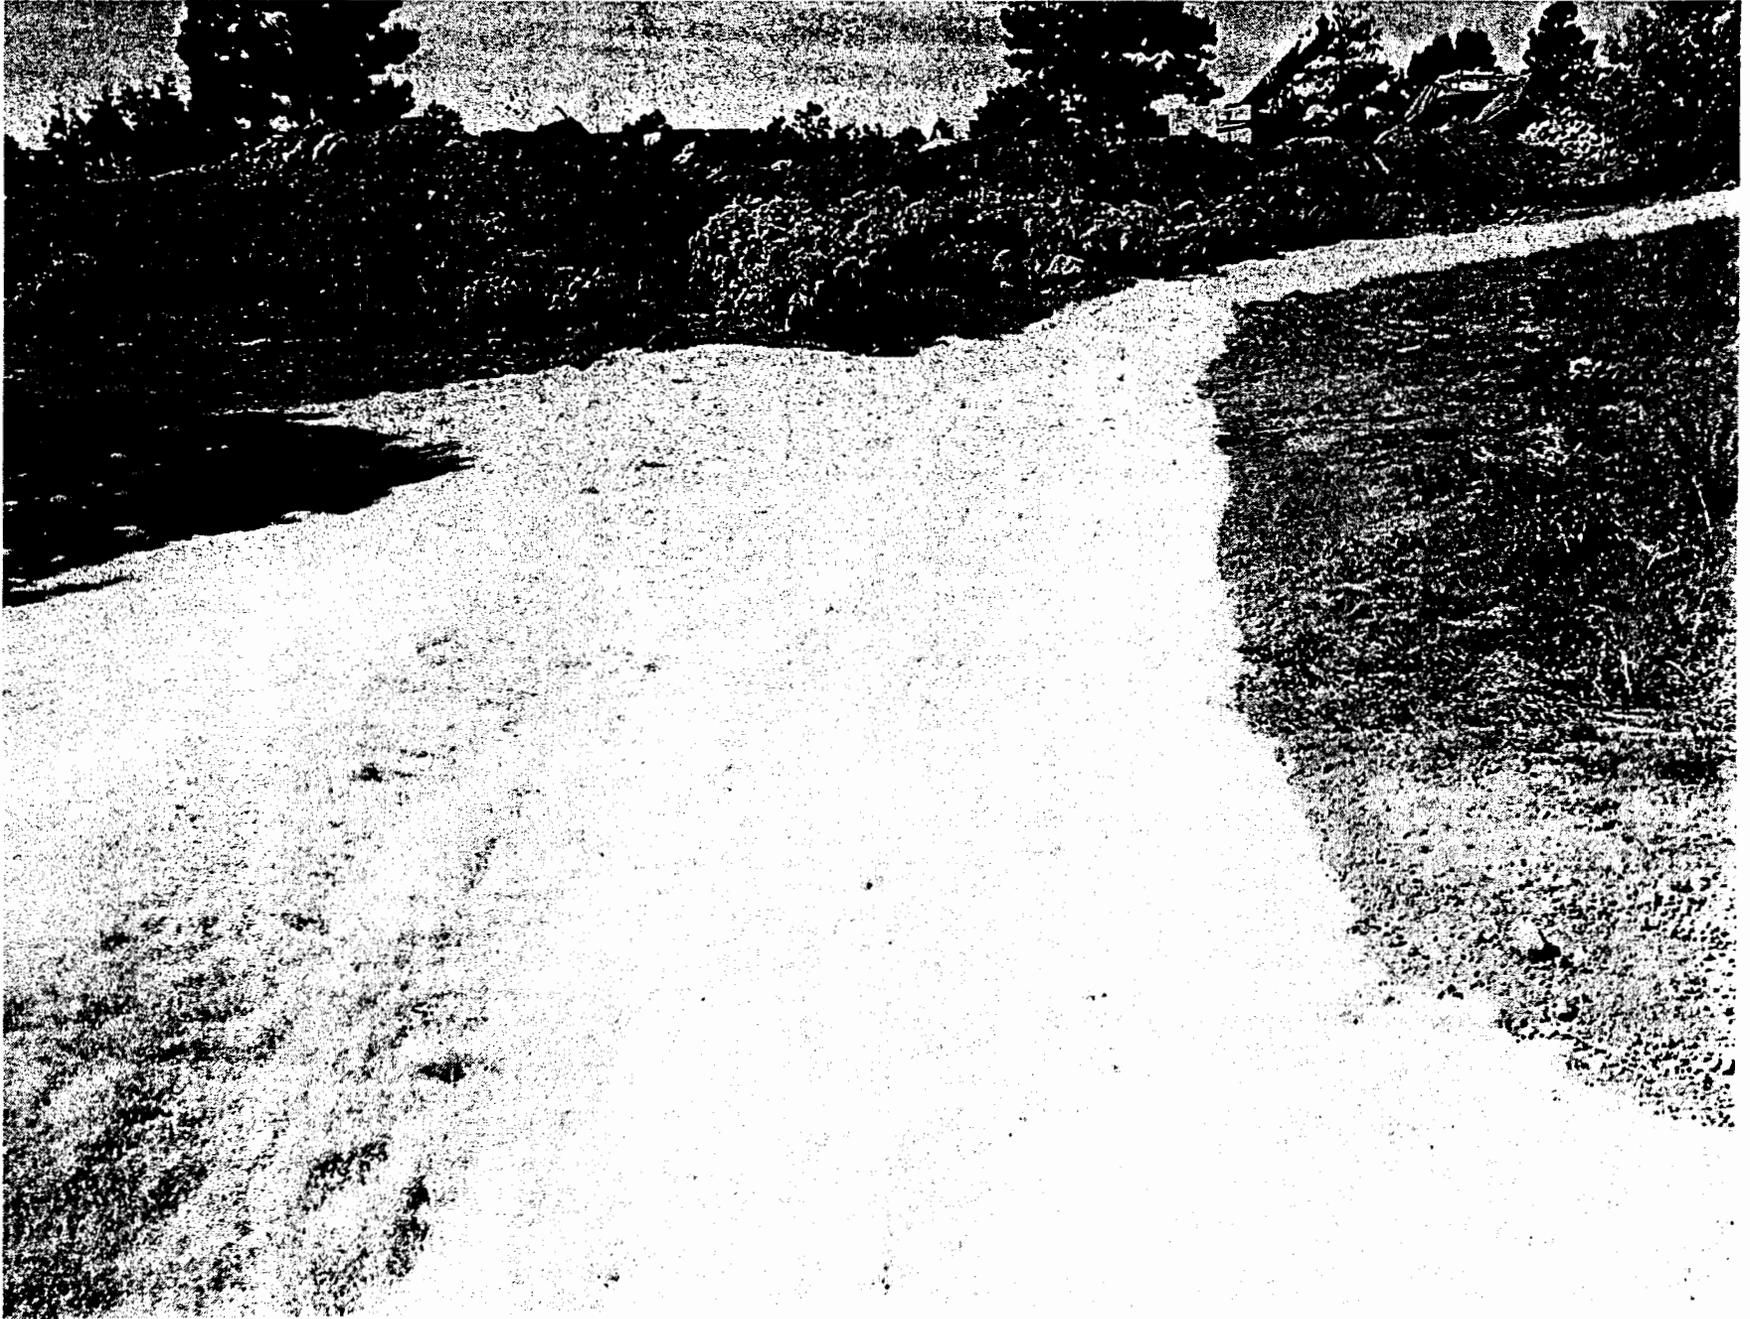
TA-35 Interim Action using jute mat for erosion control

The IA began on September 3, 1996, and was completed on September 23, 1996. Activities included conducting a health and safety survey; performing a utilities markout survey; backfilling, compacting, and revegetating the erosion channels; constructing a diversion berm near the head of the former erosion channels; plugging the 12-in.-diameter storm water CMP; and installing a new 24-in.-diameter CMP, which has an inlet at the southwest corner of former TA-35-7 and extends southward to Ten Site Canyon. The new CMP extends 240 ft to the south along a 1% slope at a depth of 4 ft near the inlet and surfaces at the point of discharge. A riprap apron was placed at the discharge point.
