LA-UR-00-3767

Title: CERRO GRANDE FIRE AFTERMATH:
ENVIRONMENTAL RESTORATION PROJECT
ACTIVITIES TO REDUCE THE MIGRATION OF
CONTAMINATION FROM POTENTIAL RELEASE SITES

Author(s): STEVEN J. VEENIS, CPESC

Submitted to: WATER QUALITY & HYDROLOGY GROUP (ESH-18)
ENVIRONMENTAL RESTORATION PROJECT

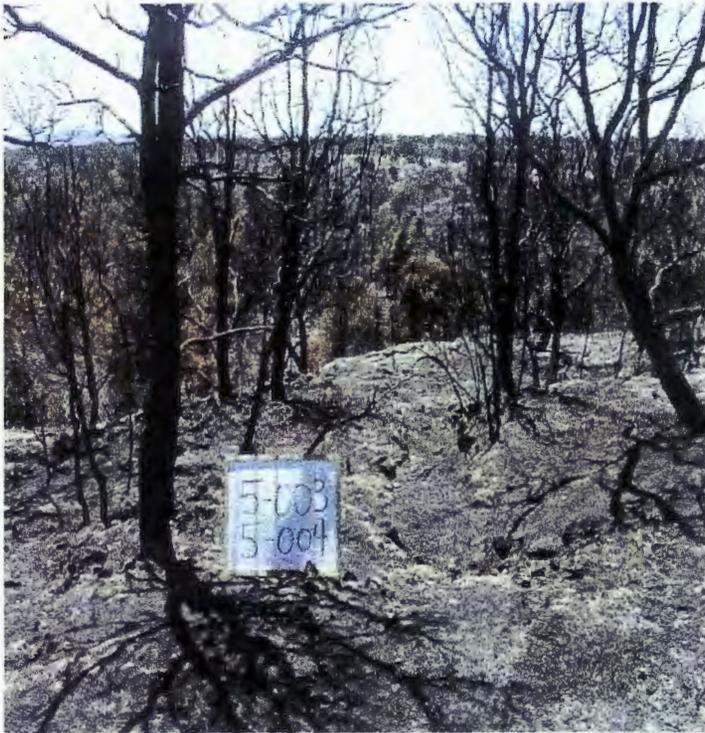
This site is located on the south rim of a tributary to Mortandad Canyon within the Upper Canada del Buey Watershed Aggregate. The fire damage was moderate to severe with nearly complete damage to the ground cover and canopy.

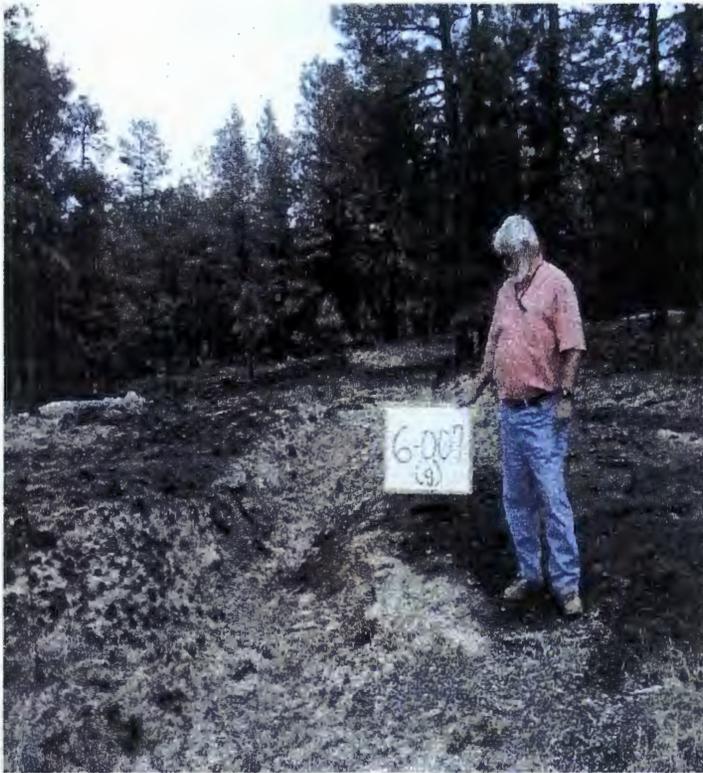
This site is located on the south side of Pajarito Canyon within the Two Mile Canyon Watershed Aggregate. The drainage channel east of building TA-6-6 has minor evidence of fire damage. Miscellaneous debris was observed around the area including concrete, rebar and old building wood. A pre-existing erosional feature was observed.

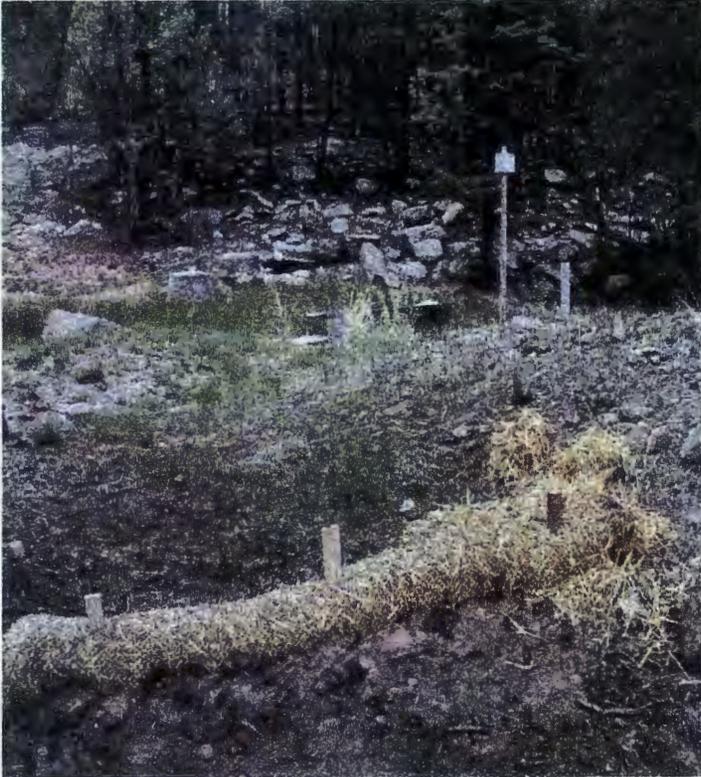
This site is located south of Pajarito Canyon within the Starmer/Upper Pajarito Watershed Aggregate. The area received minor to moderate fire damage. The ground cover was completely burned but the canopy cover was only partially affected. The grasses have recovered quickly in most of the area.

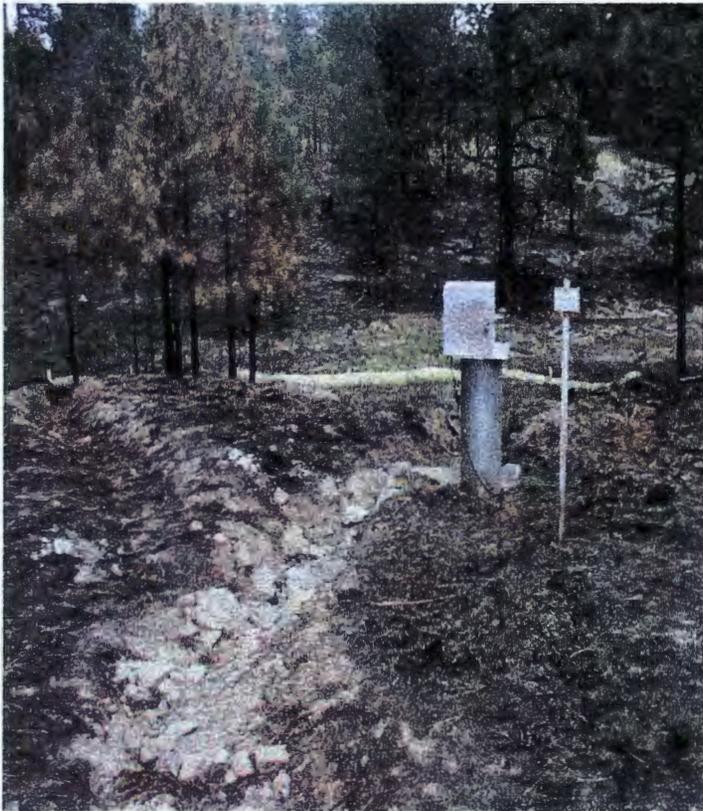
This site is located south of Pajarito Canyon within the Starmer/Upper Pajarito Watershed Aggregate. The PRS is the former Sanitary Wastewater Treatment Facility north of TA-9. Site has moderate fire damage with ground and canopy cover being impacted. The erosional feature below the site that previously existed is at the greatest risk.

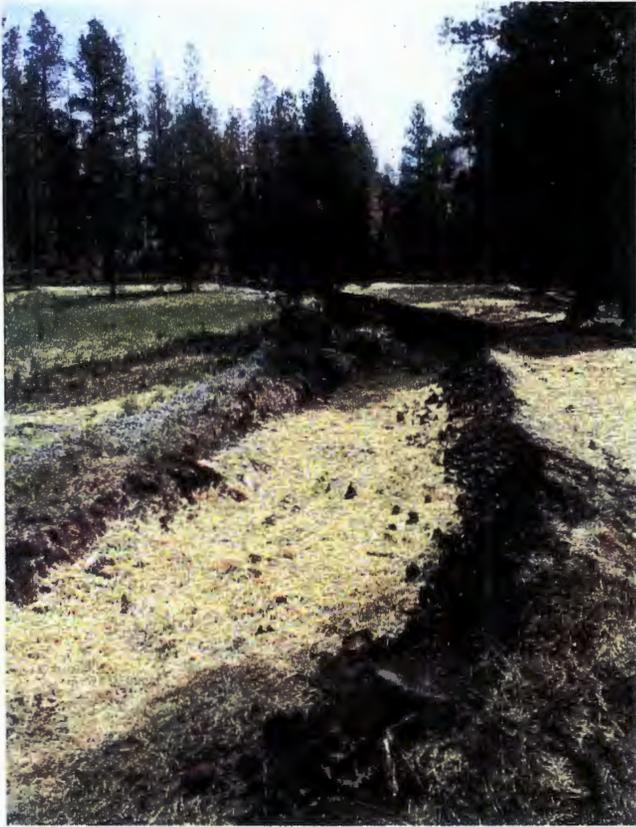
This site is located south of Pajarito Canyon within the Starmer/Upper Pajarito Watershed Aggregate. The area surrounding MDA M was moderately to severely burned as was a majority of the upper Pajarito Watershed. All of the existing erosion controls at the site were destroyed.

Run-on controls were replaced as shown below. The entire site was hand raked, reseeded and mulched. A retention basin was installed at the bottom of the slope to create a "zero discharge" area.

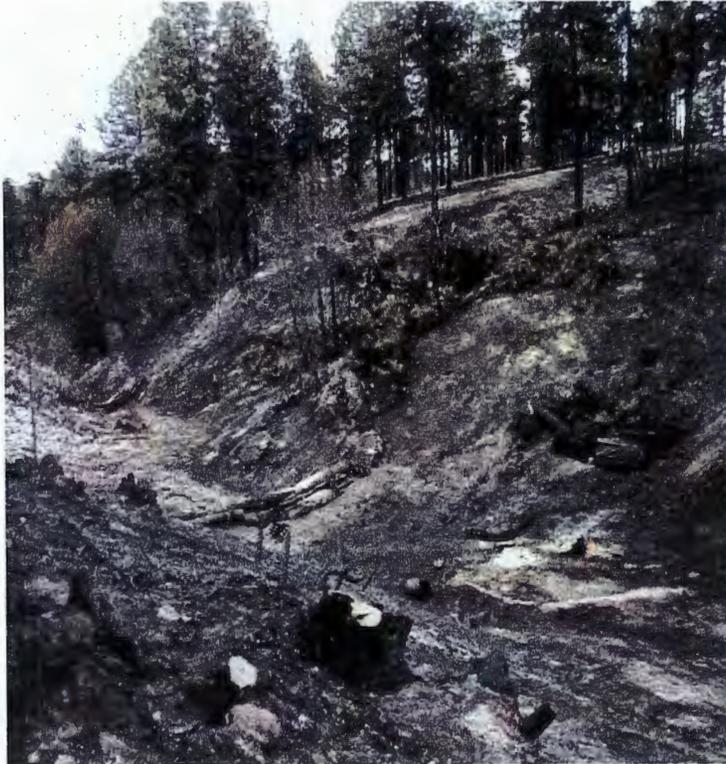
This site is located north of Water Canyon within the S-Site Watershed Aggregate. The site has moderate to severe fire damage in the area surrounding the TA-11 Drop Tower. Log check dams within the major drainages received partial damage. All straw barriers installed around site were destroyed.

The log check dams (on-site materials used) were replaced with the adjacent drainages. Straw wattles were placed on the slope geotextile was installed in the areas with the most erosion potential. The area surrounding the Drop Tower was hydromulched to aid the revegetation process.

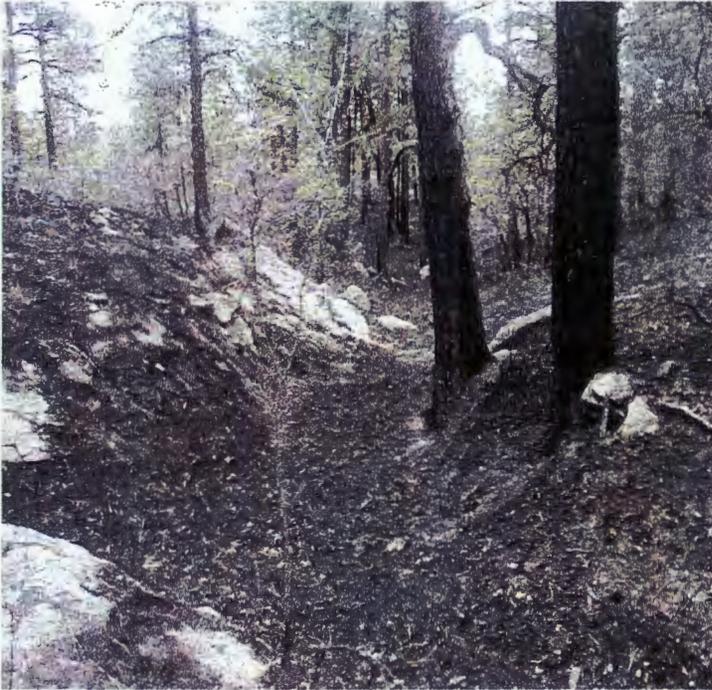
This site is located north of Canon de Valle within the Canon de Valle Watershed Aggregate. The eastern portion of TA-14 was moderately burned with substantial damage to the groundcover.

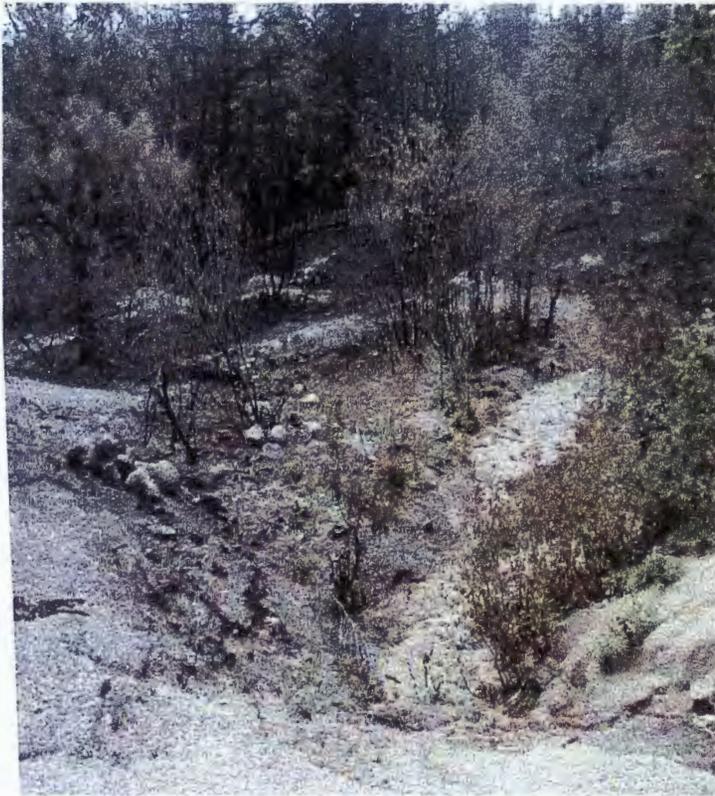
This site is located north of Canon de Valle within the Canon de Valle Watershed Aggregate. The central portion of TA-14 was moderately burned with substantial damage to the groundcover.

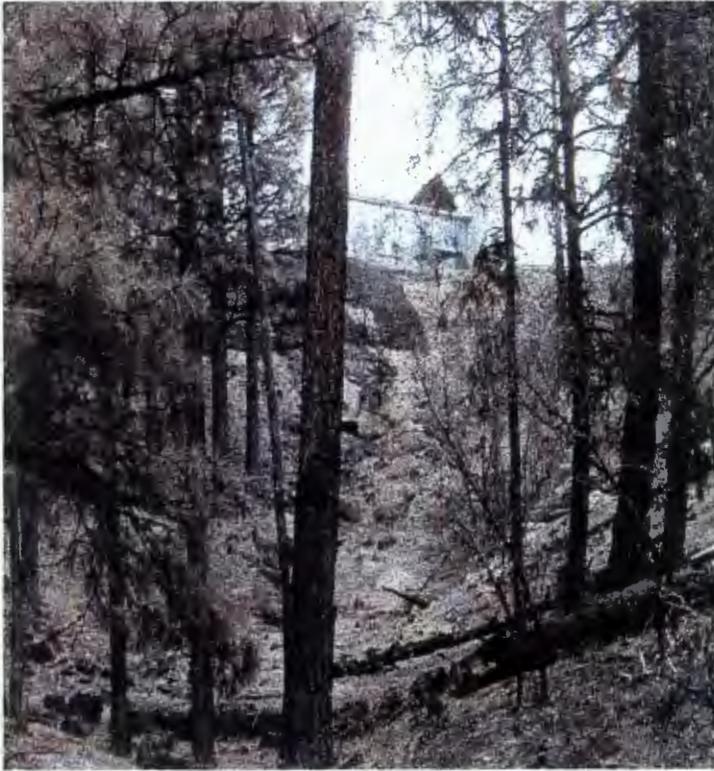
This site is located north of Canon de Valle within the Canon de Valle Watershed Aggregate. The western portion of TA-14 was moderately to severely burned with substantial damage to the canopy and groundcover.

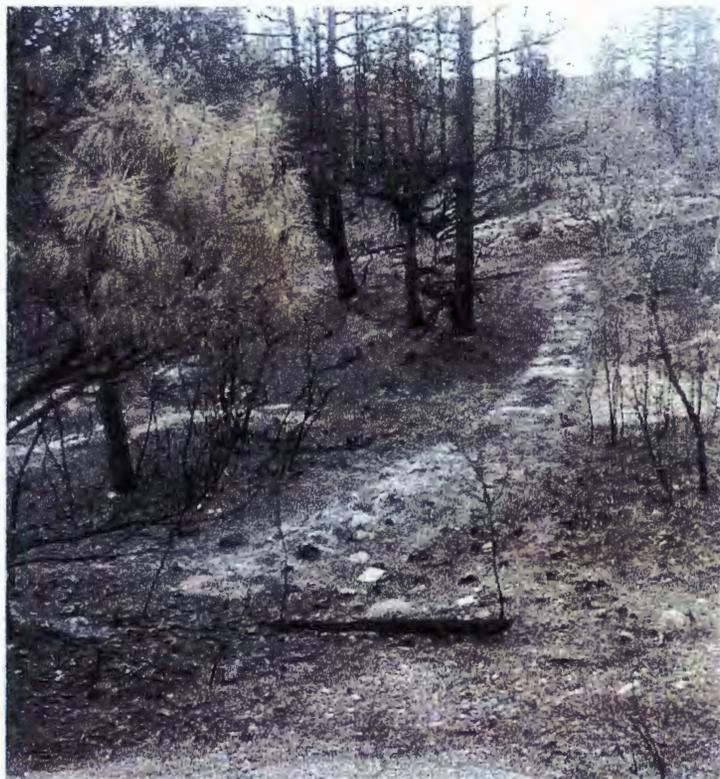
This site is located north of Canon de Valle within the Canon de Valle Watershed Aggregate. The western portion of TA-14 was moderately to severely burned with substantial damage to the canopy and groundcover. Most of the existing BMPs at the site were destroyed. As a result, the erosion potential for the site is moderate to high.

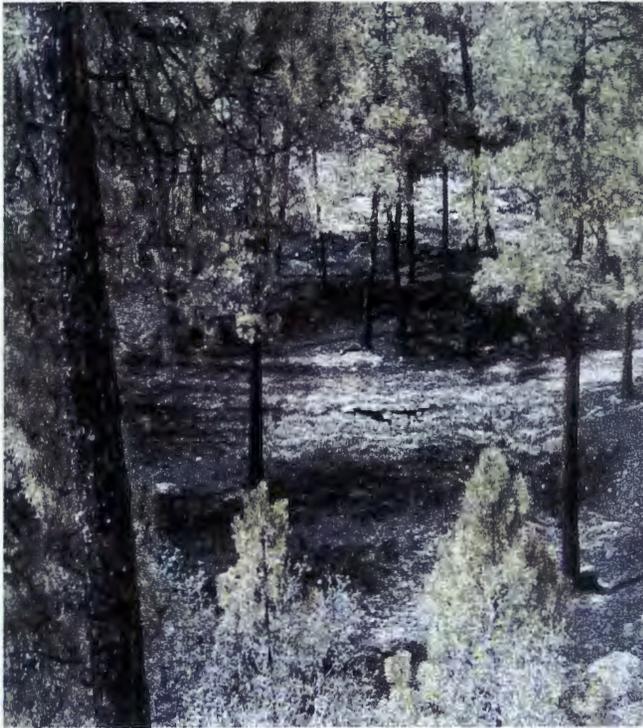
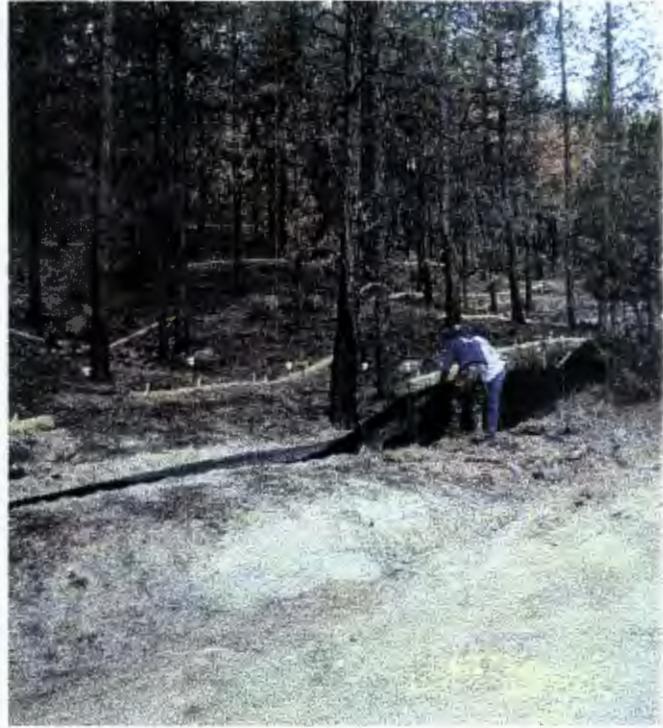
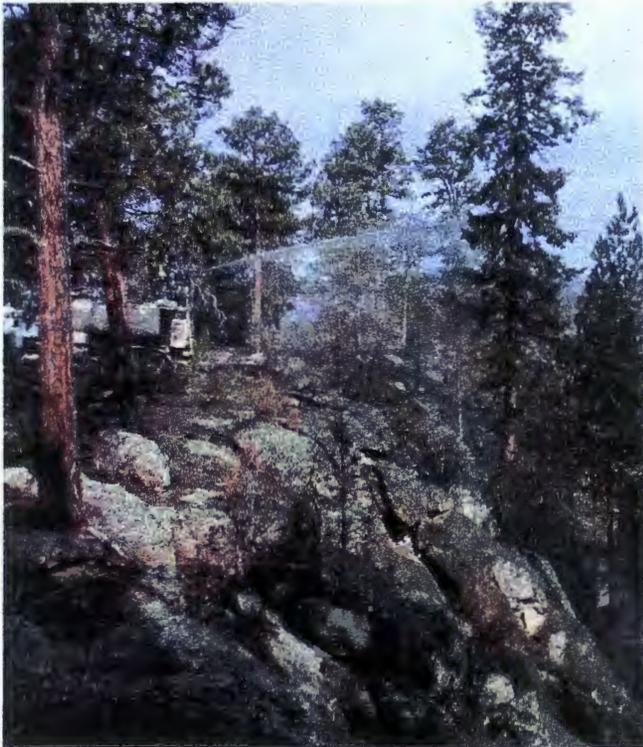
This site is located on the south rim of Three Mile Canyon within the Three Mile Watershed Aggregate. 15-006(c) has moderate to severe burn damage with most of the damage adjacent to the former R-44 Firing Pad. A large amount of firing site related debris has been exposed throughout the site (especially towards the east).

Straw wattles, rock check dams and silt fencing were installed throughout the burned areas. Over 20 cubic yards of firing site debris was removed from the surrounding area. The area was then hydromulched to enhance the revegetation process.

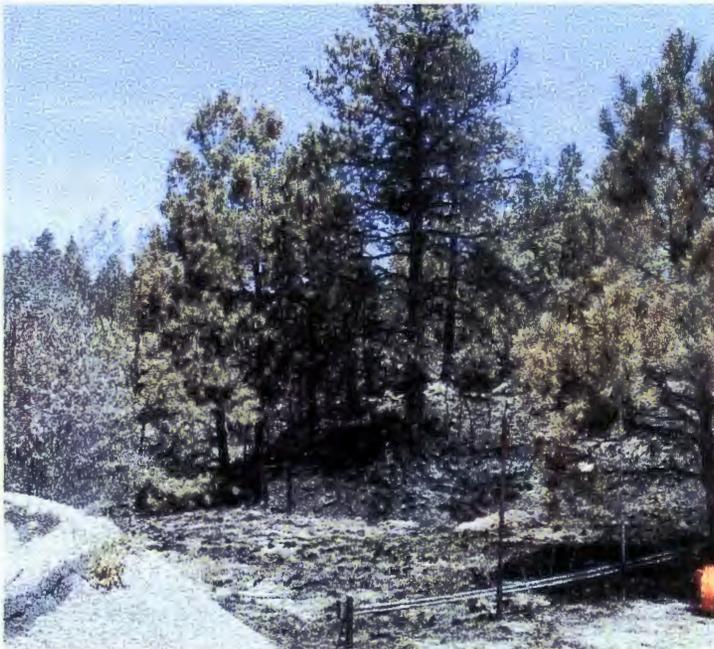
This site is located near the confluence of Canon de Valle and Water Canyon within the Canon de Valle Watershed Aggregate. The site was moderately to severely damaged including several burned structures. The ground cover and canopy surrounding the site was extensively damaged. Runoff from the entire Hollow site discharges into a small tributary (to Canon de Valle) west/southwest of the site near oil storage tank (15-011(b)).

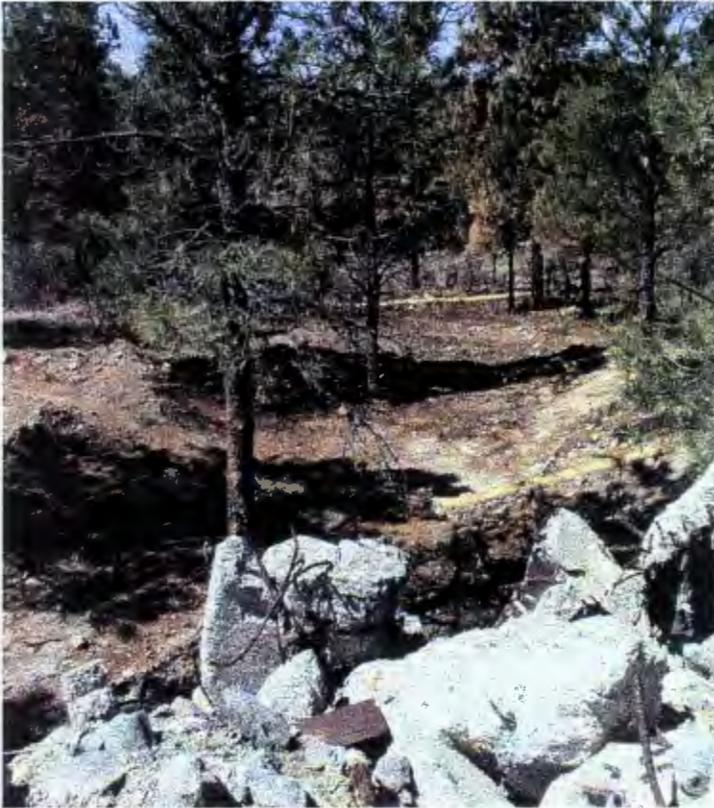
This site is located near the confluence of Canon de Valle and Water Canyon within the Canon de Valle Watershed Aggregate. The area received minor burn damage primarily to the ground cover.

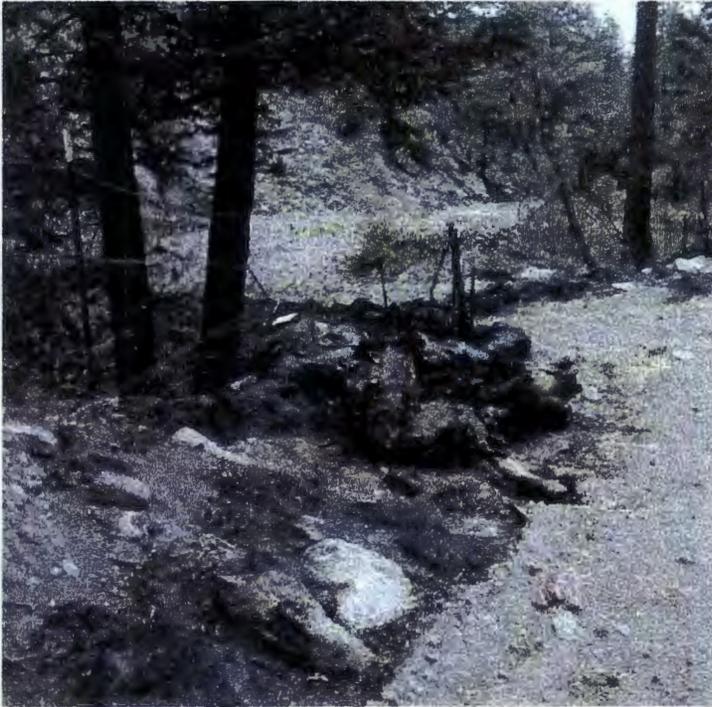
This site is located on the edge of Canon de Valle within the Canon de Valle Watershed Aggregate. MDA-P received only peripheral fire damage on the lower portion of the site. The existing straw barriers and silt fencing were destroyed. No construction equipment and project infrastructure were damaged.

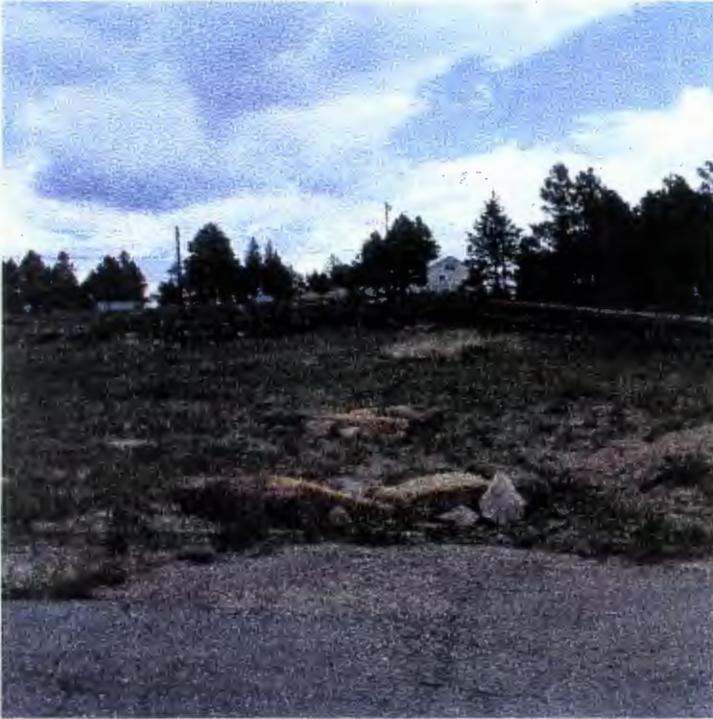
This site is located near a tributary of Water Canyon within the Canon de Valle Watershed Aggregate. The site has minimal fire damage to the west and south. Some minor burning occurred within the SWMU boundary, but consisted mostly of destroyed grasses. The HEWTF remains operational.

Straw barriers and rock check dams (existing materials found on site) were placed within the drainage swale to reduce sediment transport potential.

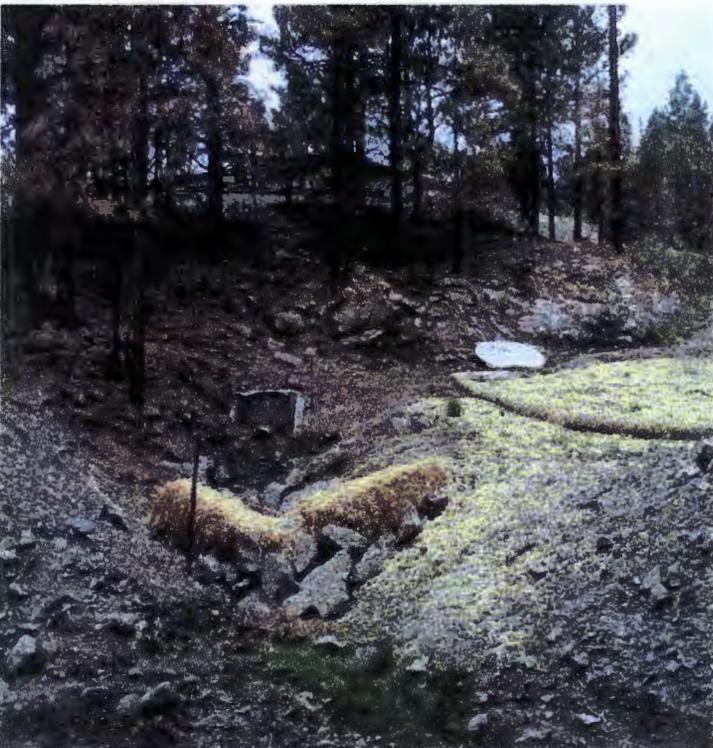
Site is located in a small tributary drainage to Water Canyon within the S-Site Watershed Aggregate. Site has minor to moderate fire damage within the outfall drainage. Ground cover has begun to re-establish itself.

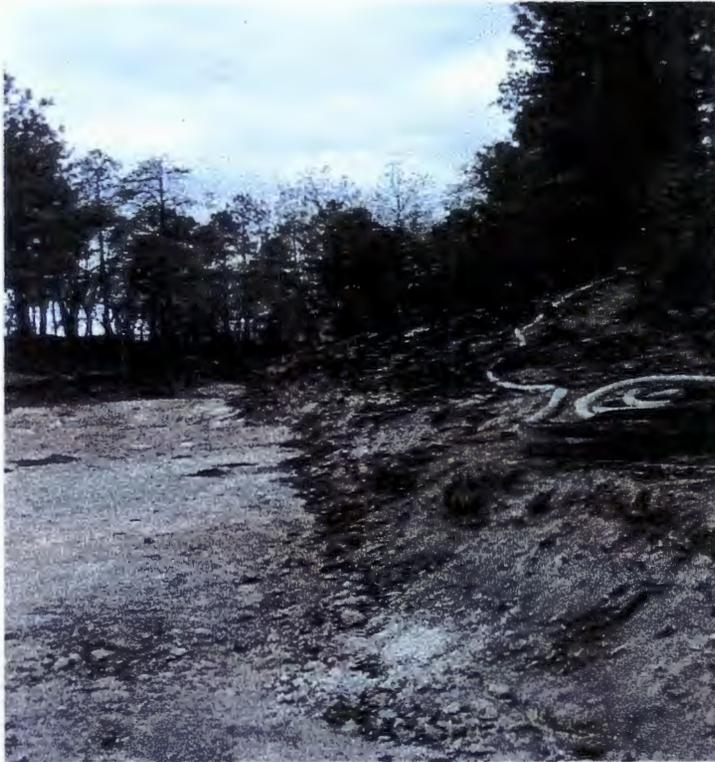
This site is located in a tributary drainage of Canon de Valle within the Canon de Valle Watershed Aggregate. Burn damage is minor to moderate within the SWMU boundary. All large equipment on-site was not affected by the fire; however, some hoses, drums and misc. equipment were damaged. The upper drainage pond was not burned. The lower drainage received minimal damage from the fire.

Straw barriers were replaced within the drainage channel and jute matting was installed to protect the exposed slopes. All excavated material remains covered with HDPE liners and is surrounded by an earthen berm. The storm water retention pond was unharmed and remains effective as a “zero discharge” BMP.

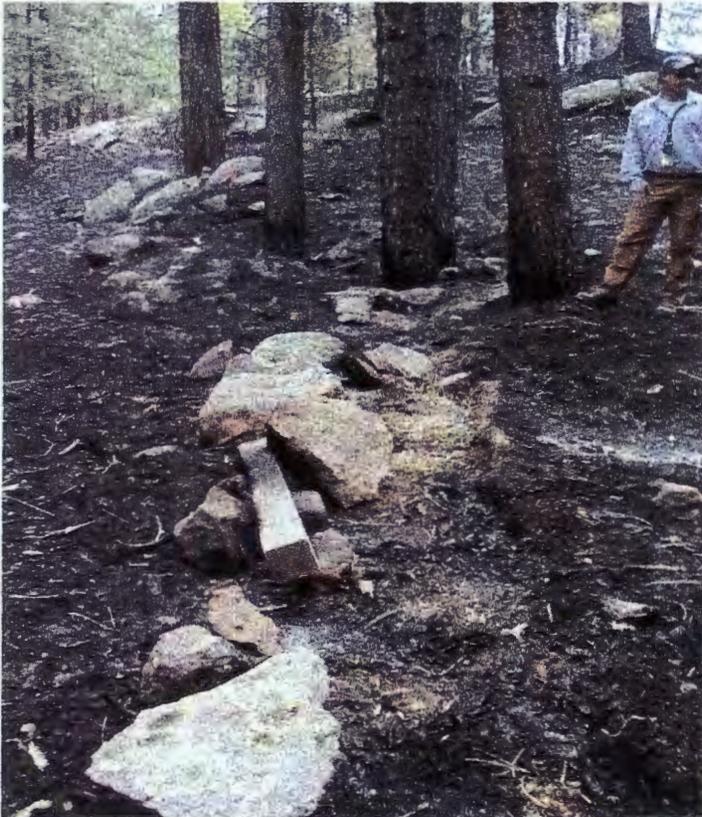
This site is located east of S-Site Road in the upper tributary of Canon de Valle within the Canon de Valle Watershed Aggregate. No damage was observed from the outfall to the first rock check dam. Below the second rock check dam, fire damaged much of the ground cover and several of the ponderosa pine trees. All straw were destroyed.

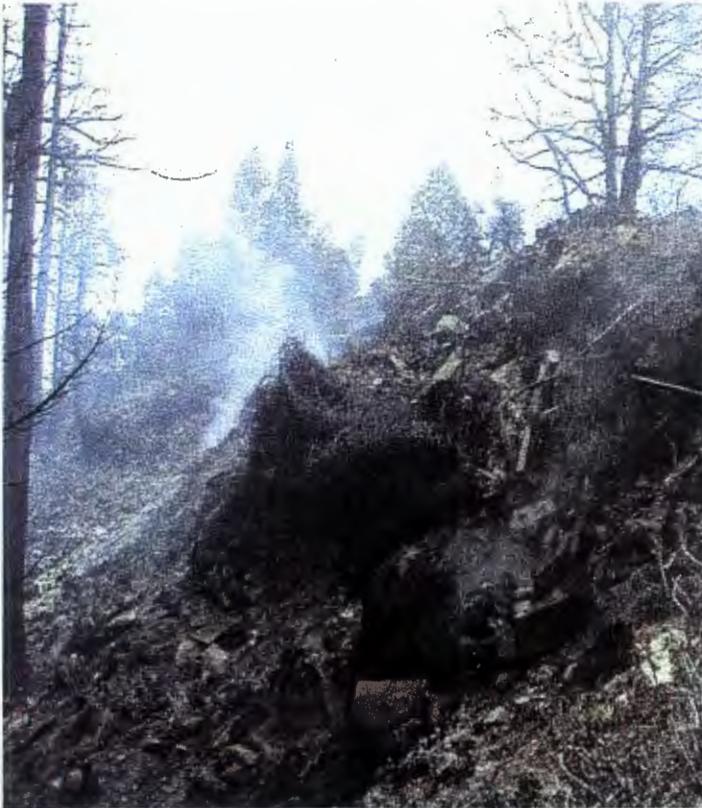
This site is located near building TA-16-260 above Canon de Valle within the Canon de Valle Watershed Aggregate. The site has moderate to severe fire damage over a majority of the area. Miscellaneous debris was exposed on the mesa and slope above canyon channel. The dissipation controls installed within the eastern drainage were destroyed. The ground and canopy cover was completely destroyed. Ash is up to 12” deep in some areas at the toe of slope. Burning occurred in the Canon de Valle leaving severe erosion potential behind.

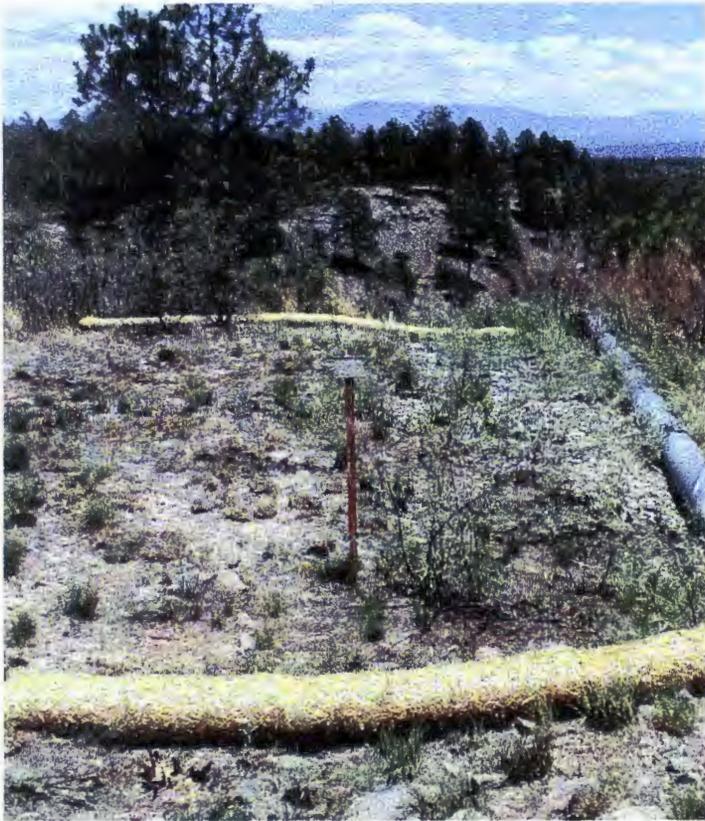
Site is located near a tributary in upper Water Canyon within the Upper Water Canyon Watershed Aggregate. The site has minor to moderate fire damage within the outfall drainage.

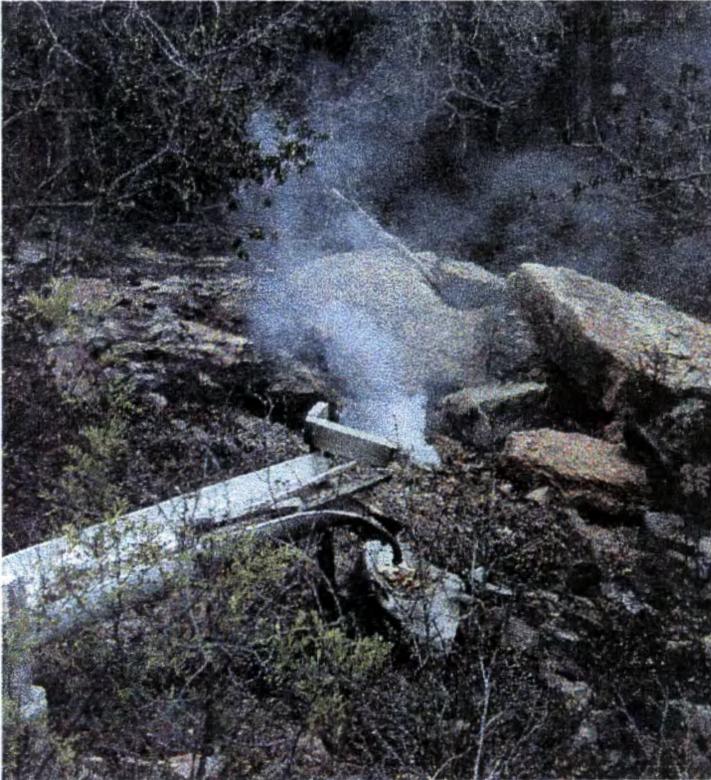
The site is located in a tributary drainage of Water Canyon within the Canon de Valle Watershed Aggregate. The “fish ladder” was destroyed by the fire. The remainder of the site has minor to moderate fire damage within the drainage channel down to the existing wetlands located approximately ¼ mile downstream.

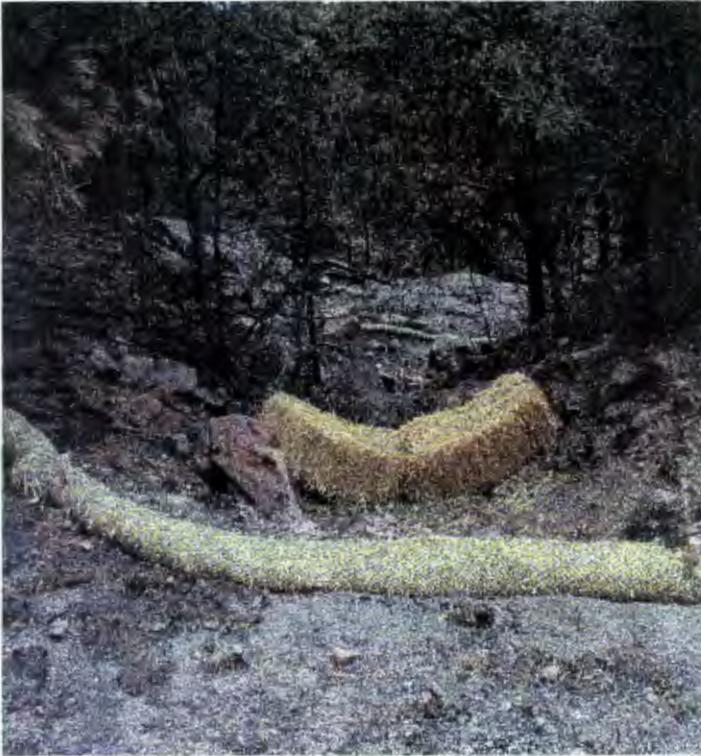
The site is located in a tributary drainage of Water Canyon within the Upper Water Canyon Watershed Aggregate. The site has minor to moderate fire damage within drainage channel.

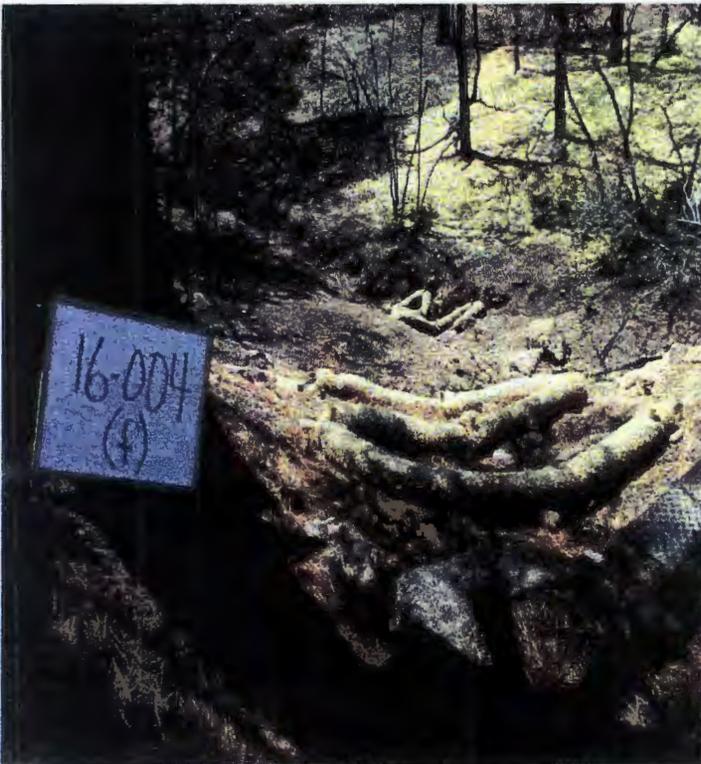
The site is located in a tributary drainage of Water Canyon within the S-Site Canyon Watershed Aggregate. The site has minor to moderate fire damage within drainage channel.

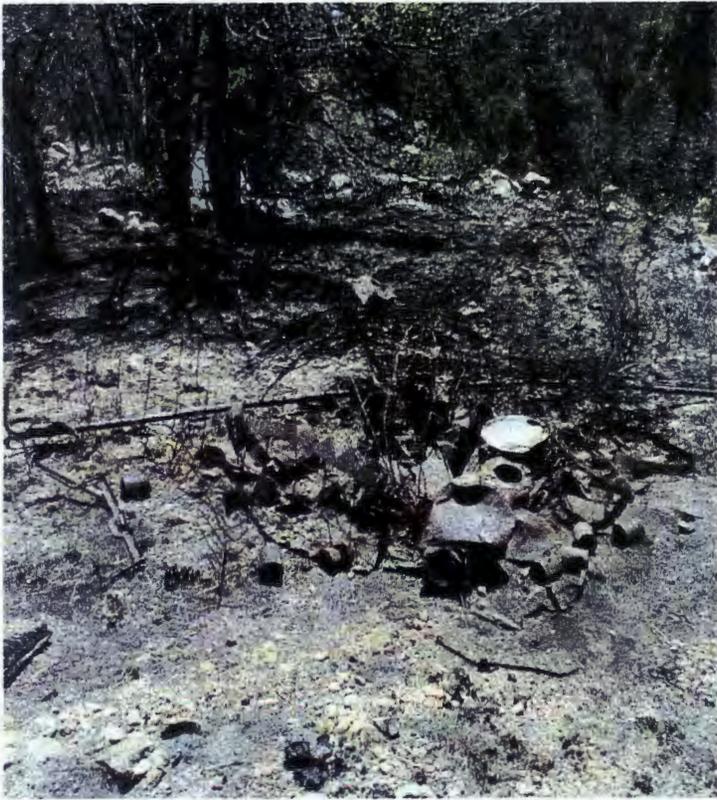
The site is located in a tributary drainage of Water Canyon within the Canon de Valle Watershed Aggregate. The site has minor to moderate fire damage within drainage channel. Debris was exposed within channel near the inactive outfall.

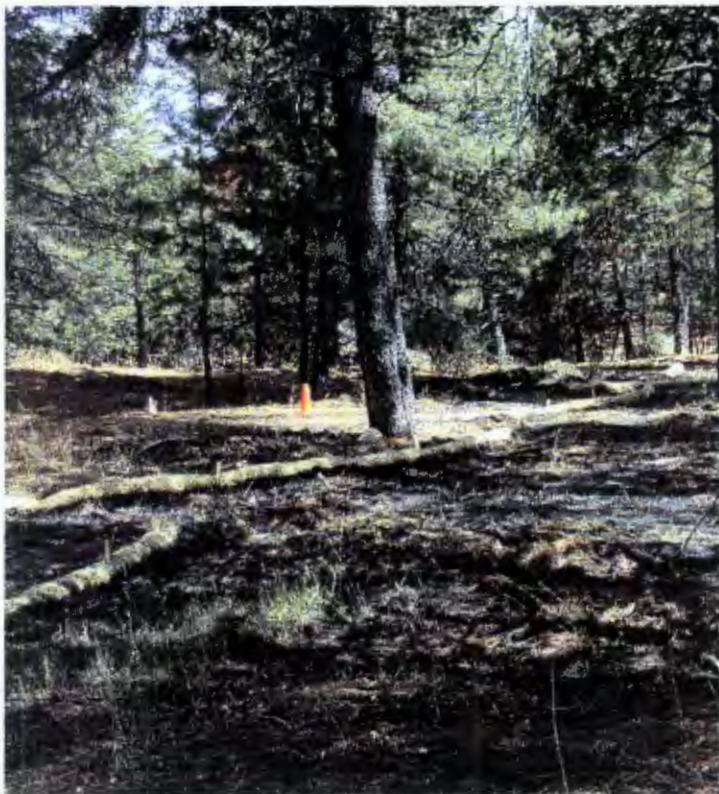
The site is located in a tributary drainage of Water Canyon within the Upper Water Canyon Watershed Aggregate. The site has moderate fire damage of the ground cover with minor canopy damage.

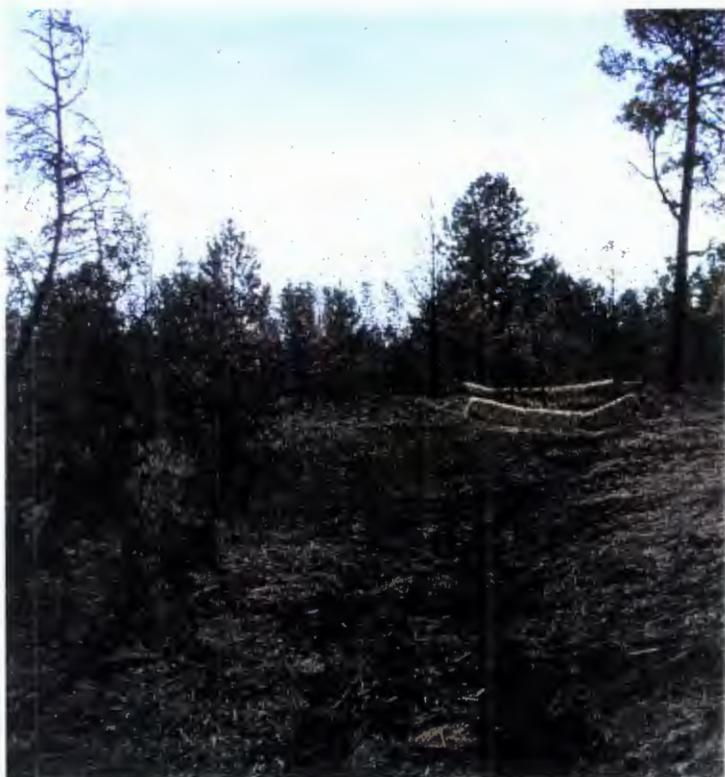
The site is located in a tributary drainage of Water Canyon within the Upper Water Canyon Watershed Aggregate. The site has moderate fire damage of the ground cover with minor canopy damage.

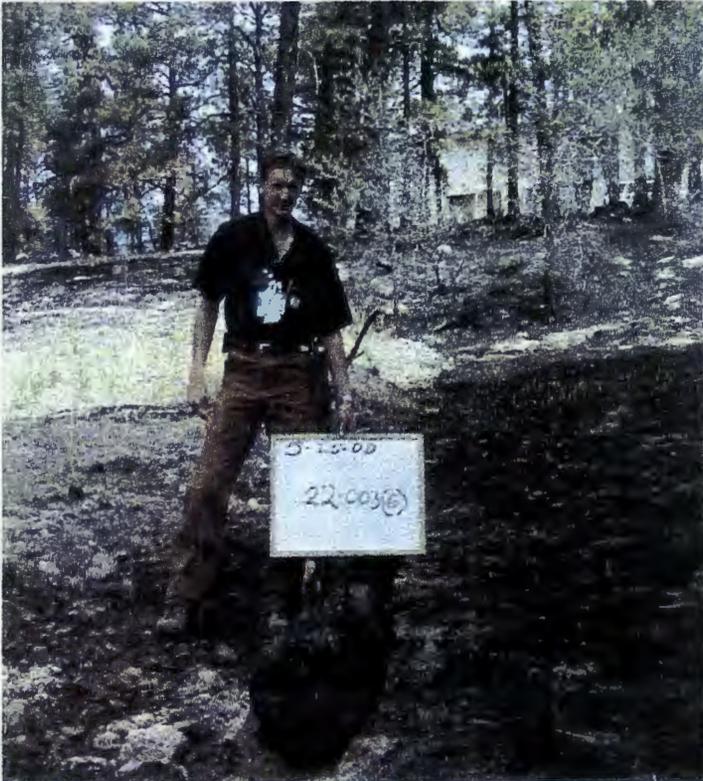
The site is located in a tributary drainage of Pajarito Canyon within the Starmer's/Pajarito Canyon Watershed Aggregate. Moderate fire damage was found at 22-015(c) including the drainage swale below the inactive outfall, the pond area and stained areas leading to the mesa edge. The ground cover was severely damaged leaving little or no protection.

*Photograph is mislabeled.

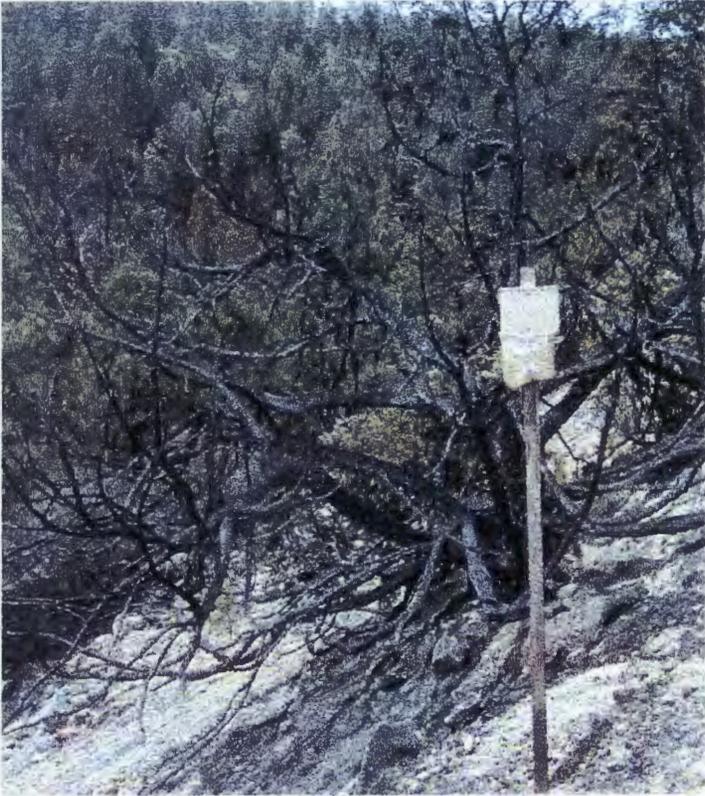
The site is located on the edge of Pajarito Canyon within the Starmer's/Pajarito Canyon Watershed Aggregate. The fire damage was moderate to severe with several buildings destroyed near this site.

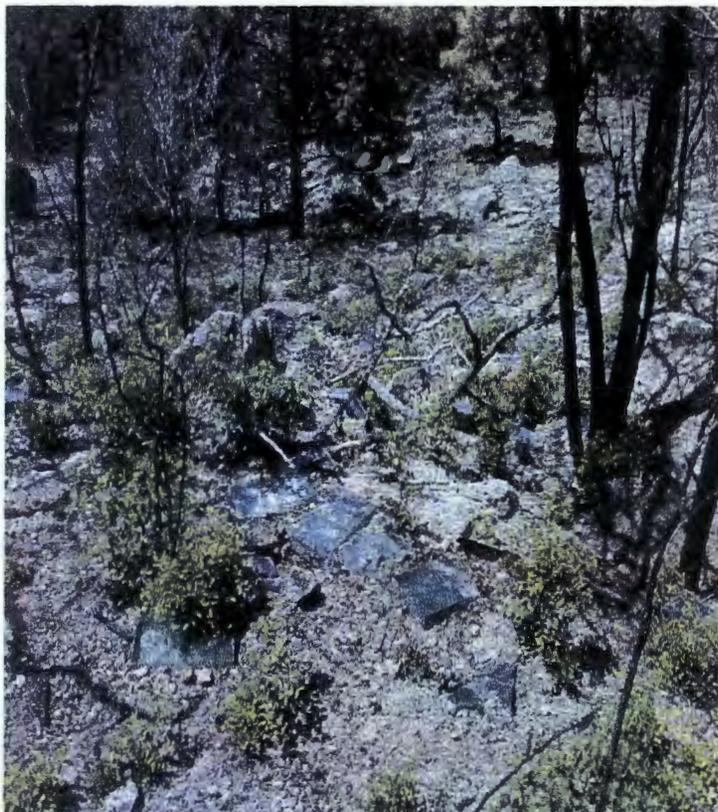
Site is located on the edge of Pajarito Canyon within the Starmer's/Pajarito Canyon Watershed Aggregate. The fire damage was moderate to severe with several buildings destroyed near this site.

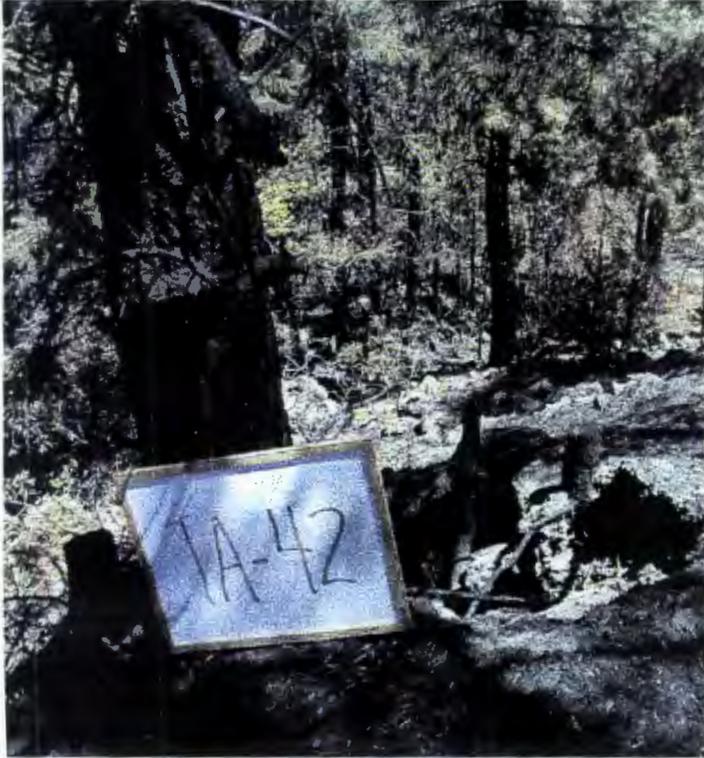
The site is located on a tributary drainage to Mortandad Canyon within the Upper Mortandad Canyon Watershed Aggregate. The entire north facing slope below former TA-42 was moderately burned. Debris on the slope was exposed as a result of the fire. Two distinct drainage channels bisect the area behind the new building constructed near TA-55. The run-on to the western most drainage has been diverted away from the area of concern. The other drainage receives only direct rainfall, with minimal upslope sources.

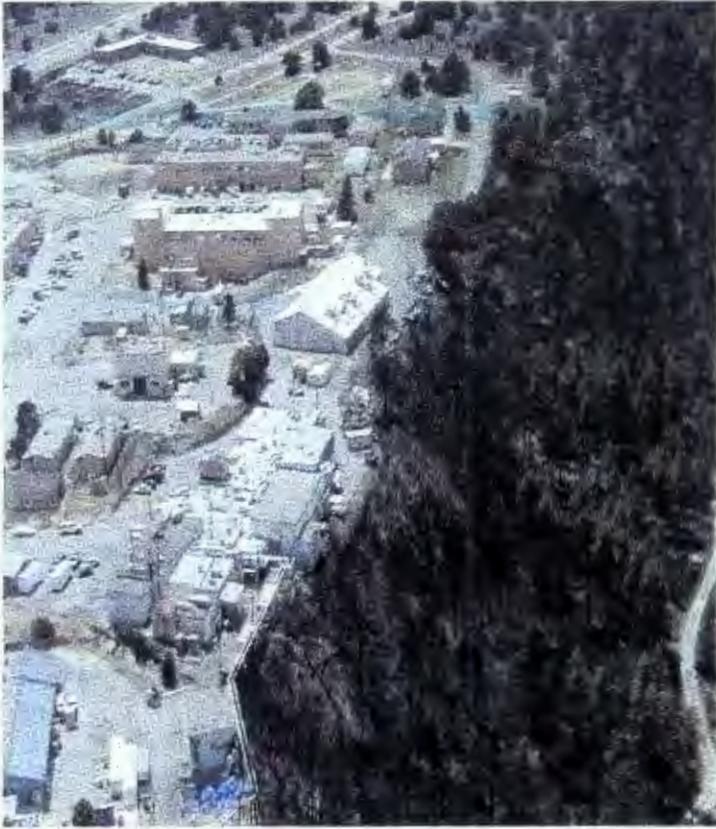
The site is located on the northern edge of Canada del Buey within the Middle Mortandad/Canada del Buey Watershed Aggregate. The entire north-facing slope behind TA-46 was moderately to severely burned. Several buildings along the mesa edge were destroyed. The canopy and ground cover were mostly destroyed. The northern slope is extremely steep with several inactive outfalls, pipes and old infrastructure parts exposed.

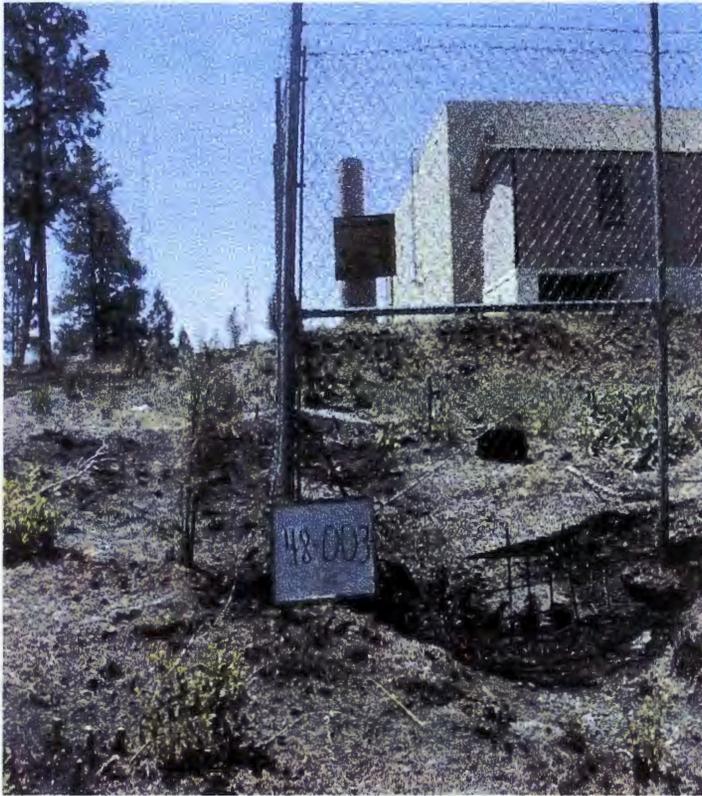
This site is located on the northern edge of Mortandad Canyon within the Upper Mortandad Watershed Aggregate. The northern part of TA-48 was moderately burned, with damage to ground cover and canopy.

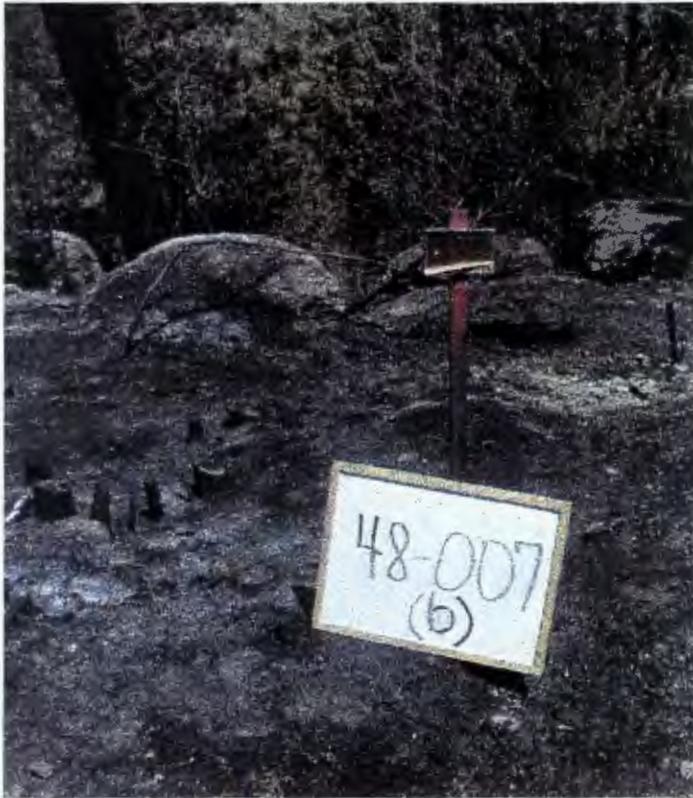
This site is located on the northern edge of Mortandad Canyon within the Upper Mortandad Watershed Aggregate. The northern part of TA-48 was moderately burned, with damage to ground cover and canopy.

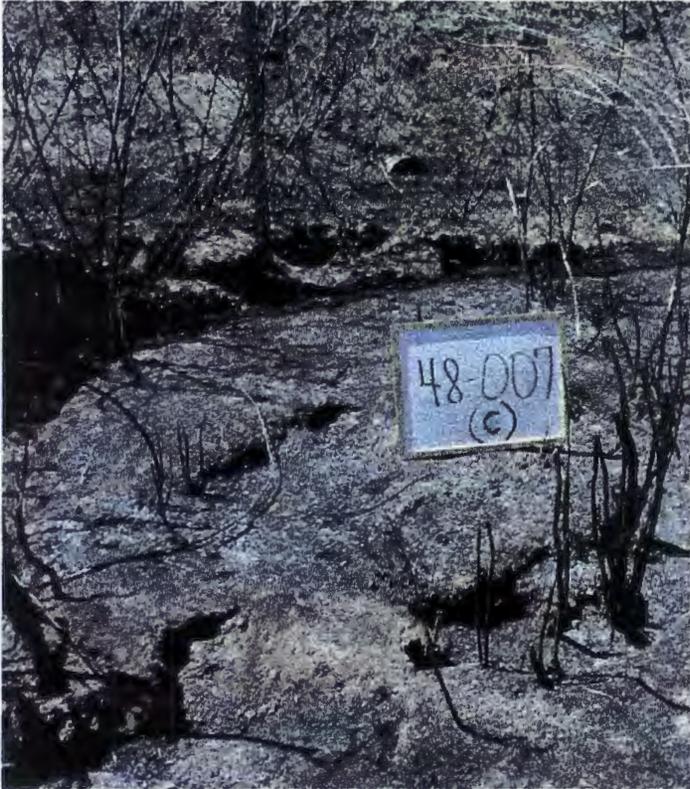
This site is located on the northern edge of Mortandad Canyon within the Upper Mortandad Watershed Aggregate. The northern part of TA-48 was moderately burned, with damage to ground cover and canopy.
