LA-UR-00-3767

Title: CERRO GRANDE FIRE AFTERMATH:
ENVIRONMENTAL RESTORATION PROJECT
ACTIVITIES TO REDUCE THE MIGRATION OF
CONTAMINATION FROM POTENTIAL RELEASE SITES

Author(s): STEVEN J. VEENIS, CPESC

Submitted to: WATER QUALITY & HYDROLOGY GROUP (ESH-18)
ENVIRONMENTAL RESTORATION PROJECT

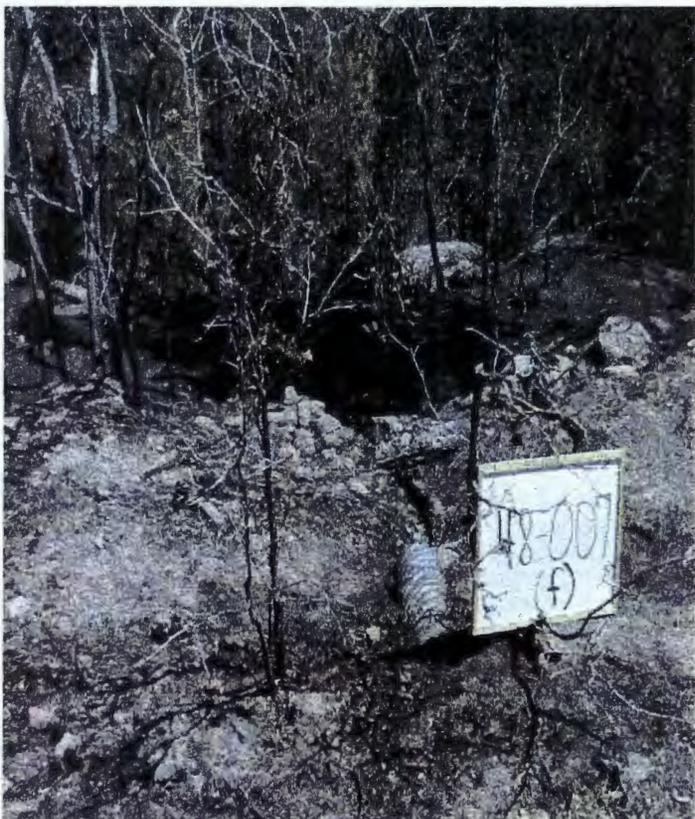
This site is located on the northern edge of Mortandad Canyon within the Upper Mortandad Watershed Aggregate. The northern part of TA-48 was moderately burned, with damage to ground cover and canopy.

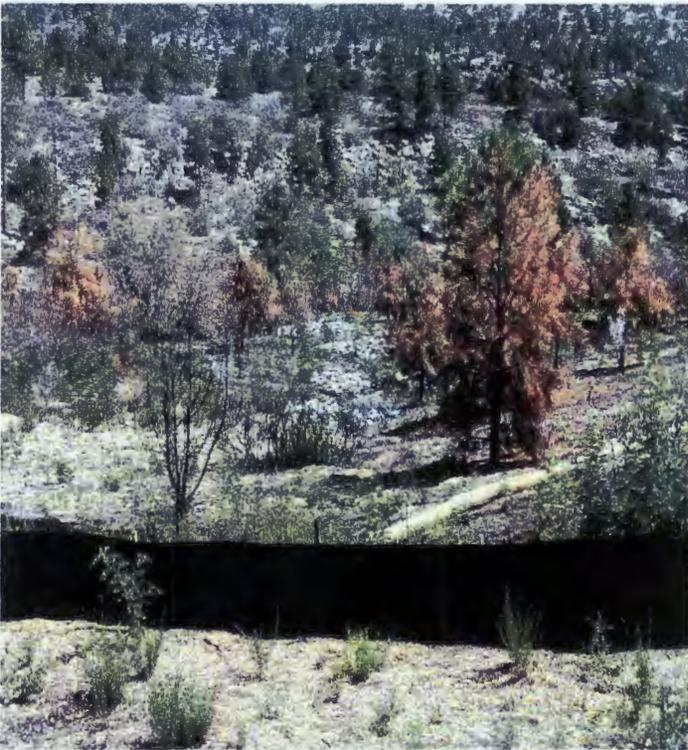
This site is located on a tributary to Water Canyon within the Lower Water/Indio Watershed Aggregate. The area was lightly to moderately burned from MDA AB towards the canyon edge. All existing BMPs were destroyed
