Title: CERRO GRANDE FIRE ONE YEAR AFTER:

AN UPDATE ON ER ACTIVITIES TO REDUCE
THE POTENTIAL MOVEMENT OF
CONTAMINATION AT POTENTIAL RELEASE
SITES

Authors: STEVEN J. VEENIS, CPESC
RANDY JOHNSON, IT CORPORATION

Submitted to: WATER QUALITY & HYDROLOGY GROUP (ESH-18)
ENVIRONMENTAL RESTORATION PROJECT

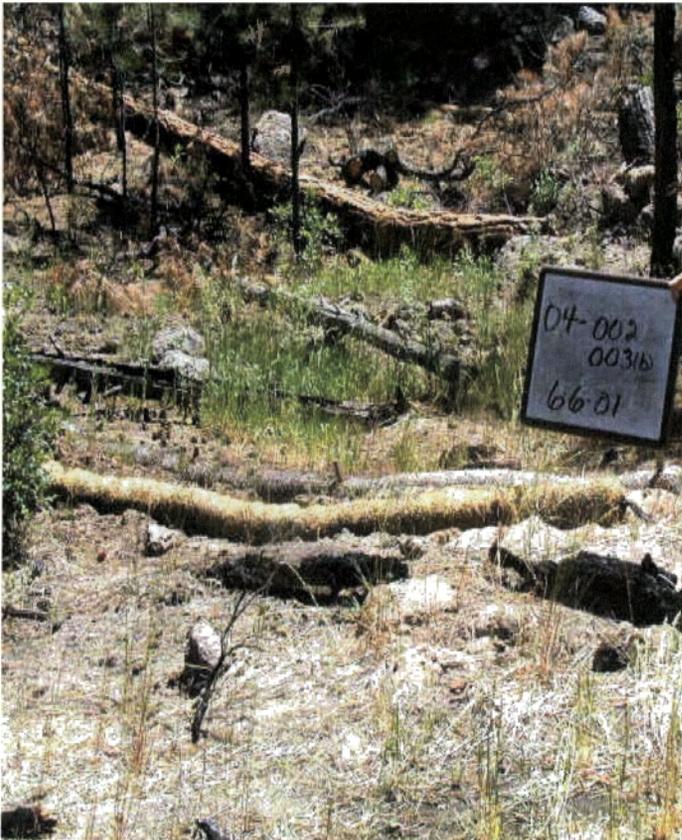
Site is in good condition, with vegetative cover of greater than 50%. The area appears stable with evidence of sediment migration being minimal.

Maintenance consisted of installation of an additional 15 wattles throughout the site. Several trees were trimmed and used as sediment retention in adjacent drainage swales.

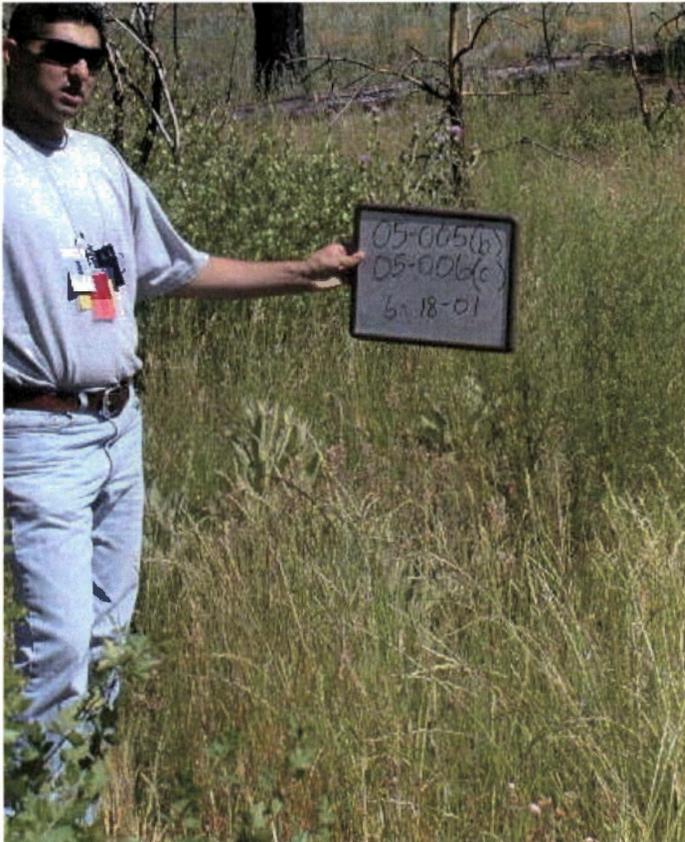
Site is in good condition, with vegetative cover of greater than 70%. Sediment migration is occurring in the steepest part of several drainage channels, but the straw wattles on the flatter bench appear to be keeping sediment from entering into Canada del Buey.

Maintenance consisted of installation of an additional 28 wattles throughout the site. A few more trees were felled within drainages and spot reseeding and mulch were applied.

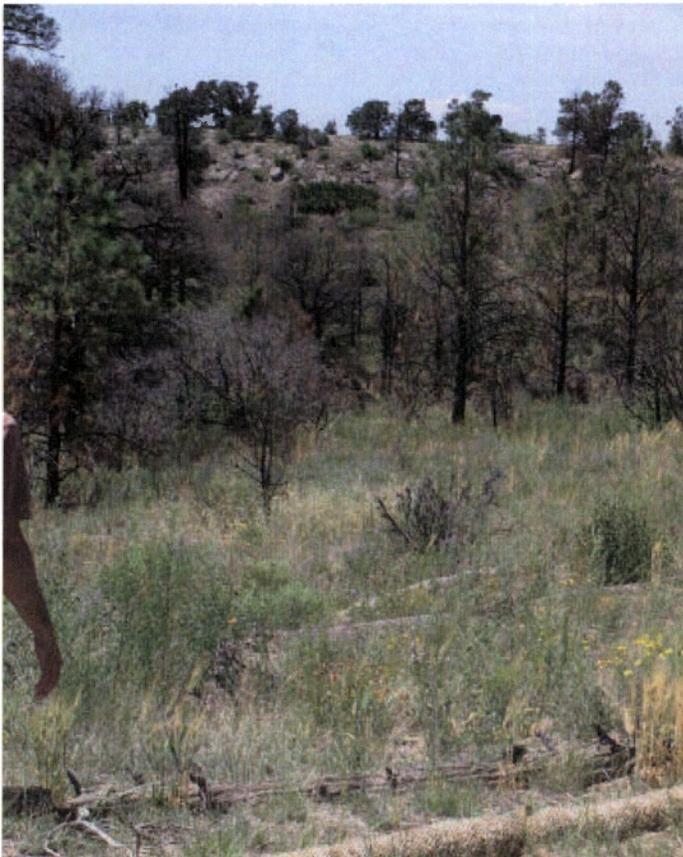
Site is in good condition, with vegetative cover of greater than 50%. Sediment migration is occurring in the steepest part of several drainage channels, but the straw wattles on the flatter bench appear to be keeping sediment from entering into tributary drainage.

Maintenance consisted of installation of an additional 22 wattles directly down gradient of existing wattles. Spot reseeding and mulch were applied where needed.

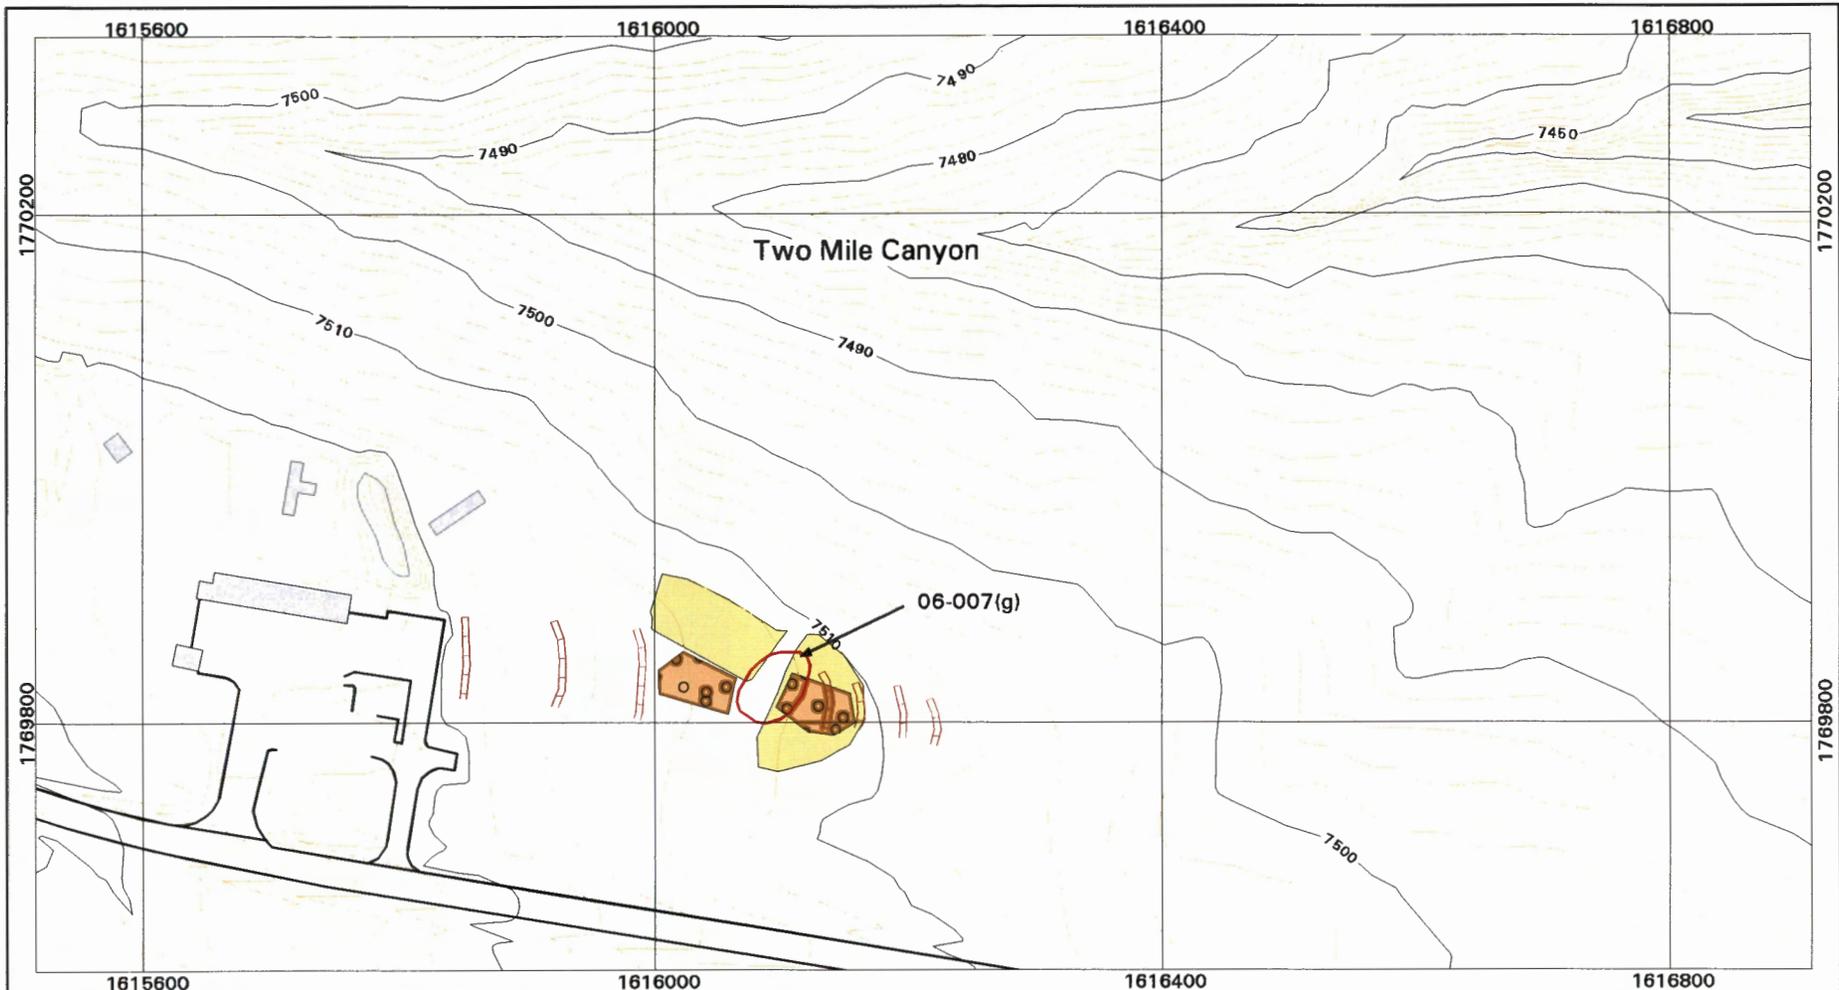
Best Management Practices at PRS 06-007(g)

Site is in good condition, with vegetative cover of greater than 70%. The area appears stable with evidence of sediment migration being minimal.

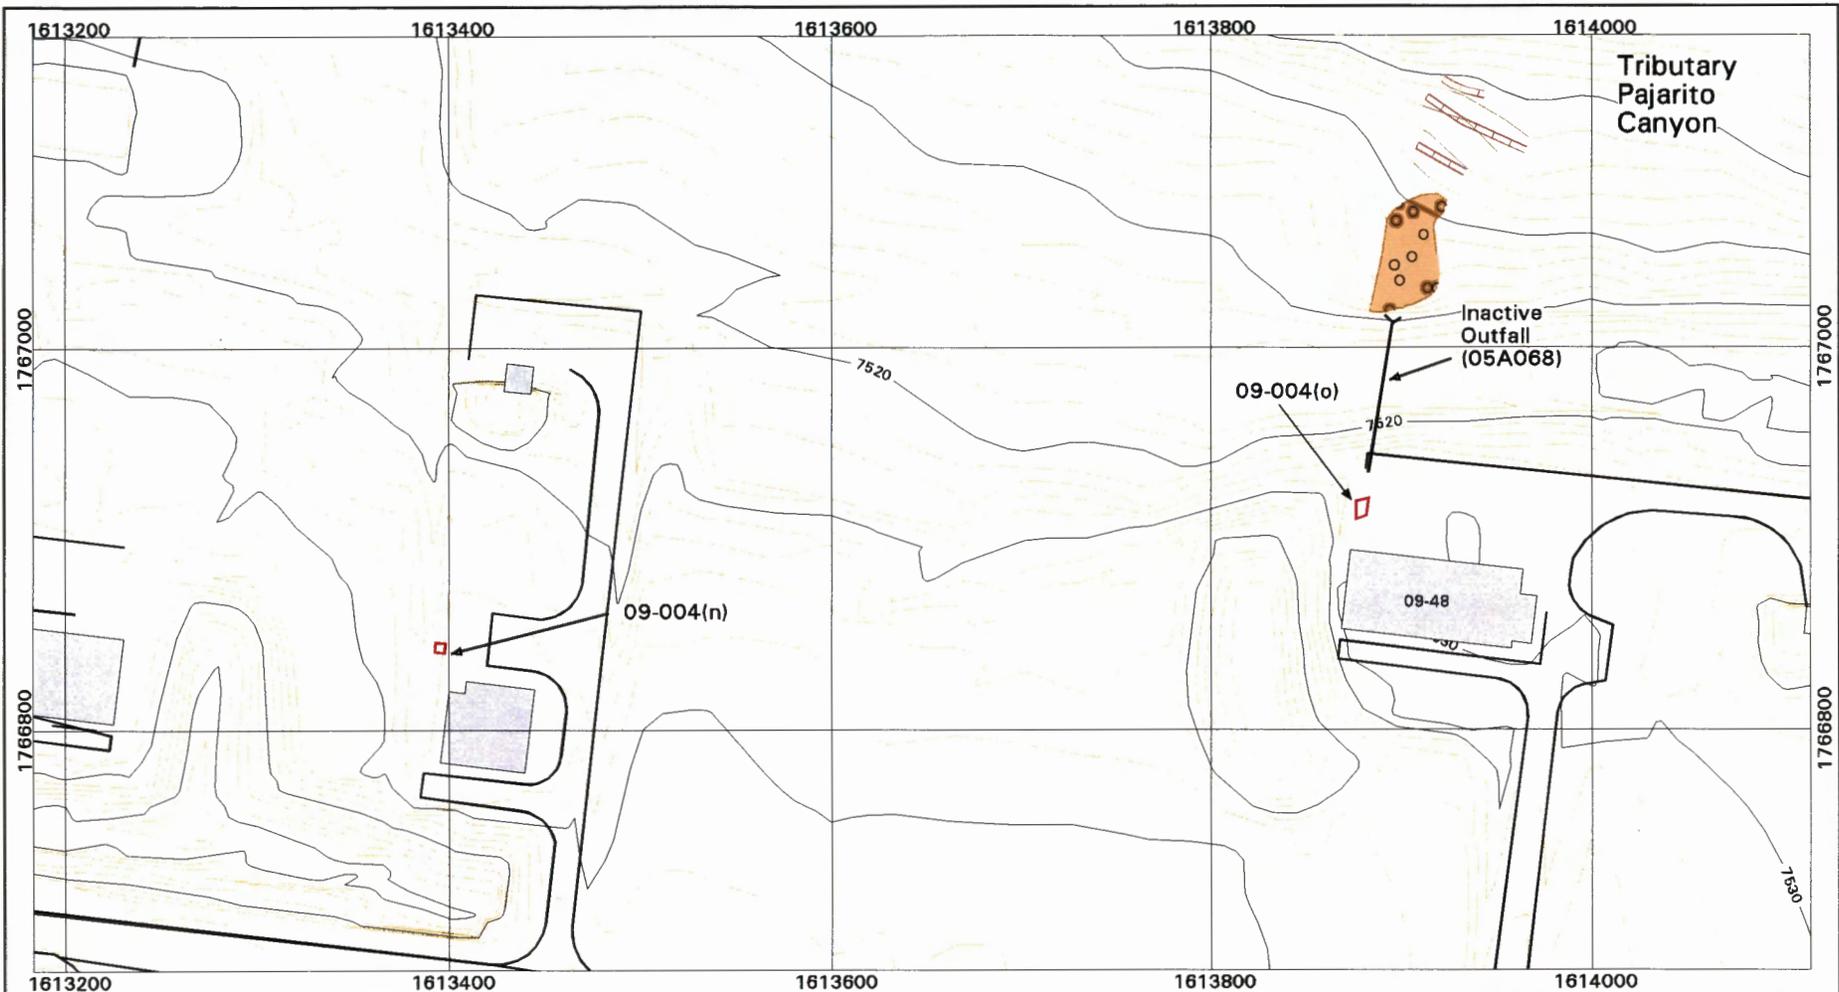
Best Management Practices at PRSs 09-004(n,o)

Site is in good condition, with vegetative cover of greater than 70%. The area appears stable with evidence of sediment migration being minimal.

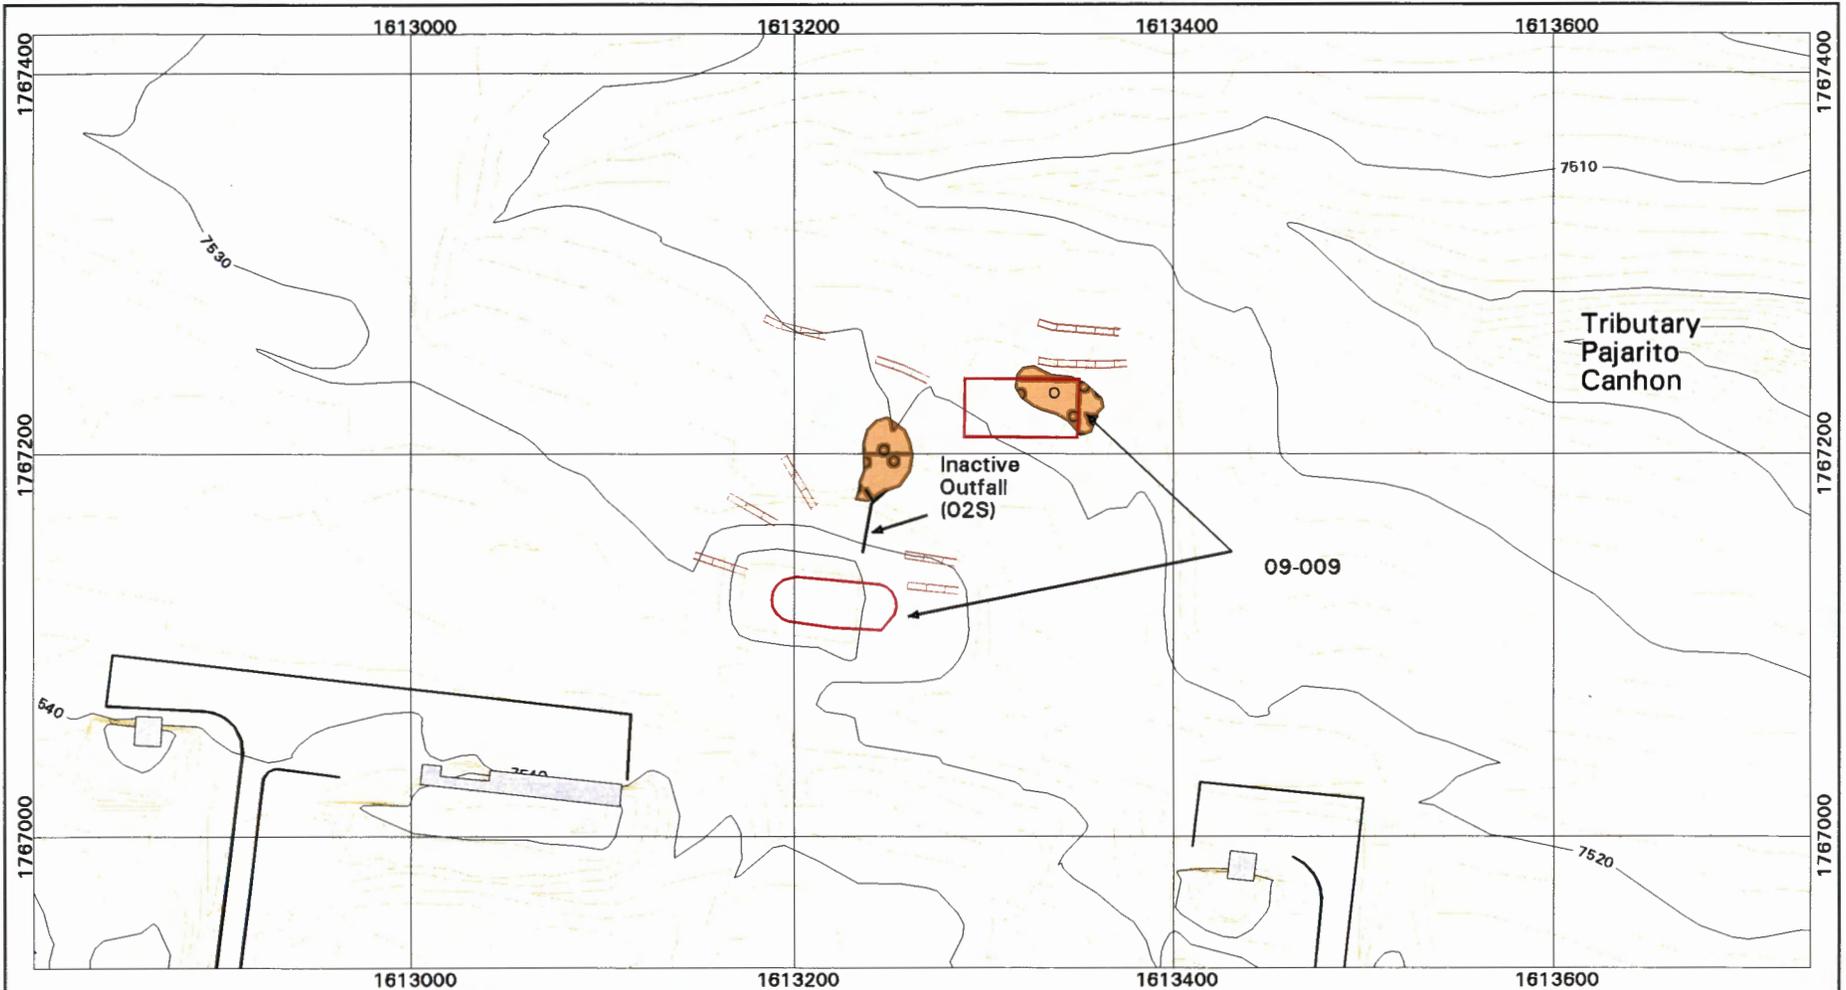
Best Management Practices at PRS 09-009

Site is in good condition, with vegetative cover of greater than 40%. The area appears stable with evidence of sediment migration being minimal.

Straw wattles were installed in the drainage swales and rock check dams were placed in the channels to dissipate flow (using existing materials found on-site). Wattles were also provided upslope for run-on diversion.

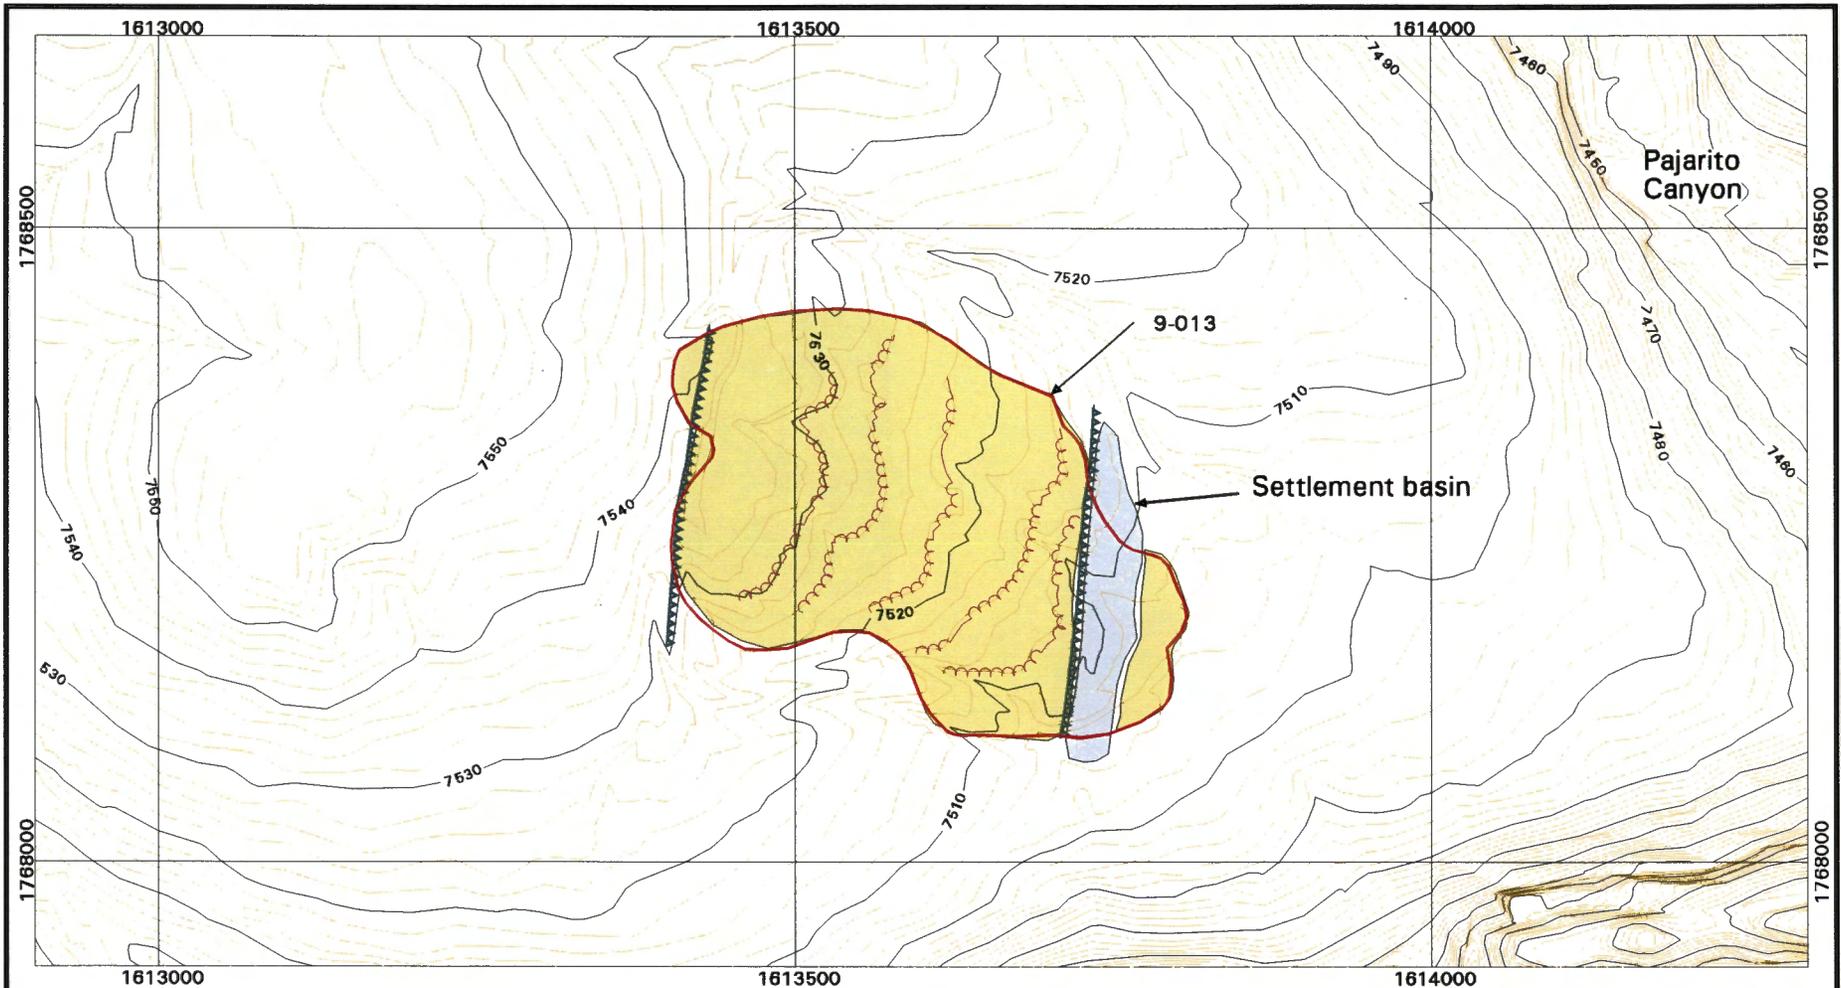
Best Management Practices at PRS 09-013

This site is located south of Pajarito Canyon within the Starmer/Upper Pajarito Watershed Aggregate. The area surrounding MDA M was moderately to severely burned as was a majority of the upper Pajarito Watershed. All of the existing erosion controls at the site were destroyed.

Site is in good condition, with vegetative cover of greater than 70%. The area appears stable with evidence of sediment migration being minimal.

Run-on controls were replaced as shown below. The entire site was hand raked, reseeded and mulched. A retention basin was installed at the bottom of the slope to create a "zero discharge" area.

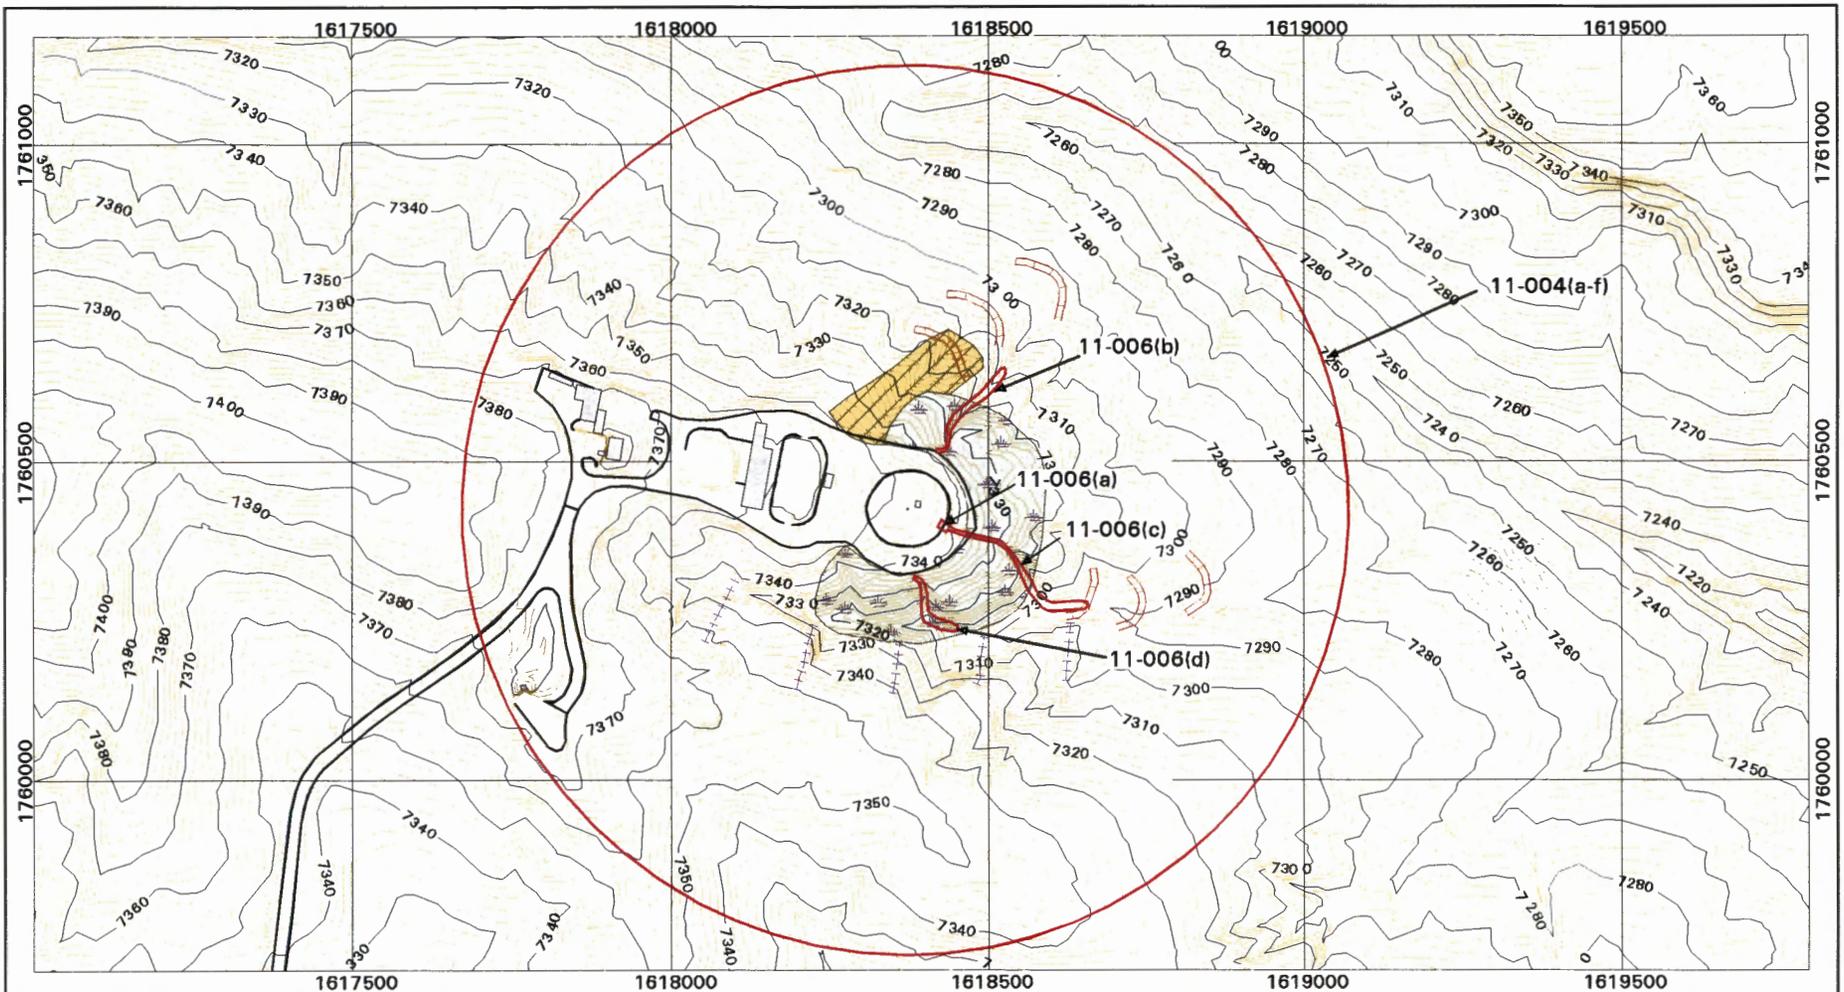
Best Management Practices at PRS 11-004(a-f) and 11-006(a-d)

This site is located north of Water Canyon within the S-Site Watershed Aggregate. The site has moderate to severe fire damage in the area surrounding the TA-11 Drop Tower. Log check dams within the major drainages received partial damage. All straw barriers installed around site were destroyed.

Site is in good condition, with vegetative cover of greater than 60%. The area appears stable with evidence of sediment migration being minimal.

The log check dams (on-site materials used) were replaced within the adjacent drainages. Straw wattles were placed on the slopes and geotextile was installed in the areas with the most erosion potential. The area surrounding the Drop Tower was hydromulched to enhance the revegetation process.

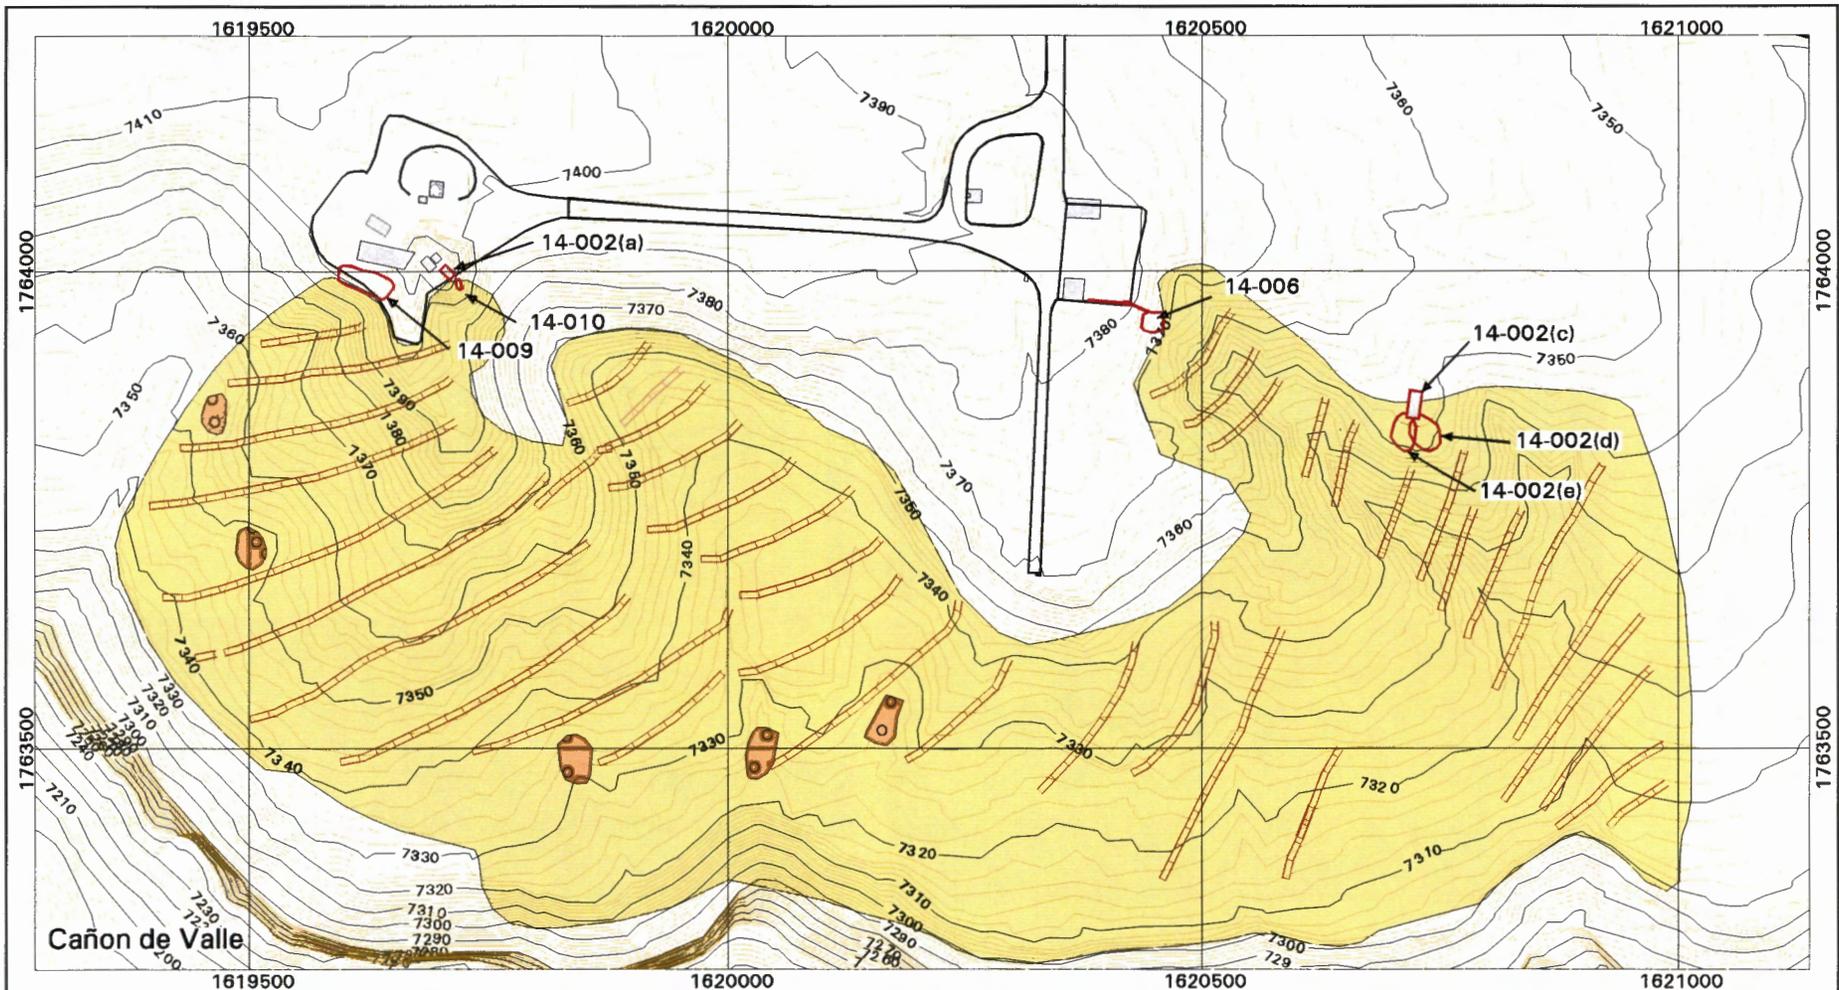
Best Management Practices at PRSs 14-002(a,c-e), 14-006, 14-009, and 14-010

This site is located north of Canon de Valle within the Canon de Valle Watershed Aggregate. The entire south facing slope located to the south of TA-14 structures was moderately burned with substantial damage to the groundcover.

Site is in good condition, with vegetative cover of greater than 70% throughout the site. The area appears stable with evidence of sediment migration being minimal.

Several more straw wattles were installed due to damage from wildlife.

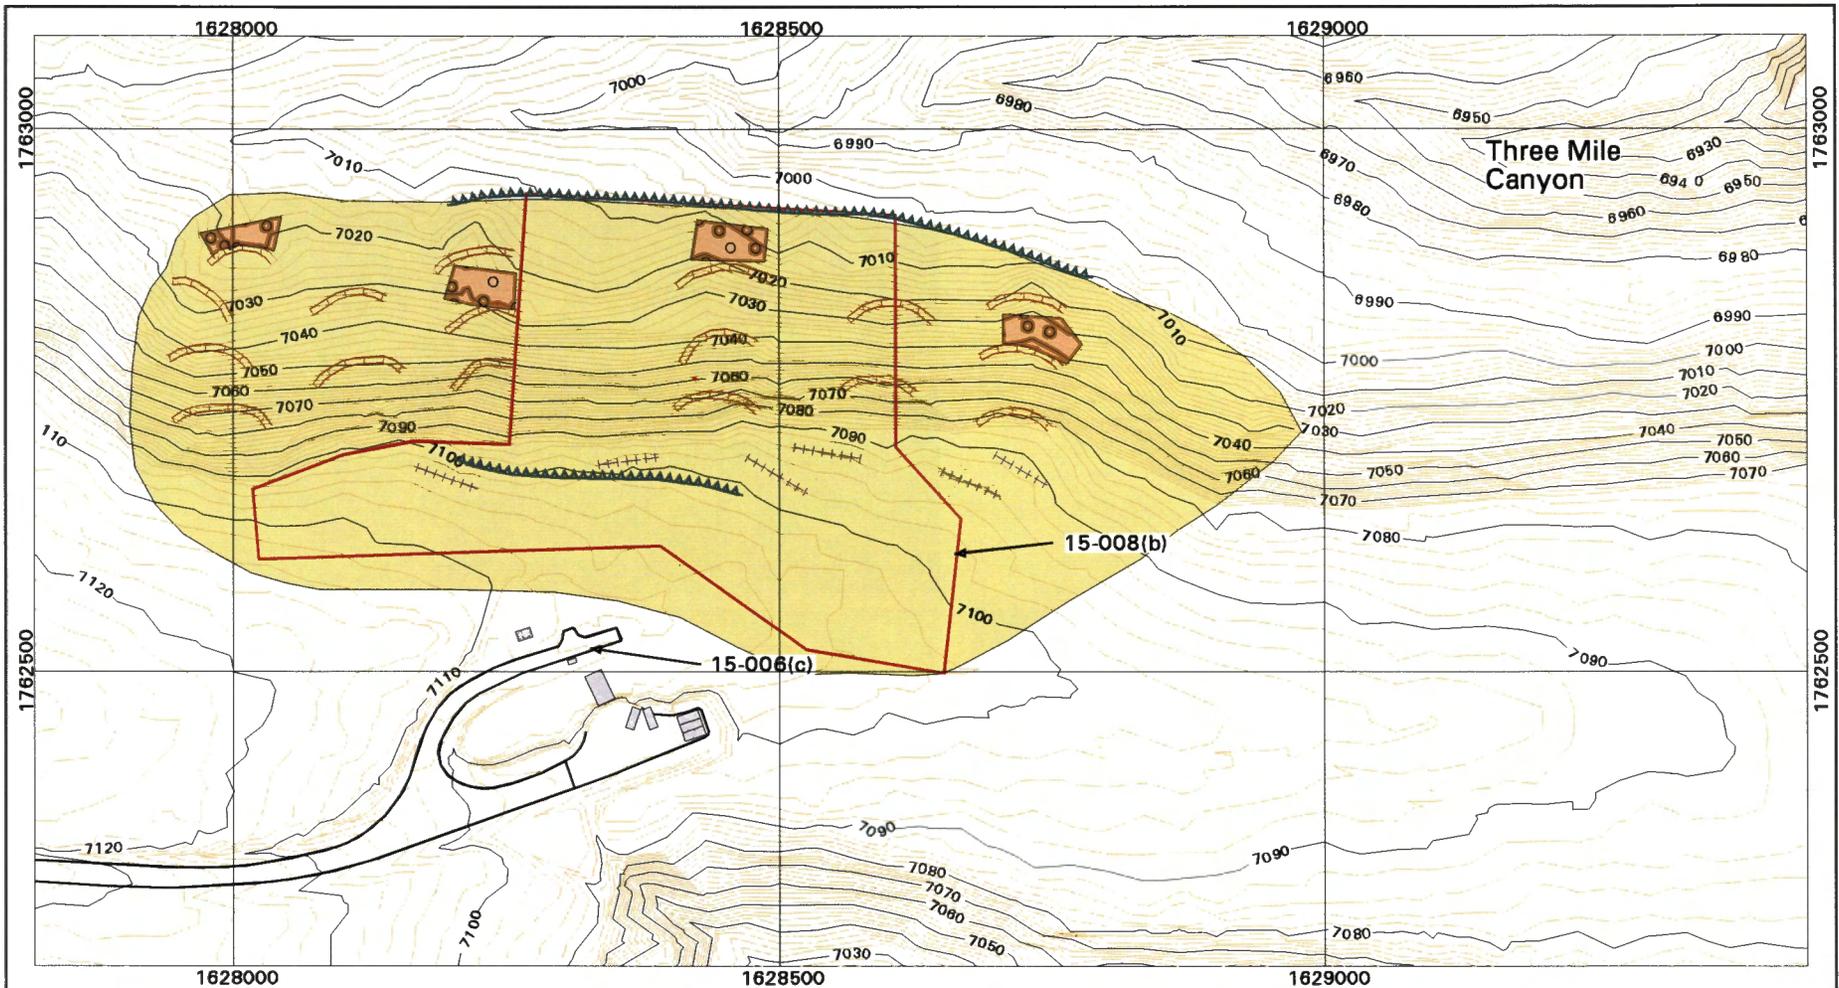
Best Management Practices at PRSs 15-006(c) and 15-008(b) (R-44)

This site is located on the south rim of Three Mile Canyon within the Three Mile Watershed Aggregate. 15-006(c) has moderate to severe burn damage with most of the damage adjacent to the former R-44 Firing Pad. A large amount of firing site related debris has been exposed throughout the site (especially towards the east).

Over 20 cubic yards of firing site debris was removed from the surrounding area. Site is in good condition, with vegetative cover of greater than 70%. The area appears stable with evidence of sediment migration being minimal.

Straw wattles, rock check dams and silt fencing were installed throughout the burned areas. The area was then hydromulched to enhance the revegetation process.

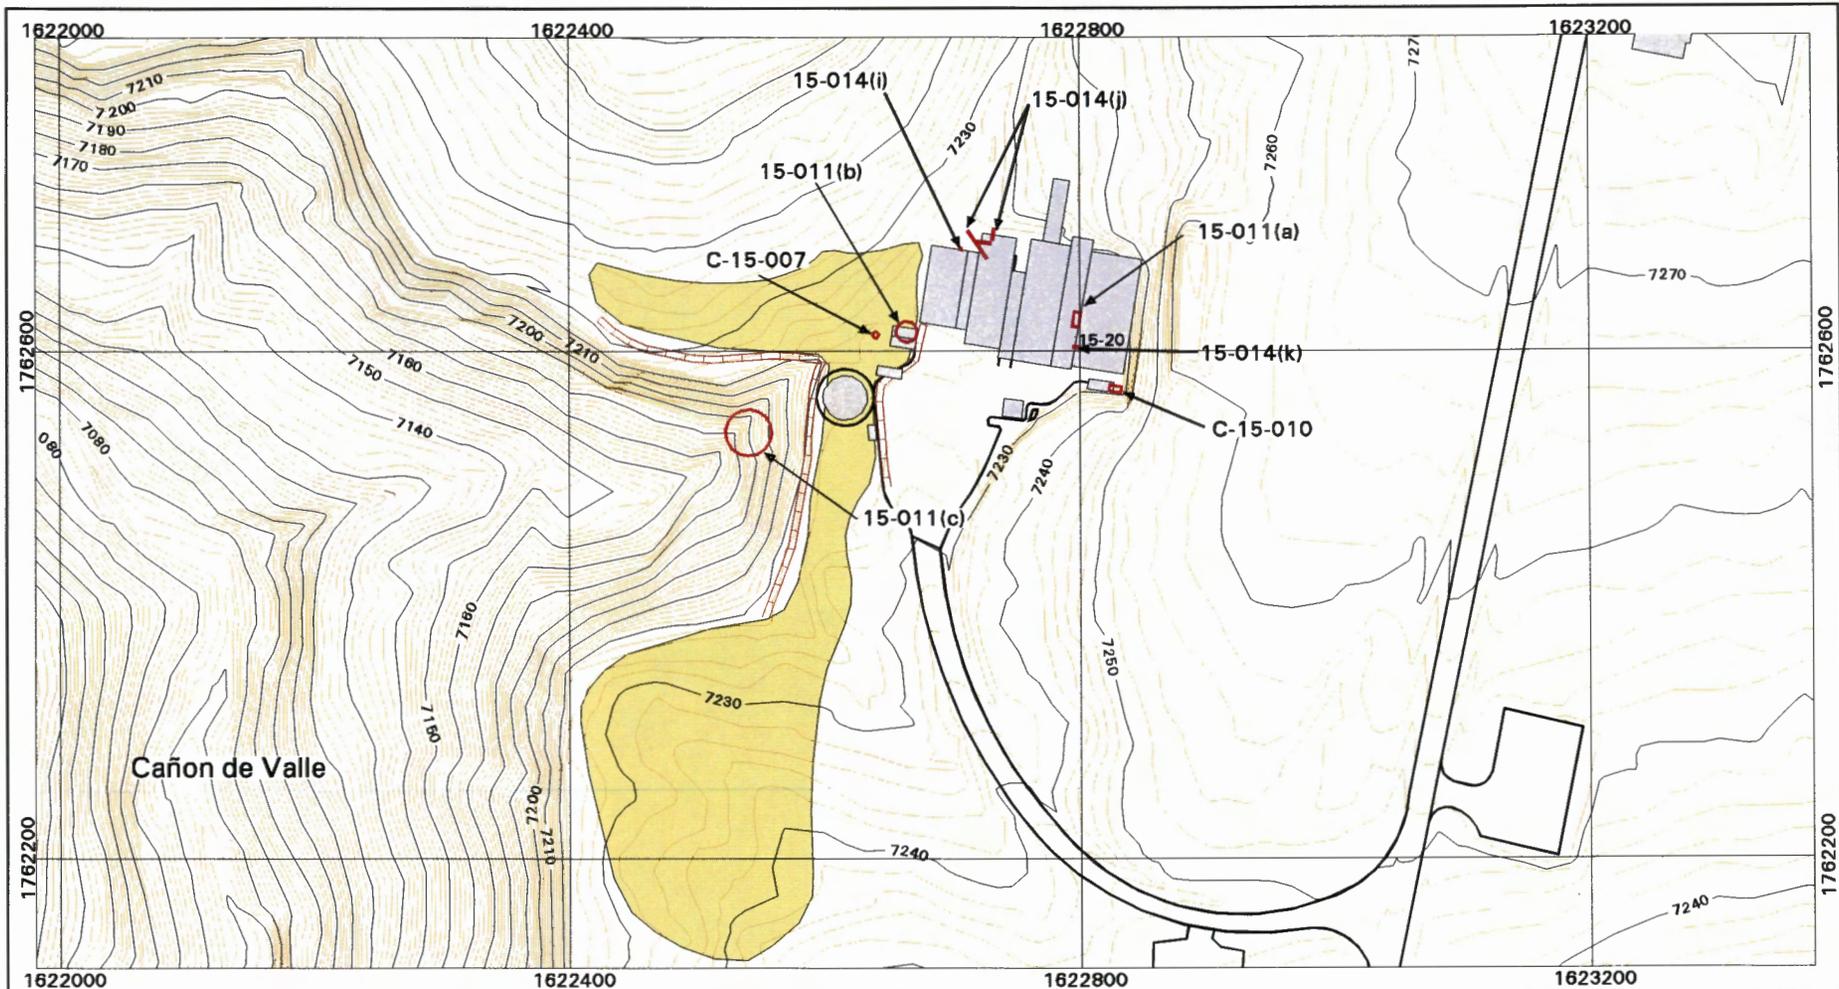
Best Management Practices at PRSs 15-011(a-c), 15-014(i-k), C-15-007, and C-15-010

This site is located near the confluence of Canon de Valle and Water Canyon within the Canon de Valle Watershed Aggregate. The site was moderately to severely damaged including several burned structures.

Site is in good condition, with vegetative cover of greater than 70%. The area appears stable with evidence of sediment migration being minimal.

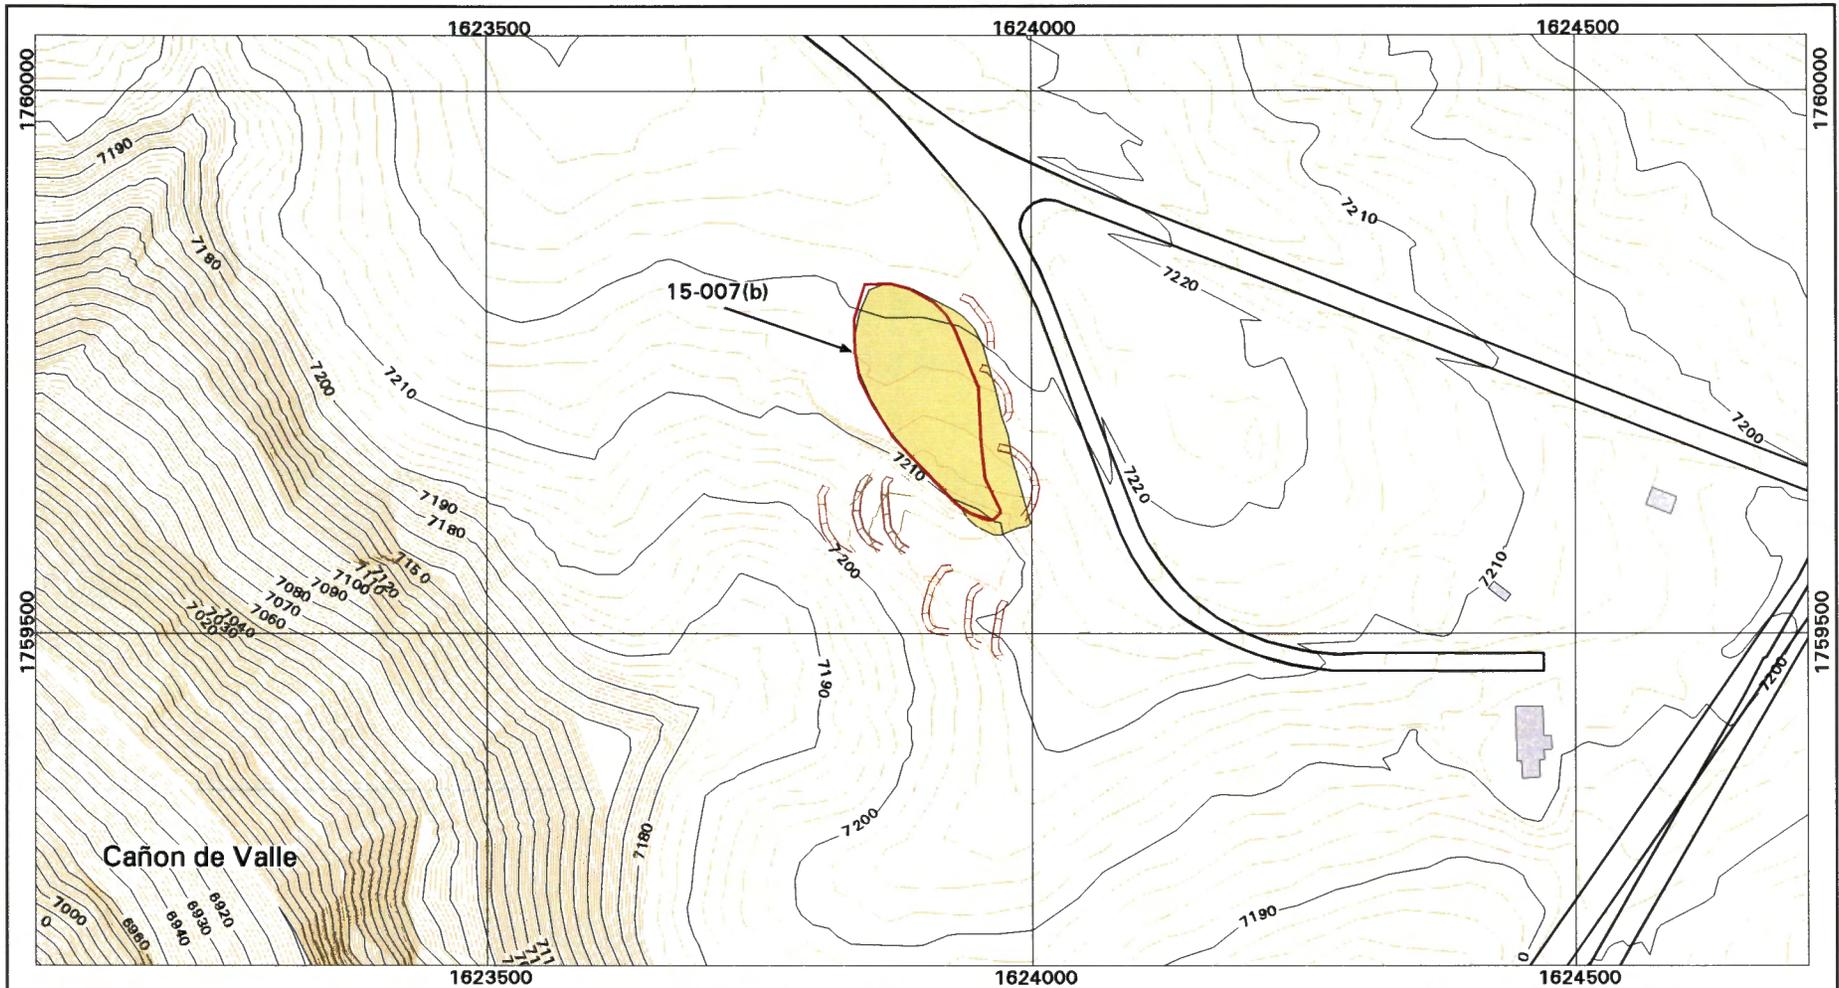
Best Management Practices at PRSs 15-007(b)

This site is located near the confluence of Canon de Valle and Water Canyon within the Canon de Valle Watershed Aggregate. The area received minor burn damage primarily to the ground cover.

Site is in good condition, with vegetative cover of greater than 50%. The area appears stable with evidence of sediment migration being minimal.

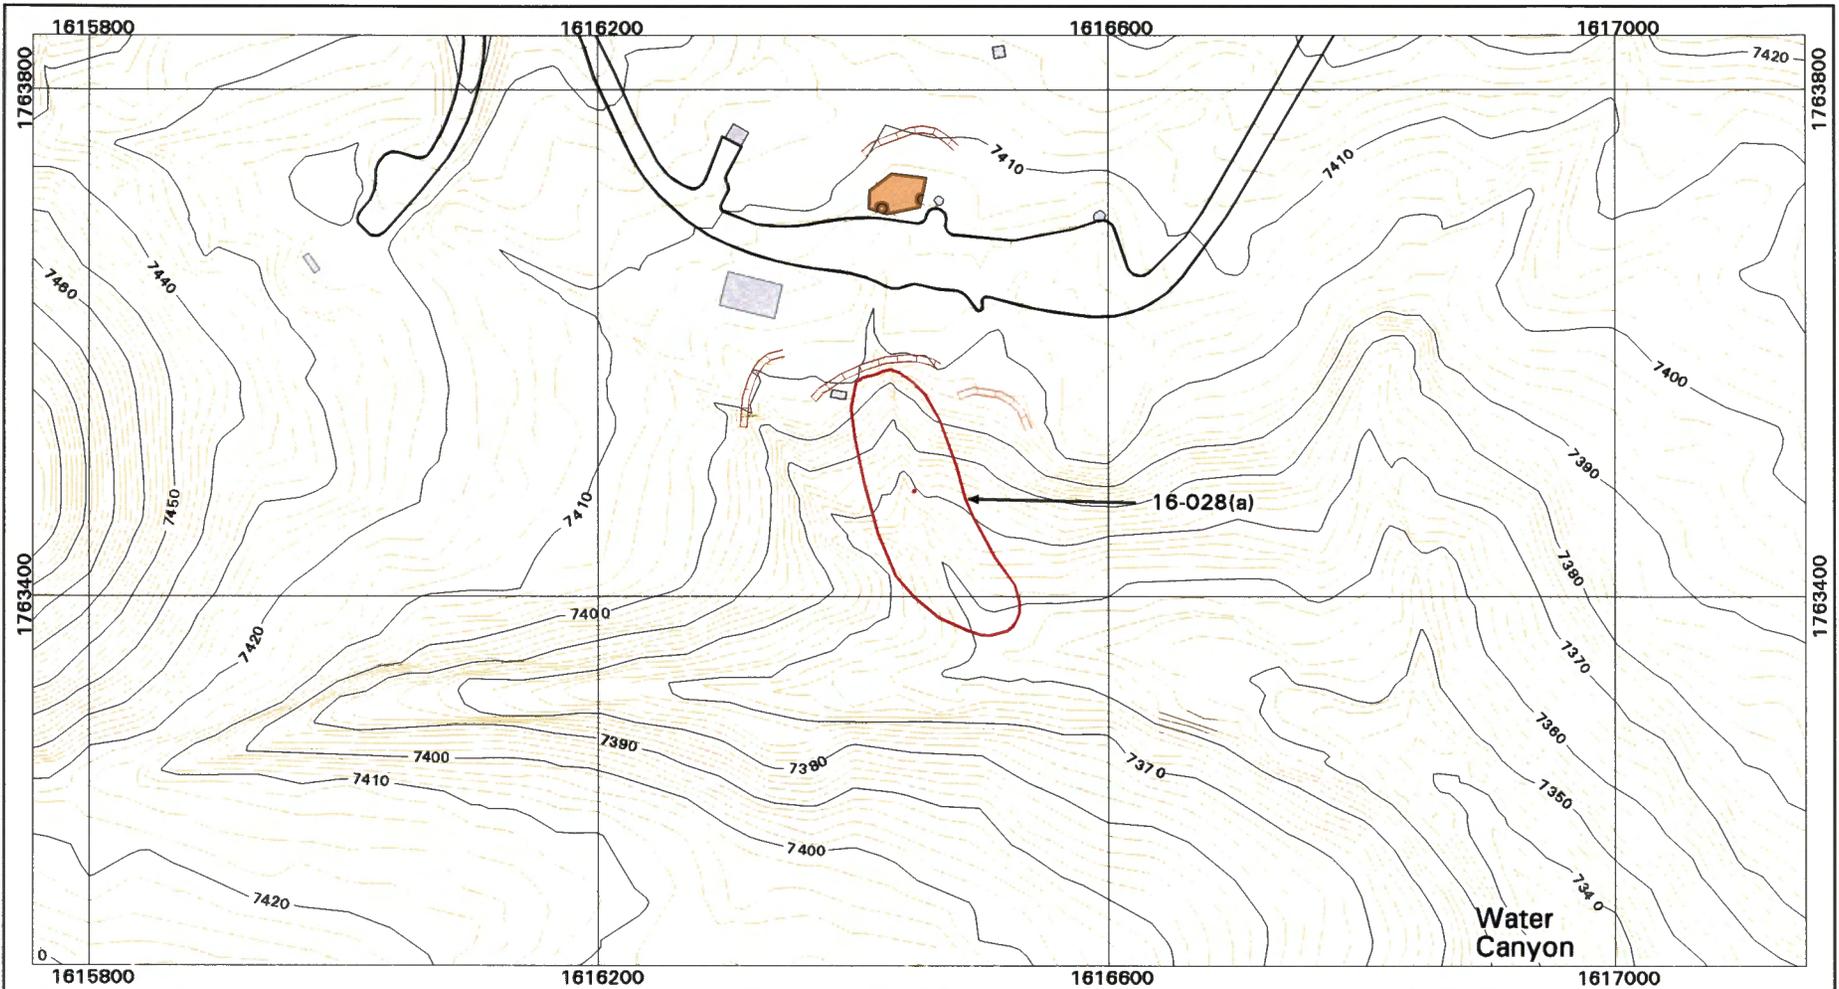
Best Management Practices at PRS 16-028(a)

This site is located near a tributary of Water Canyon within the Canon de Valle Watershed Aggregate. The site has minimal fire damage to the west and south. Some minor burning occurred within the SWMU boundary, but consisted mostly of destroyed grasses. The HEWTF remains operational.

Site is in good condition, with vegetative cover of greater than 50%. The area appears stable with evidence of sediment migration being minimal.

Straw barriers and rock check dams (existing materials found on site) were placed within the drainage swale to reduce sediment transport potential.
