Title: CERRO GRANDE FIRE ONE YEAR AFTER:

AN UPDATE ON ER ACTIVITIES TO REDUCE
THE POTENTIAL MOVEMENT OF
CONTAMINATION AT POTENTIAL RELEASE
SITES

Authors: STEVEN J. VEENIS, CPESC
RANDY JOHNSON, IT CORPORATION

Submitted to: WATER QUALITY & HYDROLOGY GROUP (ESH-18)
ENVIRONMENTAL RESTORATION PROJECT

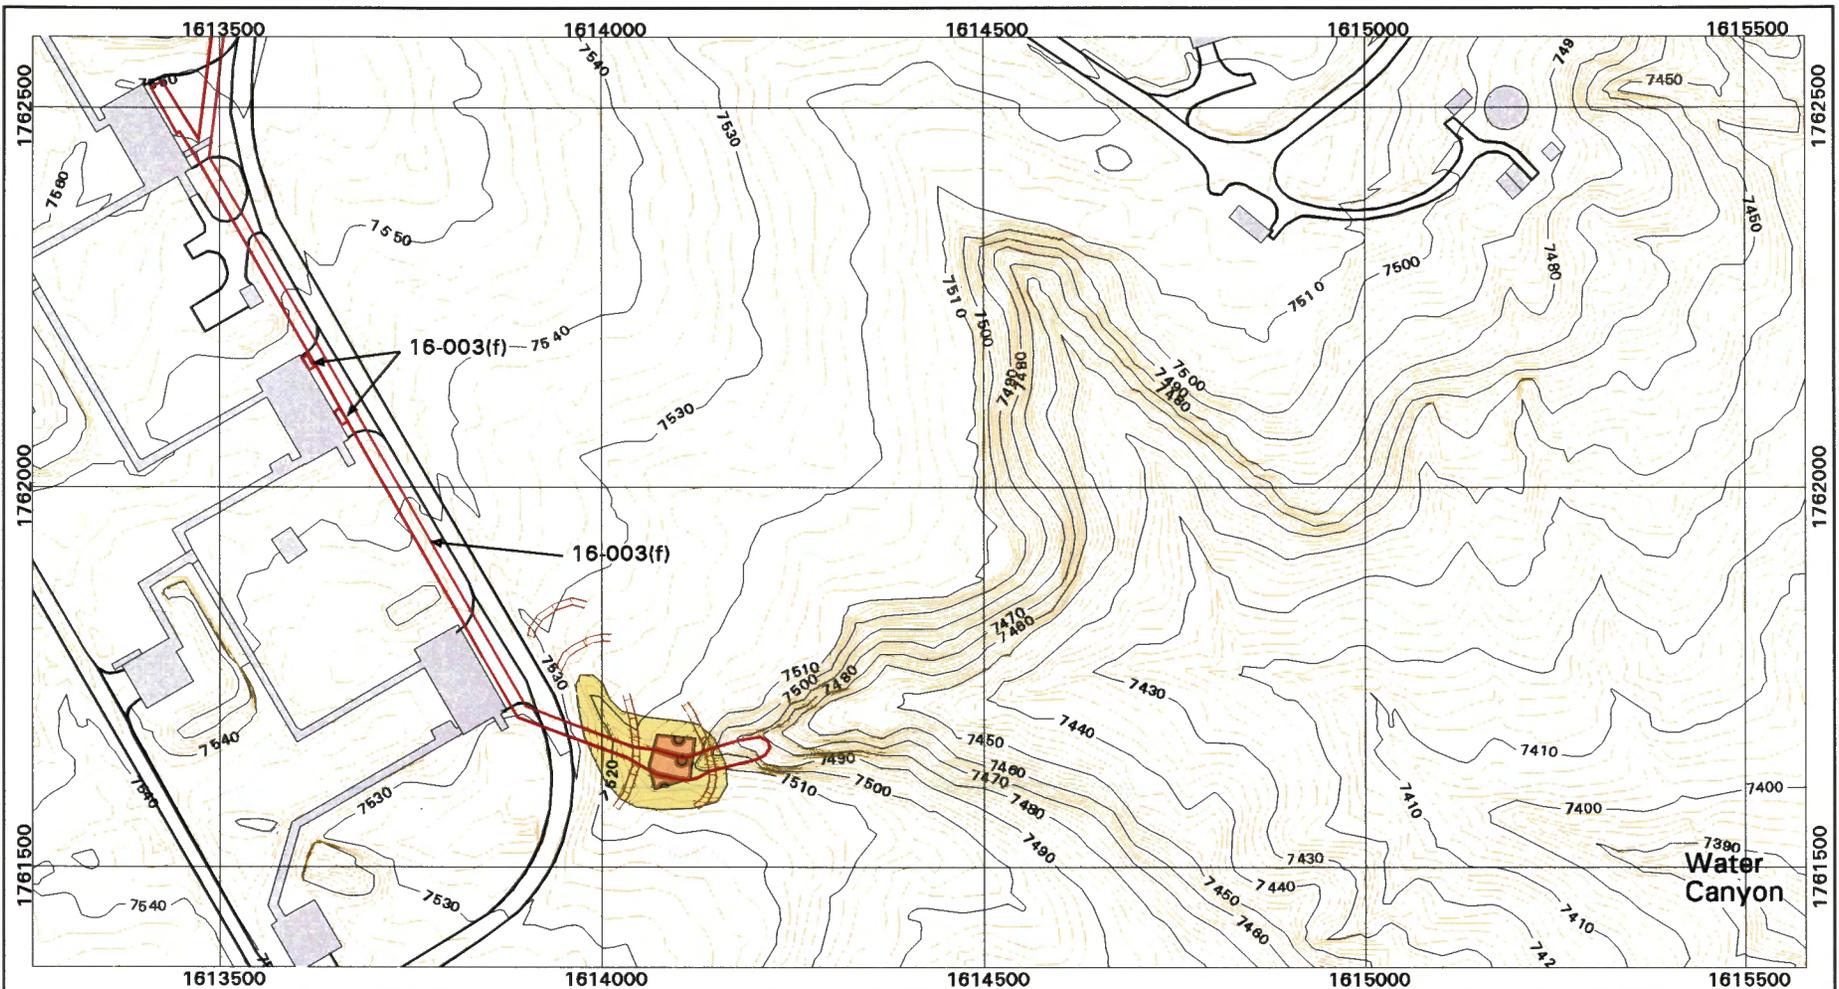
Best Management Practices at PRS 16-003(f)

Site is located in a small tributary drainage to Water Canyon within the S-Site Watershed Aggregate. Site has minor to moderate fire damage within the outfall drainage.

Site is in good condition, with vegetative cover of greater than 70%. The area appears stable with evidence of sediment migration being minimal.

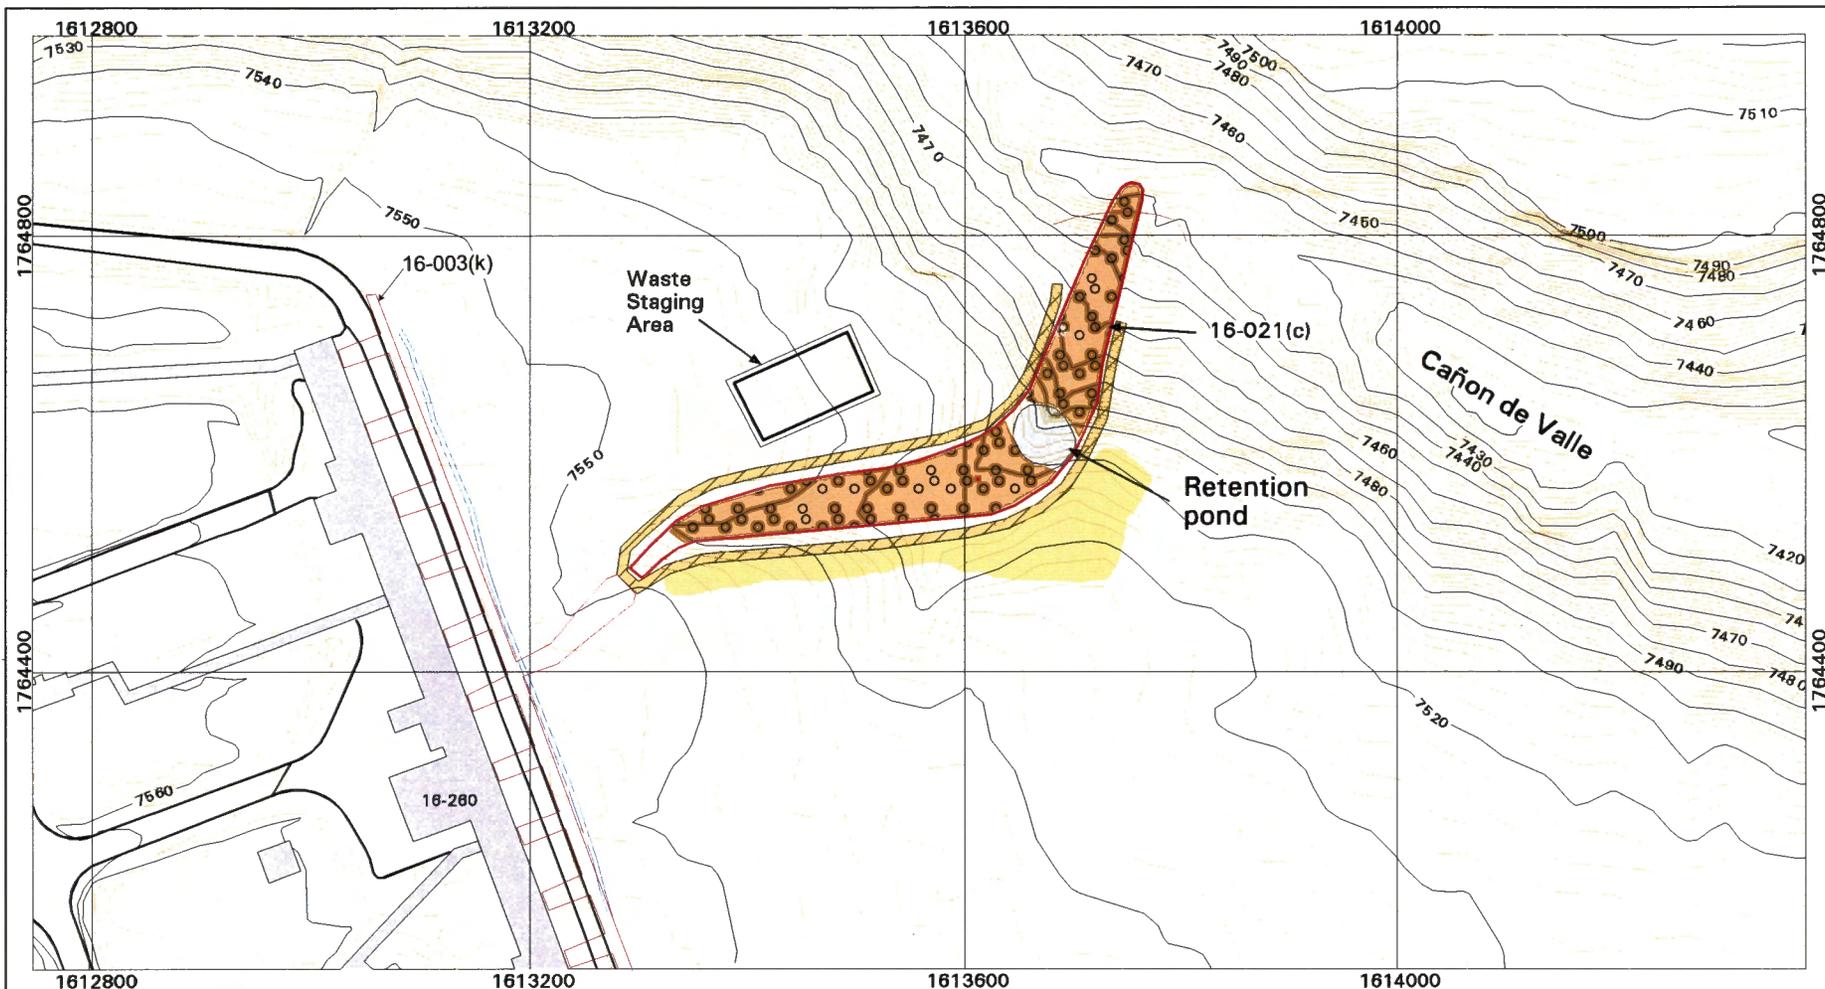
Best Management Practices at PRS 16-021(c)

This site is located in a tributary drainage of Canon de Valle within the Canon de Valle Watershed Aggregate. Burn damage is minor to moderate within the SWMU boundary. Heavy equipment on-site was not affected by the fire, although some hoses, drums and misc. equipment were damaged. The upper drainage pond was not burned. The lower drainage received minimal damage from the fire.

Site is in good condition, with vegetative cover of greater than 60% along the channel banks. The channel has been completely excavated of contaminated soil and river rock was placed to dissipate any future storm water runoff.

Straw barriers were replaced within the drainage channel and jute matting was installed to protect the exposed slopes. All excavated material remains covered with HDPE liners and is surrounded by an earthen berm. The storm water retention pond was unharmed and remains effective as a retention area.

An interim measure was recently completed at the site to remove several hundred cubic yards of HE contaminated soil from the drainage channel. The excavation is complete and site restoration activities are ongoing. The site will be inspected and maintained until final stabilization is completed.

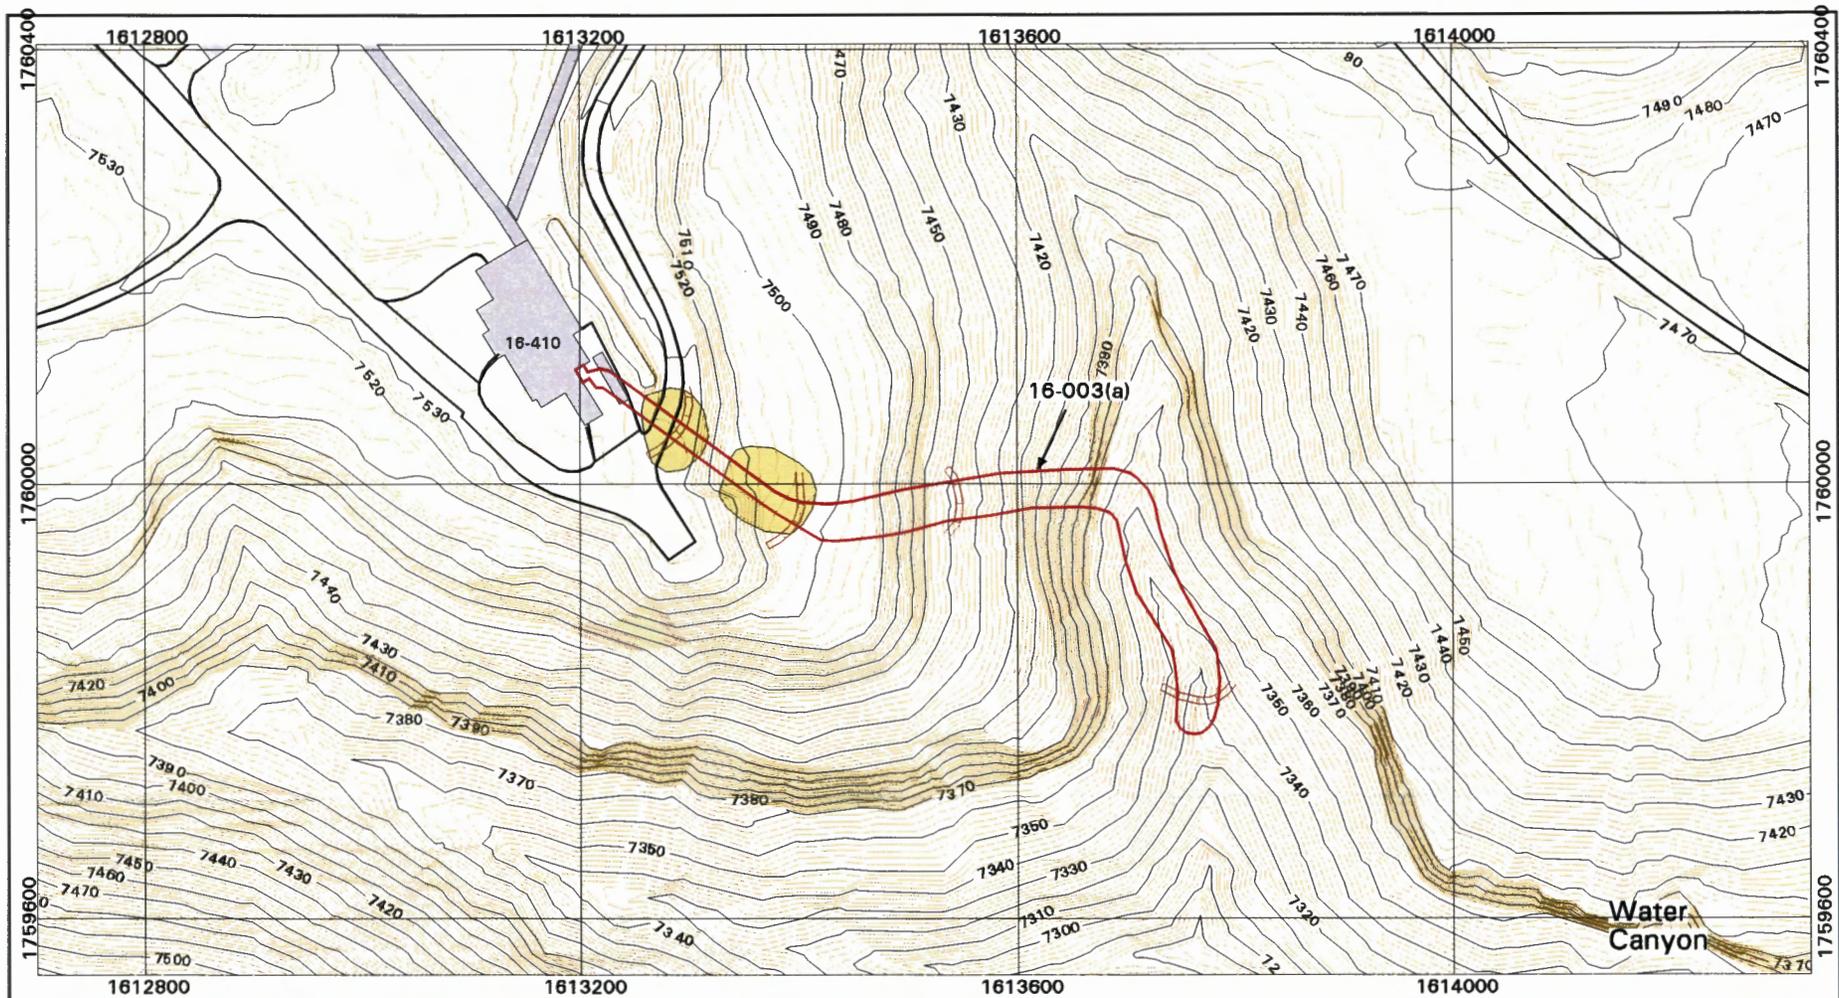
Best Management Practices at PRS 16-003(a)

Site is located near a tributary in upper Water Canyon within the Upper Water Canyon Watershed Aggregate. The site has minor to moderate fire damage within the outfall drainage.

Site is in good condition, with vegetative cover of greater than 70%. The area appears stable with evidence of sediment migration being minimal.

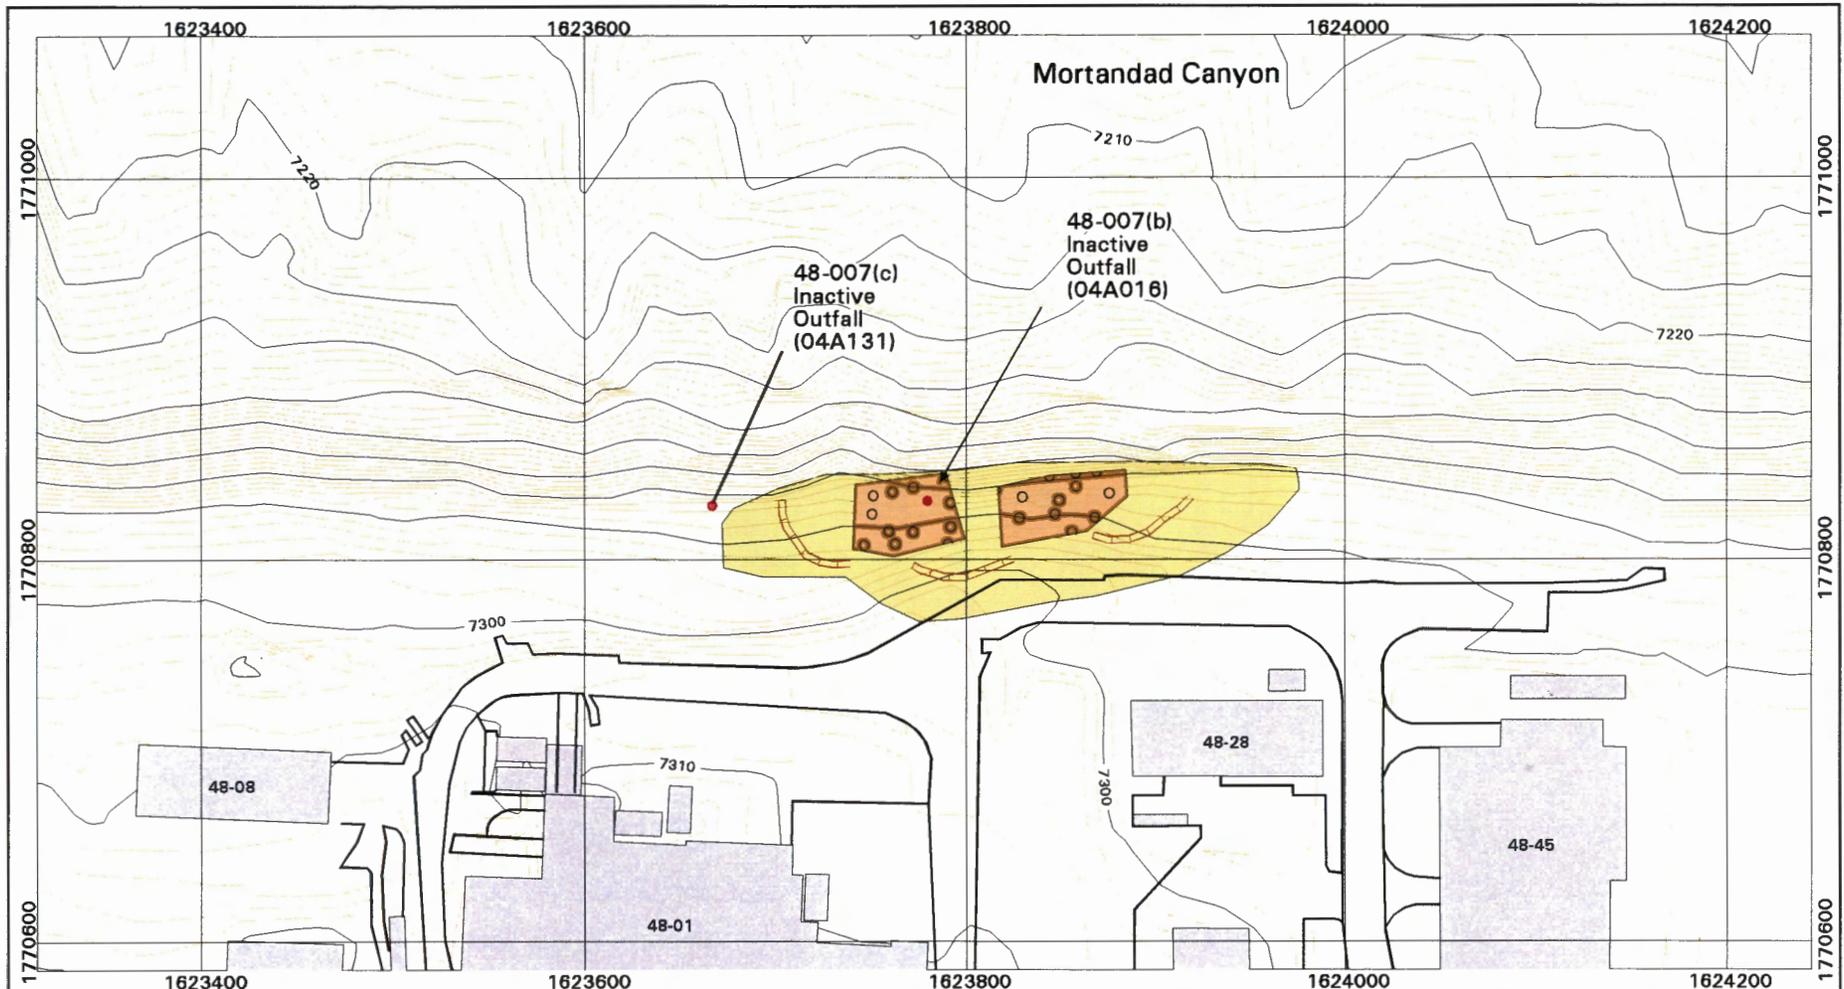
Best Management Practices at PRSs 48-007(b,c)

Site is in good condition, with vegetative cover of greater than 70%. The area appears stable with evidence of sediment migration being minimal.
