Title: CERRO GRANDE FIRE: ONE YEAR AFTER  
AN UPDATE ON ER ACTIVITIES TO REDUCE THE  
POTENTIAL MOVEMENT OF CONTAMINATION AT  
POTENTIAL RELEASE SITES

Author(s): Steven J. Veenis, CPESC  
Randy Johnson, IT Corporation

**CERRO GRANDE FIRE: ONE YEAR AFTER**  
**AN UPDATE ON ER ACTIVITIES TO REDUCE THE POTENTIAL MOVEMENT OF CONTAMINATION**  
**AT POTENTIAL RELEASE SITES**

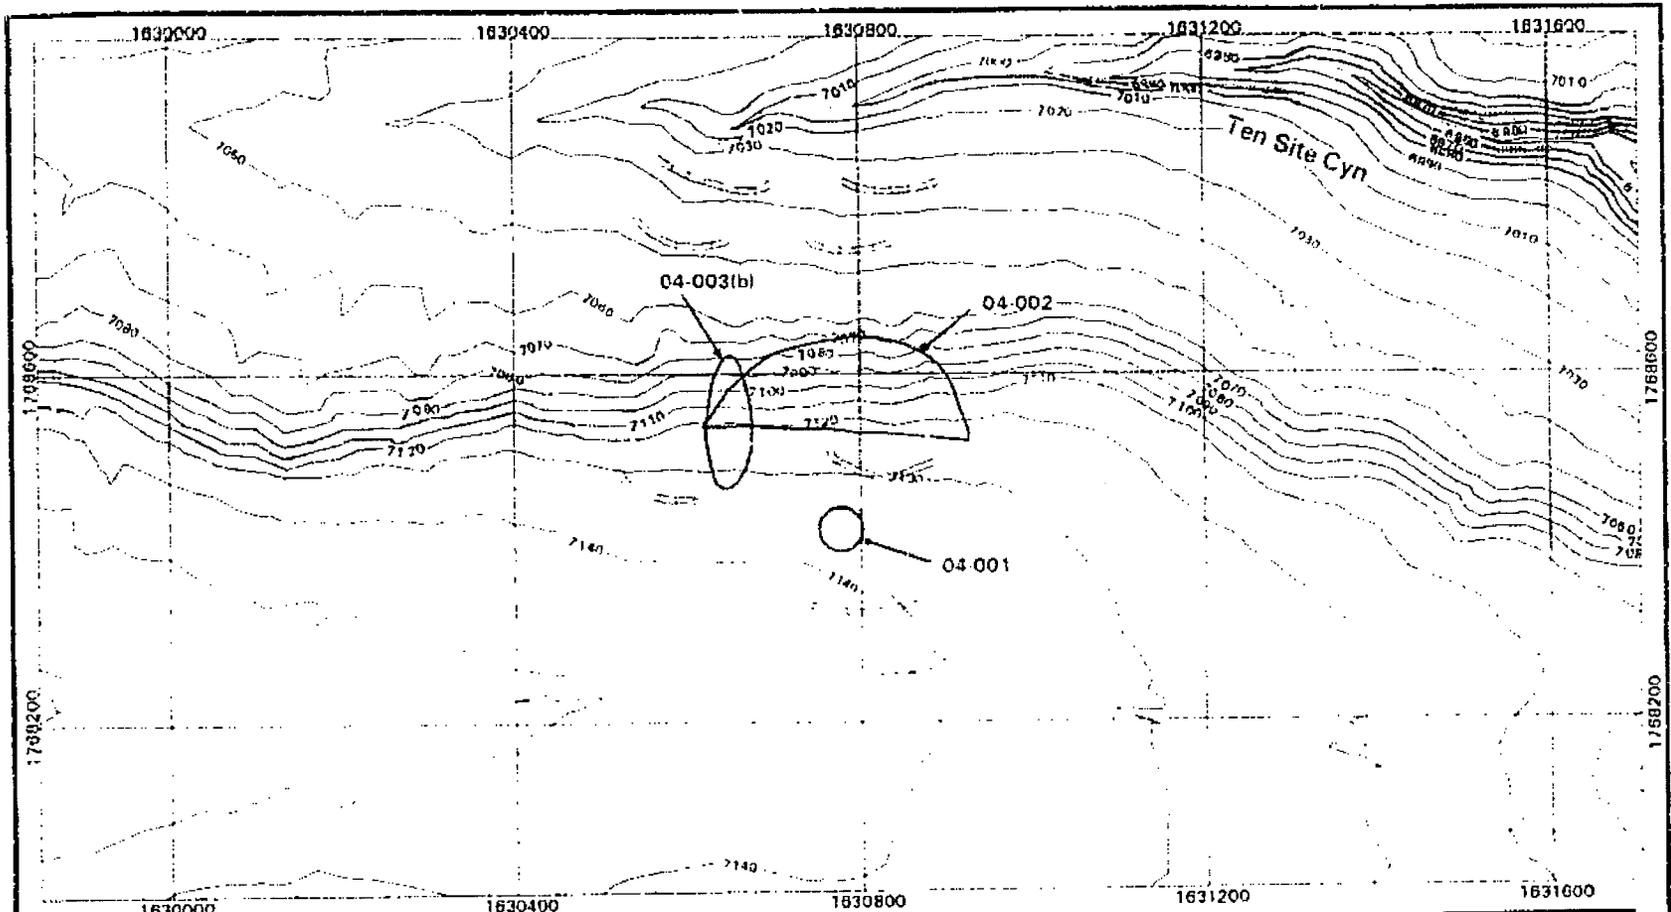
**Best Management Practices at PRSs 04-001, 04-002, 04-003(b)**

Site is in good condition, with vegetative cover of greater than 50%. The area appears stable with evidence of sediment migration being minimal.

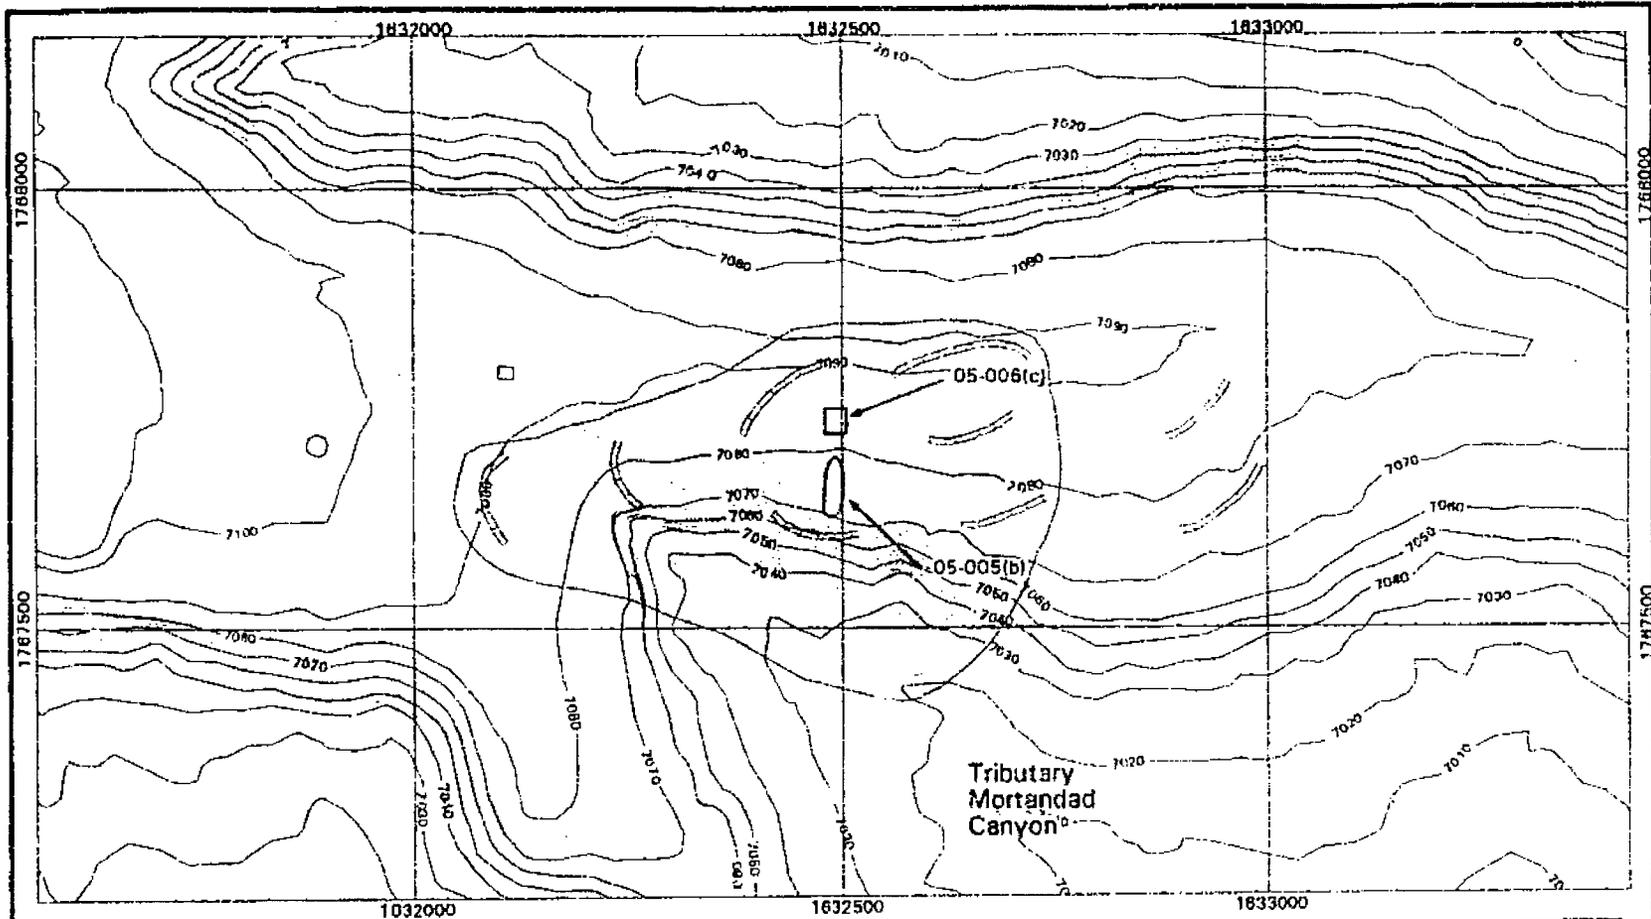
**Best Management Practices at PRSs 05-005(b) and 05-006(c)**

Site is in good condition, with vegetative cover of greater than 70%. Sediment migration is occurring in the steepest part of several drainage channels, but the straw wattles on the flatter bench appear to be keeping sediment from entering into Canada del Buey.

Maintenance consisted of installation of an additional 28 wattles throughout the site. A few more trees were felled within drainages and spot reseeding and mulch were applied.

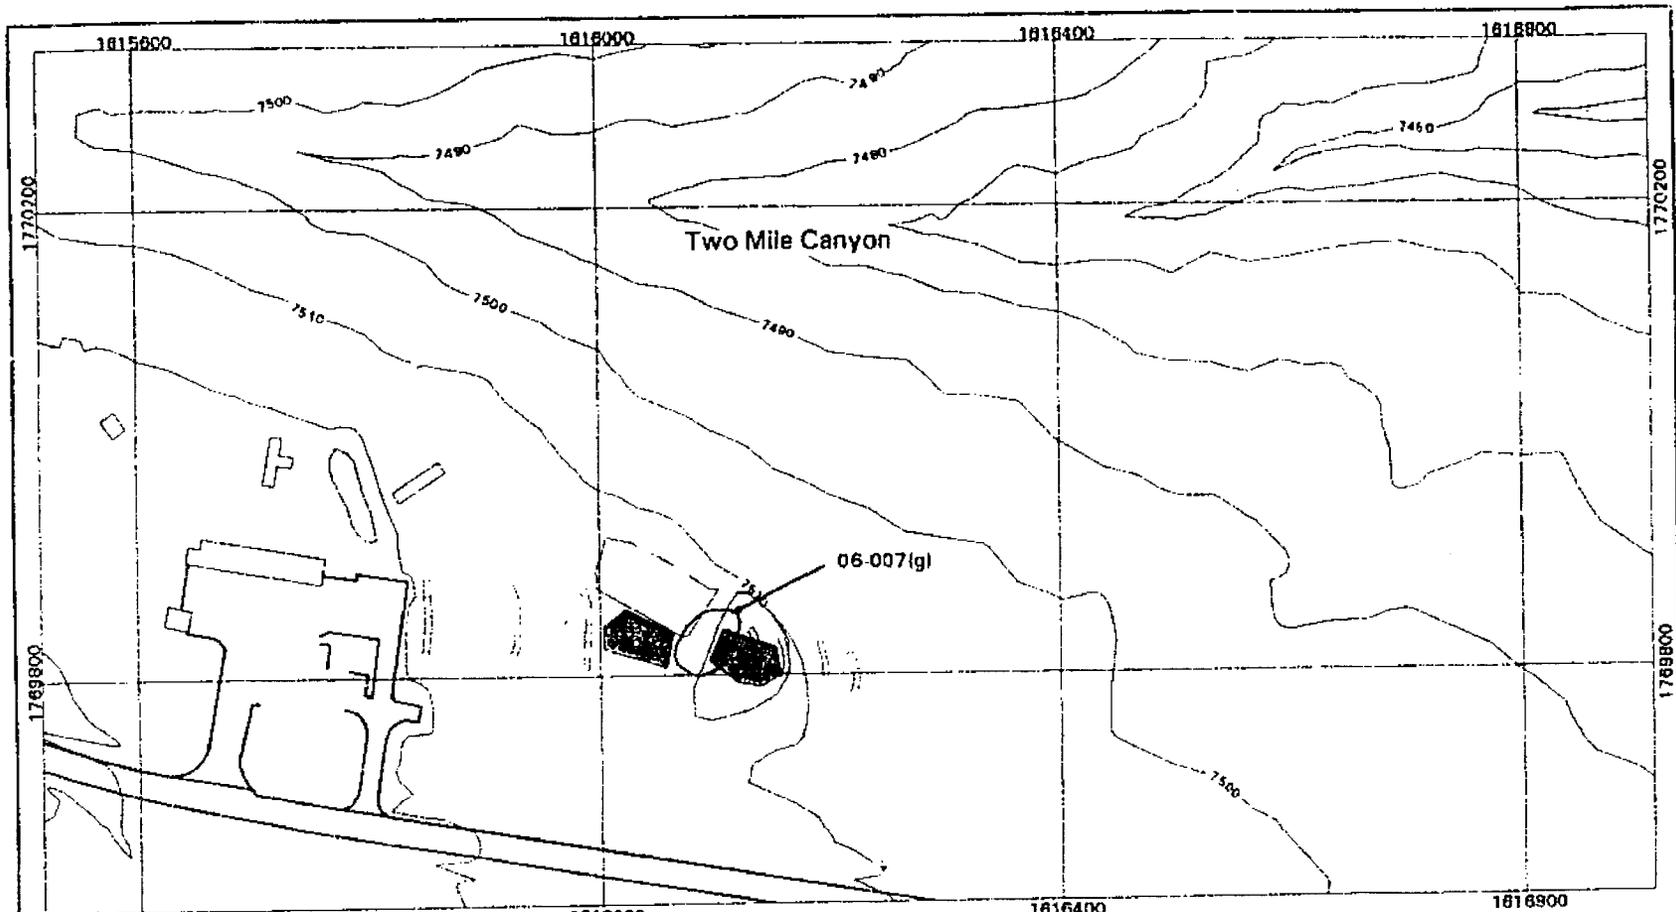
**Best Management Practices at PRS 06-007(g)**

Site is in good condition, with vegetative cover of greater than 70%. The area appears stable with evidence of sediment migration being minimal.

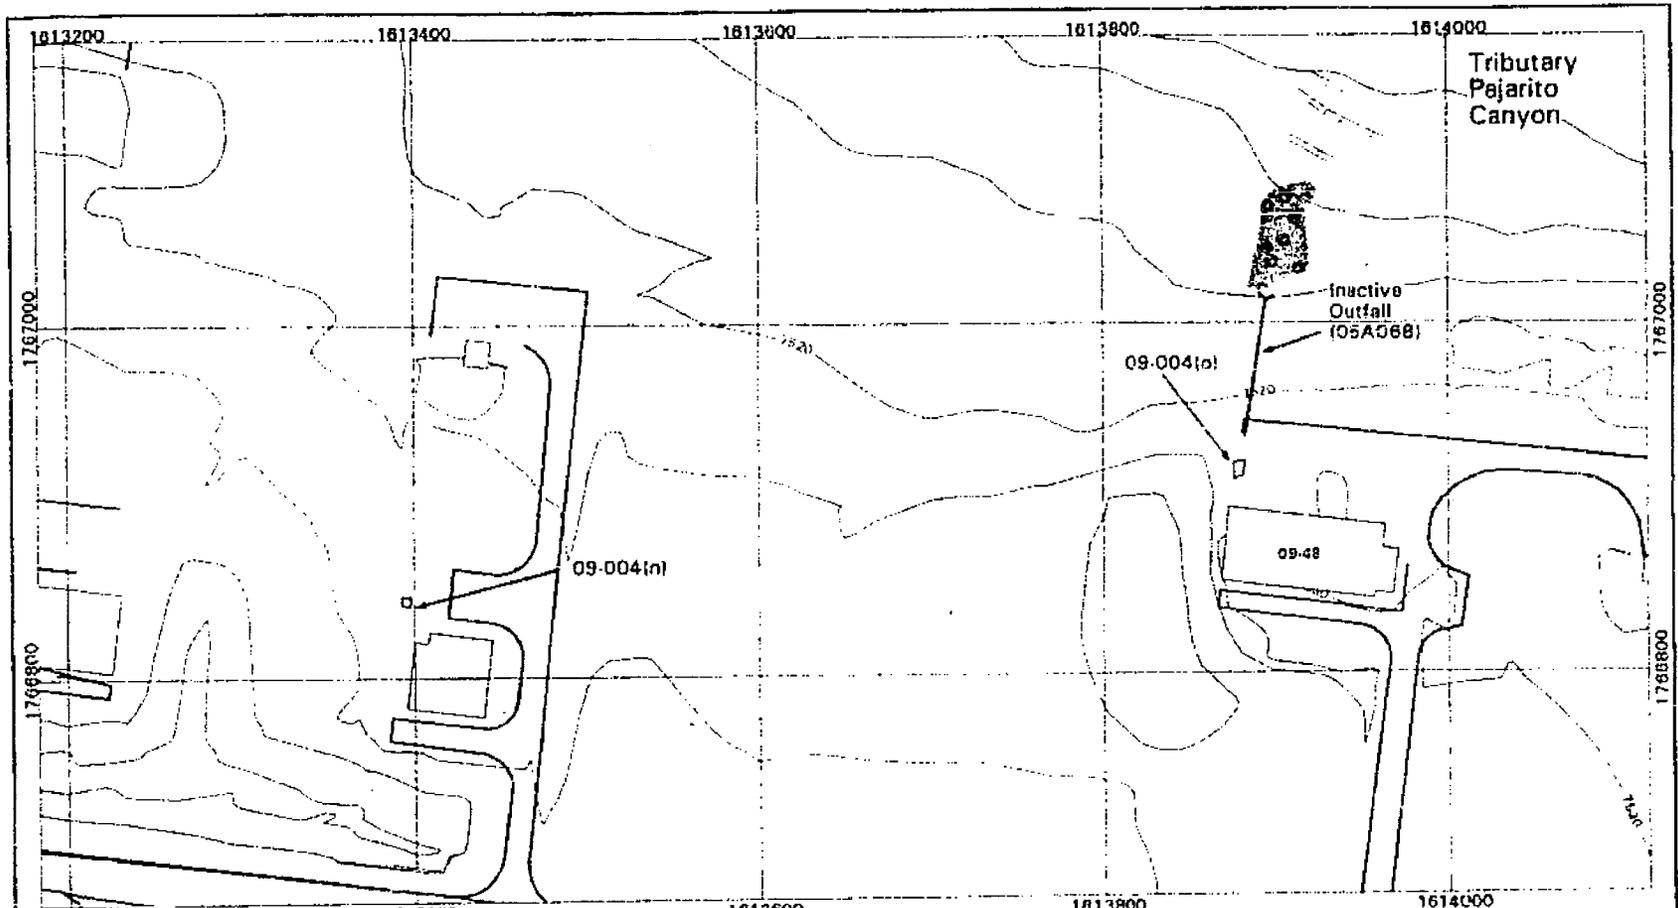
**Best Management Practices at PRSs 09-004(n,o)**

Site is in good condition, with vegetative cover of greater than 70%. The area appears stable with evidence of sediment migration being minimal.

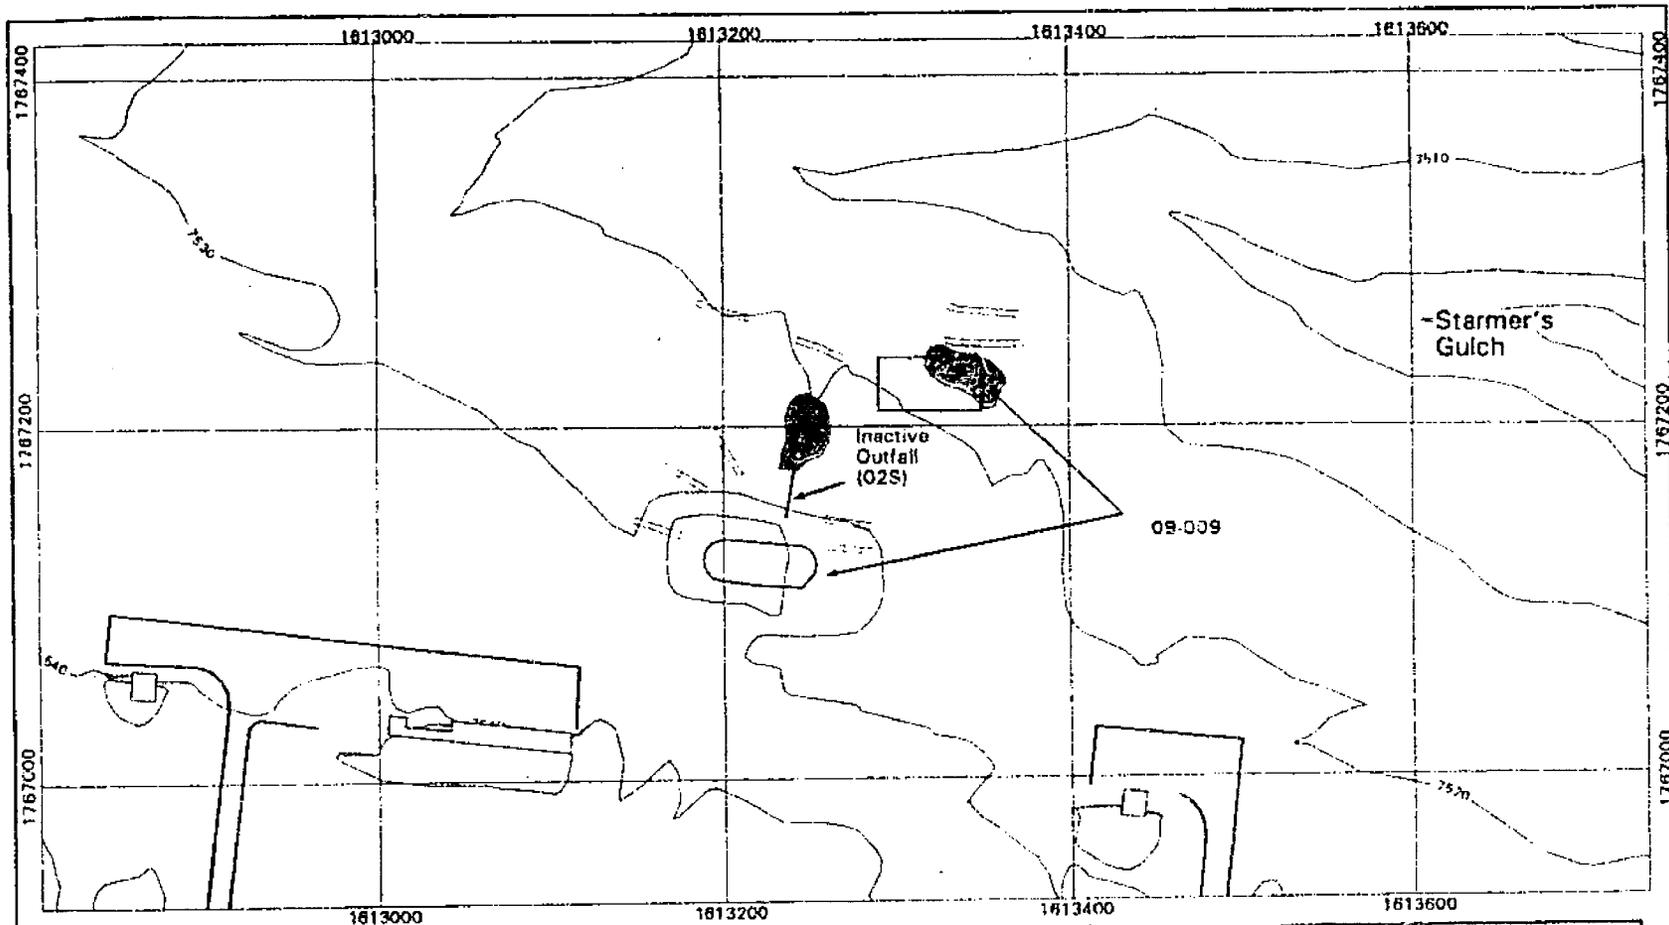
**Best Management Practices at PRS 09-009**

This site is located south of Pajarito Canyon within the Starmer/Upper Pajarito Watershed Aggregate. The PRS is the former Sanitary Wastewater Treatment Facility north of TA-9. Site has moderate fire damage with ground and canopy cover being impacted.

Site is in good condition, with vegetative cover of greater than 40%. The area appears stable with evidence of sediment migration being minimal.

Straw wattles were installed in the drainage swales and rock check dams were placed in the channels to dissipate flow (using existing materials found on-site). Watties were also provided upslope for run-on diversion.

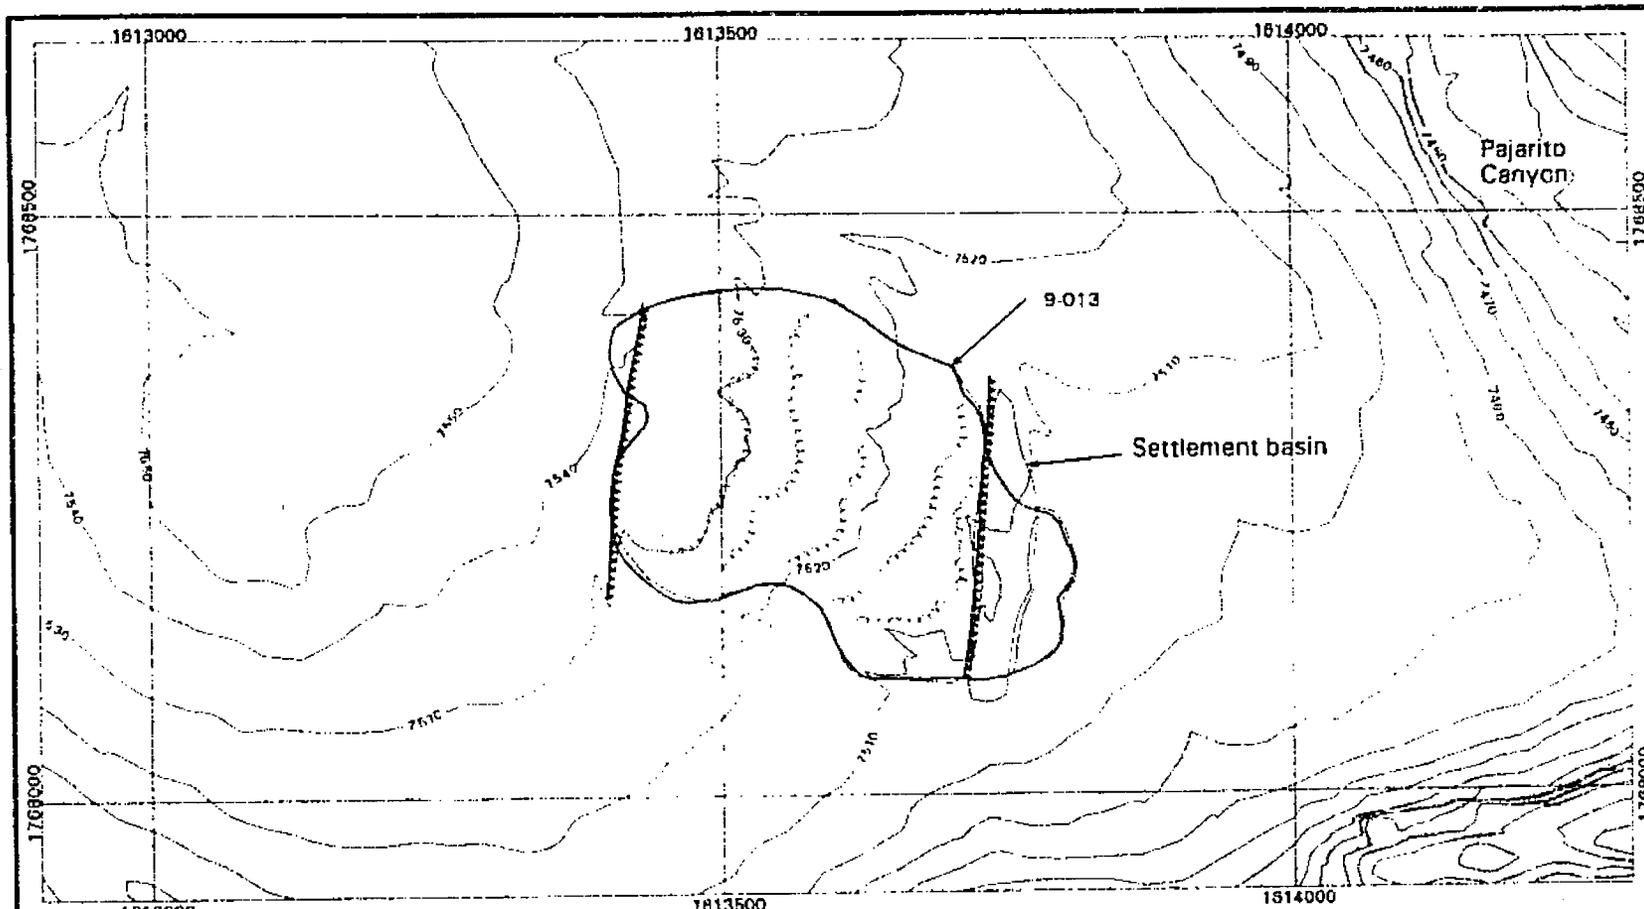
**Best Management Practices at PRS 09-013**

This site is located south of Pajarito Canyon within the Starmer/Upper Pajarito Watershed Aggregate. The area surrounding MDA M was moderately to severely burned as was a majority of the upper Pajarito Watershed. All of the existing erosion controls at the site were destroyed.

Site is in good condition, with vegetative cover of greater than 70%. The area appears stable with evidence of sediment migration being minimal.

Run-on controls were replaced as shown below. The entire site was hand raked, reseeded and mulched. A retention basin was installed at the bottom of the slope to create a "zero discharge" area.

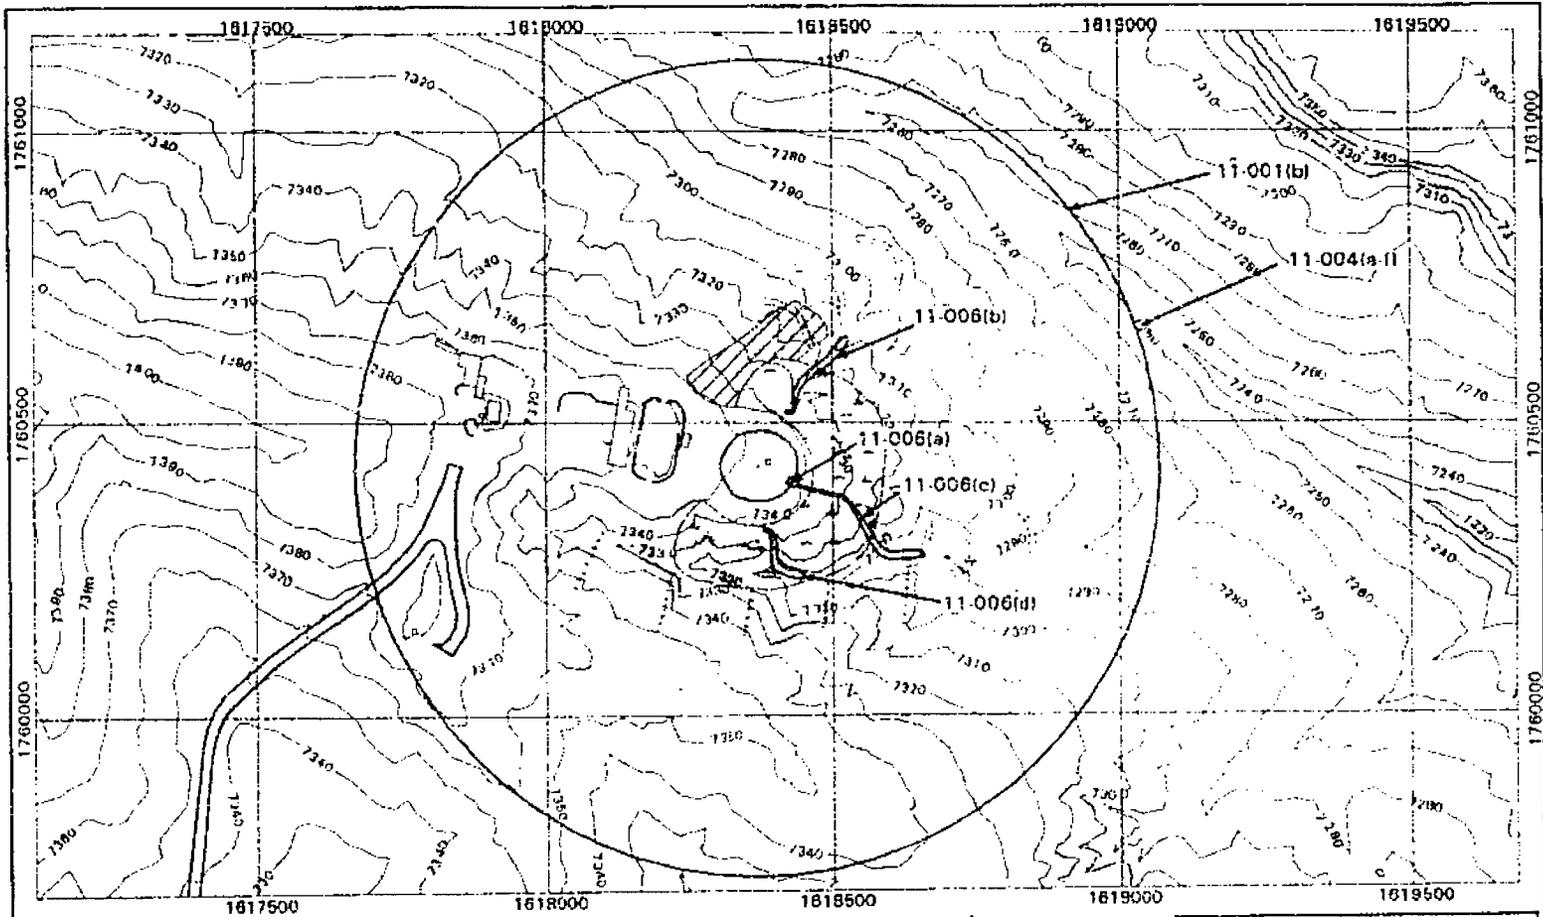
**Best Management Practices at PRS 11-001(b), 11-004(a-f), 11-006(a-d)**

This site is located north of Water Canyon within the S-Site Watershed Aggregate. The site has moderate to severe fire damage in the area surrounding the TA-11 Drop Tower. Log check dams within the major drainages received partial damage. All straw barriers installed around site were destroyed.

Site is in good condition, with vegetative cover of greater than 60%. The area appears stable with evidence of sediment migration being minimal.

The log check dams (on-site materials used) were replaced within the adjacent drainages. Straw watties were placed on the slopes and geotextile was installed in the areas with the most erosion potential. The area surrounding the Drop Tower was hydromulched to enhance the revegetation process.

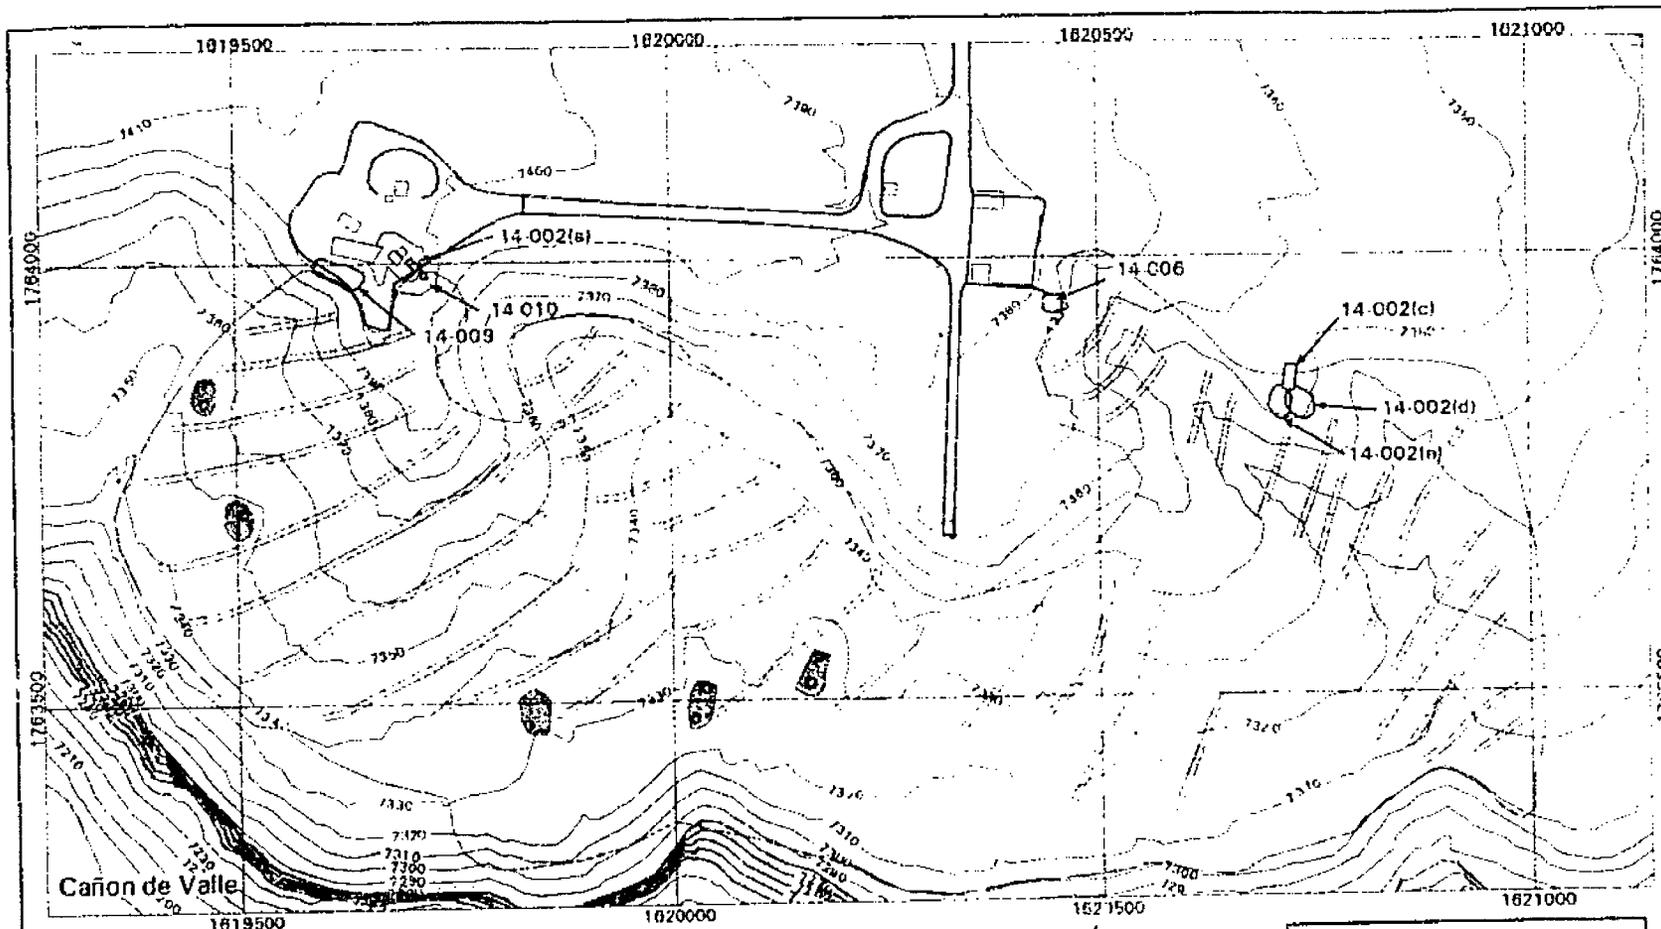
**Best Management Practices at PRSs 14-002(s,c-e), 14-006, 14-009, and 14-010**

This site is located north of Canon de Valle within the Canon de Valle Watershed Aggregate. The entire south facing slope located to the south of TA-14 structures was moderately burned with substantial damage to the groundcover.

Site is in good condition, with vegetative cover of greater than 70% throughout the site. The area appears stable with evidence of sediment migration being minimal.

Several more straw wattles were installed due to damage from wildlife.

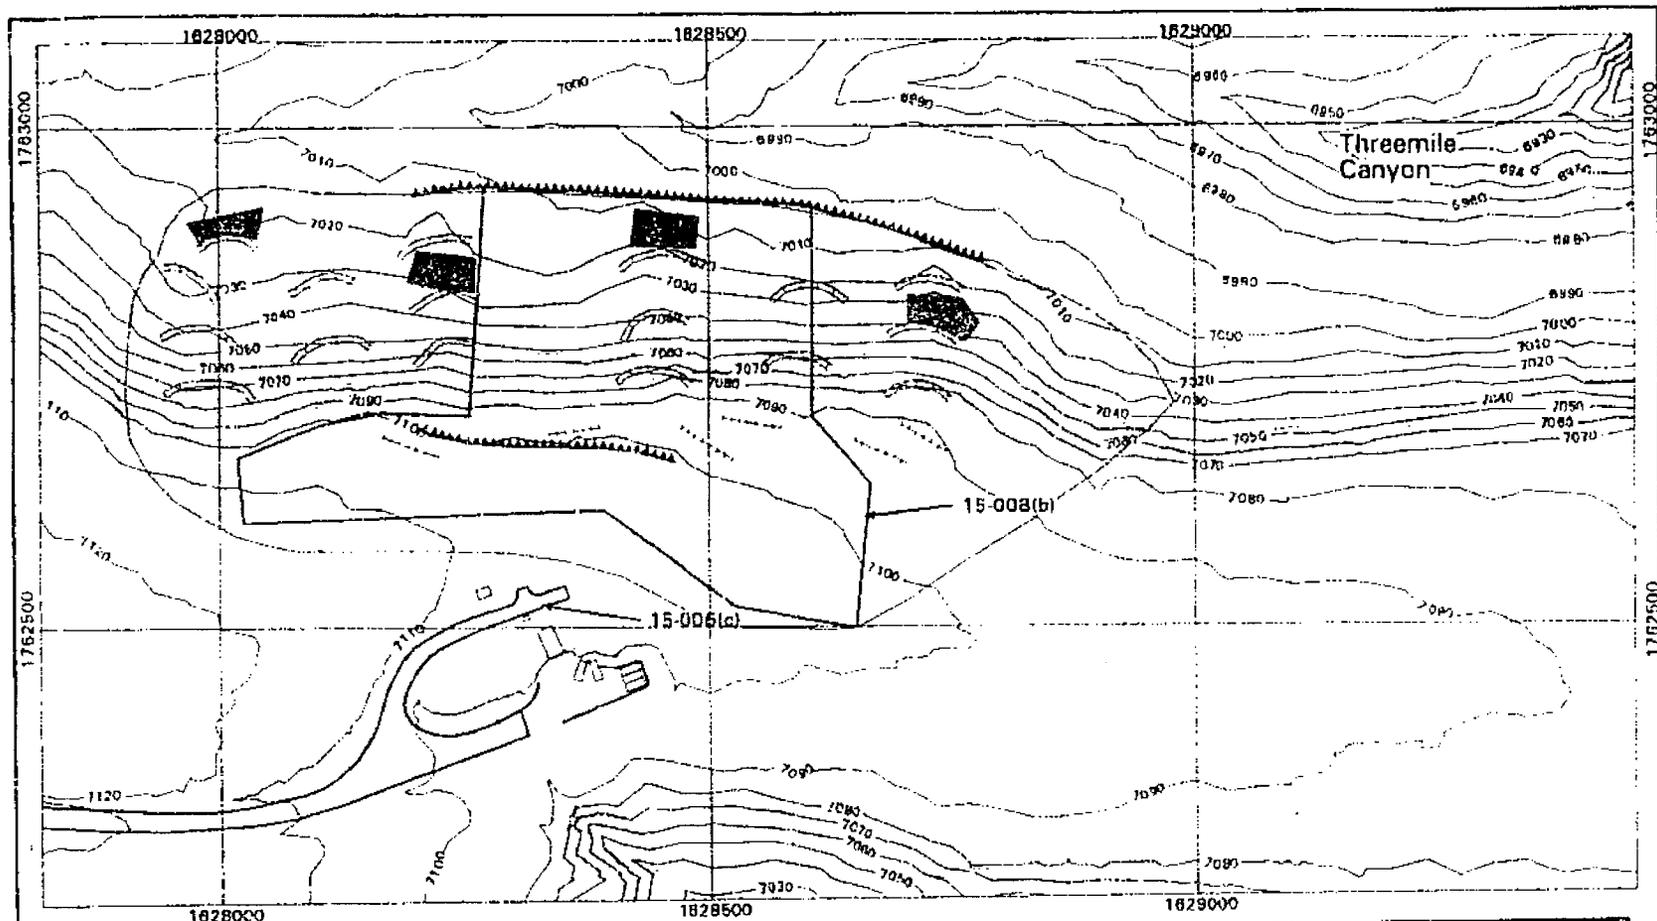
**Best Management Practices at PRSs 15-006(c) and 15-008(b) (R-44)**

This site is located on the south rim of Three Mile Canyon within the Three Mile Watershed Aggregate. 15-006(c) has moderate to severe burn damage with most of the damage adjacent to the former R-44 Firing Pad. A large amount of firing site related debris has been exposed throughout the site (especially towards the east).

Over 20 cubic yards of firing site debris was removed from the surrounding area. Site is in good condition, with vegetative cover of greater than 70%. The area appears stable with evidence of sediment migration being minimal.

Straw wattles, rock check dams and silt fencing were installed throughout the burned areas. The area was then hydromulched to enhance the revegetation process.

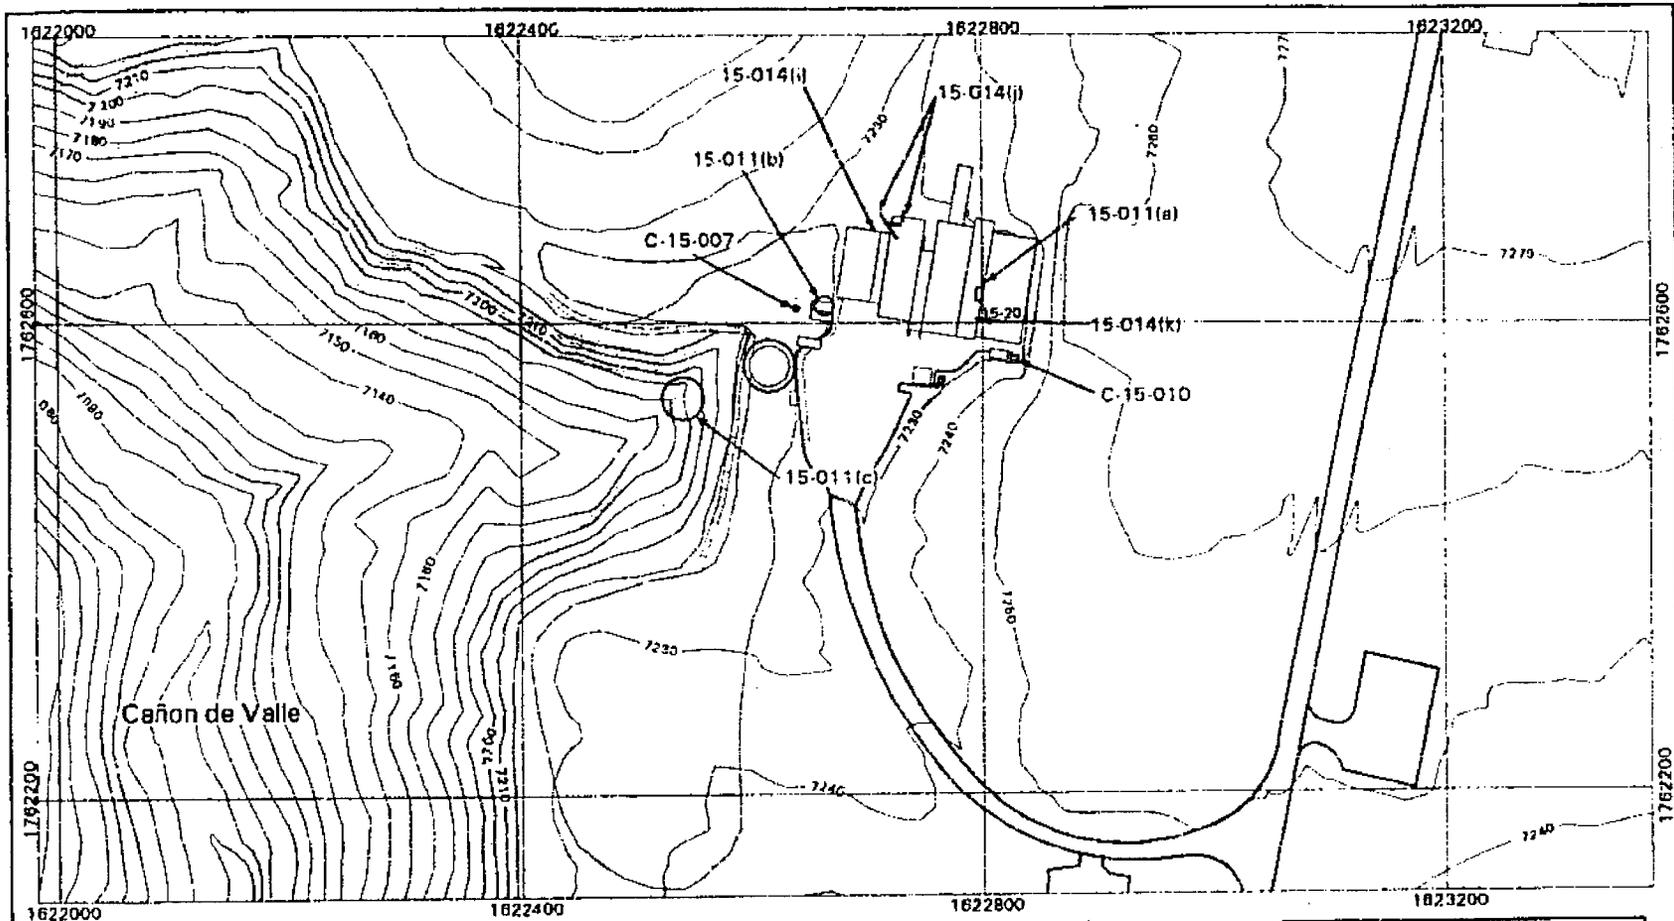
**Best Management Practices at FRSs 15-011(a-c), 15-014(i-k), C-15-007, and C-15-010**

This site is located near the confluence of Canon de Valle and Water Canyon within the Canon de Valle Watershed Aggregate. The site was moderately to severely damaged including several burned structures.

Site is in good condition, with vegetative cover of greater than 70%. The area appears stable with evidence of sediment migration being minimal.

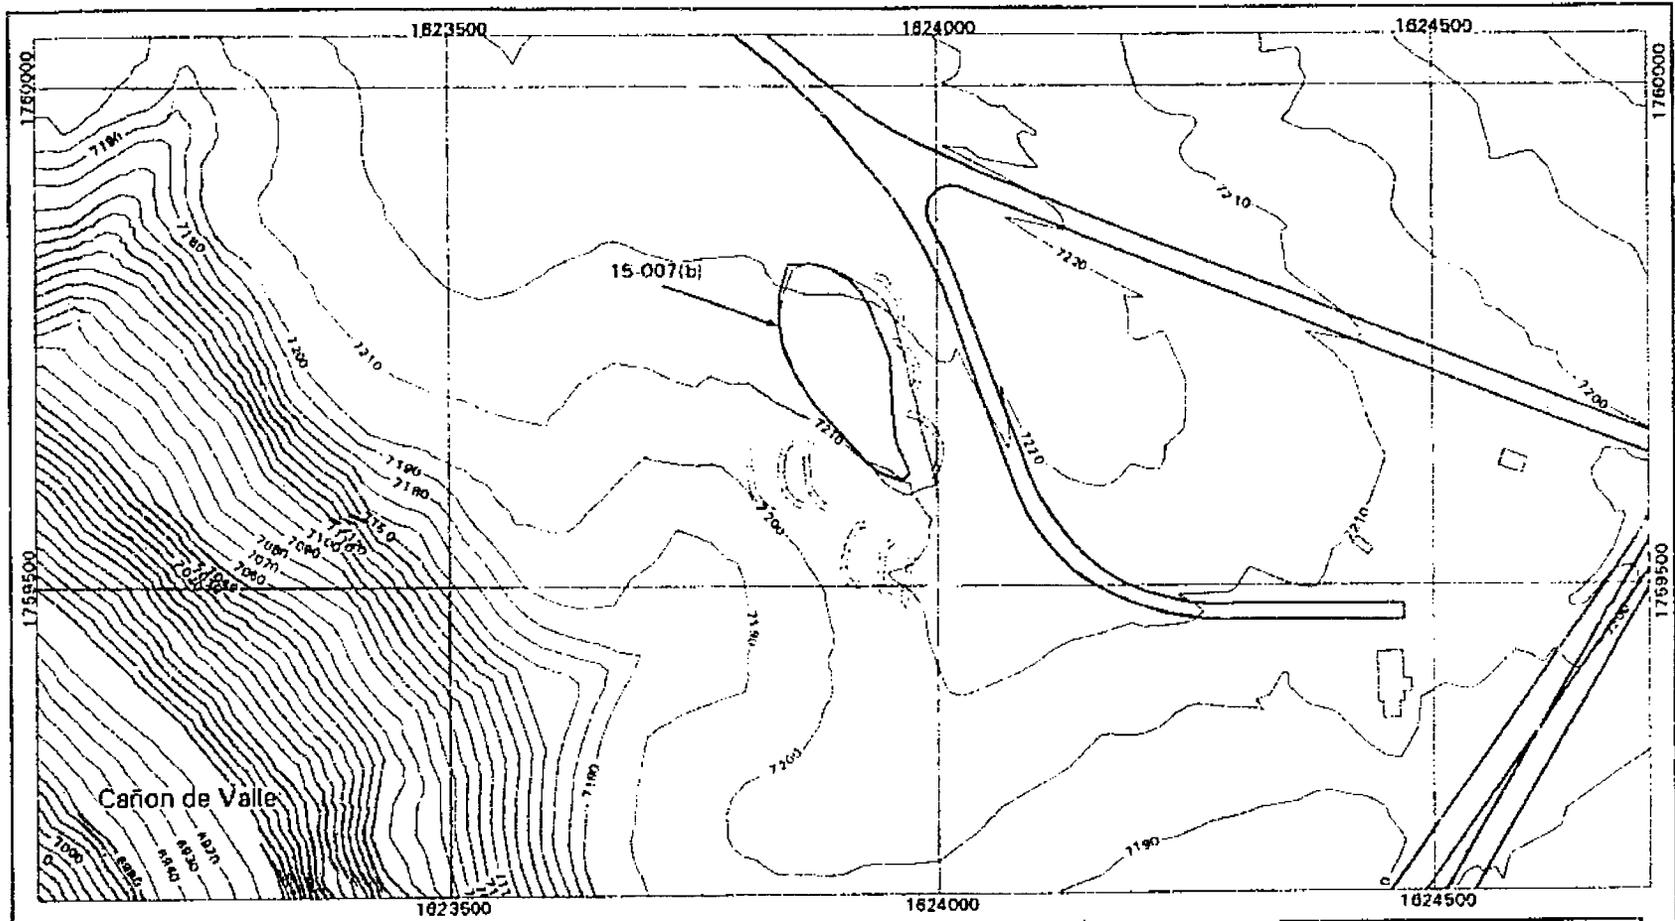
**Best Management Practices at PRSs 15-007(b)**

This site is located near the confluence of Canon de Valle and Water Canyon within the Canon de Valle Watershed Aggregate. The area received minor burn damage primarily to the ground cover.

Site is in good condition, with vegetative cover of greater than 50%. The area appears stable with evidence of sediment migration being minimal.

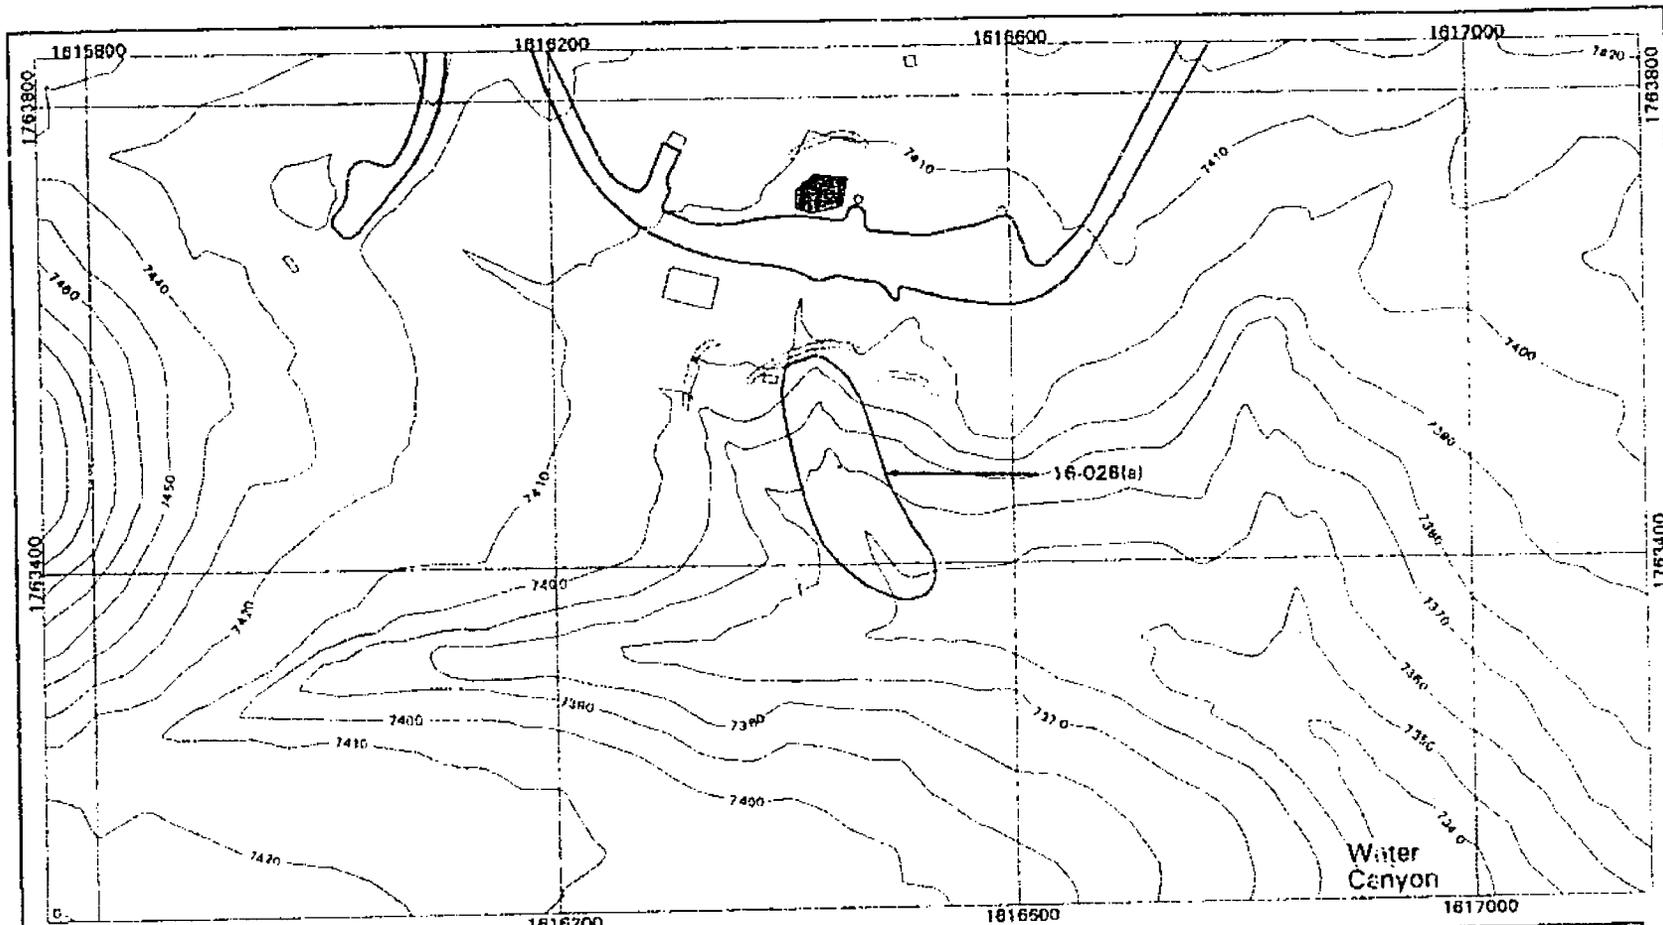
**Best Management Practices at PRS 16-028(a)**

This site is located near a tributary of Water Canyon within the Canon de Valle Watershed Aggregate. The site has minimal fire damage to the west and south. Some minor burning occurred within the SWMU boundary, but consisted mostly of destroyed grasses. The HEWTF remains operational.

Site is in good condition, with vegetative cover of greater than 50%. The area appears stable with evidence of sediment migration being minimal.

Straw barriers and rock check dams (existing materials found on site) were placed within the drainage swale to reduce sediment transport potential.

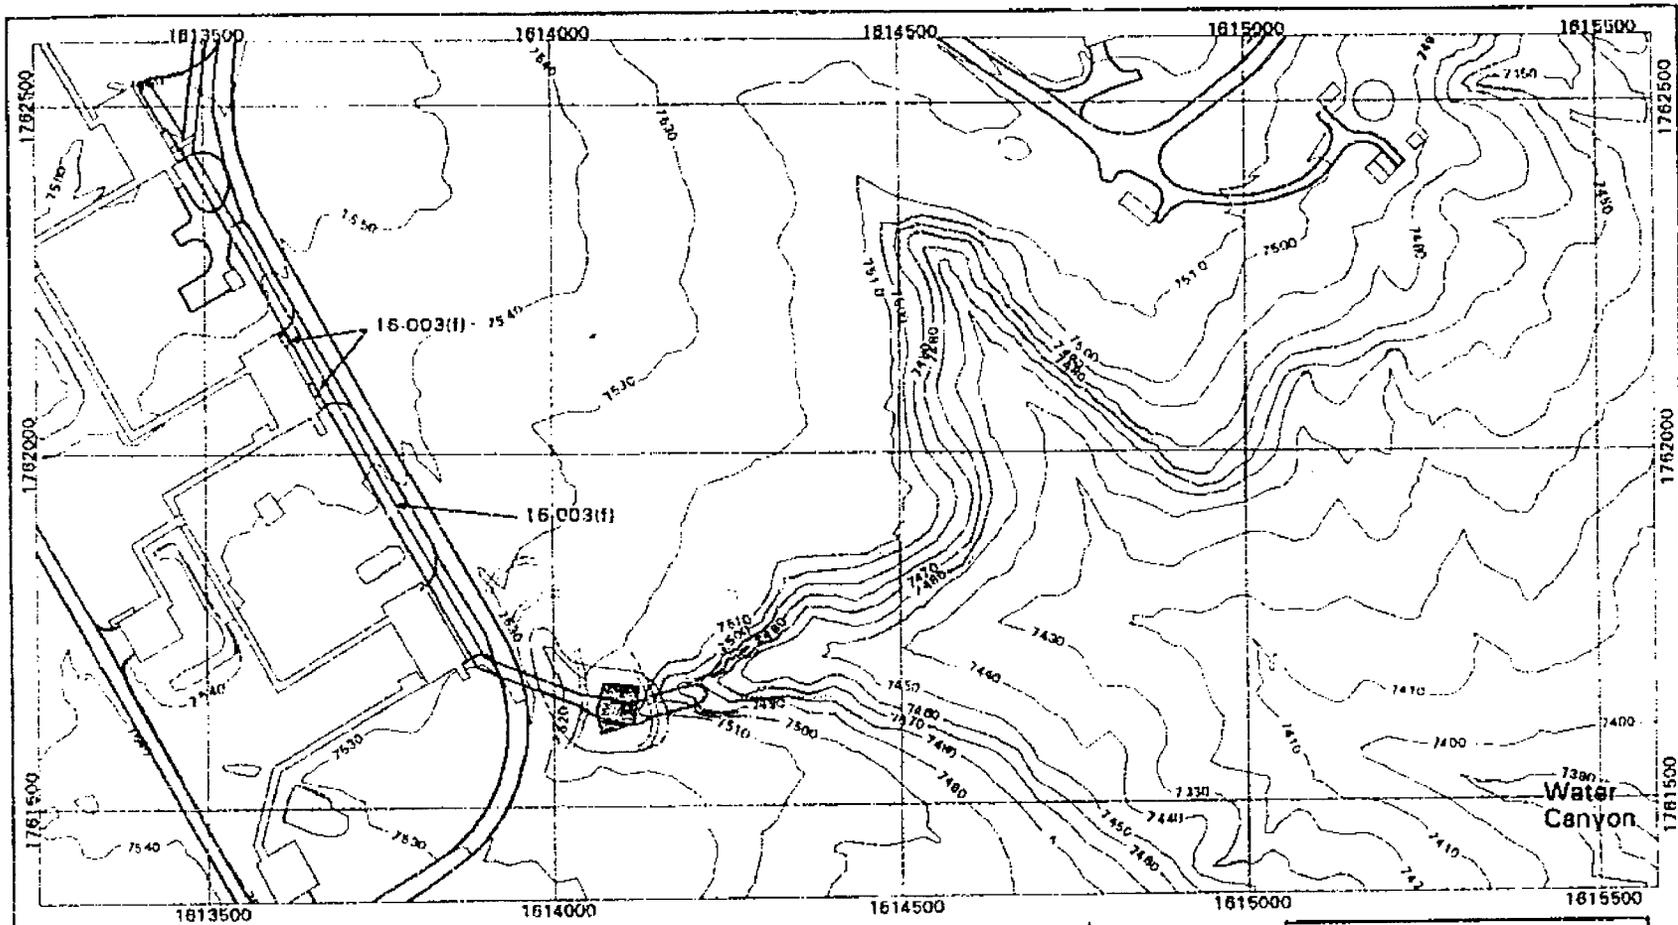
**Best Management Practices at PRS 16-003(f)**

Site is located in a small tributary drainage to Water Canyon within the S-Site Watershed Aggregate. Site has minor to moderate fire damage within the outfall drainage.

Site is in good condition, with vegetative cover of greater than 70%. The area appears stable with evidence of sediment migration being minimal.
