Title: CERRO GRANDE FIRE: ONE YEAR AFTER  
AN UPDATE ON ER ACTIVITIES TO REDUCE THE  
POTENTIAL MOVEMENT OF CONTAMINATION AT  
POTENTIAL RELEASE SITES

Author(s): Steven J. Veenis, CPESC  
Randy Johnson, IT Corporation

**CERRO GRANDE FIRE: ONE YEAR AFTER**  
**AN UPDATE ON ER ACTIVITIES TO REDUCE THE POTENTIAL MOVEMENT OF CONTAMINATION**  
**AT POTENTIAL RELEASE SITES**

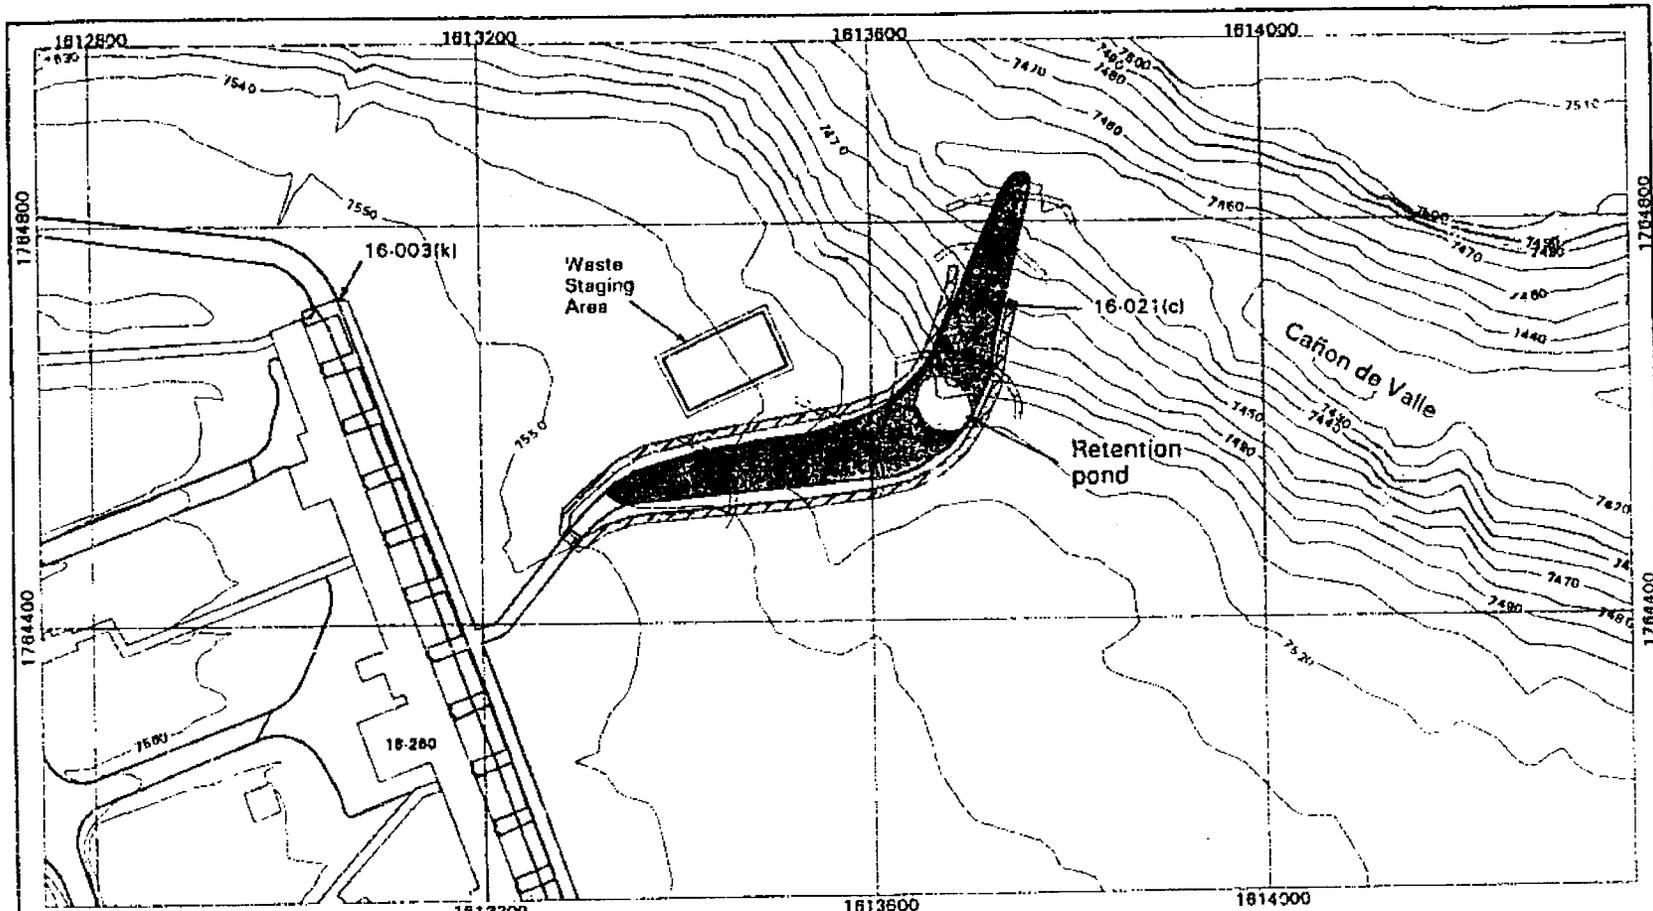
**Best Management Practices at PRS 16-021(c)**

This site is located in a tributary drainage of Canon de Valle within the Canon de Valle Watershed Aggregate. Burn damage is minor to moderate within the SWMU boundary. Heavy equipment on-site was not affected by the fire, although some hoses, drums and misc. equipment were damaged. The upper drainage pond was not burned. The lower drainage received minimal damage from the fire.

Site is in good condition, with vegetative cover of greater than 60% along the channel banks. The channel has been completely excavated of contaminated soil and river rock was placed to dissipate any future storm water runoff.

Straw barriers were replaced within the drainage channel and jute matting was installed to protect the exposed slopes. All excavated material remains covered with HDPE liners and is surrounded by an earthen berm. The storm water retention pond was unharmed and remains effective as a "zero discharge" BMP.

An interim measure was recently completed at the site to remove several hundred cubic yards of HE contaminated soil from the drainage channel. The excavation is complete and site restoration activities are ongoing. The site will be inspected and maintained until final stabilization is completed.

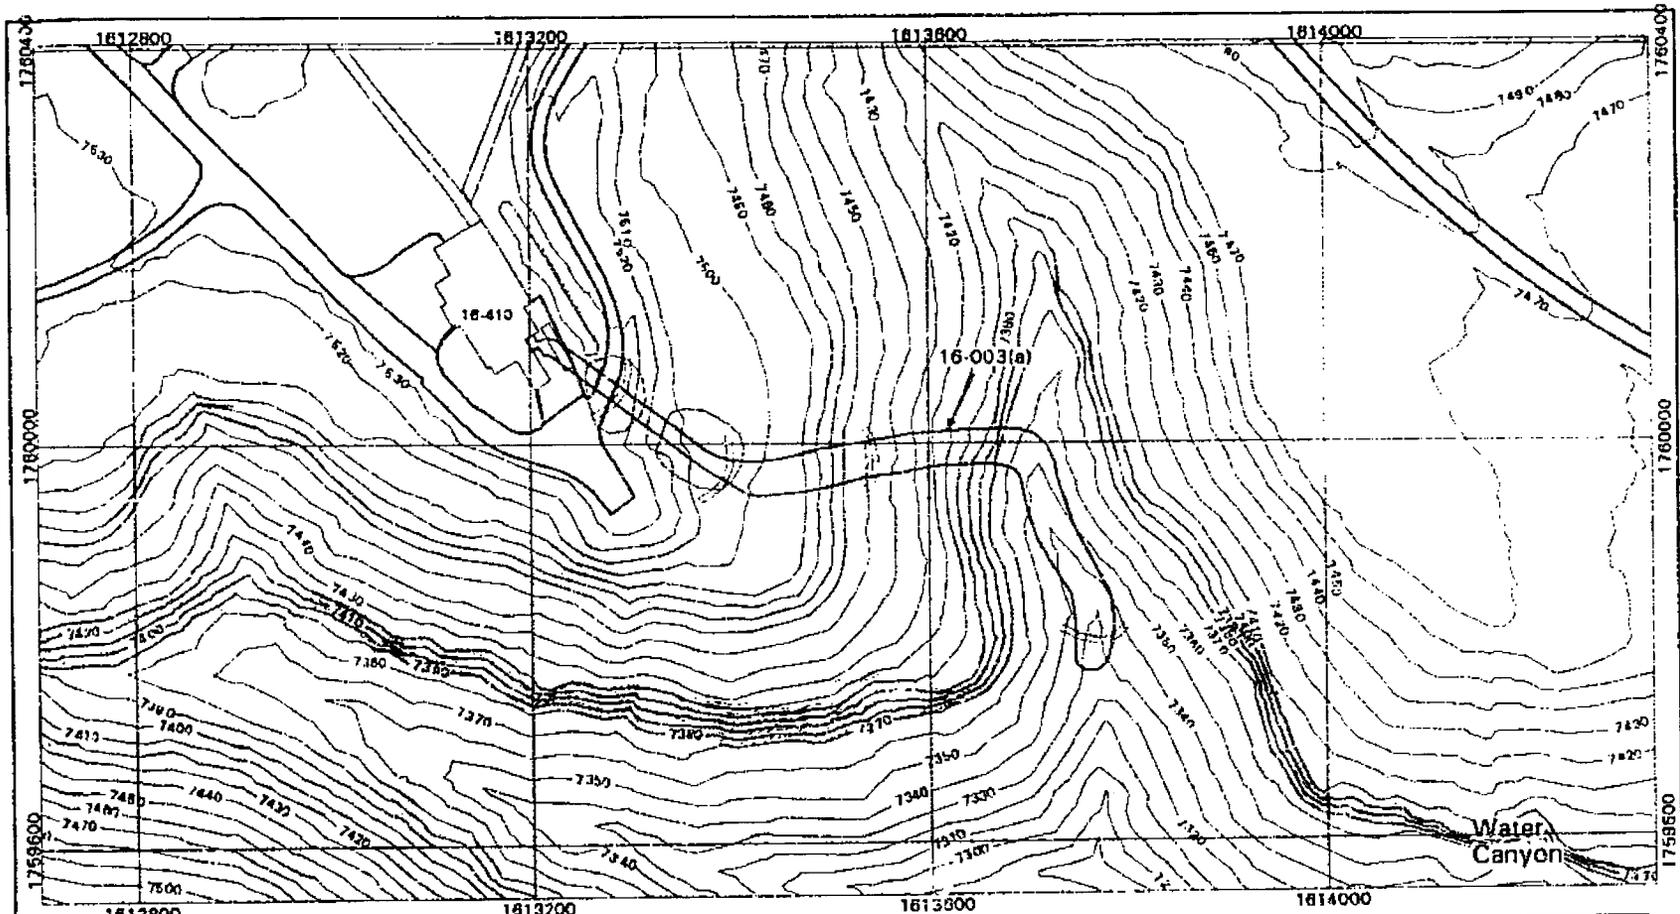
**Best Management Practices at PRS 16-003(a)**

Site is located near a tributary in upper Water Canyon within the Upper Water Canyon Watershed Aggregate. The site has minor to moderate fire damage within the outfall drainage.

Site is in good condition, with vegetative cover of greater than 70%. The area appears stable with evidence of sediment migration being minimal.
