CHARACTERIZATION REPORT
FOR
THE DECONTAMINATION AND DECOMMISSIONING
OF
TECHNICAL AREA 3
BUILDINGS 36, 224 AND 1233
FOR
LOS ALAMOS NATIONAL LABORATORY

CHARACTERIZATION REPORT
FOR
BUILDINGS 36, 224 AND 1233
AT
TECHNICAL AREA 3
LOS ALAMOS NATIONAL LABORATORY
FOR
DECONTAMINATION & DECOMMISSIONING
GROUP

March 1999

ICF Kaiser Engineers, Inc.
235 Central Park Square
Los Alamos, NM 87544

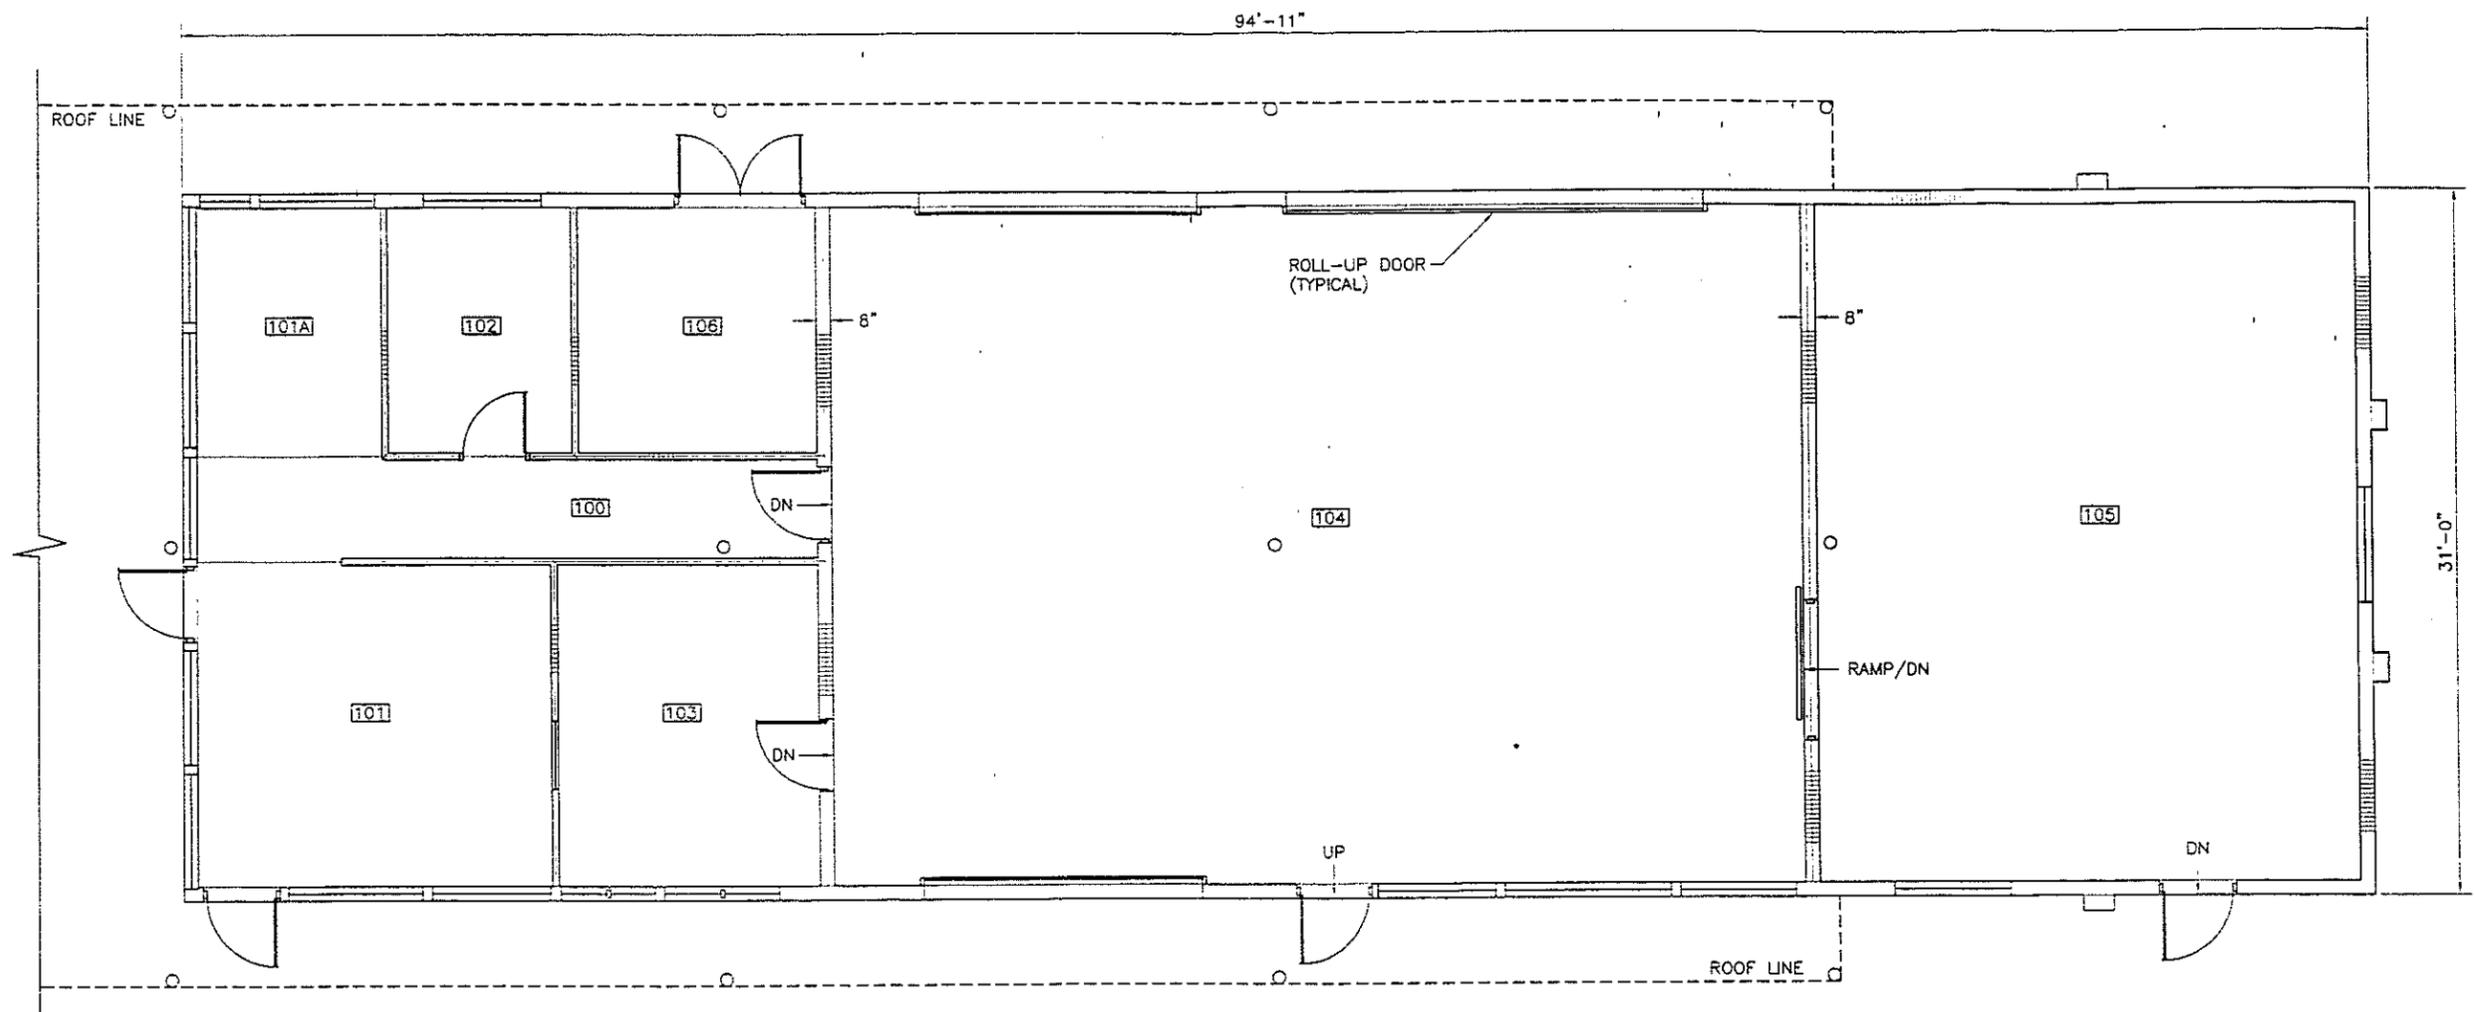
FIGURE 3

Building TA-3-36 was built in 1952 and served as a gas and service station for Los Alamos National Laboratory (LANL) until the late 1990's when it was slated for decommissioning. As originally designed, the "Motor Pool" floor plan consisted of five principle rooms including an office space with a service counter in the far north end of the building, a stock room, lavatory, utility room and a large service room at the south end of the building occupying a total area of approximately 2,945 gross square feet. The north end of the building was used as office space after the pumps were removed. A flammable liquid storeroom, which now serves as a lunch room and storage area of approximately 744 gross square feet, was added after 1952 but before 1983. A sliding gate connects the original section of the building with the addition. (Figure 3)

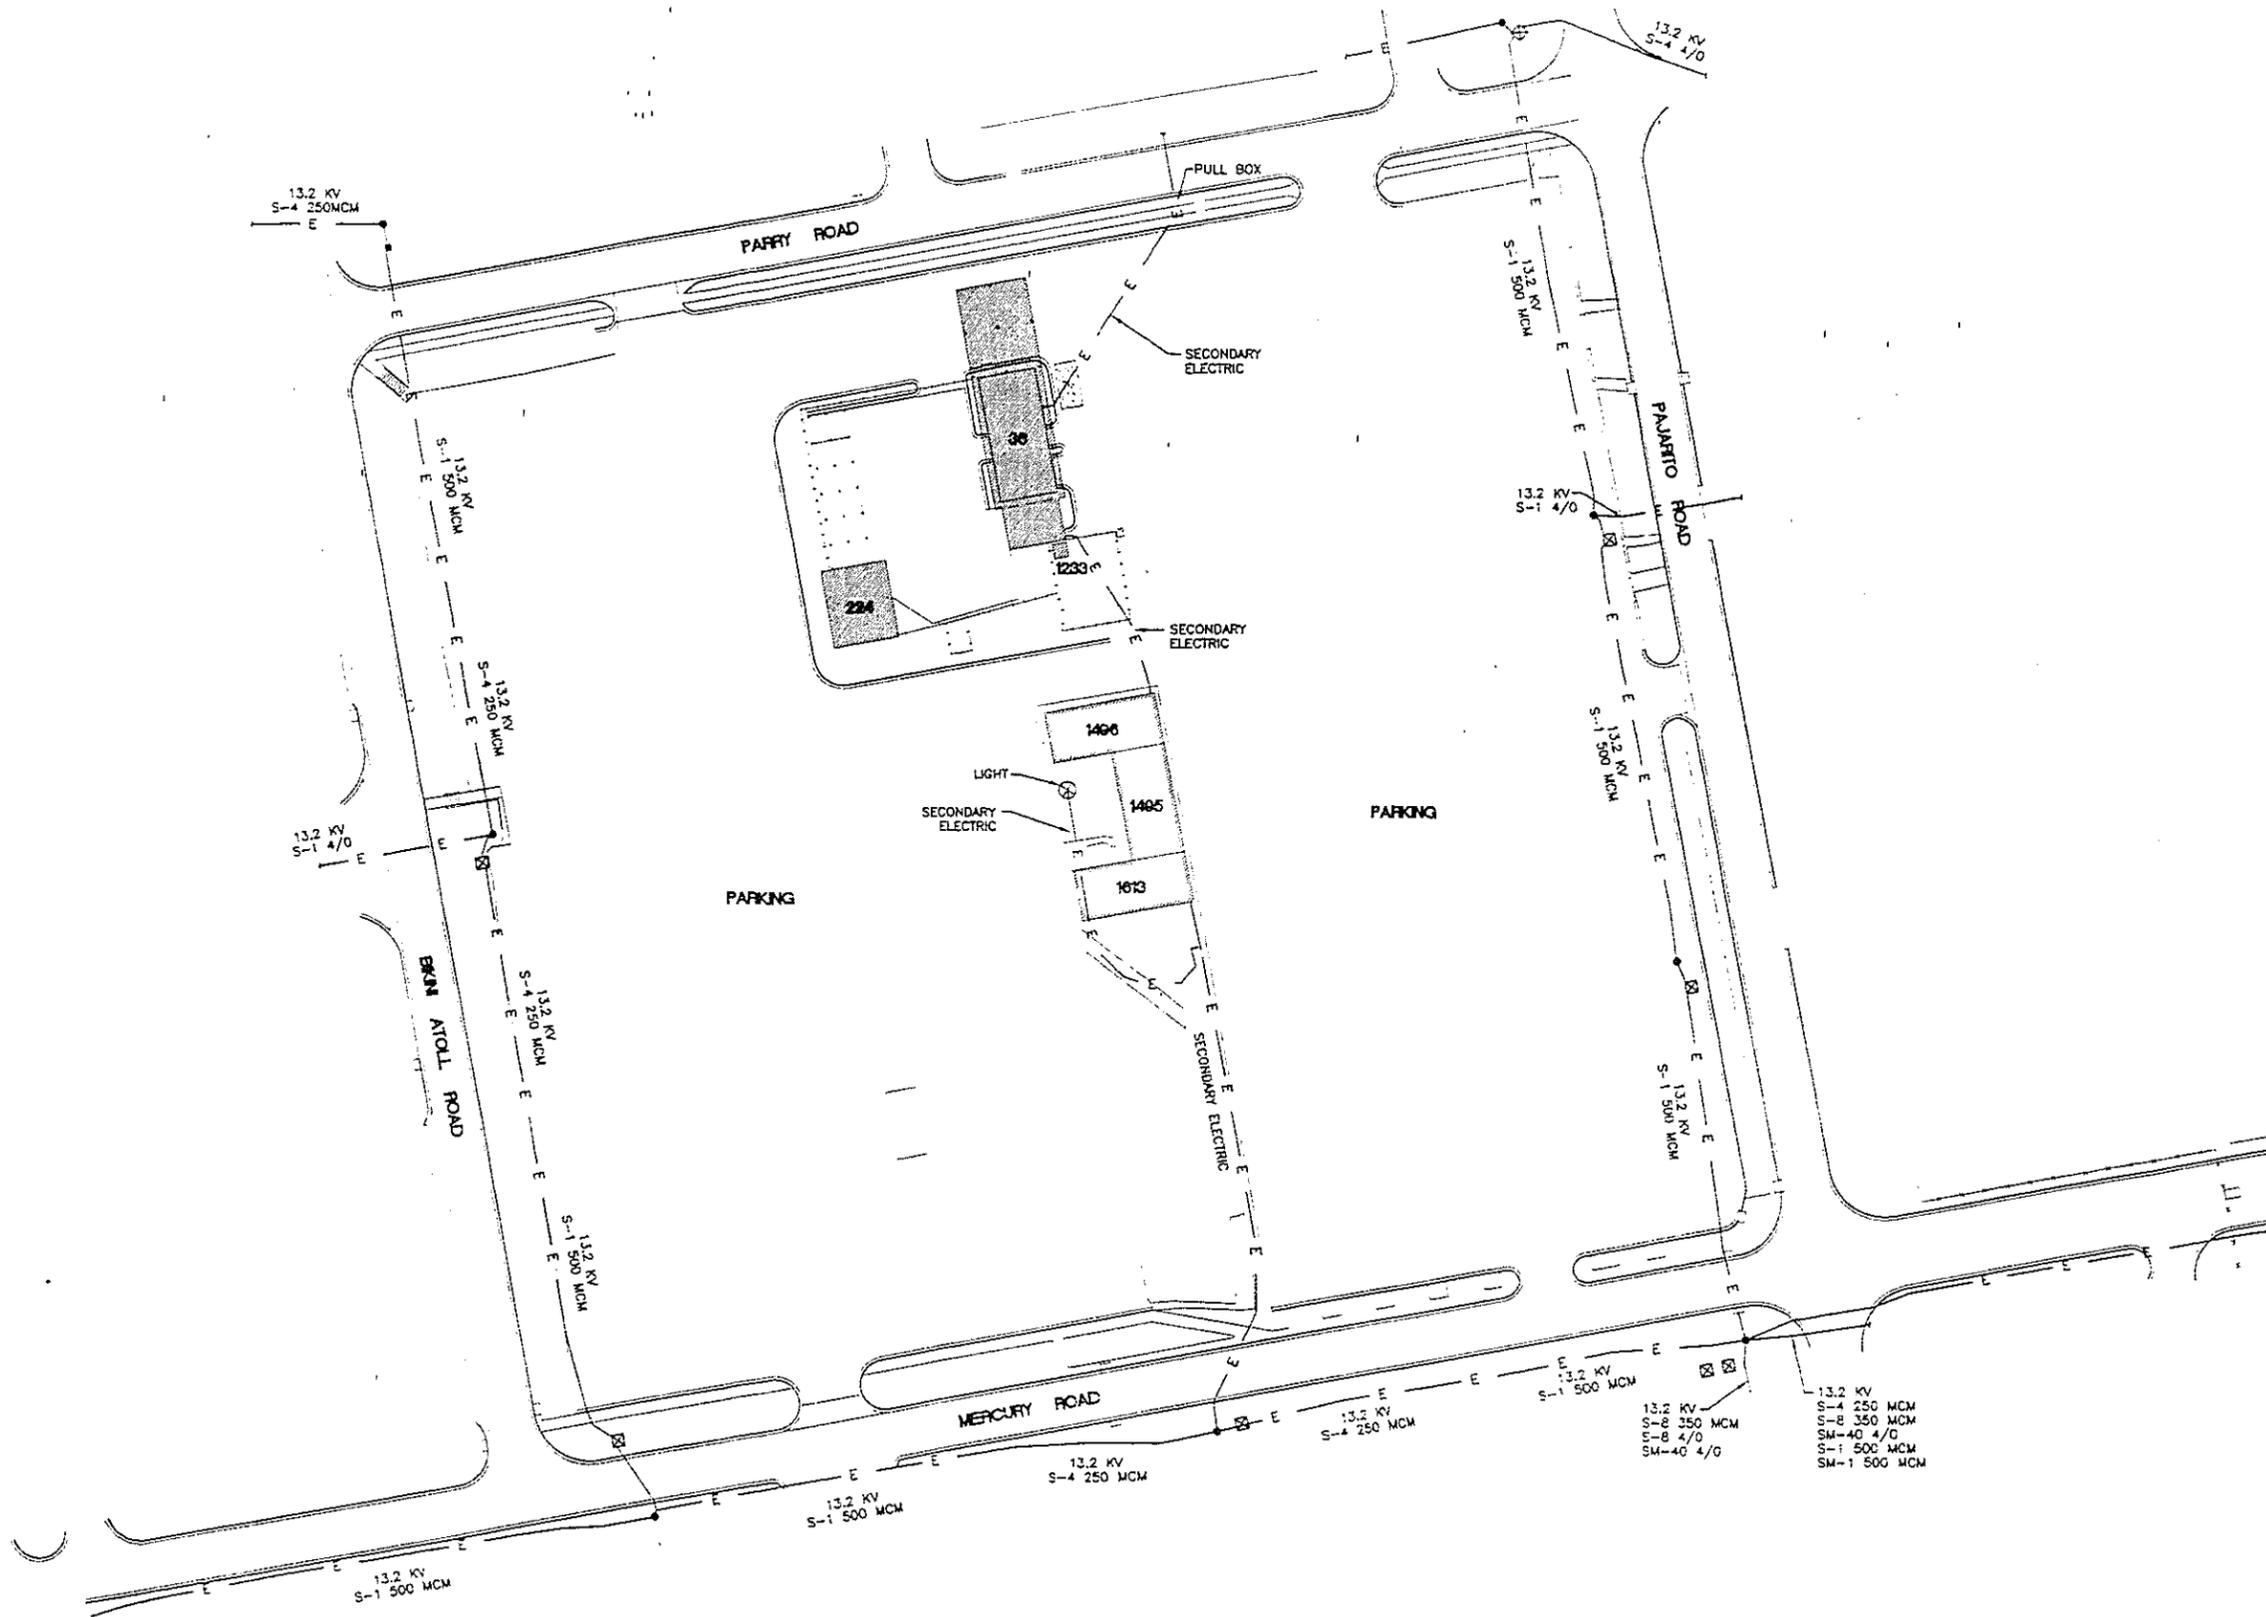
FIGURE 2-1

Primary electrical service to Bldg. TA-03-36 is supplied from the basement of Bldg. TA-03-38, Room B1, from panel LP-5/ckt.39 (120/208 volt). From there it runs underground across Parry Road into Bldg. TA-03-36 and into the utility room (RM 106) at LP-1 and LP-2 (both 120/208volts) where power is distributed to the building. LP-2 is served by LP-1, Bldg. TA-03-36. CDD-2 is served by LP-1/Crt. 42 (120/208 volt)s.

There is no electrical service to structure TA-03-224 and it appears from observation and site investigation that TA-03-1233 also does not have electrical service. At the time of this field investigation, structure TA-03-1233 was chain locked and an investigation of the interior could not be undertaken. But it did not appear to be connected to electrical service from a visual investigation of the exterior of the structure.

Primary electrical service is supplied to Bldg. TA-03-1496, 1495 and 1613 (transportables) located south of Bldg. TA-03-36 by transformer TR-A located east of Bldg. TA-03-1496, 1495 and 1613. This utility is currently "hot".

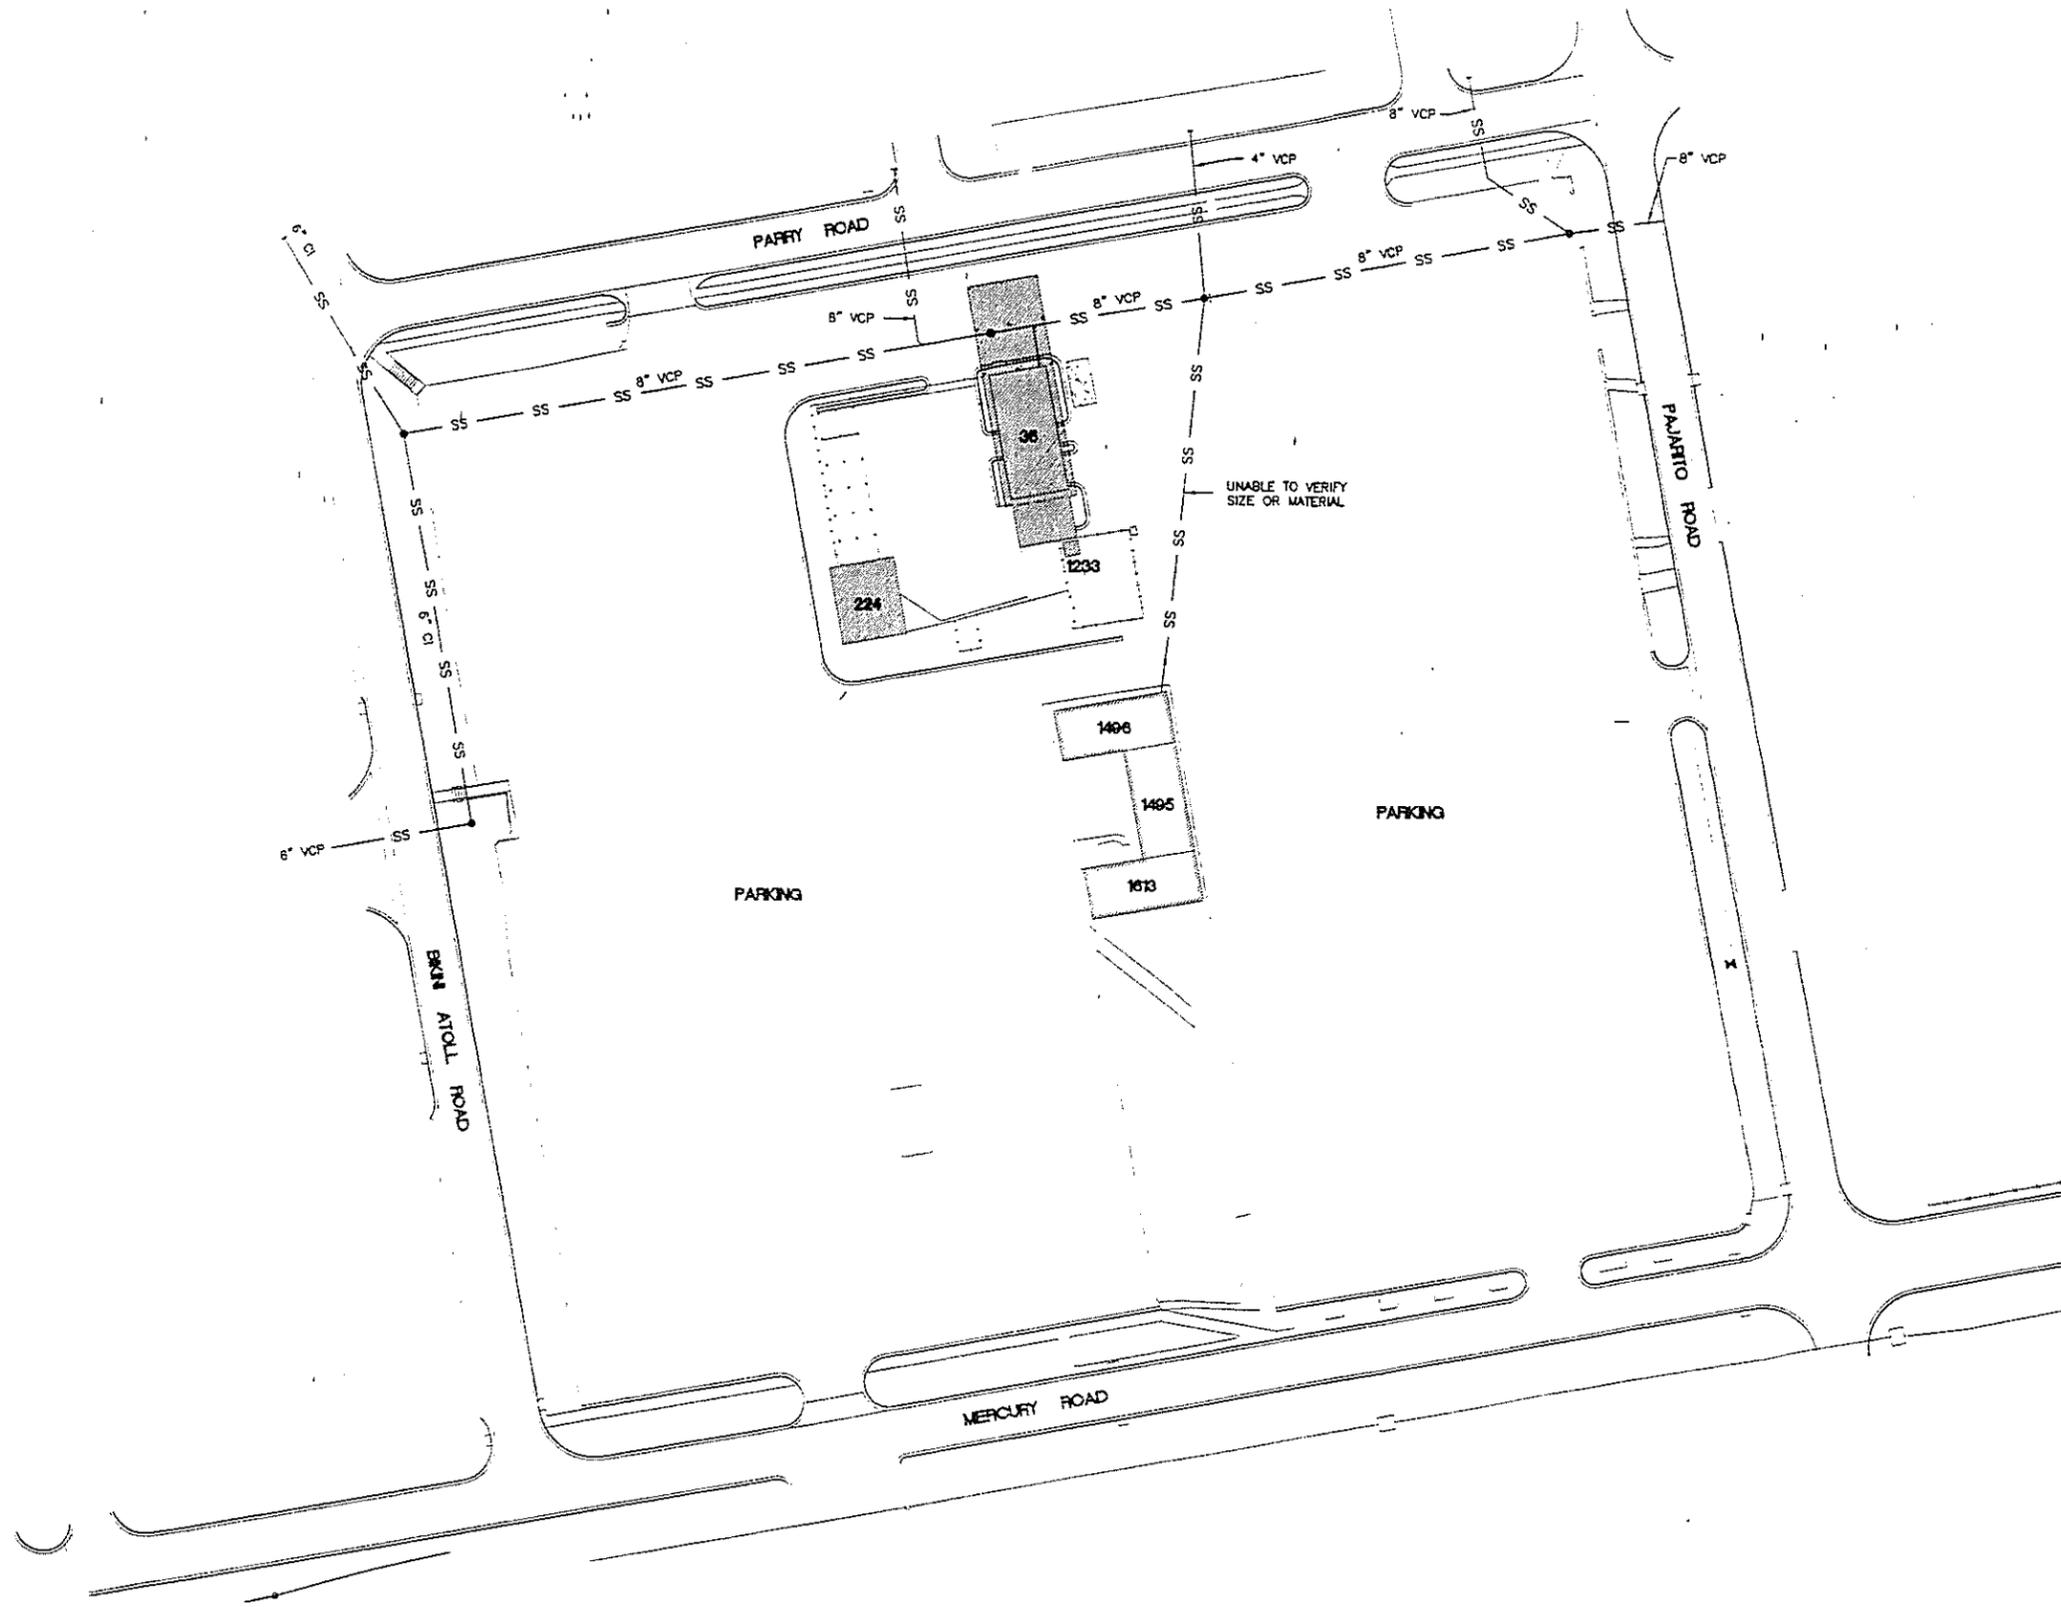
FIGURE 2-2

Sanitary Sewer services the site by an 8" vitrified clay pipe (VCP) running parallel to Parry Road north of Bldg. 36. There are 4 manholes located along this line between Pajarito Road and the west property corner. A VCP line running perpendicular to this line enters Bldg. 36 on the north side of the bldg. A second VCP line connects bldg. 1495, 1496 and 1613 with the VCP line that runs parallel to Parry Road.

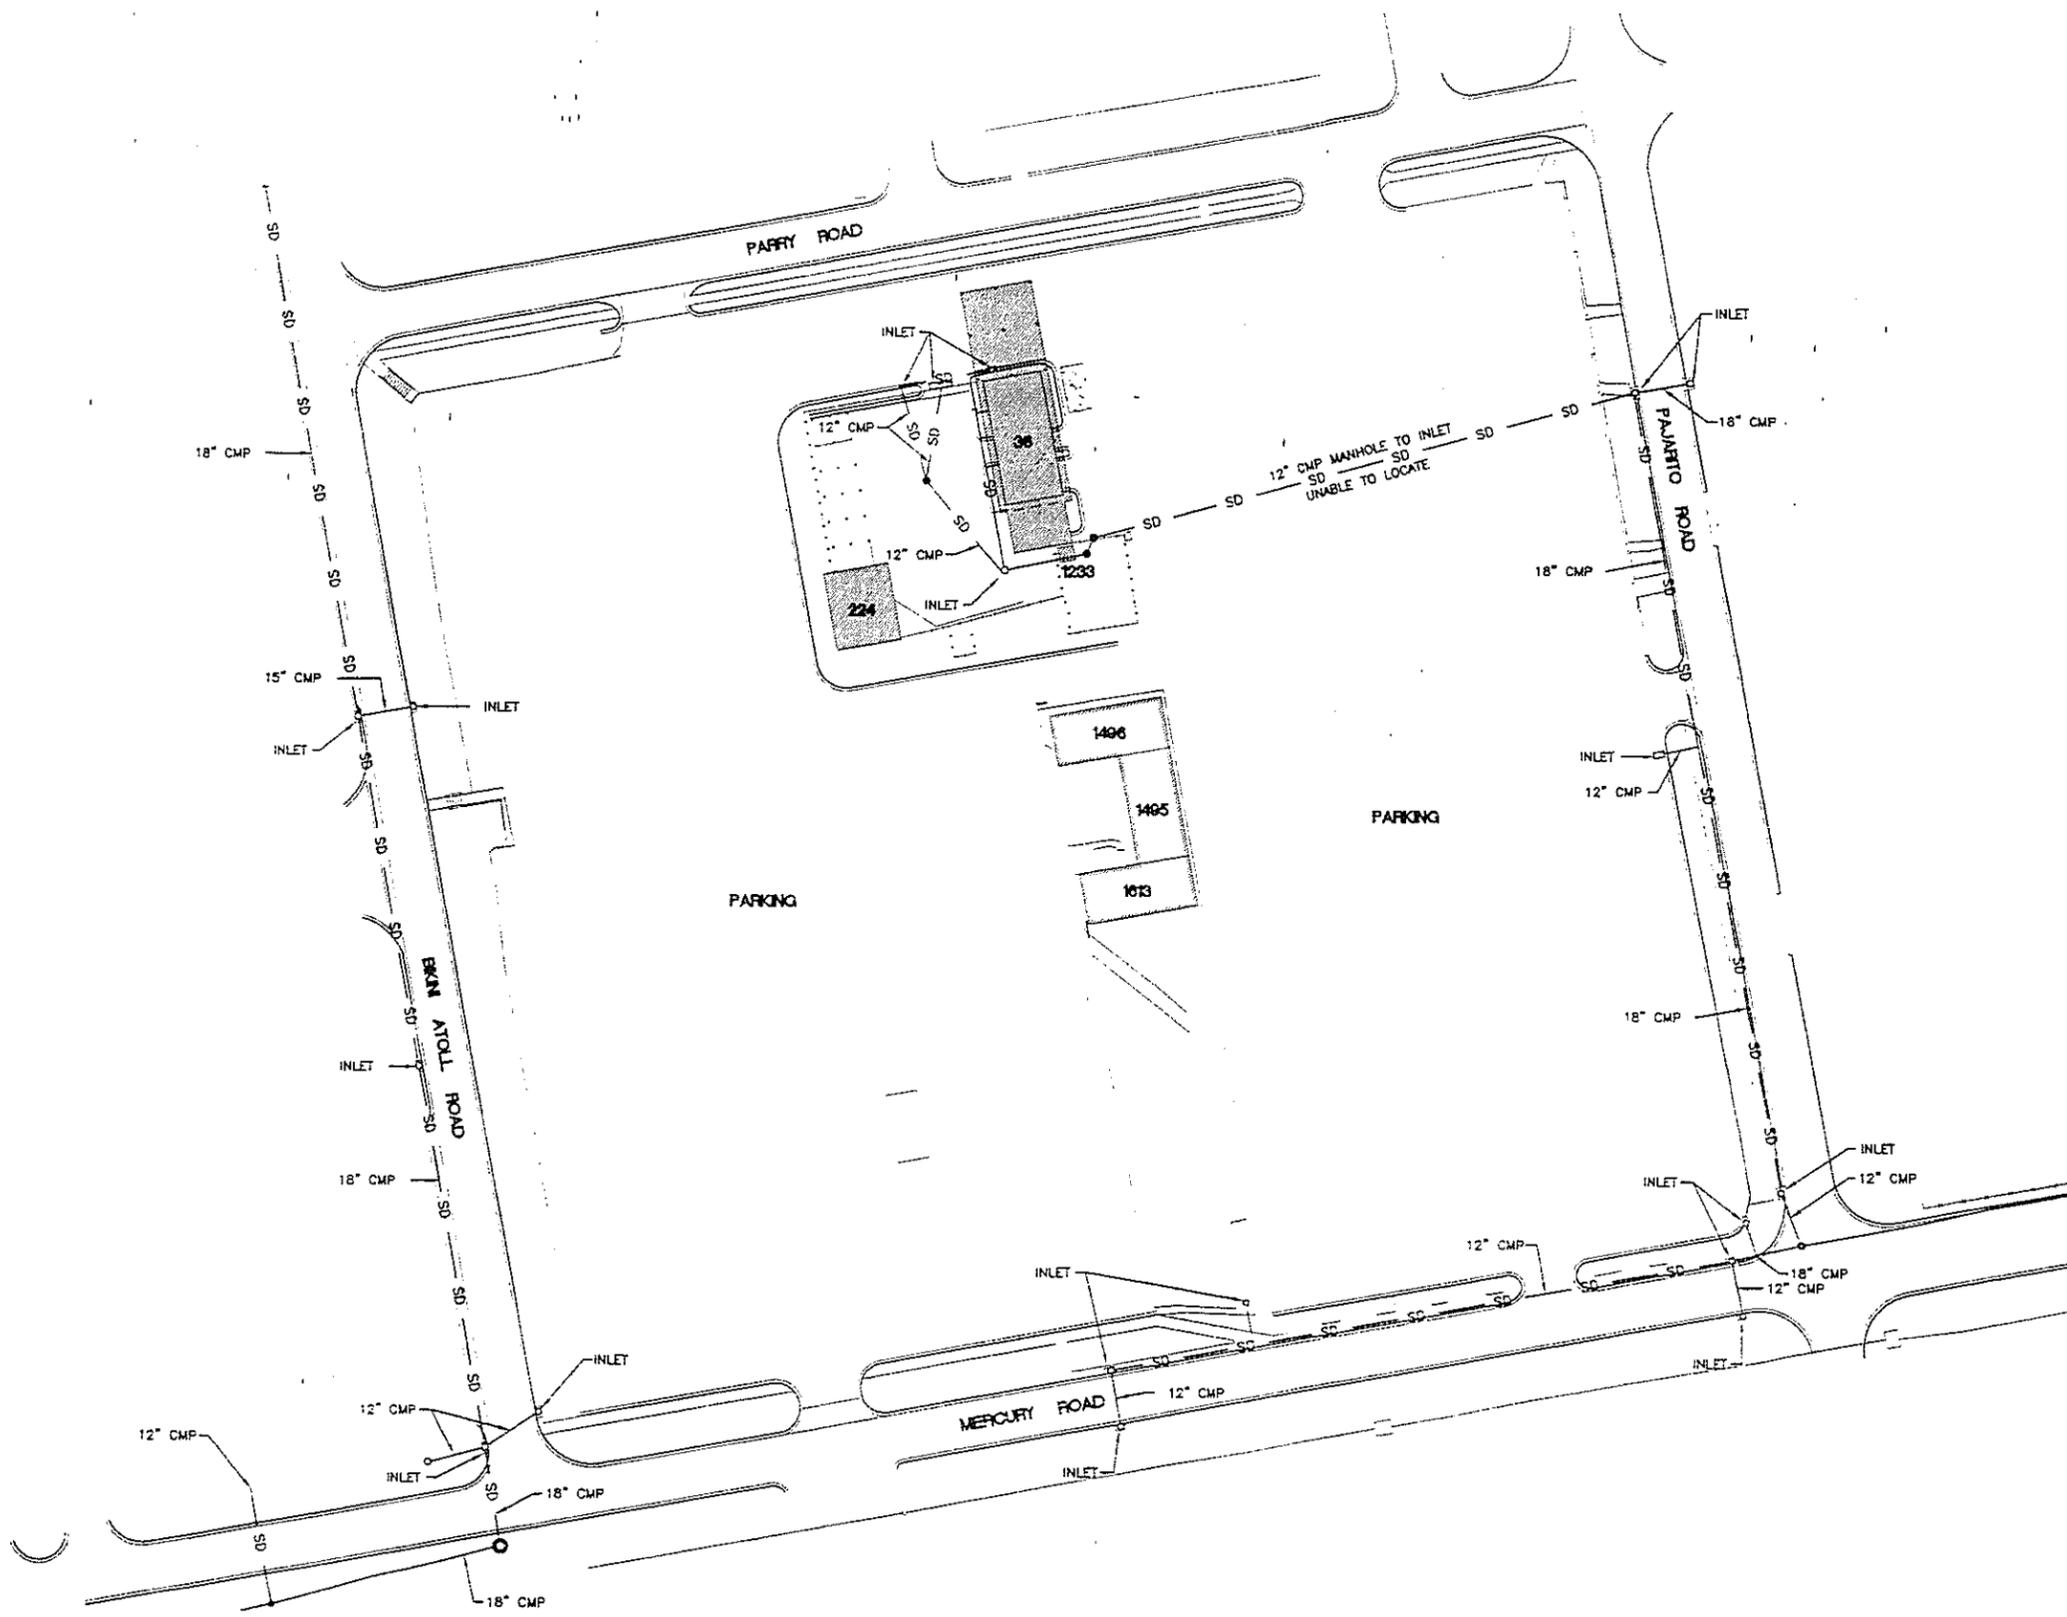
FIGURE 2-3

The parking lot west of Bldg. TA-03-36, east and north of Bldg. TA-03-224 and west and north of Bldg. TA-03-1233 is served by a 12" corrugated metal pipe (cmp), running into a storm drain/manhole in the center of the parking lot. There are three inlets within the parking lot at the north end, connected to 2 12" cmps and running south to a storm drain manhole. From the manhole an additional 12" cmp runs south to a second manhole. All storm drainage associated with this site is contained, directed and released into an 18" cmp running parallel along Pajarito Road, east of the three mentioned buildings.

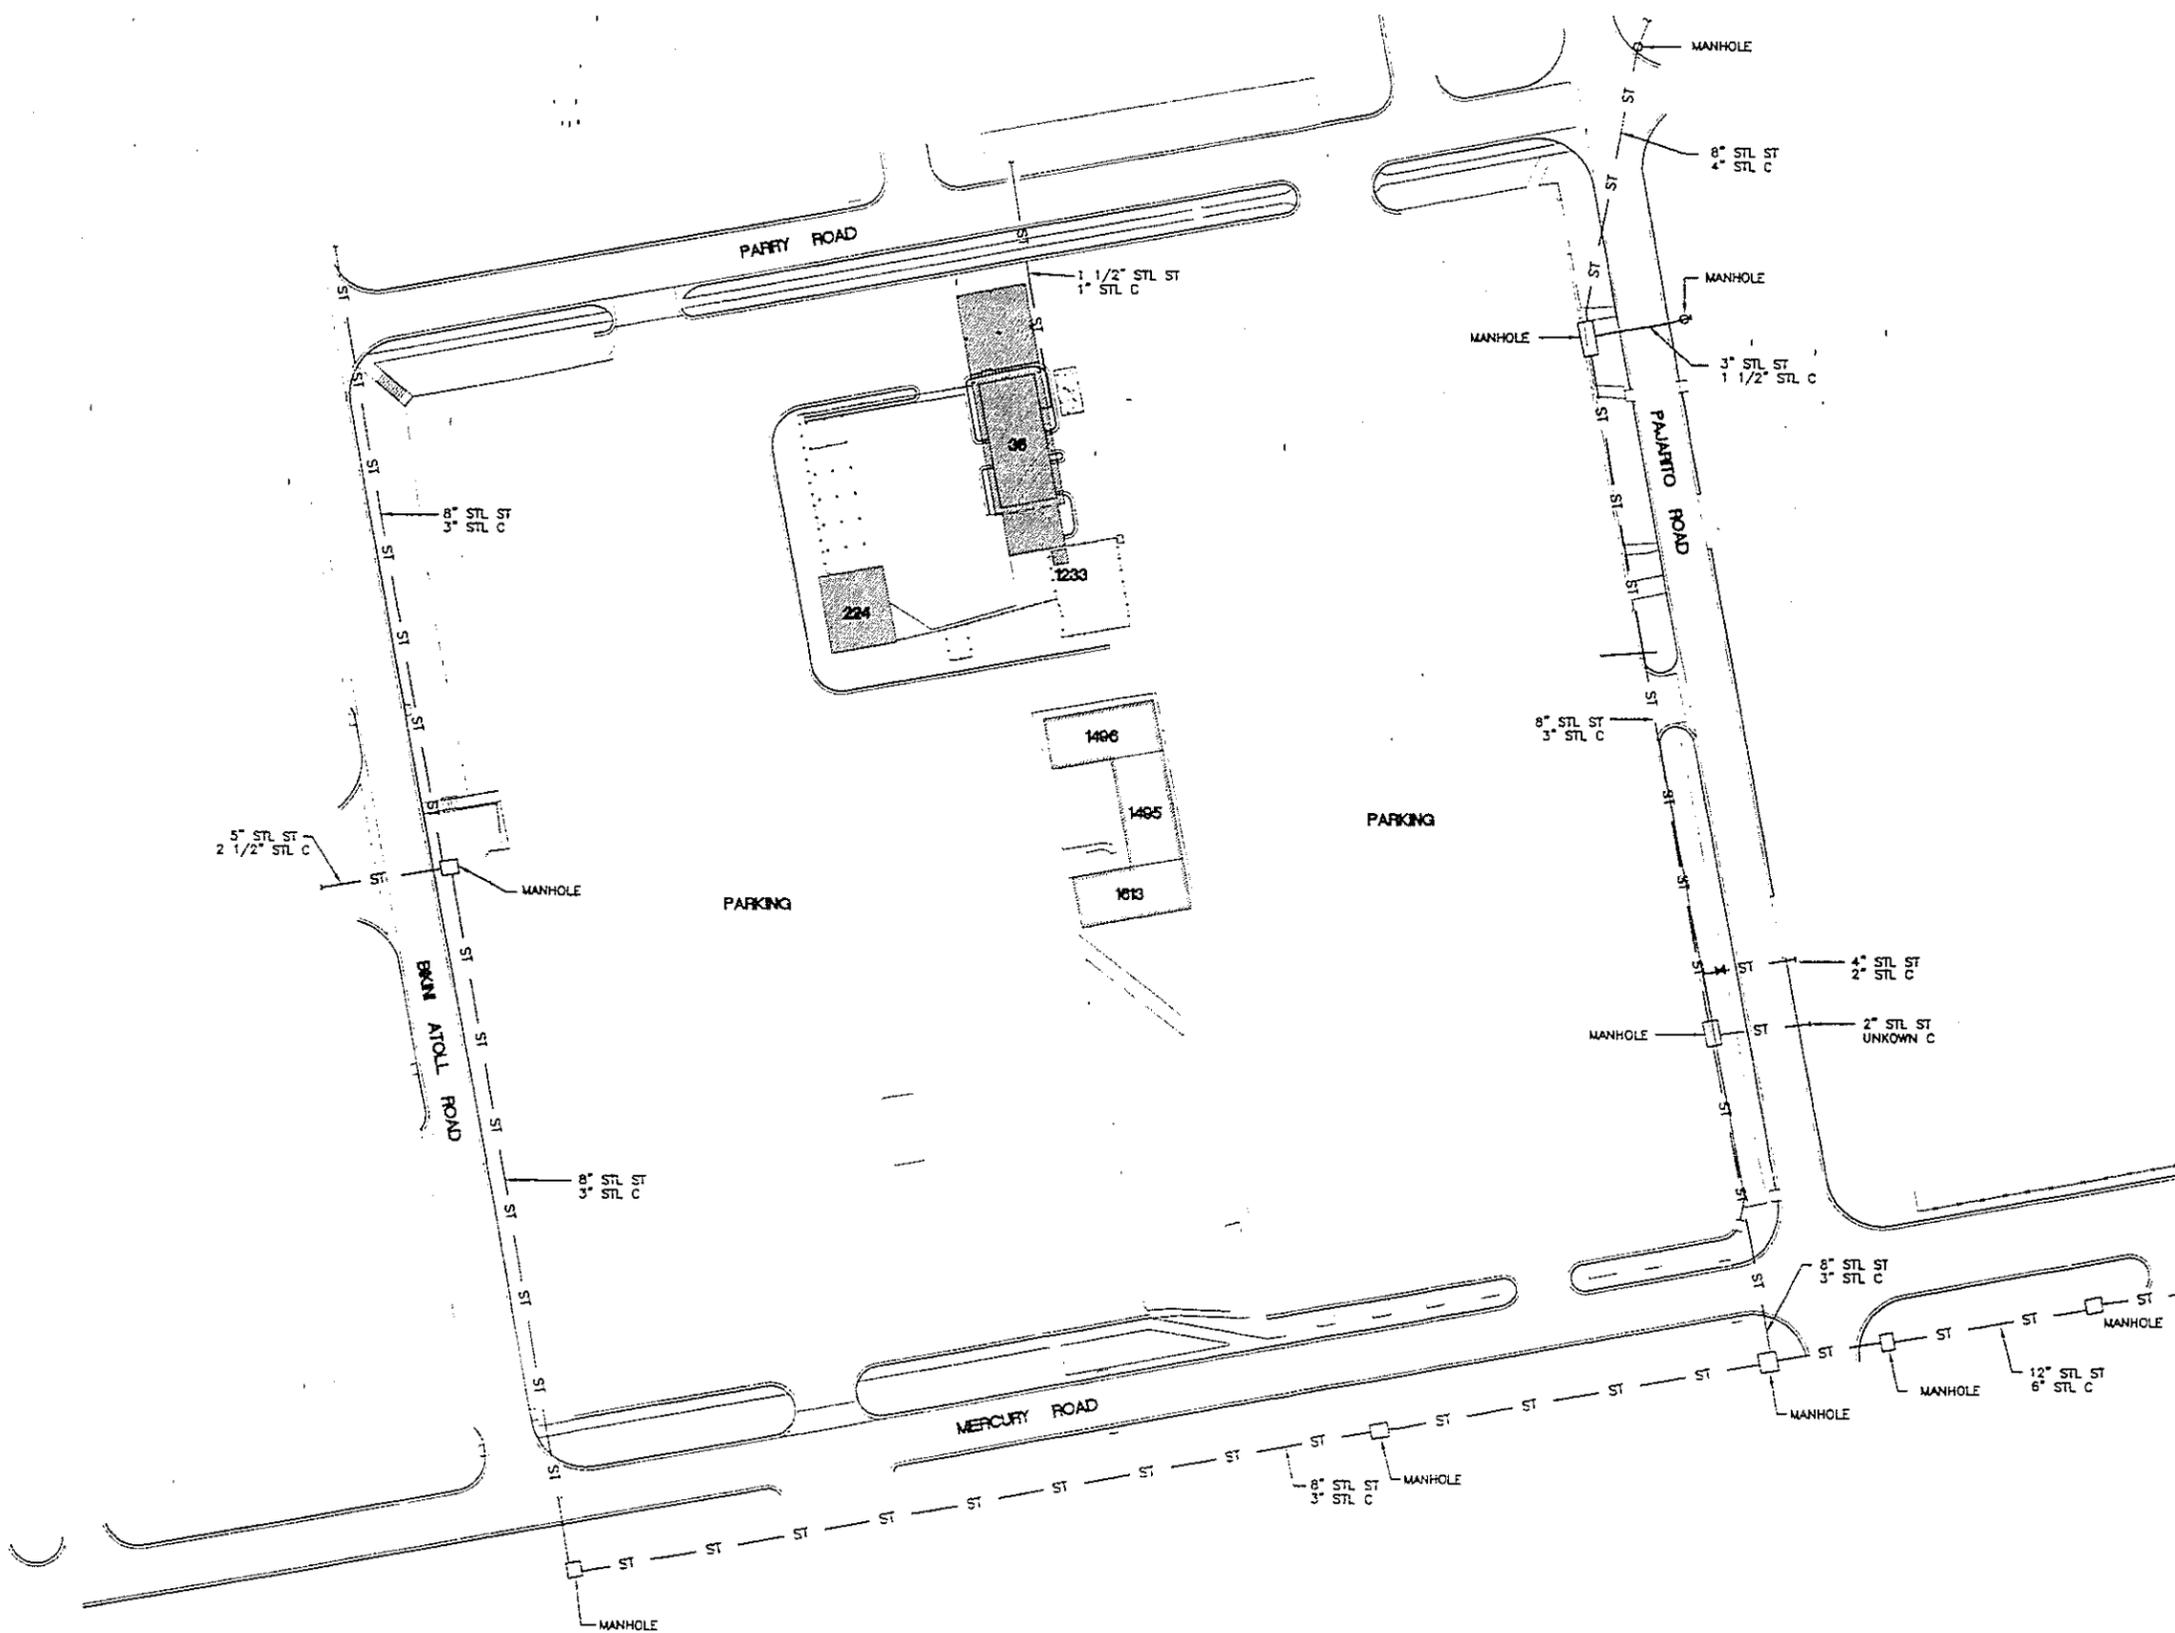
FIGURE 2-4

Bldg. TA-03-36 is serviced by a 1 1/2" steel underground steam line entering the building on the east side and running north across Parry Road to a manhole. In addition, a 1" steel condensate line originates at the same location in the steam manhole (#1015) across Parry Road and enters Bldg. 36 at the same location, east side of the building.

The steam system is currently active in Bldg. 36 and does not supply service to any other building.

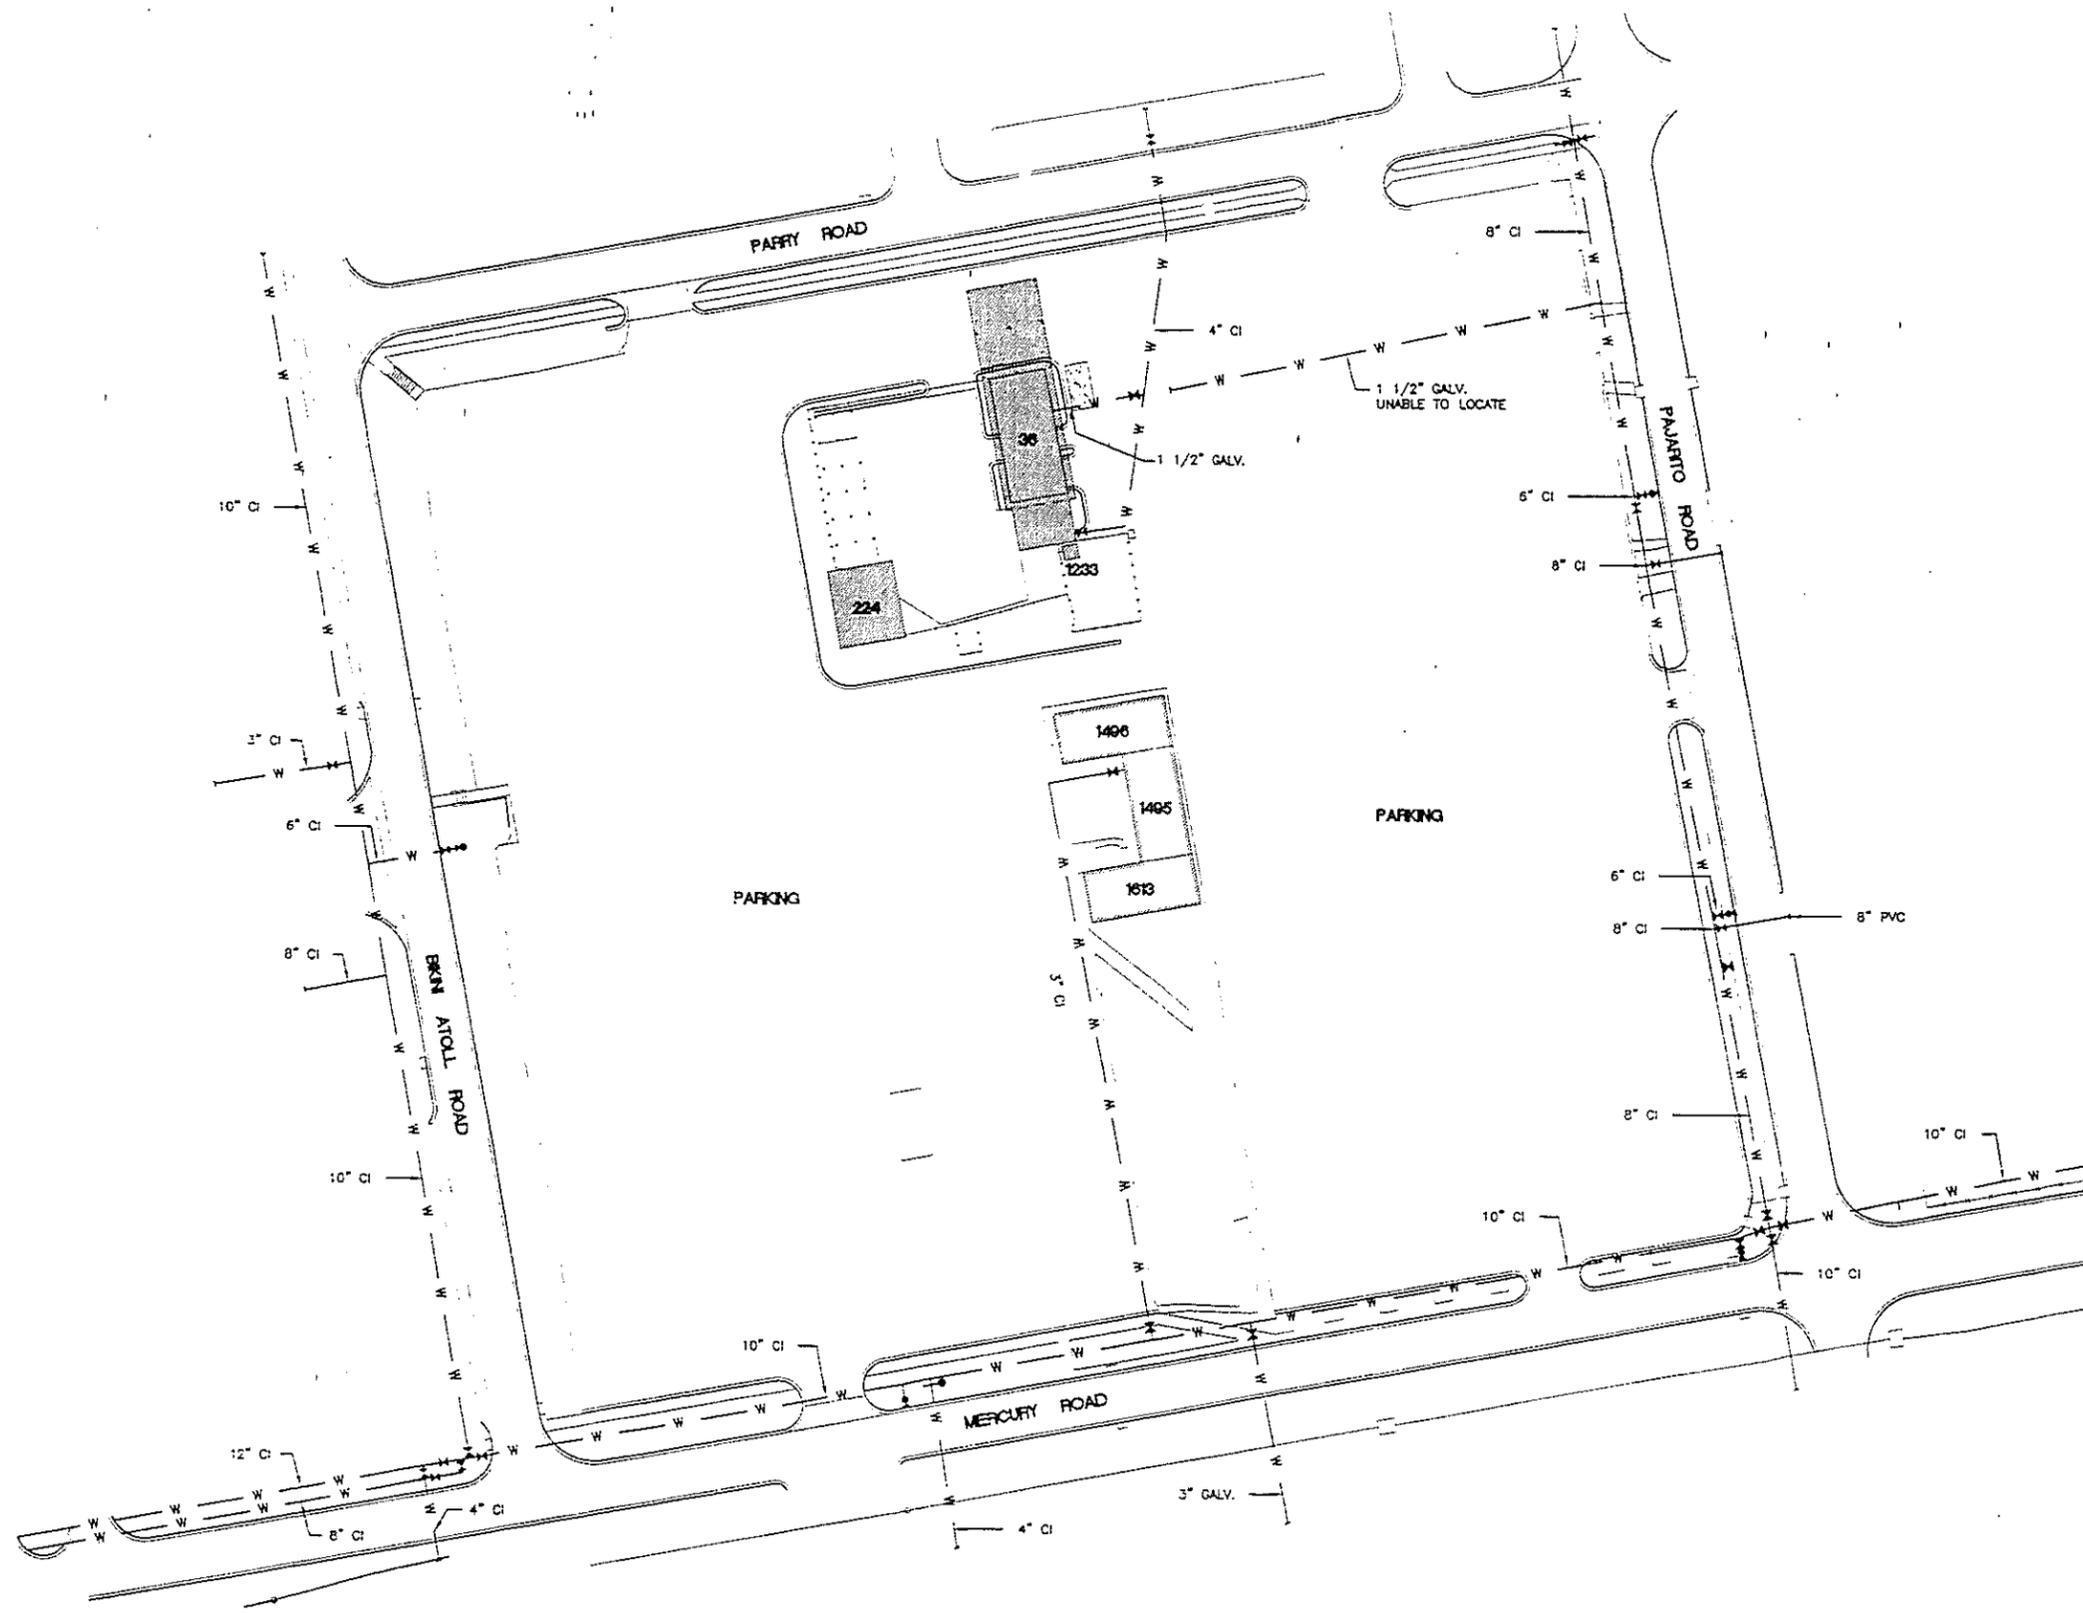
FIGURE 2-5

Potable water is provided to Bldg. TA-03-36 by a 1 1/2" galvanized pipe entering the building on the east side and into the utility room. From the utility room the pipe exits the building underground and runs across the parking lot and to an 8" cast iron pipe running parallel to Pajarito Road.

A separate 4" cast iron pipe supplying fire protection water enters Bldg. TA-03-36 at the southeast corner. From this location a valve lies approximately 20' east, then proceeds northeast across the parking lot to Parry Road to a second valve within the roadway. All lines appear to be "active".
