CHARACTERIZATION REPORT
FOR
THE DECONTAMINATION AND DECOMMISSIONING
OF
TECHNICAL AREA 3
BUILDINGS 36, 224 AND 1233
FOR
LOS ALAMOS NATIONAL LABORATORY

CHARACTERIZATION REPORT
FOR
BUILDINGS 36, 224 AND 1233
AT
TECHNICAL AREA 3
LOS ALAMOS NATIONAL LABORATORY
FOR
DECONTAMINATION & DECOMMISSIONING
GROUP

March 1999

ICF Kaiser Engineers, Inc.
235 Central Park Square
Los Alamos, NM 87544

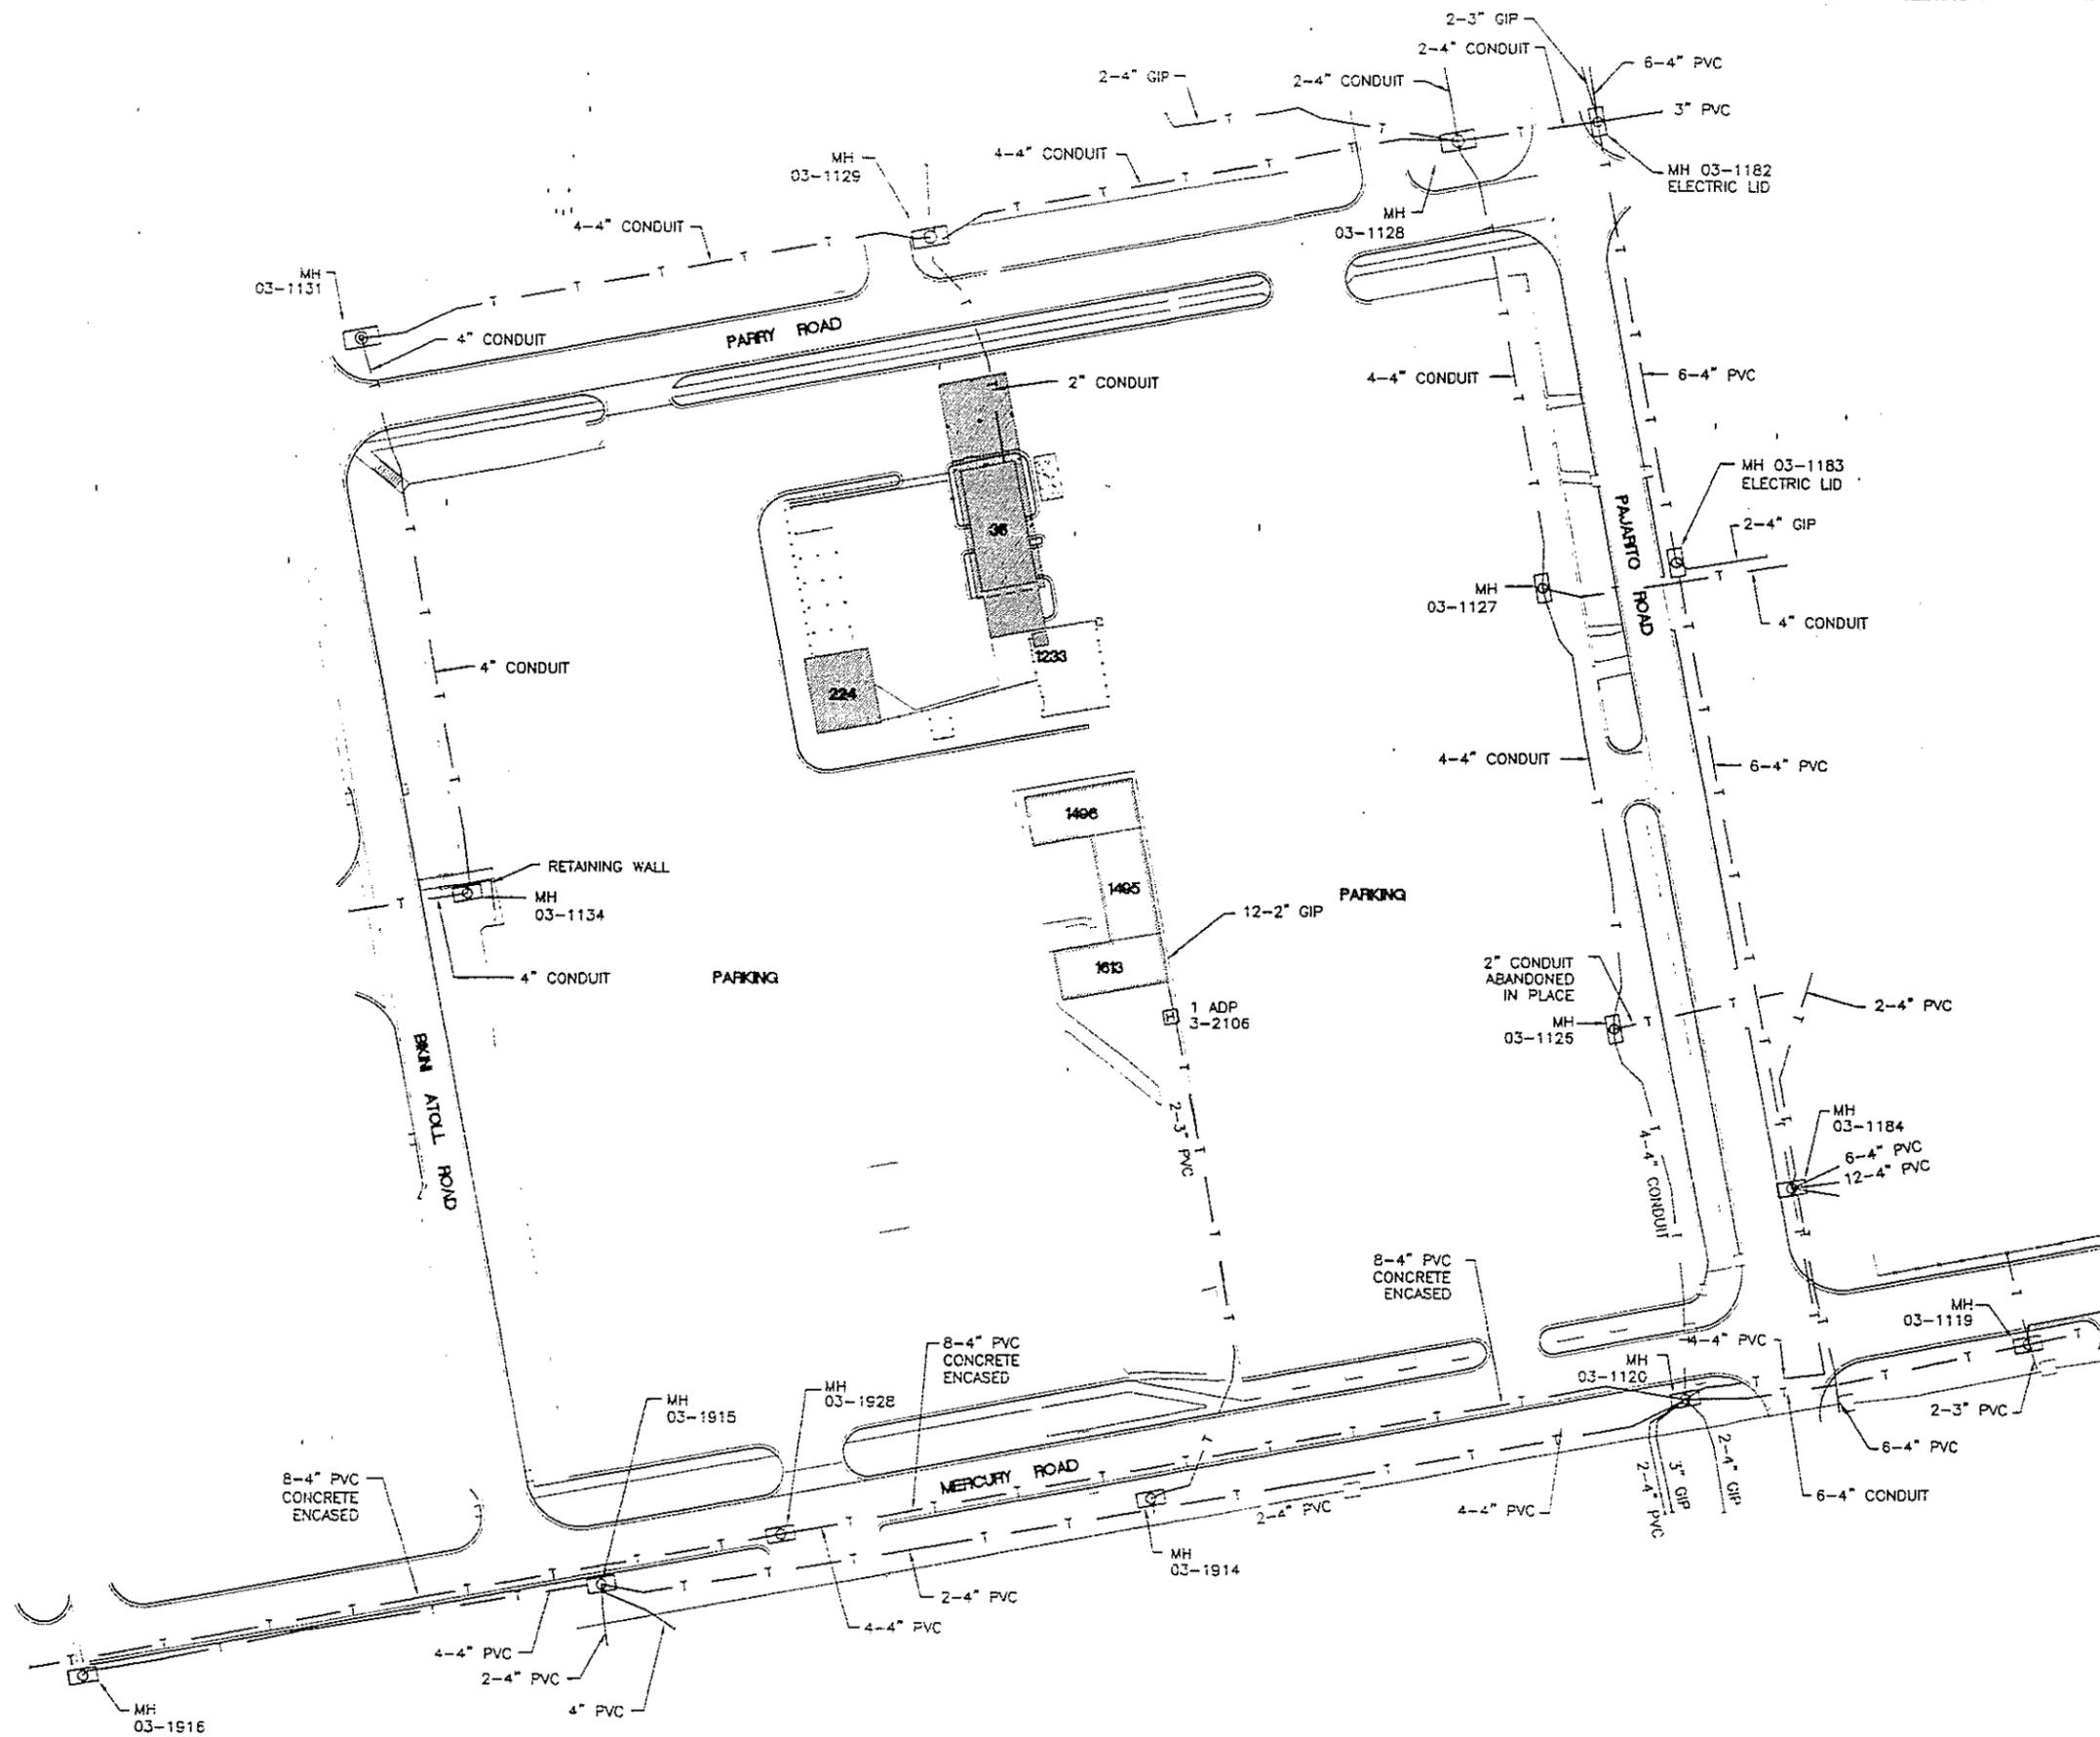
FIGURE 2-6

The telephone system is supplied to Building TA-03-36 by a 2" underground transite line entering the building at the north exterior wall and proceeding to a telephone panel located in the utility room and a second panel located on the north wall in the large service room.

The 2" transite line runs underground north from Bldg. TA-03-36 across the parking lot, across Parry Road to a telephone manhole across Parry Road containing 4-4" transite lines.

The system is currently active and provides telephone service into Bldg. TA-36. There is no apparent telephone service to Bldg. TA-03-1233 and TA-03-224. (Figure 2-6)

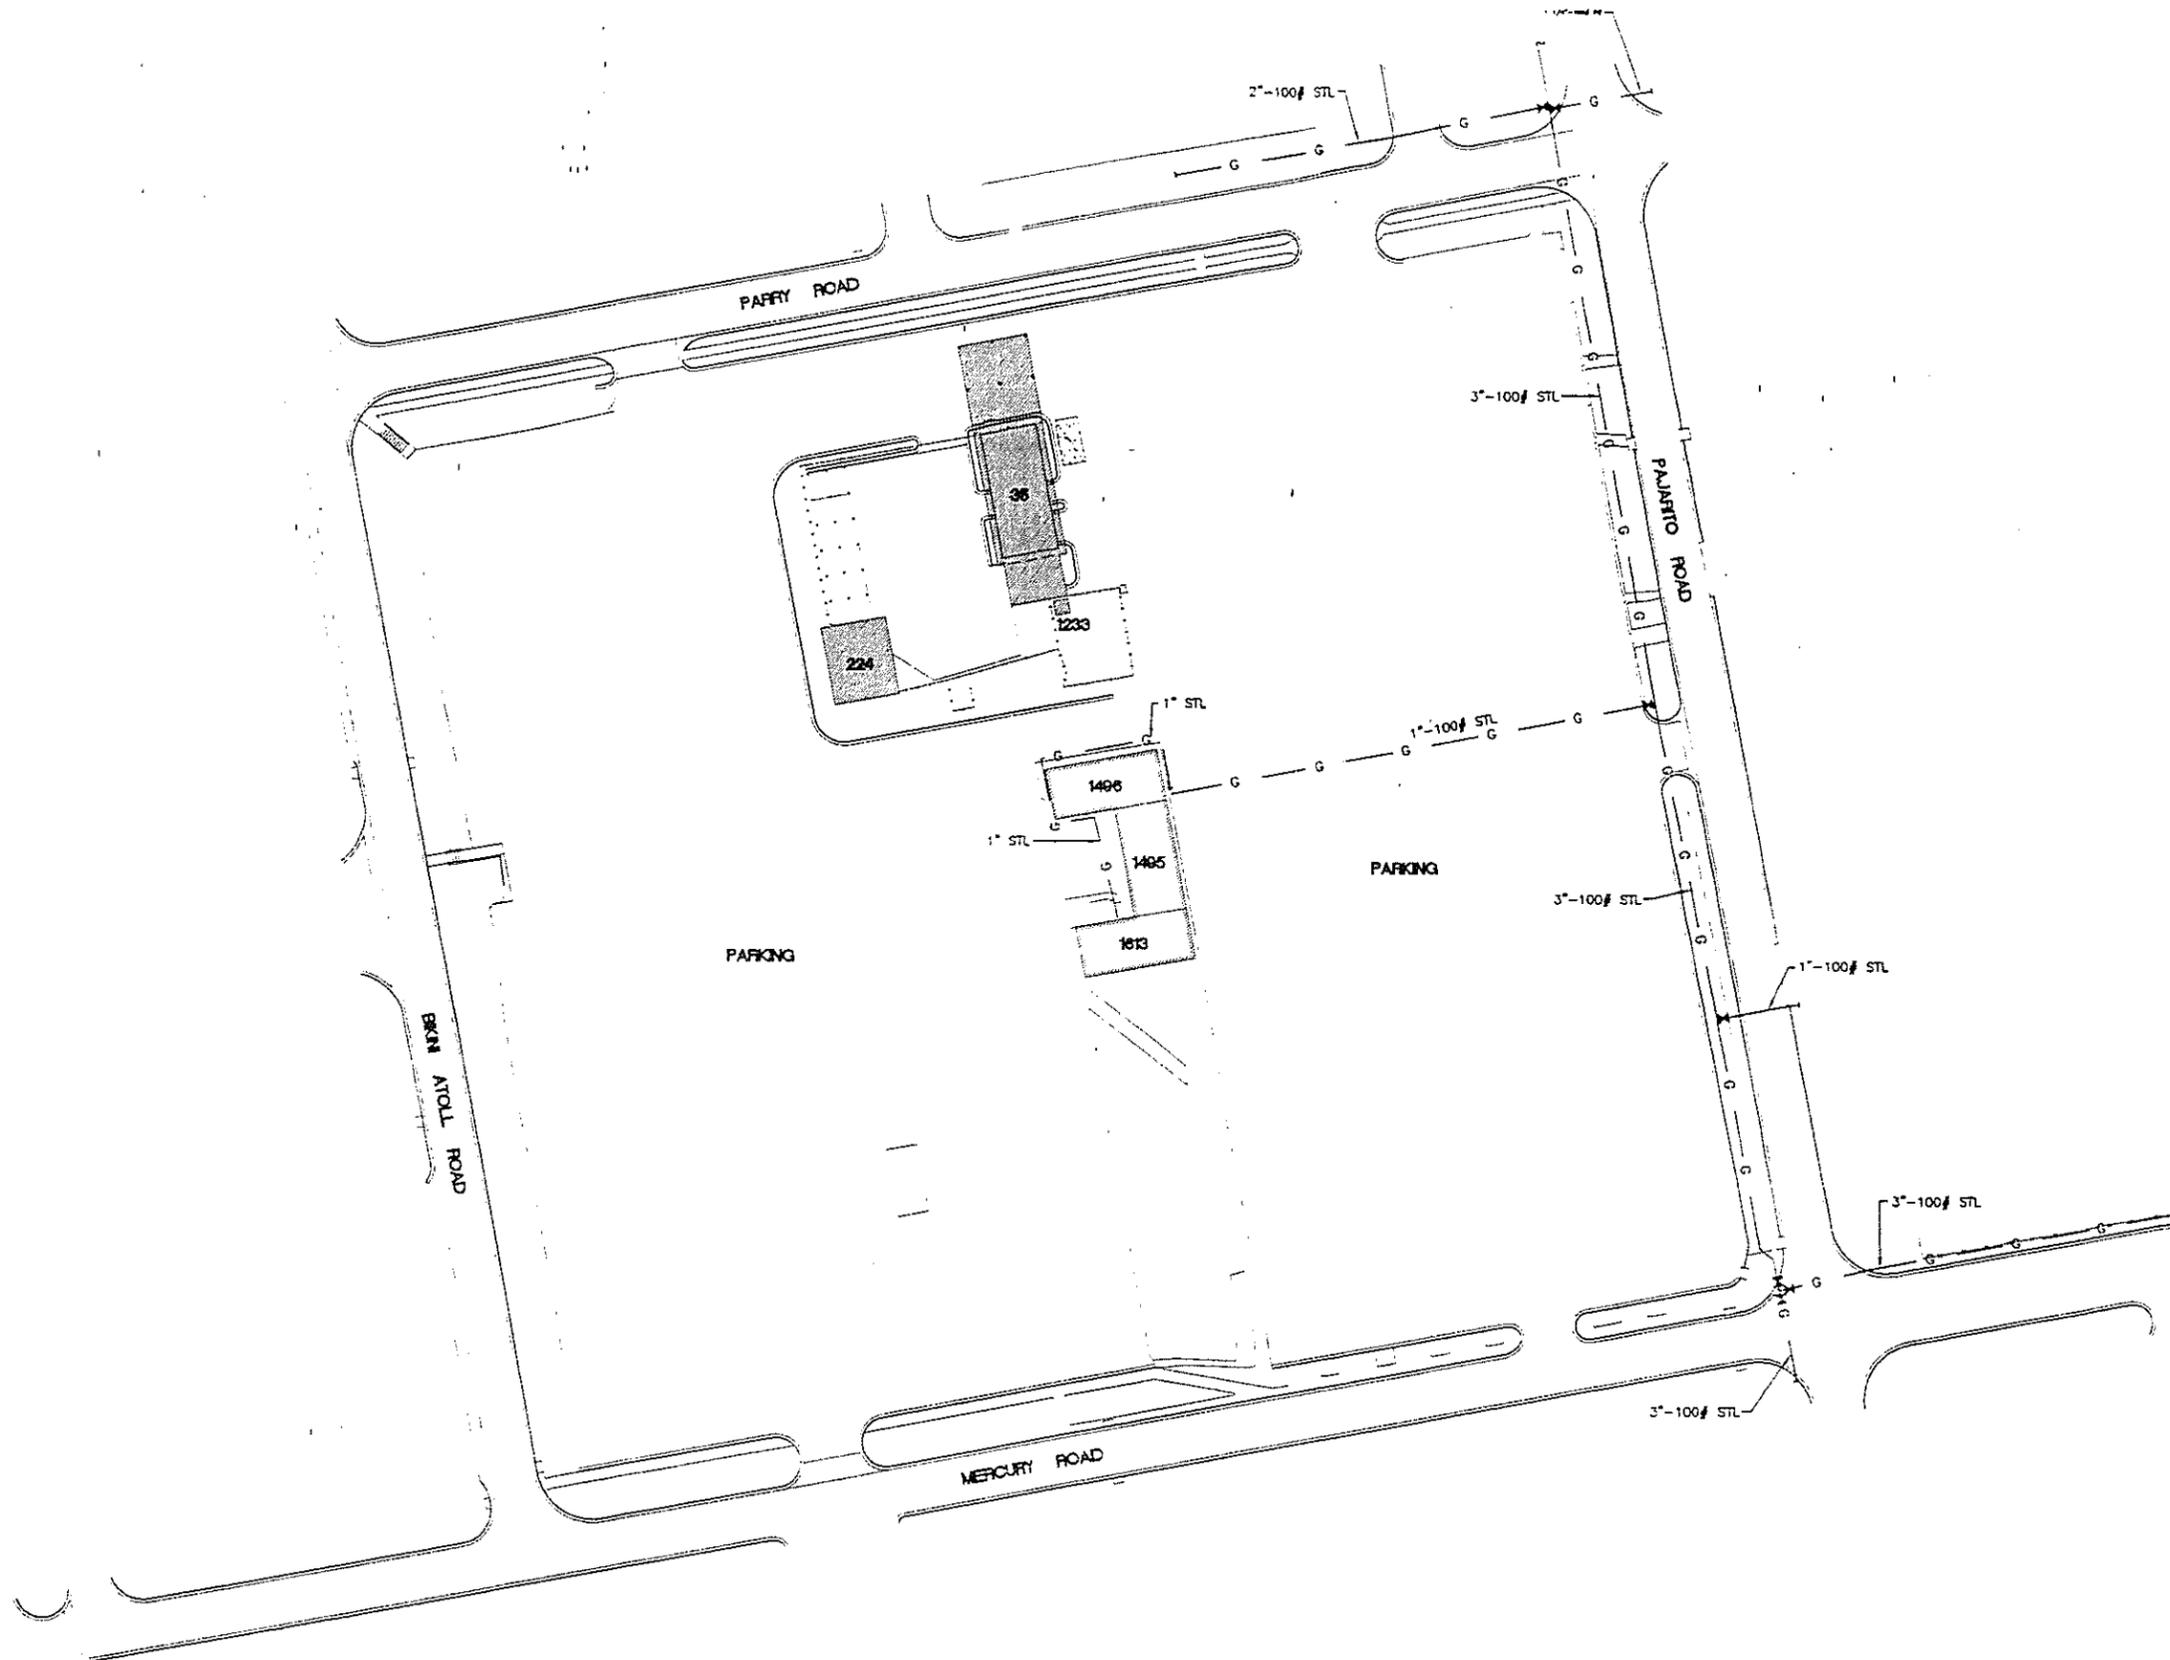
GAS SYSTEM

There is no apparent natural gas associated with Bldg. TA-03-36, 224, and 1233. However, a 1"-100# steel gas line provides gas service to the transportables Bldg. TA-03-1496, 1495, and 1613 south of Bldg. TA-03-36. This line is located east of the transportables, runs parallel to Parry Road and perpendicular to a main gas line along Pajarito Road. It appears that the gas line providing service to these transportables is independent of Bldgs. TA-03, 224 and 1233.
