Remediation & Disposal Report

**County of Los Alamos Department of Public Utilities
907 Trinity Drive
P.O. Drawer 1030
Los Alamos, NM 87544**

Report Date:
February 9, 2010

Site Description: Bayo Wastewater Treatment Plant
3500 Pueblo Canyon Road
Los Alamos, NM 87544

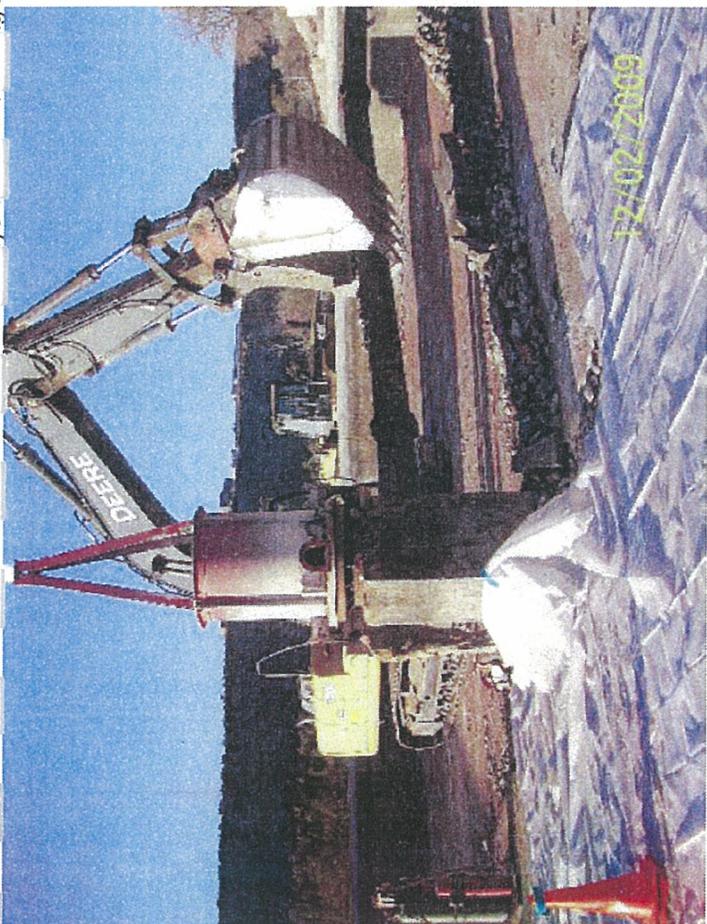
01 - Removing effluent feeder pipe from the eastern filter.jpg
12/02/2009

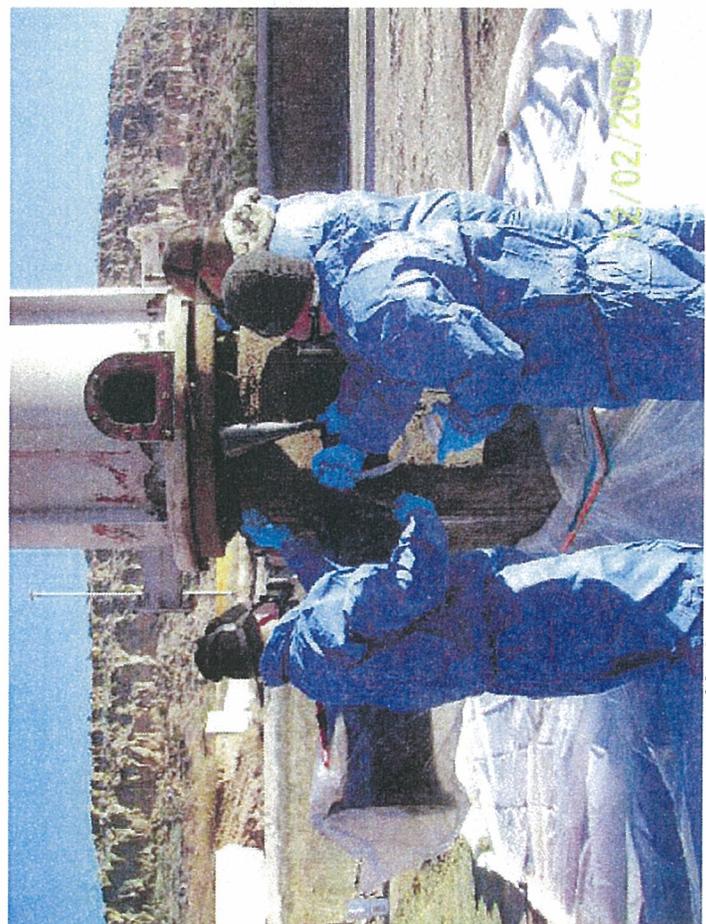
Prior to removing the rotating equipment, *SHC* personnel donned level C PPE and tried to drain mercury from a drain listed on the engineering plans; however no mercury would drain from the plug.

03 - Attempting to drain mercury from seal.jpg
12/02/2009

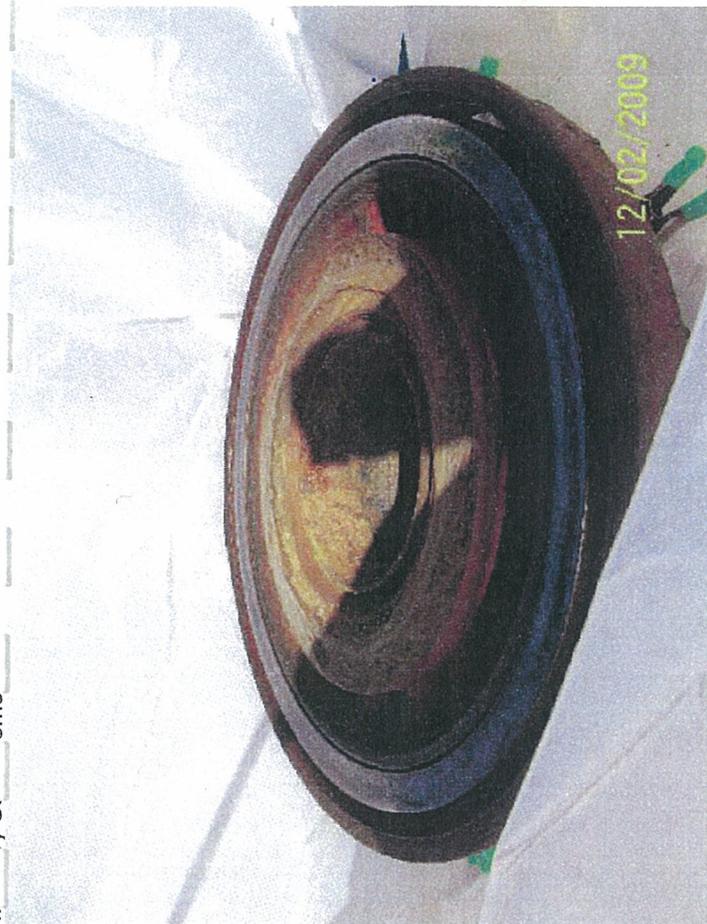
06 - Central section of rotating equipment with mercury seal.jpg
12/02/2009

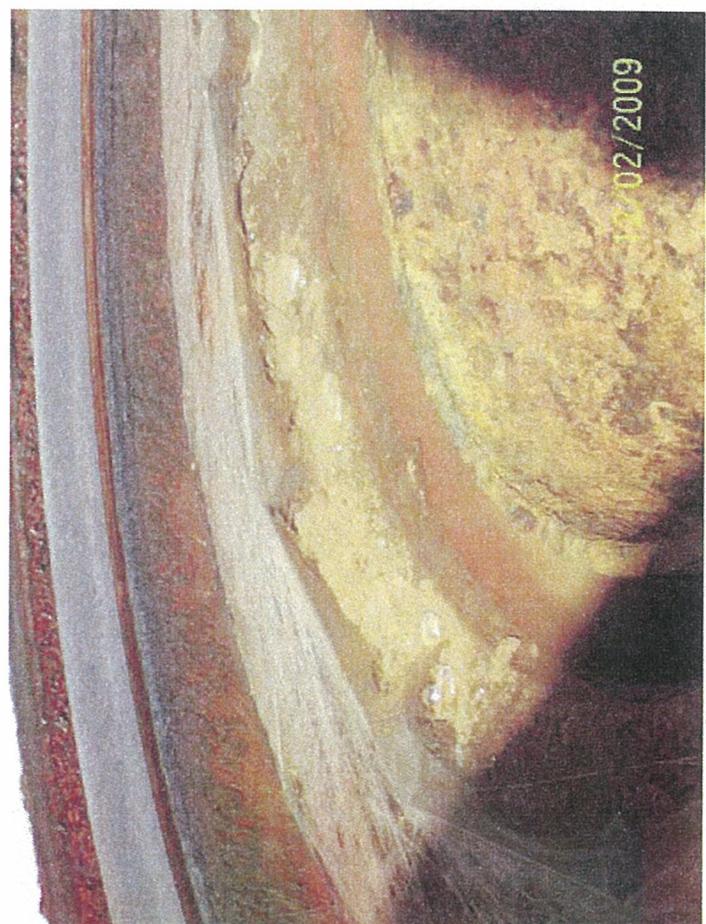
SHC personnel observed that the majority of the mercury was found in the central section of the rotating equipment and in the stationary section still attached to the vertical support column. A mercury vacuum was used to remove the visible mercury from the top section of the rotating equipment and *SHC* personnel decontaminated the equipment using a Tide™ solution. The equipment was monitored for mercury vapors using a Jerome Mercury Vapor Analyzer and was found to have vapor concentrations below the OSHA PEL of 0.1 mg/m³. The equipment was determined to be sufficiently decontaminated for recycling and was placed into the sites scrap metal recycling bin.

07 - Mercury on upper portion of central section.jpg
12/02/2009

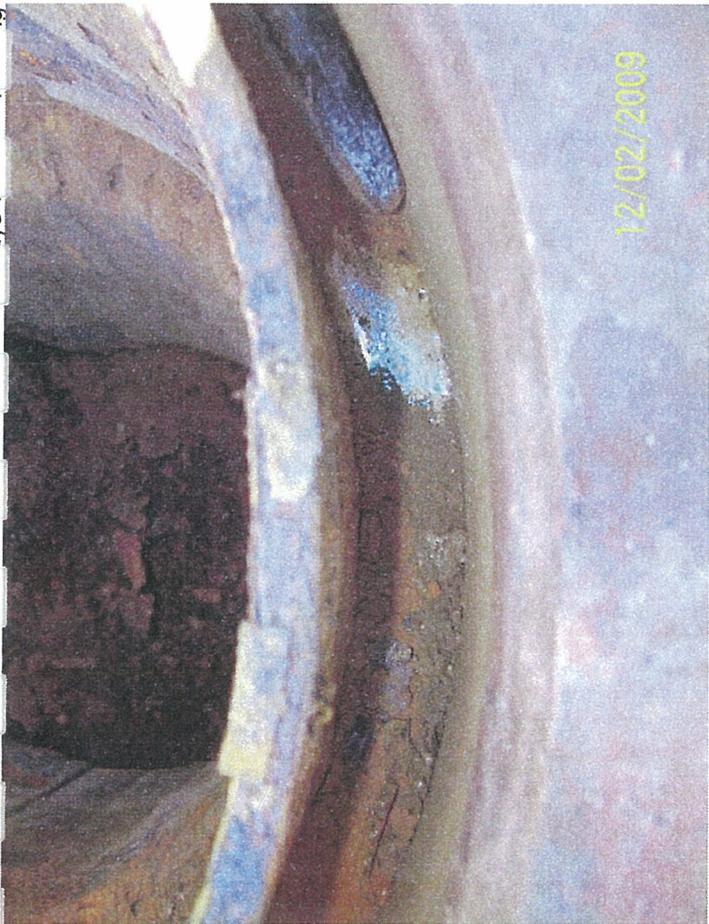
13 - Mercury on the stationary section.jpg
12/02/2009

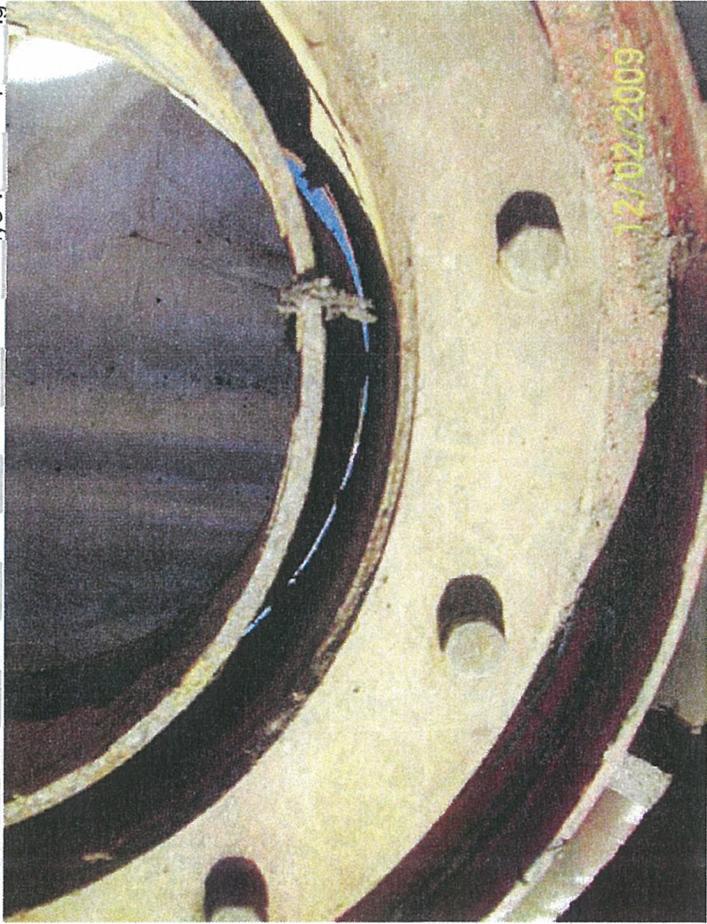
21 - Mercury in the stationary section.jpg
12/02/2009

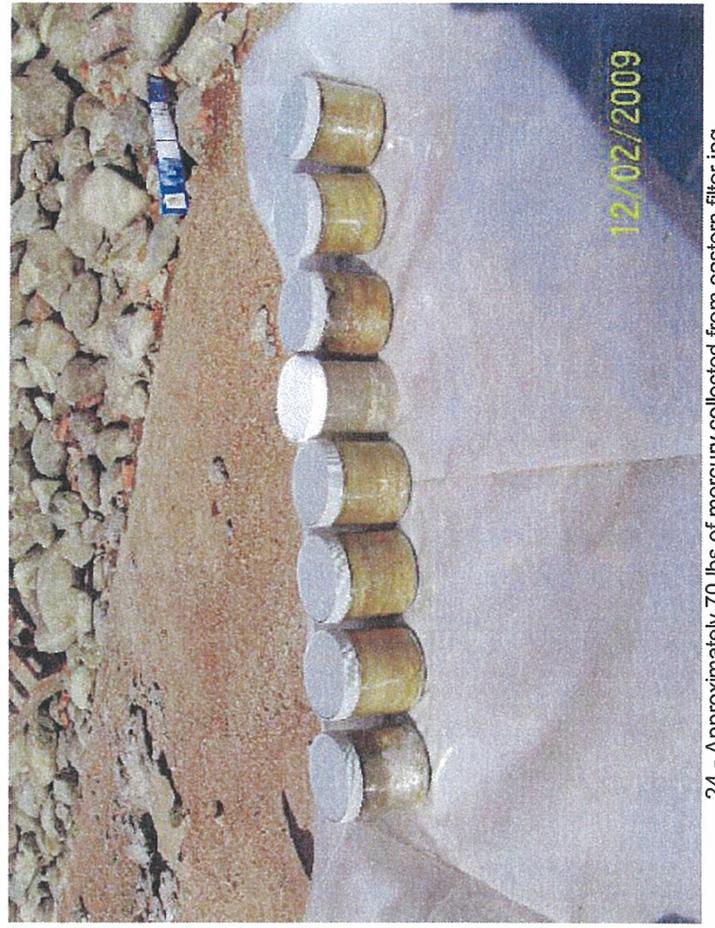
The mercury captured by the mercury vacuum was collected into 16oz glass jars. Eight jars with a total weight of approximately 70lbs (later weighed and revised from the original estimate of 90lbs) were used for the eastern filter. Due to the fact that this was approximately half of the 134lbs listed on the materials list, *SHC* believed that there was a total of 134lbs of mercury placed in the two filters.

24 - Approximately 70 lbs of mercury collected from eastern filter.jpg
12/02/2009

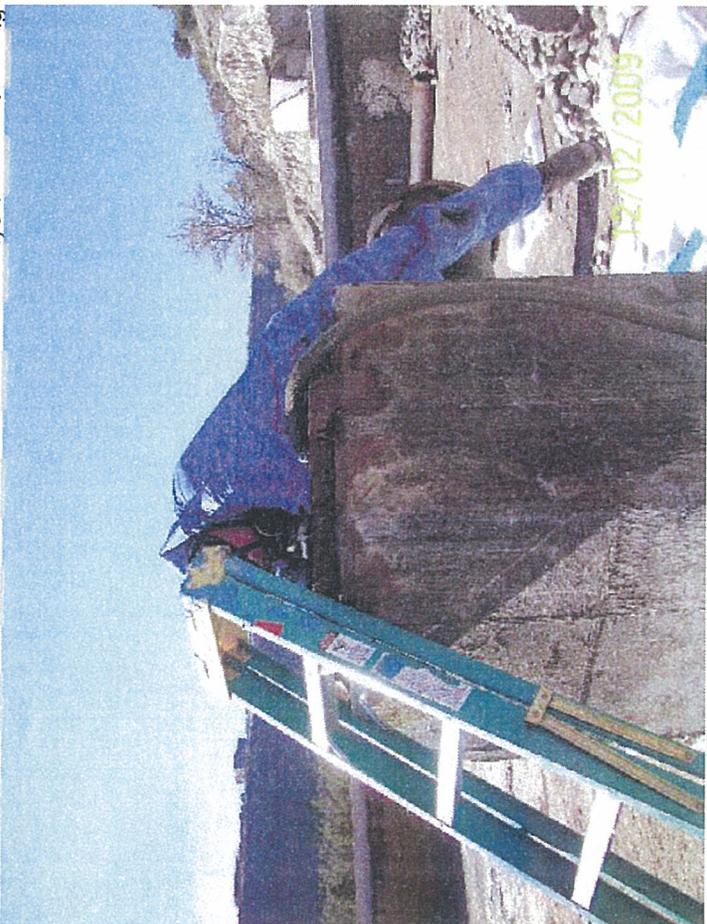
Any mercury that had spilt into the feeder pipe during the dismantling process was vacuumed up. Potentially contaminated plastic from the secondary containment and PPE was placed into bags

25 - Removing small beads of mercury from feeder pipe.jpg
12/02/2009

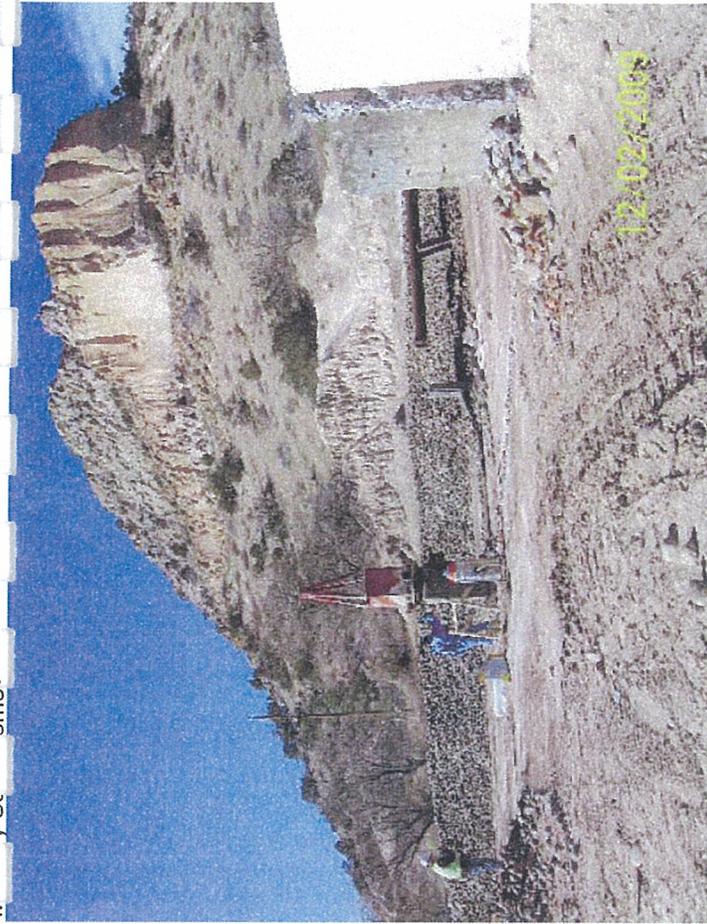
Upon arriving at the western filter, *SHC* personnel observed several areas of the concrete floor where mercury had been spilt. After some investigation, it was determined that the mercury had spilt from the feeder pipe when the 20ft section of pipe was removed. Close inspection of the feeder pipe still attached to the vertical support column and of the section of feeder pipe on the ground found that there was mercury located under a layer of sludge and ice within the pipes. Due to the amount of mercury on the ground and where the mercury was located, *SHC* determined that the mercury had leaked into the pipe prior to *SHC*'s arrival on the site and prior to Road Construction Southwest's demolition. The fact that the mercury was found underneath a layer of sludge and underneath a layer of ice several feet along the horizontal sections of the feeder pipe supports this determination. Road Construction Southwest, Inc. and the County of Los Alamos were notified of the spill and would come out to the site to observe the site.

26 - Western filter where mercury spill occurred.jpg
12/02/2009

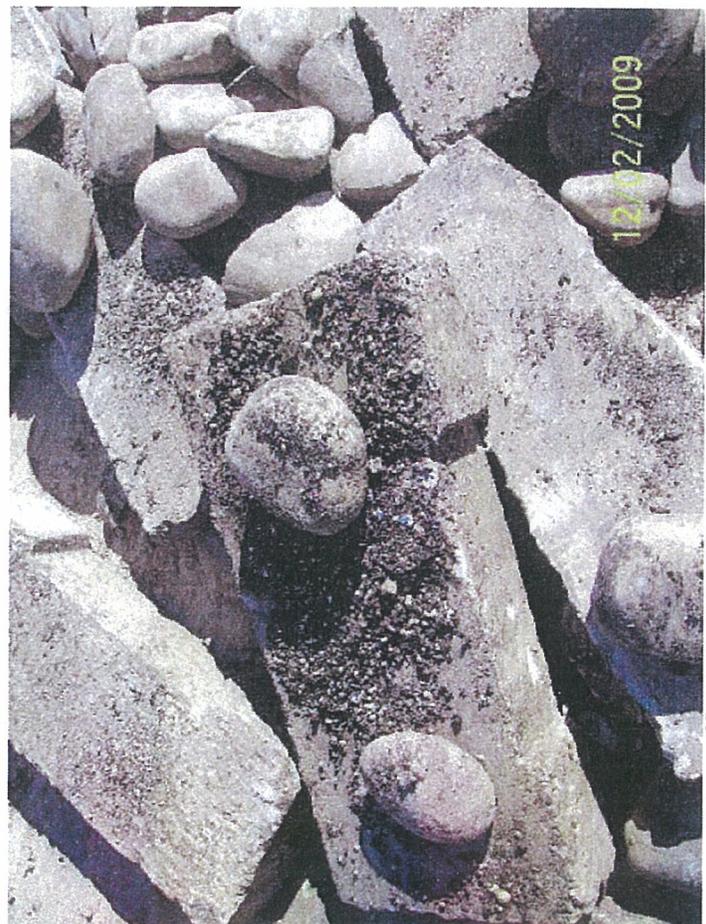
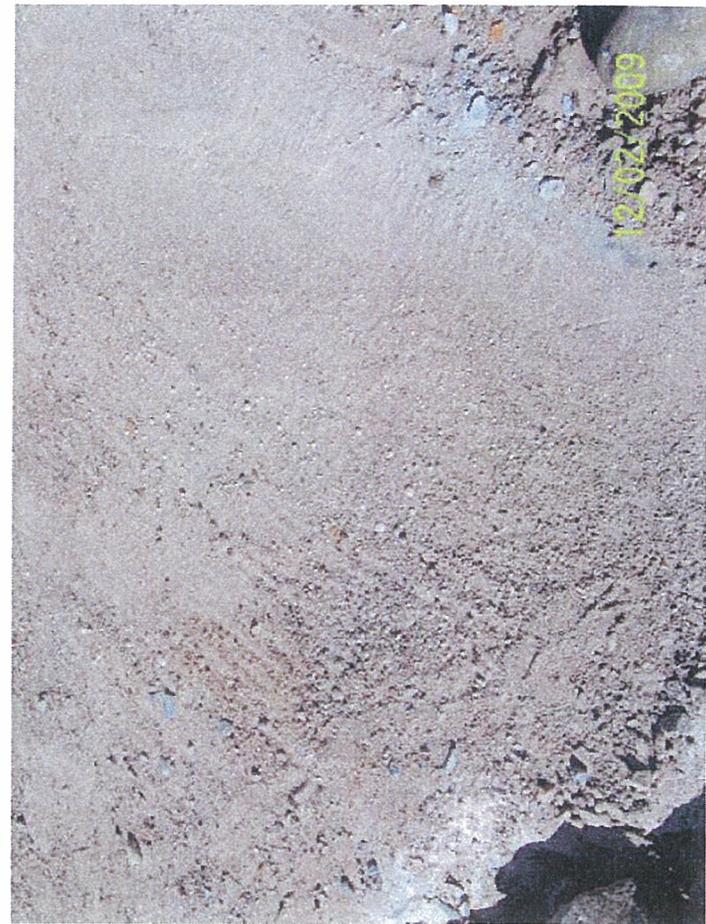
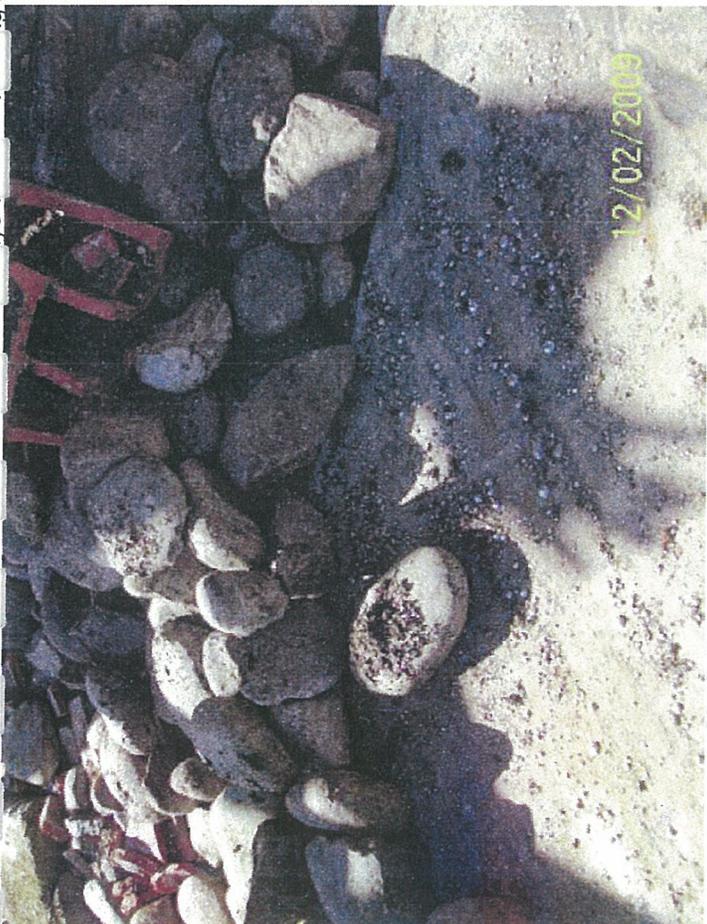
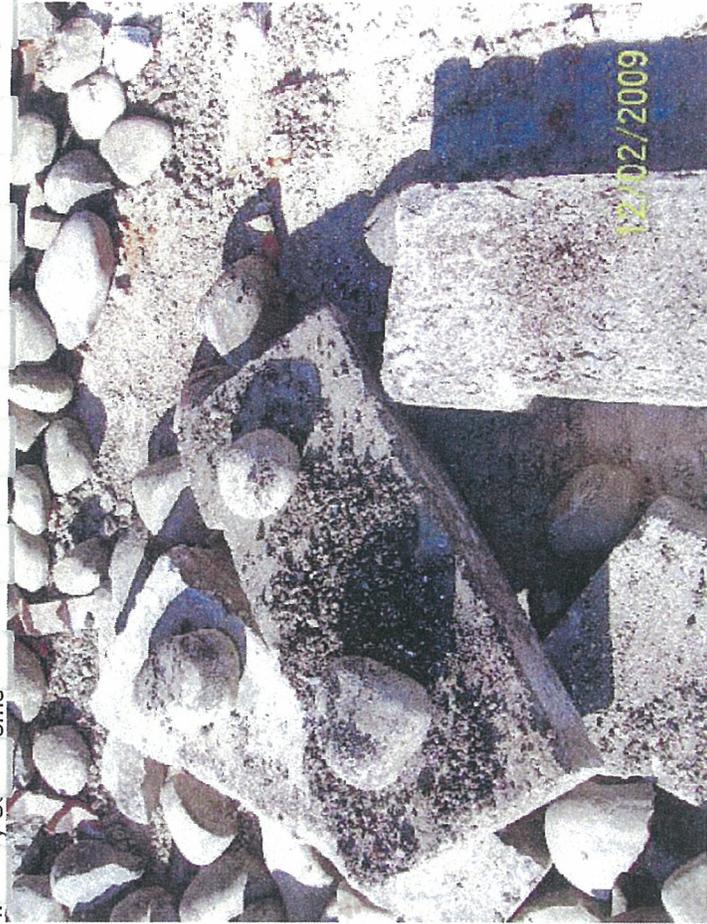
27 - Spilt mercury on ground around western filter.jpg
12/02/2009

28 - Spilt mercury on ground around western filter.jpg
12/02/2009

29 - Spill mercury on ground around western filter.jpg
12/02/2009

30 - Spill mercury on ground around western filter.jpg
12/02/2009

SHC returned to the site to clean up the mercury spill around the western filter. *SHC* personnel donned level C PPE and removed contaminated rock, brick, and dirt from two concrete channels that went around and extended out from the filter. The contaminated material was stockpiled on the concrete until the roll-off container arrived. Mercury was found inside the channel in several areas and potentially contaminated material was removed until there was no further evidence that the leak had spread.

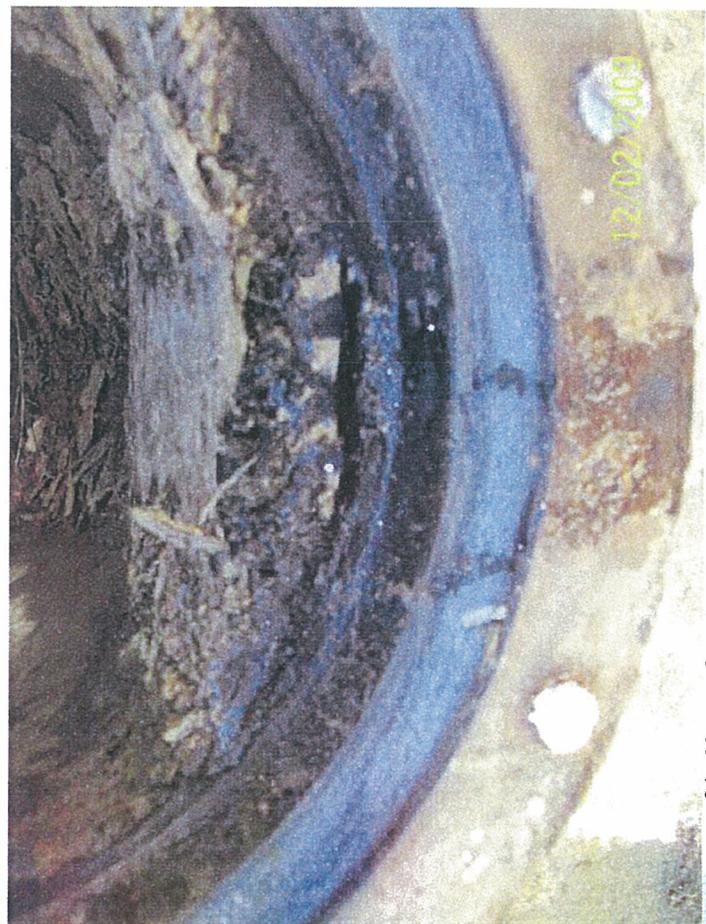
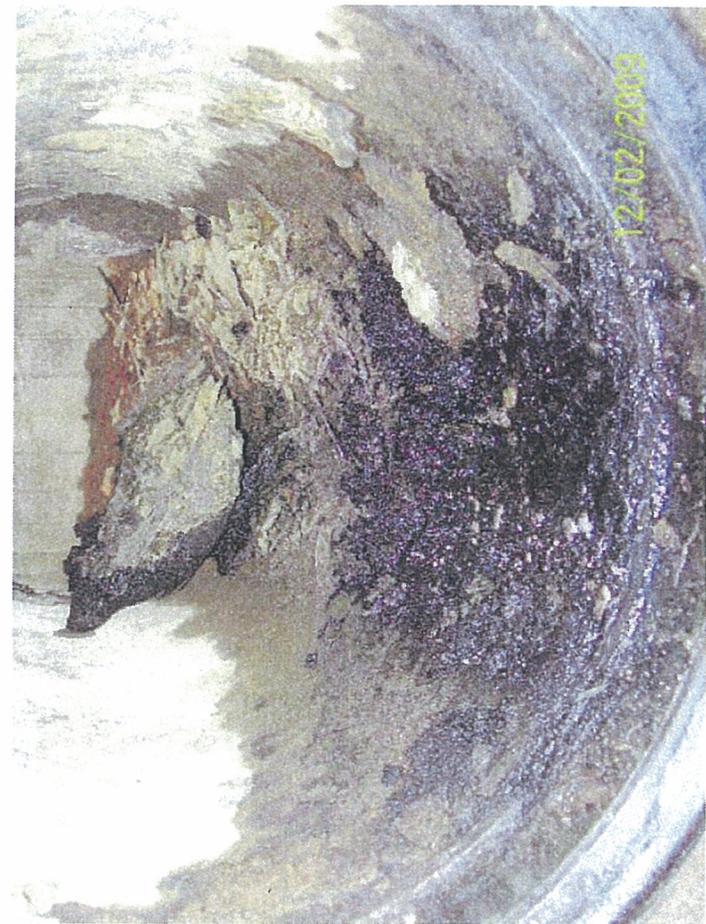
31 - Mercury found under sludge and ice in effluent feeder pipe.jpg
12/02/2009

32 - Mercury buried under sludge and ice.jpg
12/02/2009

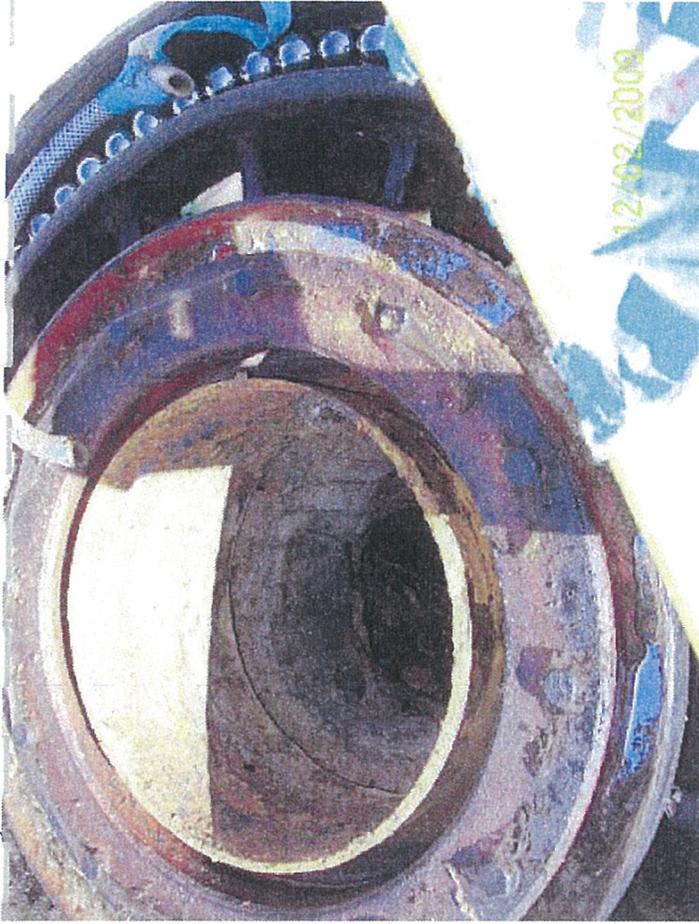
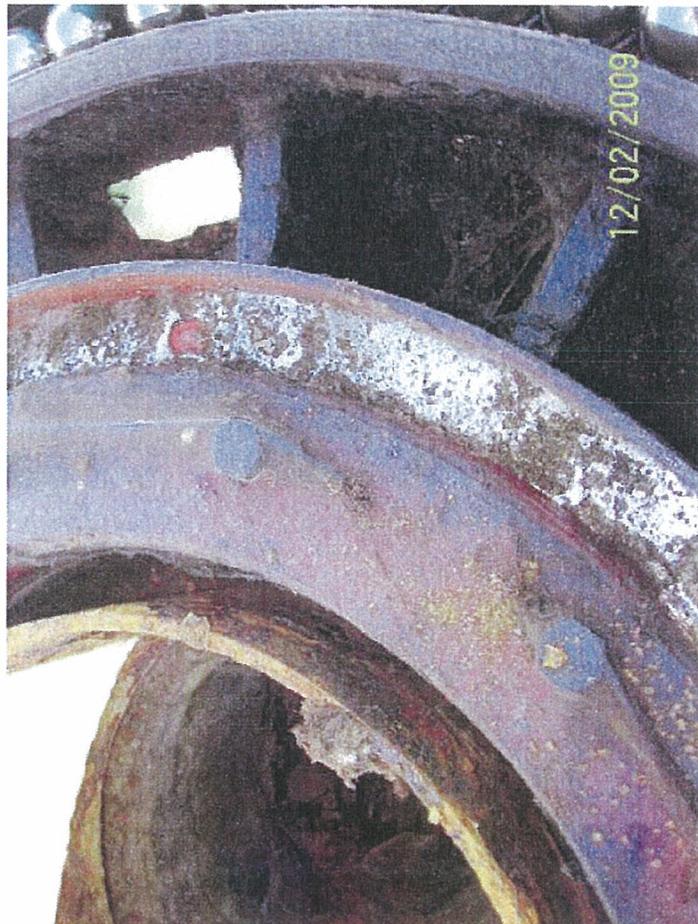
The spill area was blocked off while *SHC* personnel began dismantling the rotating equipment on the western filter. Using the same process as before, *SHC* personnel removed the top and central sections of the rotating equipment from the vertical support column. As before, the majority of the visible mercury was found in the stationary section still attached to the support column. The top and central sections were decontaminated and after being monitored and found suitable for recycling, were placed in the scrap metal recycling bin. The mercury vacuum was used to remove the mercury from the stationary section. Unlike the eastern filter, significantly less mercury was removed from the rotating equipment on the western filter.

34 - Elemental mercury in stationary section with mercury seal.jpg
12/02/2009

35 - Elemental mercury in stationary section with mercury seal.jpg
12/02/2009

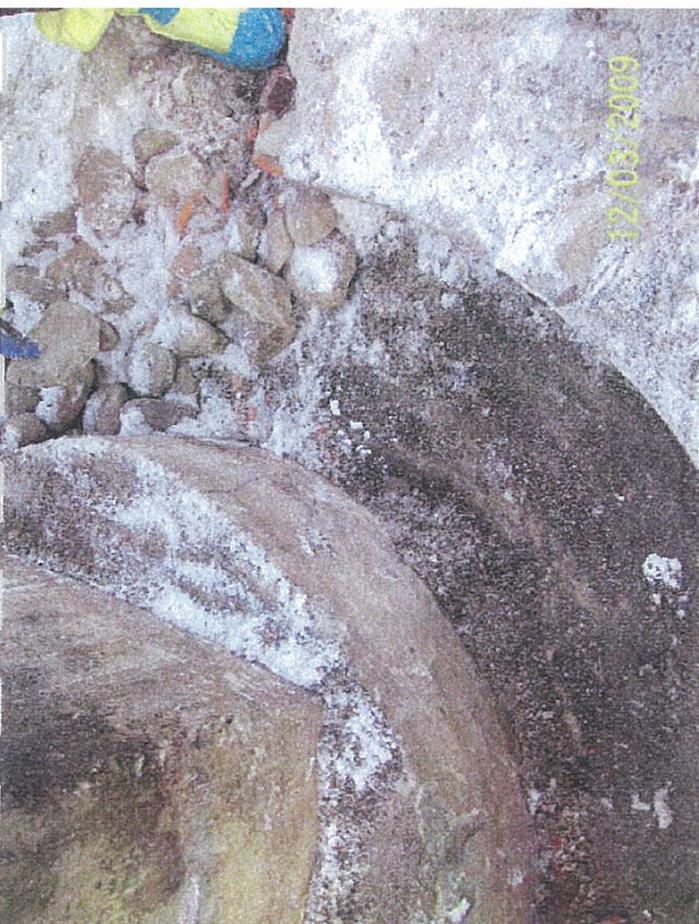
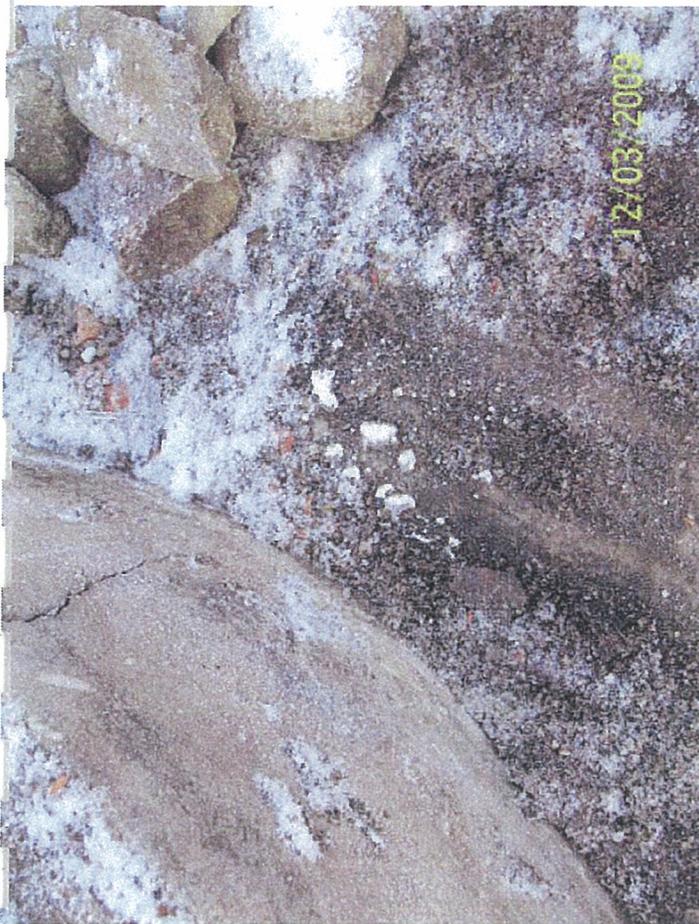
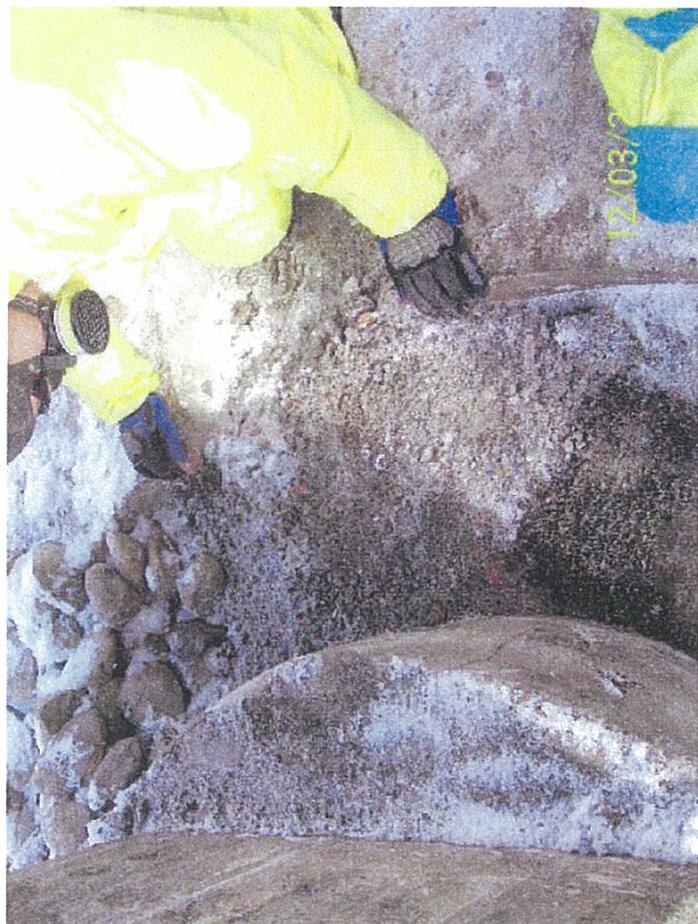
41 - Spill mercury at the base of the filter.jpg
12/03/2009

42 - Spill mercury at the base of the filter.jpg
12/03/2009

44 - Spill mercury at the base of the filter.jpg
12/03/2009

Visible mercury was vacuumed up from the channels and floor of the trickling pond. The area was also swept to move any remaining mercury missed by the vacuum into the stockpile. Due to the freezing temperatures, mercury vapor monitoring was unpractical and was not done.

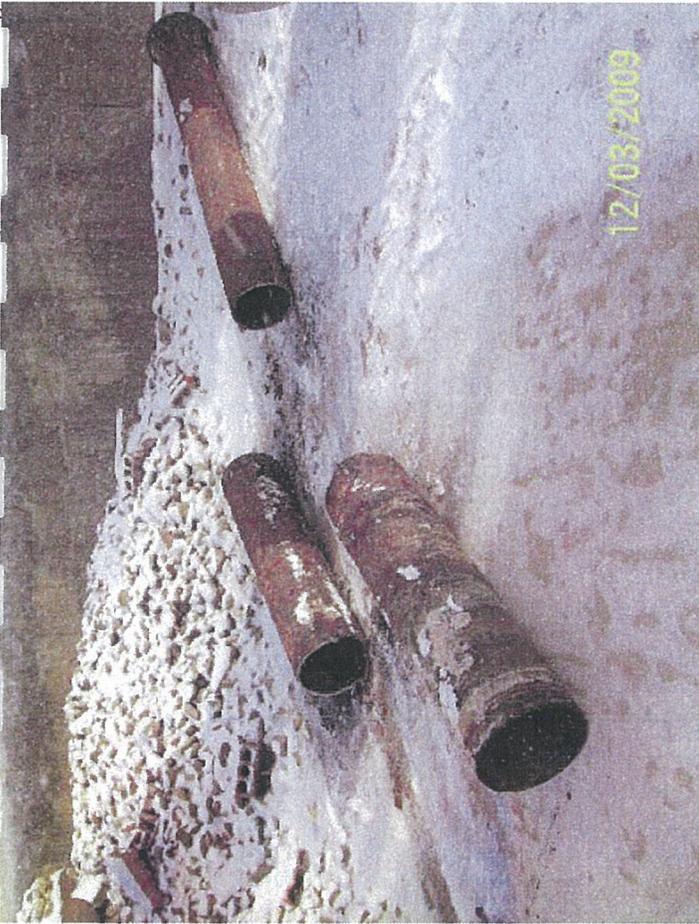
The 20ft section of feeder pipe that was removed was inspected for additional mercury contamination. After inspection it appeared that only half of the pipe was potentially contaminated. Road Construction Southwest personnel used a saw and cut the pipe in half. Half of the pipe was found to be free of any mercury contamination. *SHC* personnel attempted to decontaminate the other 10ft section of feeder pipe, however, *SHC* found areas that could not be

decontaminated. The contaminated pipe would be placed in the roll-off for disposal.

45 - Contaminated and uncontaminated sections of effluent feeder pipe.jpg
12/03/2009

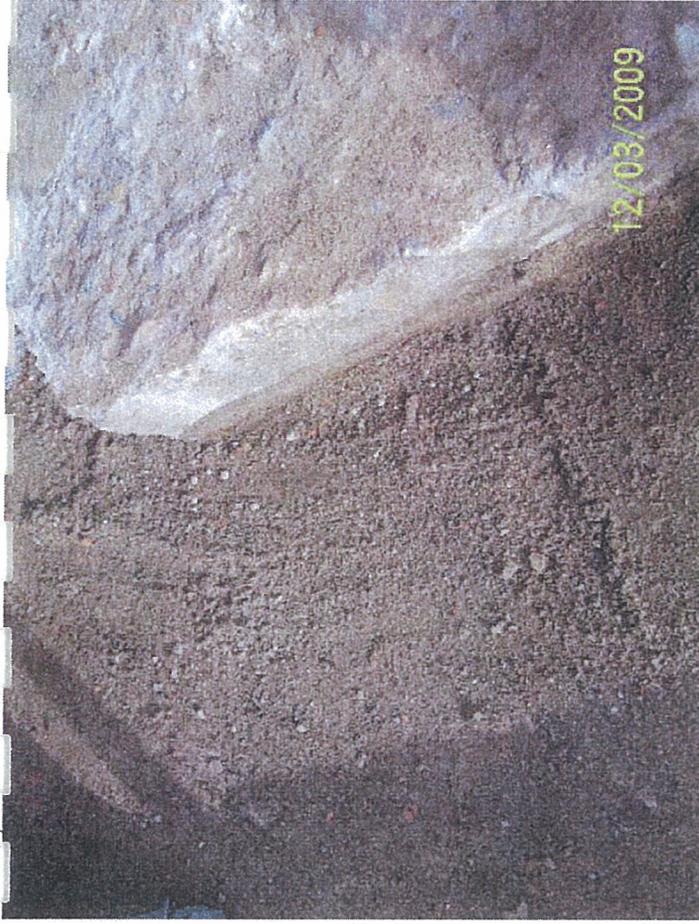
46 - Spilt mercury on the floor around the filter.jpg
12/03/2009

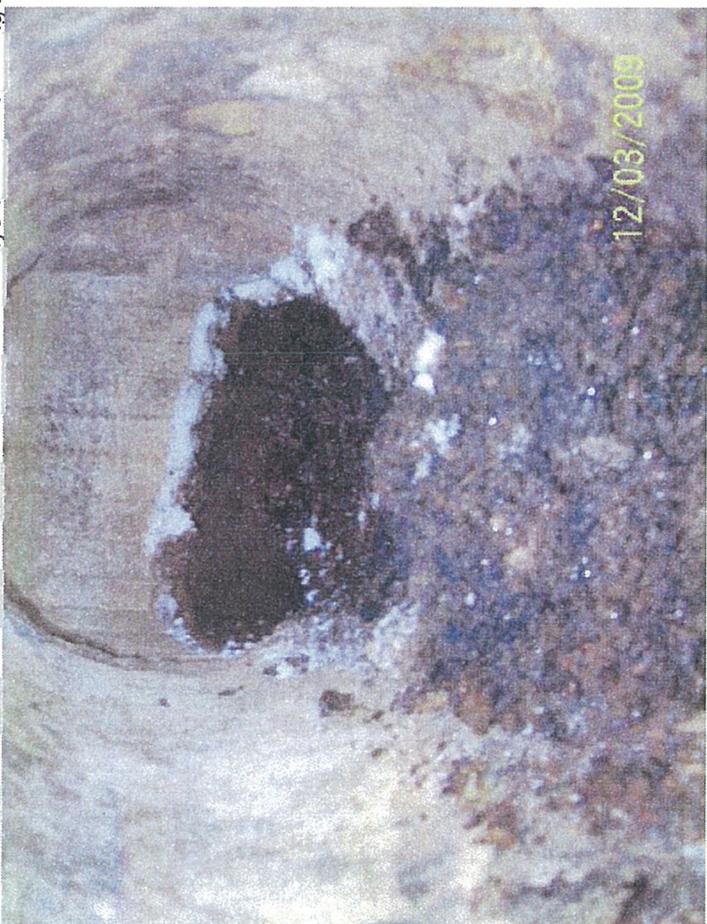
49 - Mercury imbedded in the feeder pipe sludge.jpg
12/03/2009

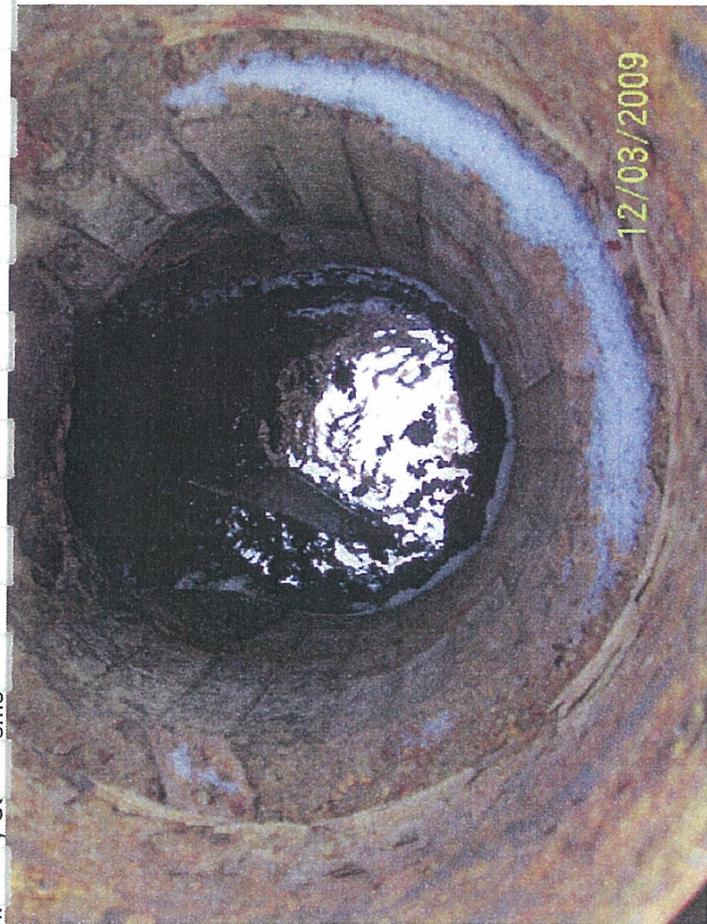
SHC personnel removed the sludge from inside the section of feeder pipe connected to the vertical support column. After removing a top layer of sludge, *SHC* personnel found a pool of elemental mercury approximately 12" in diameter and ½" deep in the bottom of the vertical section of feeder pipe. An estimated 20-25lbs of mercury was removed from the pipe using the mercury vacuum. This large pool of mercury found under the sludge and ice supports the determination that the leak in the mercury seal occurred prior to demolition and may have in fact been several years old.

50 - Pool of elemental mercury that leaked into the feeder pipe of the filter.jpg
12/03/2009

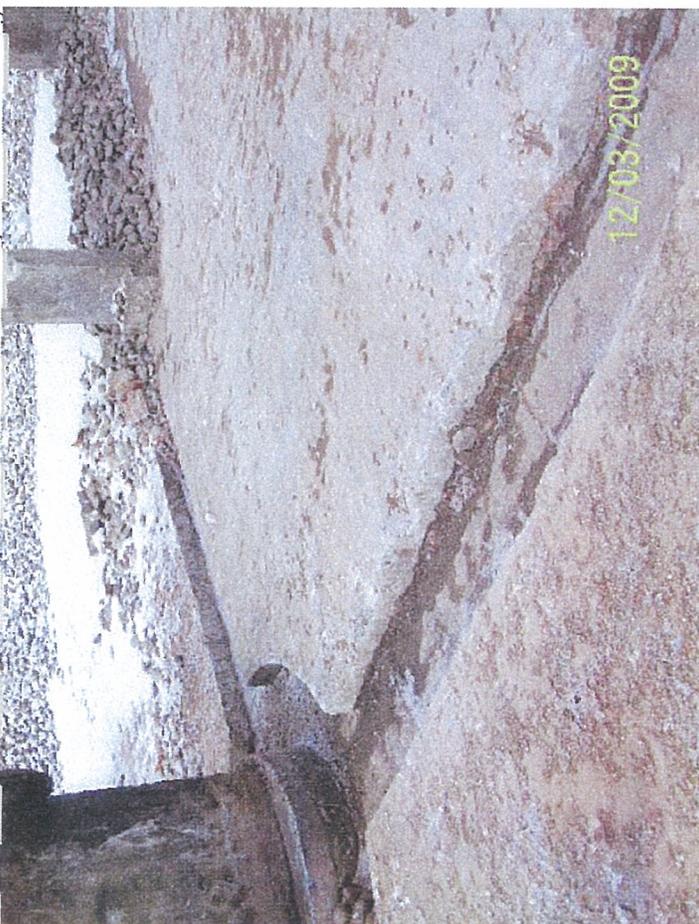
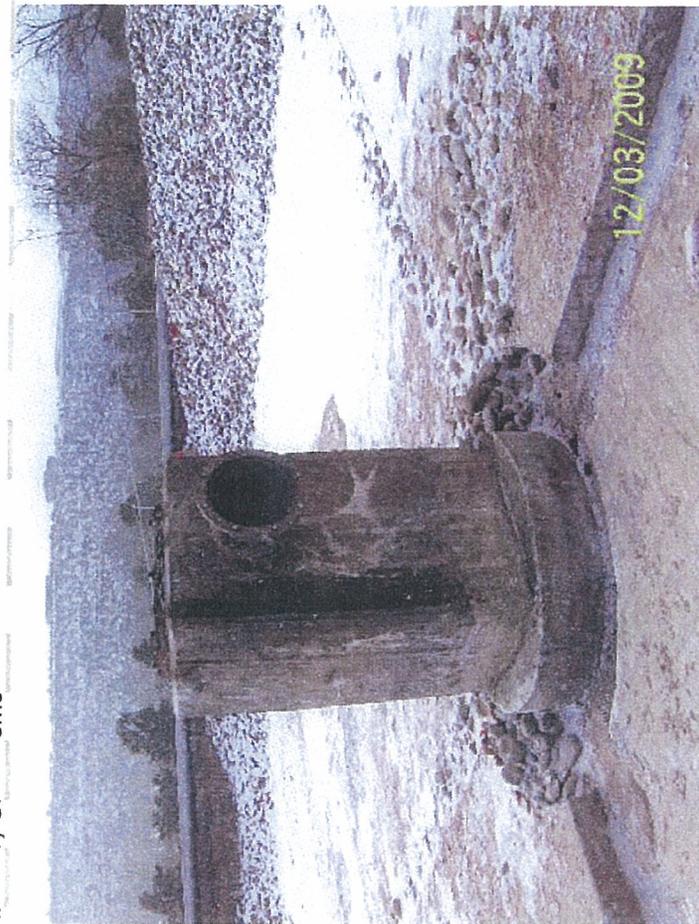
61 -Area where mercury spill occurred.jpg
12/03/2009

62 - Area where mercury spill occurred.jpg
12/03/2009

SHC personnel decontaminated the bucket of the excavator used to load the material and packed up supplies to return to Tucson. No remaining evidence of the mercury spill was found and *SHC* recommends that no further remedial actions be taken regarding the incident. An approximate total of 133.5lbs of mercury was collected in jars by the mercury vacuum and was lab packed into a 30-gallon container that would be brought back to *SHC* for disposal at a permitted facility.

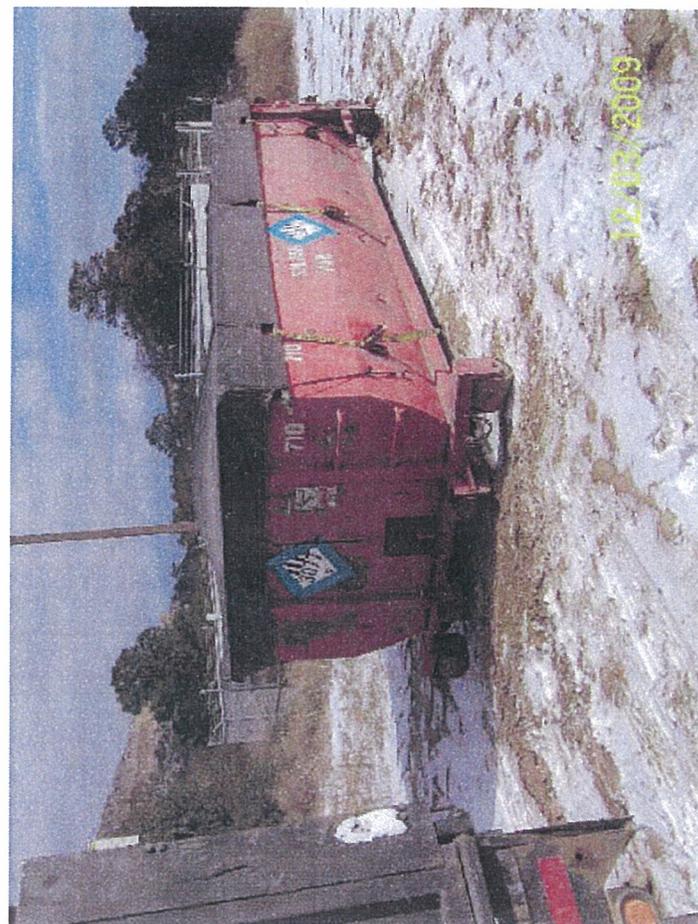
64 - 20 yd roll-off container with mercury contaminated debris.jpg
12/03/2009

CTI transported the 20yd roll-off container of mercury contaminated debris to US Ecology in Beatty, NV for disposal.
