FINAL CONDITION REPORT

Building 2, DPW, TA-21

Prepared by: H-1 Health Physics Group

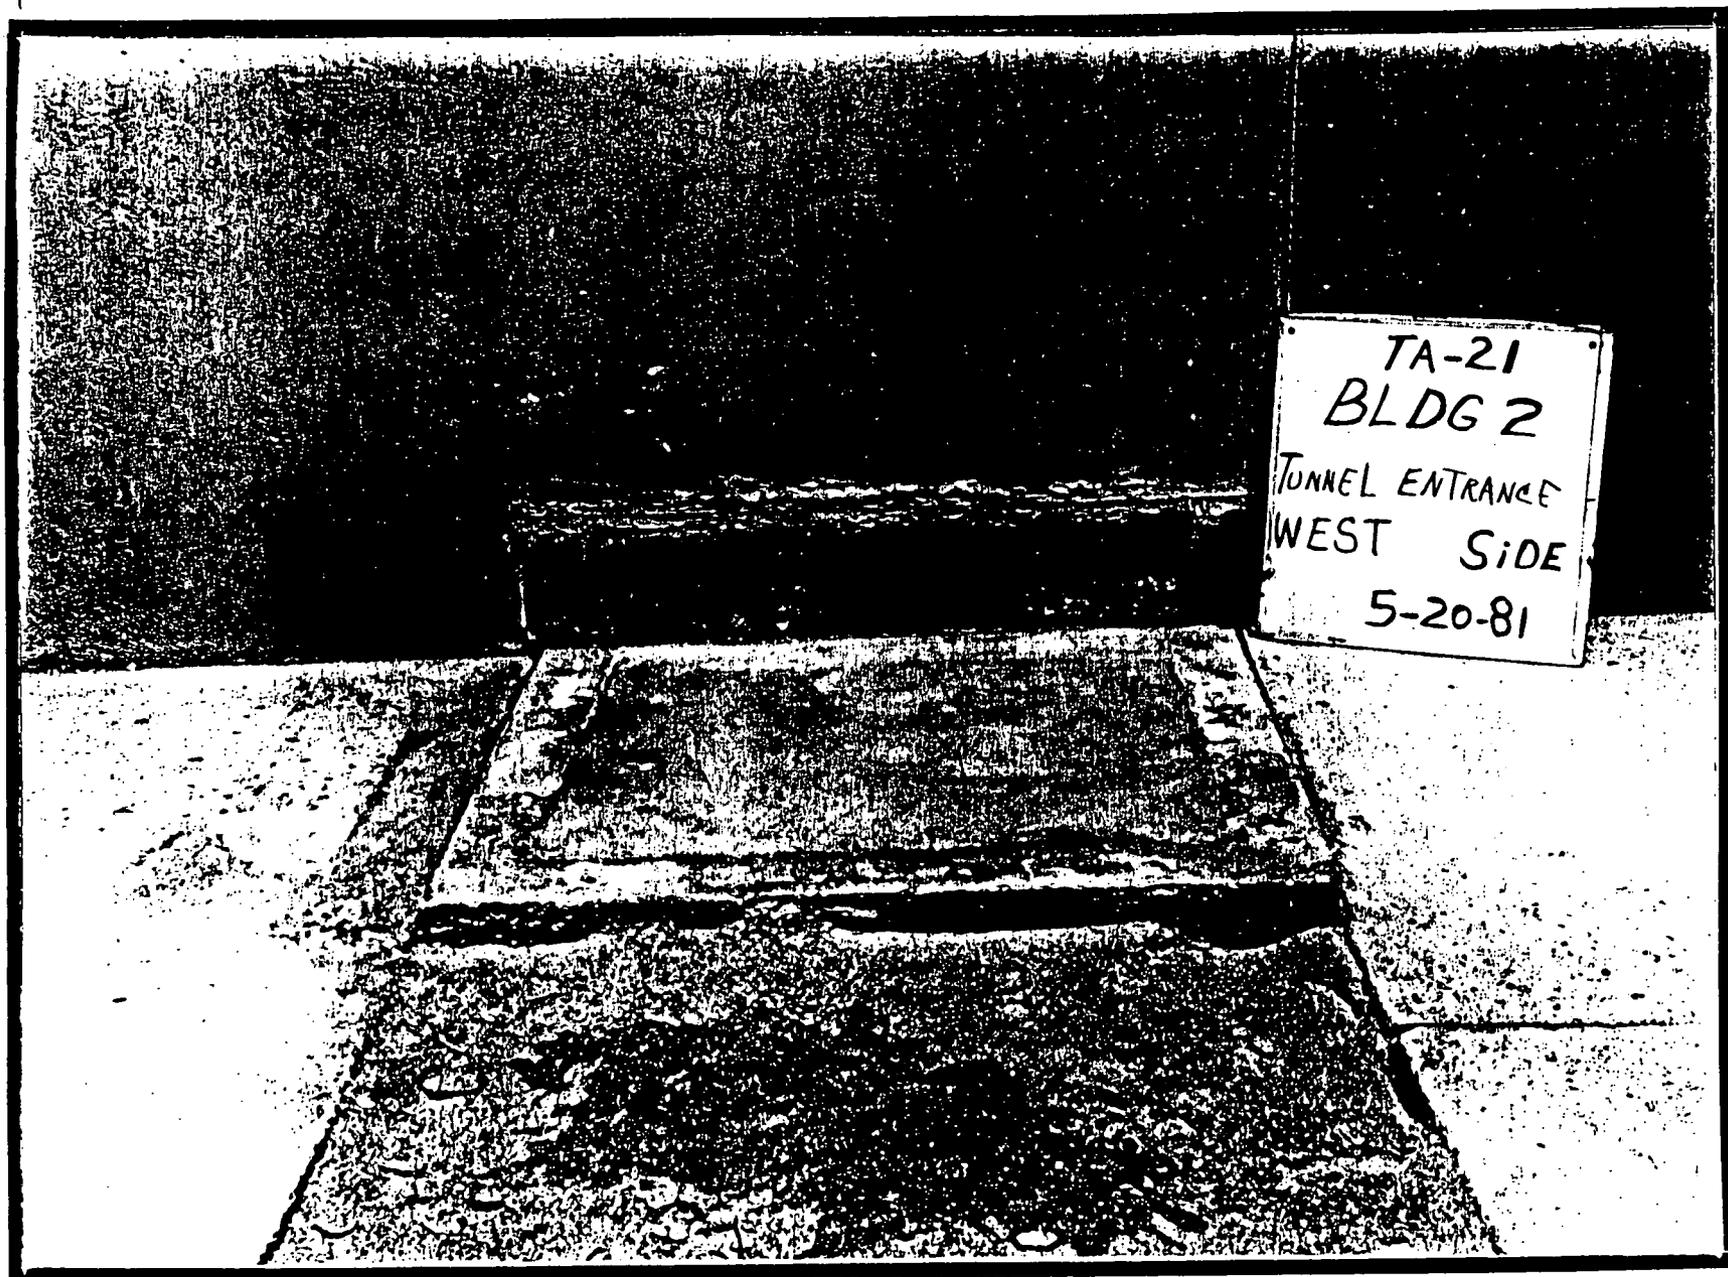
Fig. 51. Cement cover, perimeter tunnel west side of building. NEG #813727

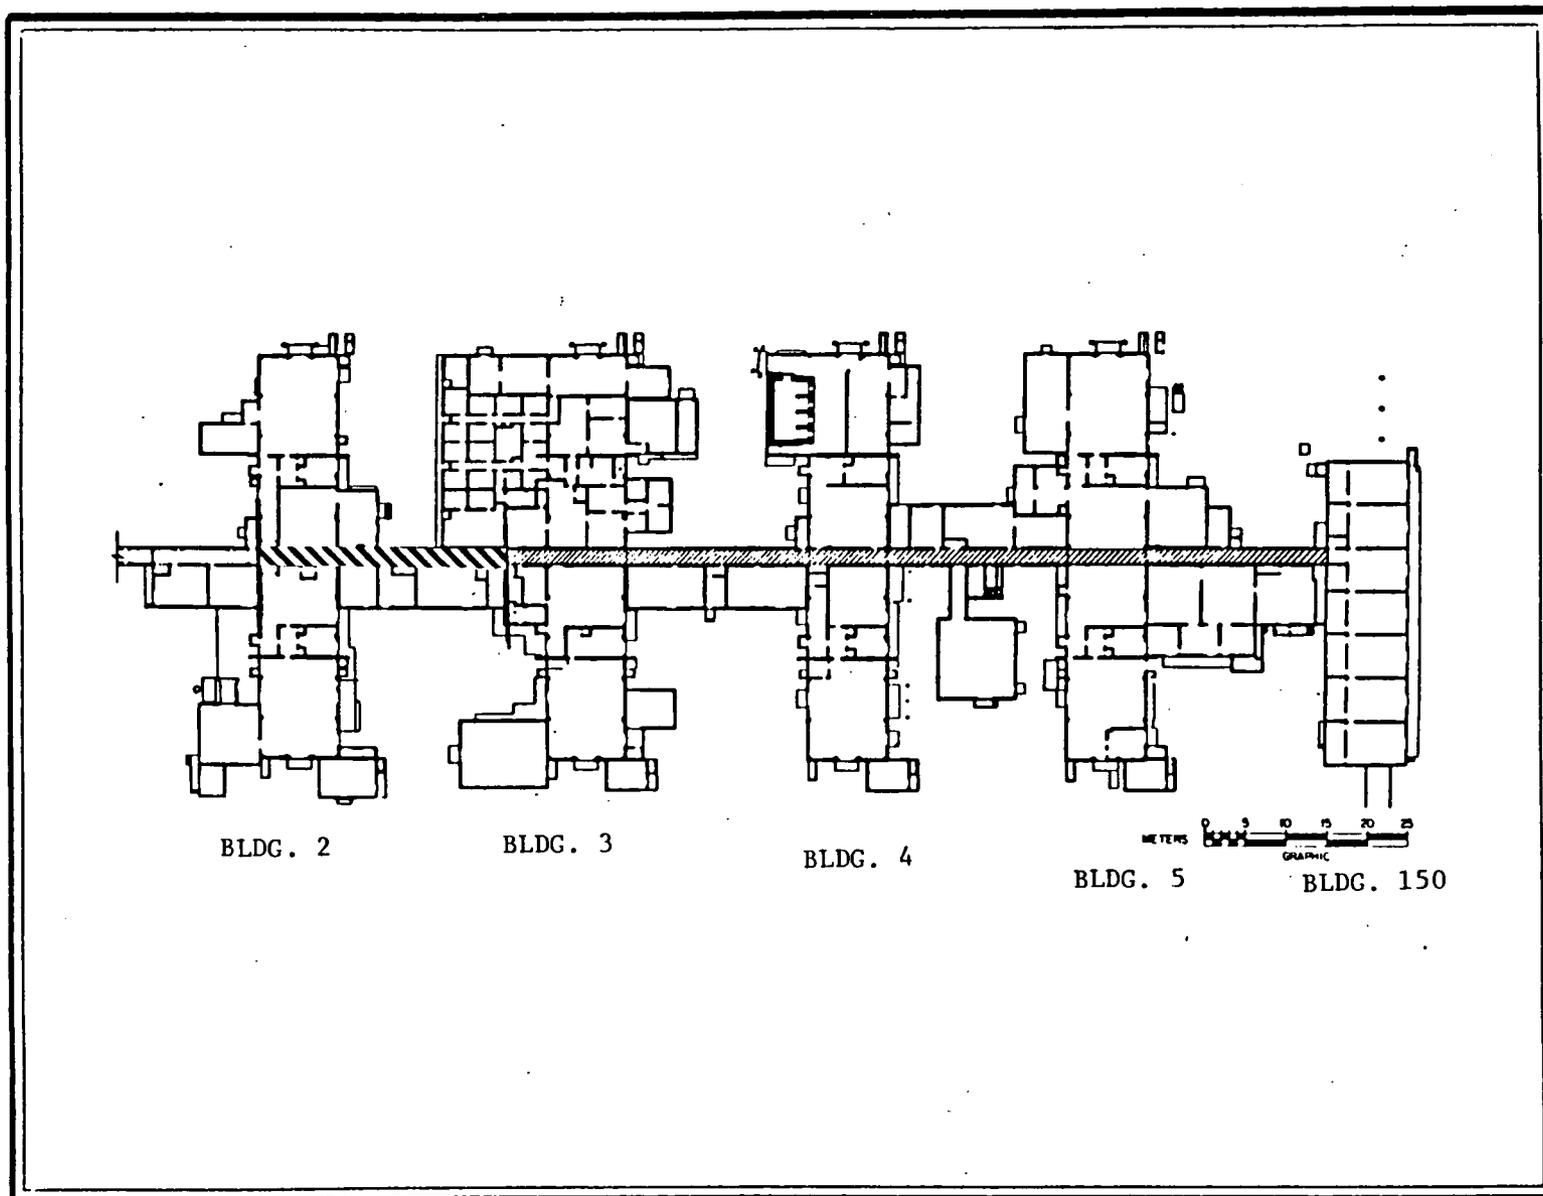
Fig. 53. Overhead utility passageway decontaminated as part of Building 2.
