DEMOLITION OF STRUCTURES AT AREA 11, TA-49

H-1 support was provided a Zia crew during the demolition and removal of the structures in area 11 at TA-49. Three of the structures were known to be alpha contaminated. This fact was known because of previous use, and radiological surveys made during and after occupation of the structures. This report will explain the support provided by H-1 personnel during the operation. The report will be a day by day account.

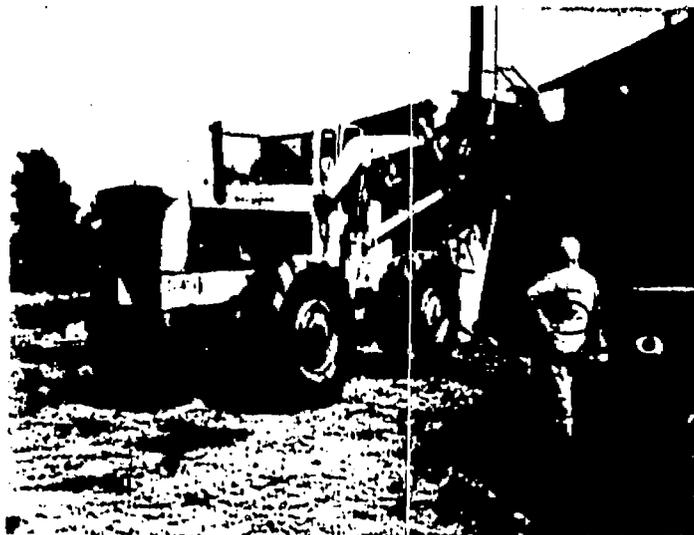
Fig. 12. The west entrance to TA-49-15 was found to be free of any detectable radioactive material and was quickly removed for non-contaminated disposal by use of a front-end loader.

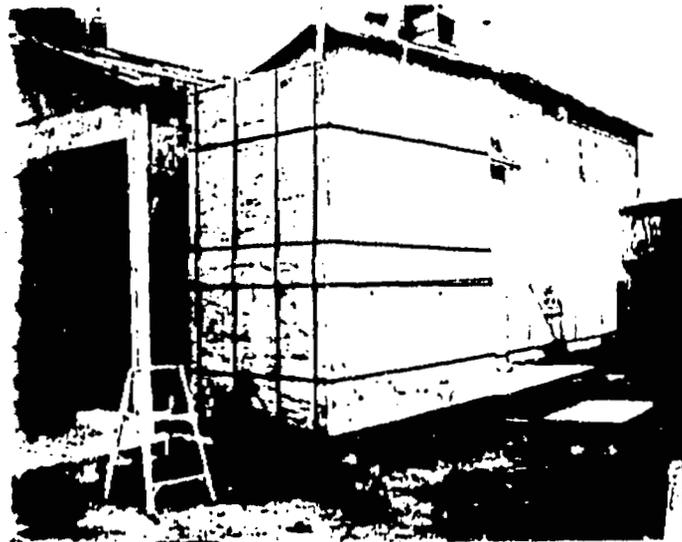
Fig. 21. This box is ready for shipment to TA-54 for storage. The boxes have been sealed both inside and outside at all joints with plastic caulking and steel bands placed around the boxes to prevent rupture during transit.

All of the radioactive contaminated material was placed in boxes made of 3/4" exterior plywood. The boxes were nailed at each joint, silicone caulking was spread inside and outside of each joint. The boxes were steel banded. They were painted designating the TA-49 area and the date the box was filled and enclosed.
