RE: Recommendation regarding replacing Alluvial Well SCA-1

Date: June 21, 2011

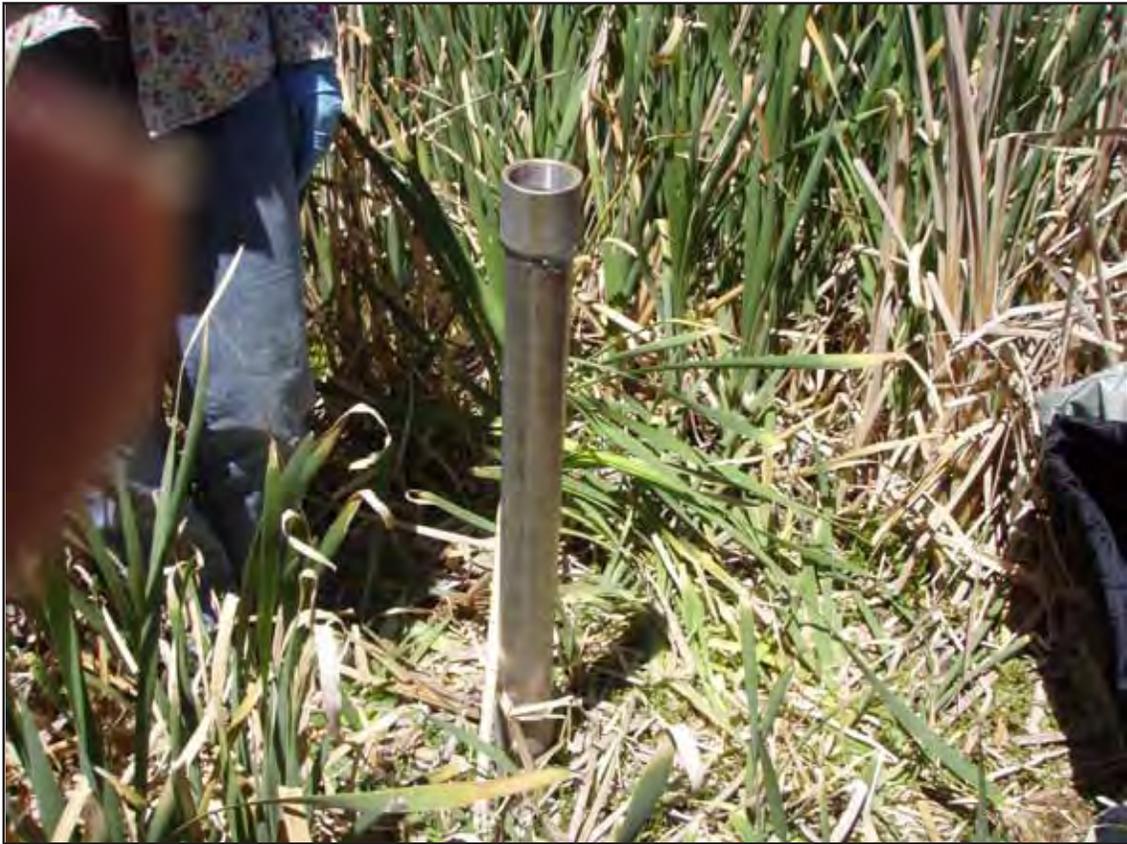
Figure 1. SCA-1-DP in wetland prior to cleaning, June 14, 2011

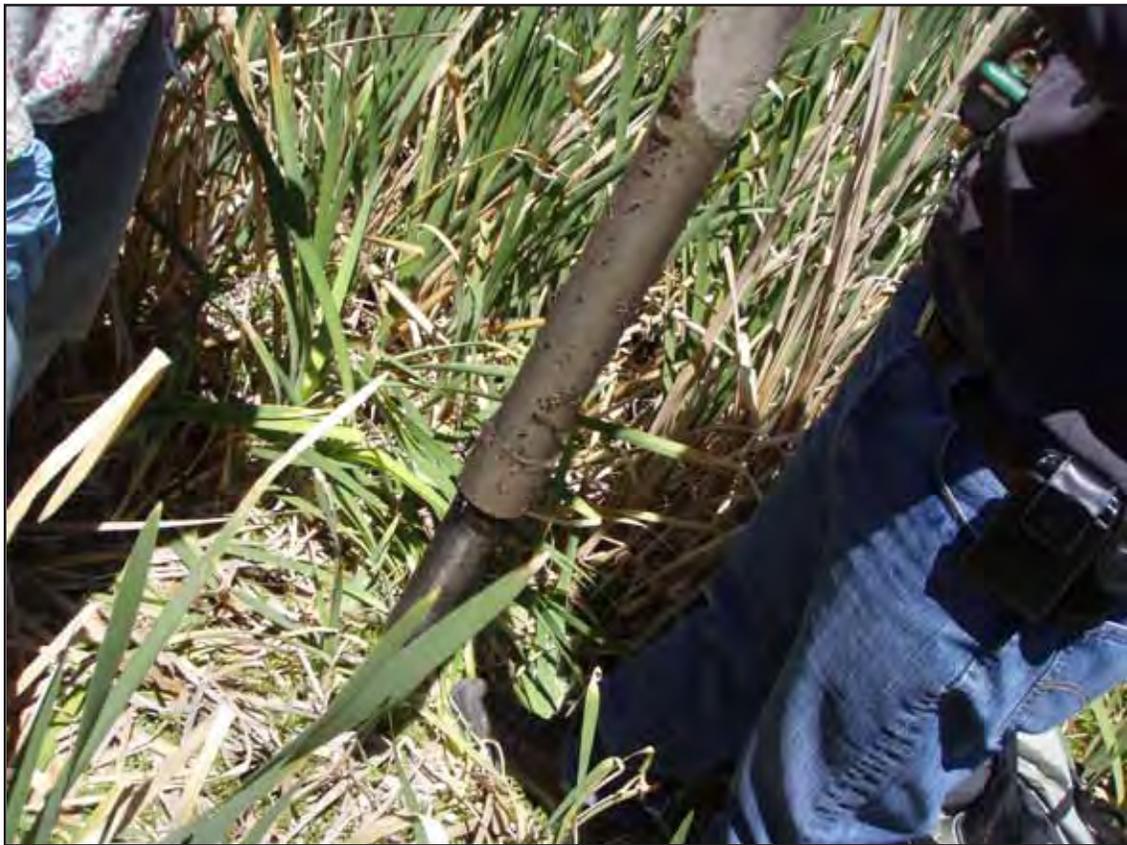
Figure 2. Removing SCA-1-DP for cleaning, June 14, 2011

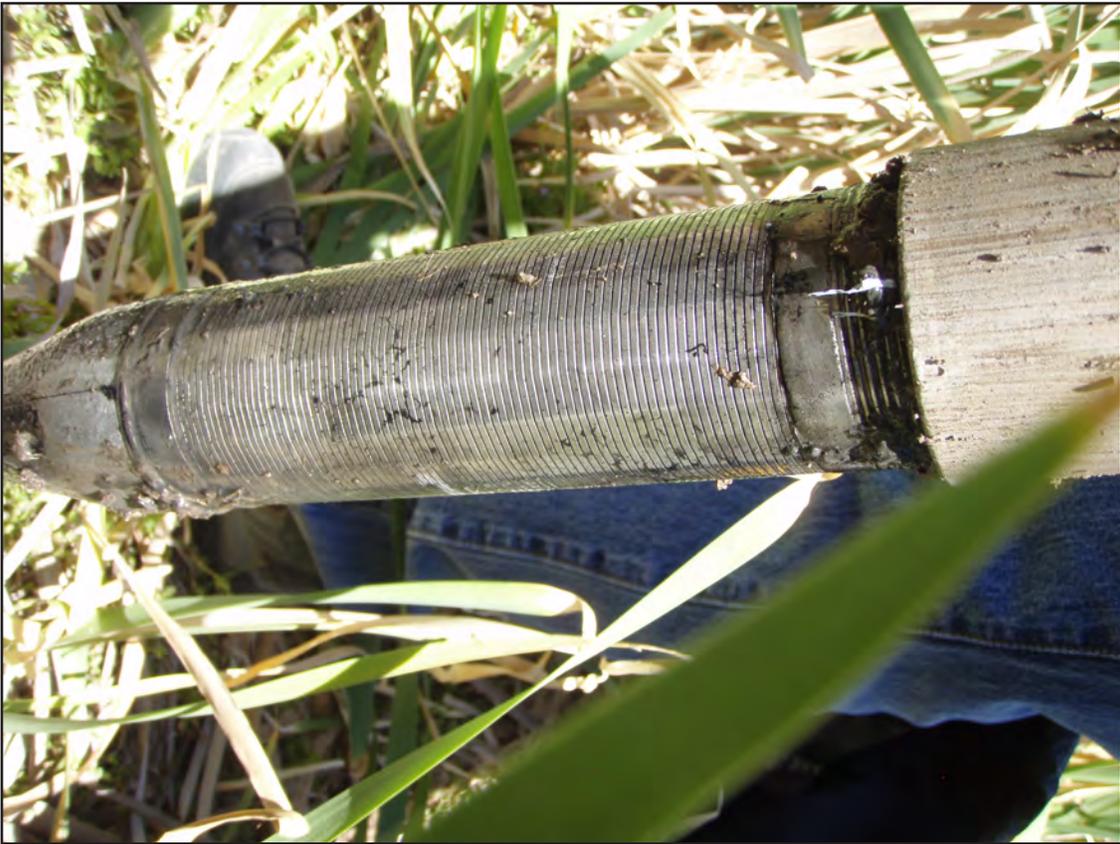
Figure 3. Six inch long screen on SCA-1-DP prior to cleaning, June 14, 2011

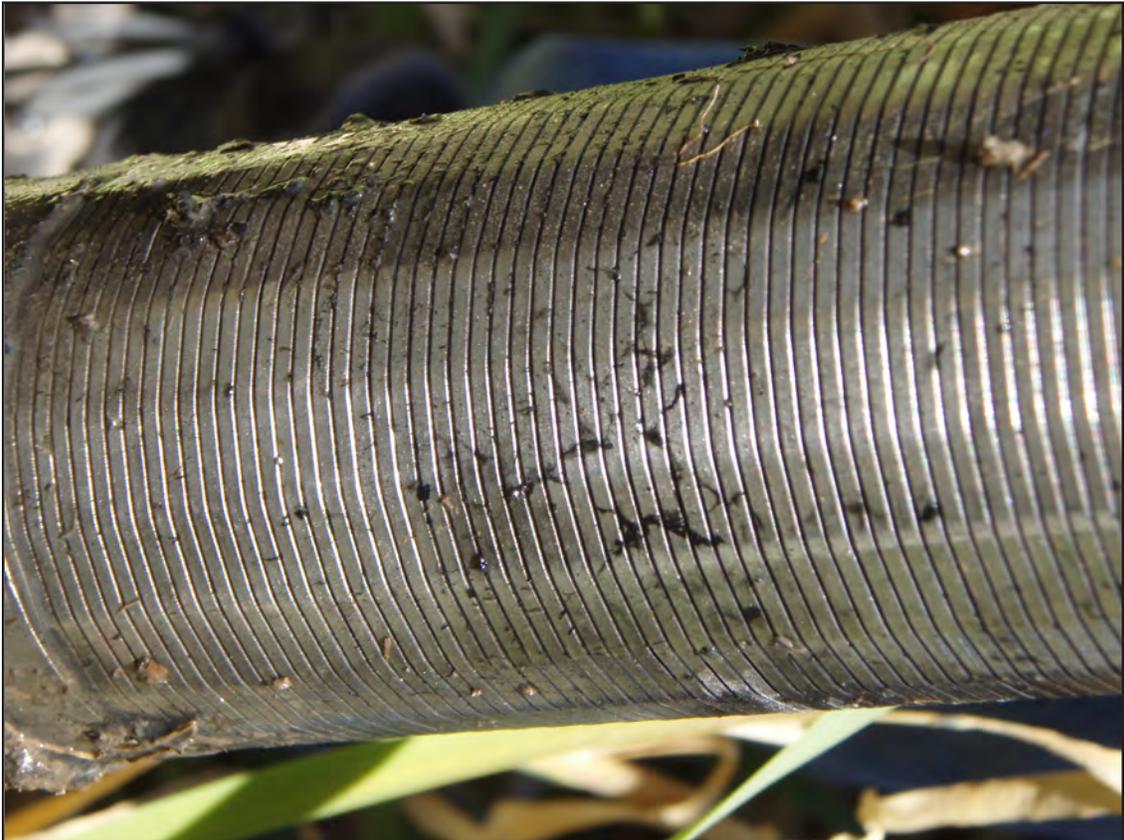
Figure 4. Close-up view of screen SCA-1-DP showing no mineral build-up, June 14, 2011
