2012 Update to the Site Discharge Pollution Prevention Plan, Revision 1

Los Alamos National Laboratory
NPDES Permit No. NM0030759
LA-UR-13-21503 • May 1, 2013

Water/Cañon de Valle Watershed

Volume 4

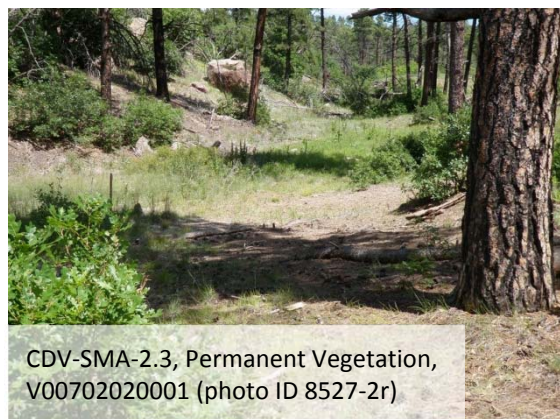
CDV-SMA-2.3, Permanent Vegetation, V00702020001 (photo ID 8527-2r)

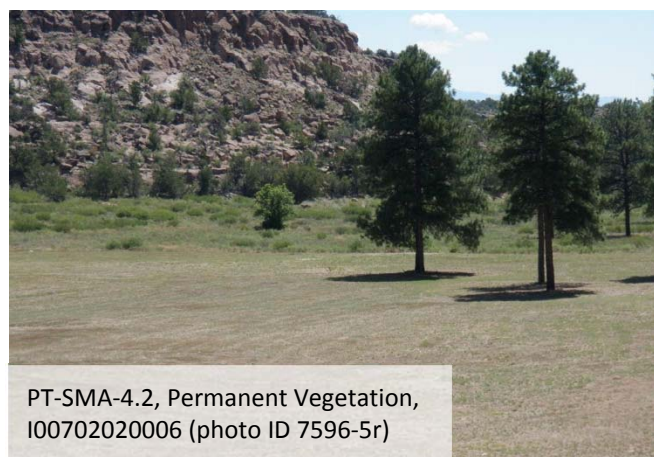
PT-SMA-4.2, Permanent Vegetation,
I00702020006 (photo ID 7596-5r)
