**Los Alamos**  
NATIONAL LABORATORY  
**memorandum**

To/MS: Dennis Erickson, ESH-DO, MS K491  
Thru: Larry Stretz, ESA-WMA, MS C930  
From/MS: Doug Hemphill, ESA-WMA, MS C930  
Phone/FAX: 7-8335/5-5548  
Symbol: ESA-WMA-94-015  
Date: October 7, 1994

**SUBJECT: RESPONSE TO APPARENT FINDINGS FROM THE ANNUAL  
RCRA INSPECTION OUT-BRIEFING**

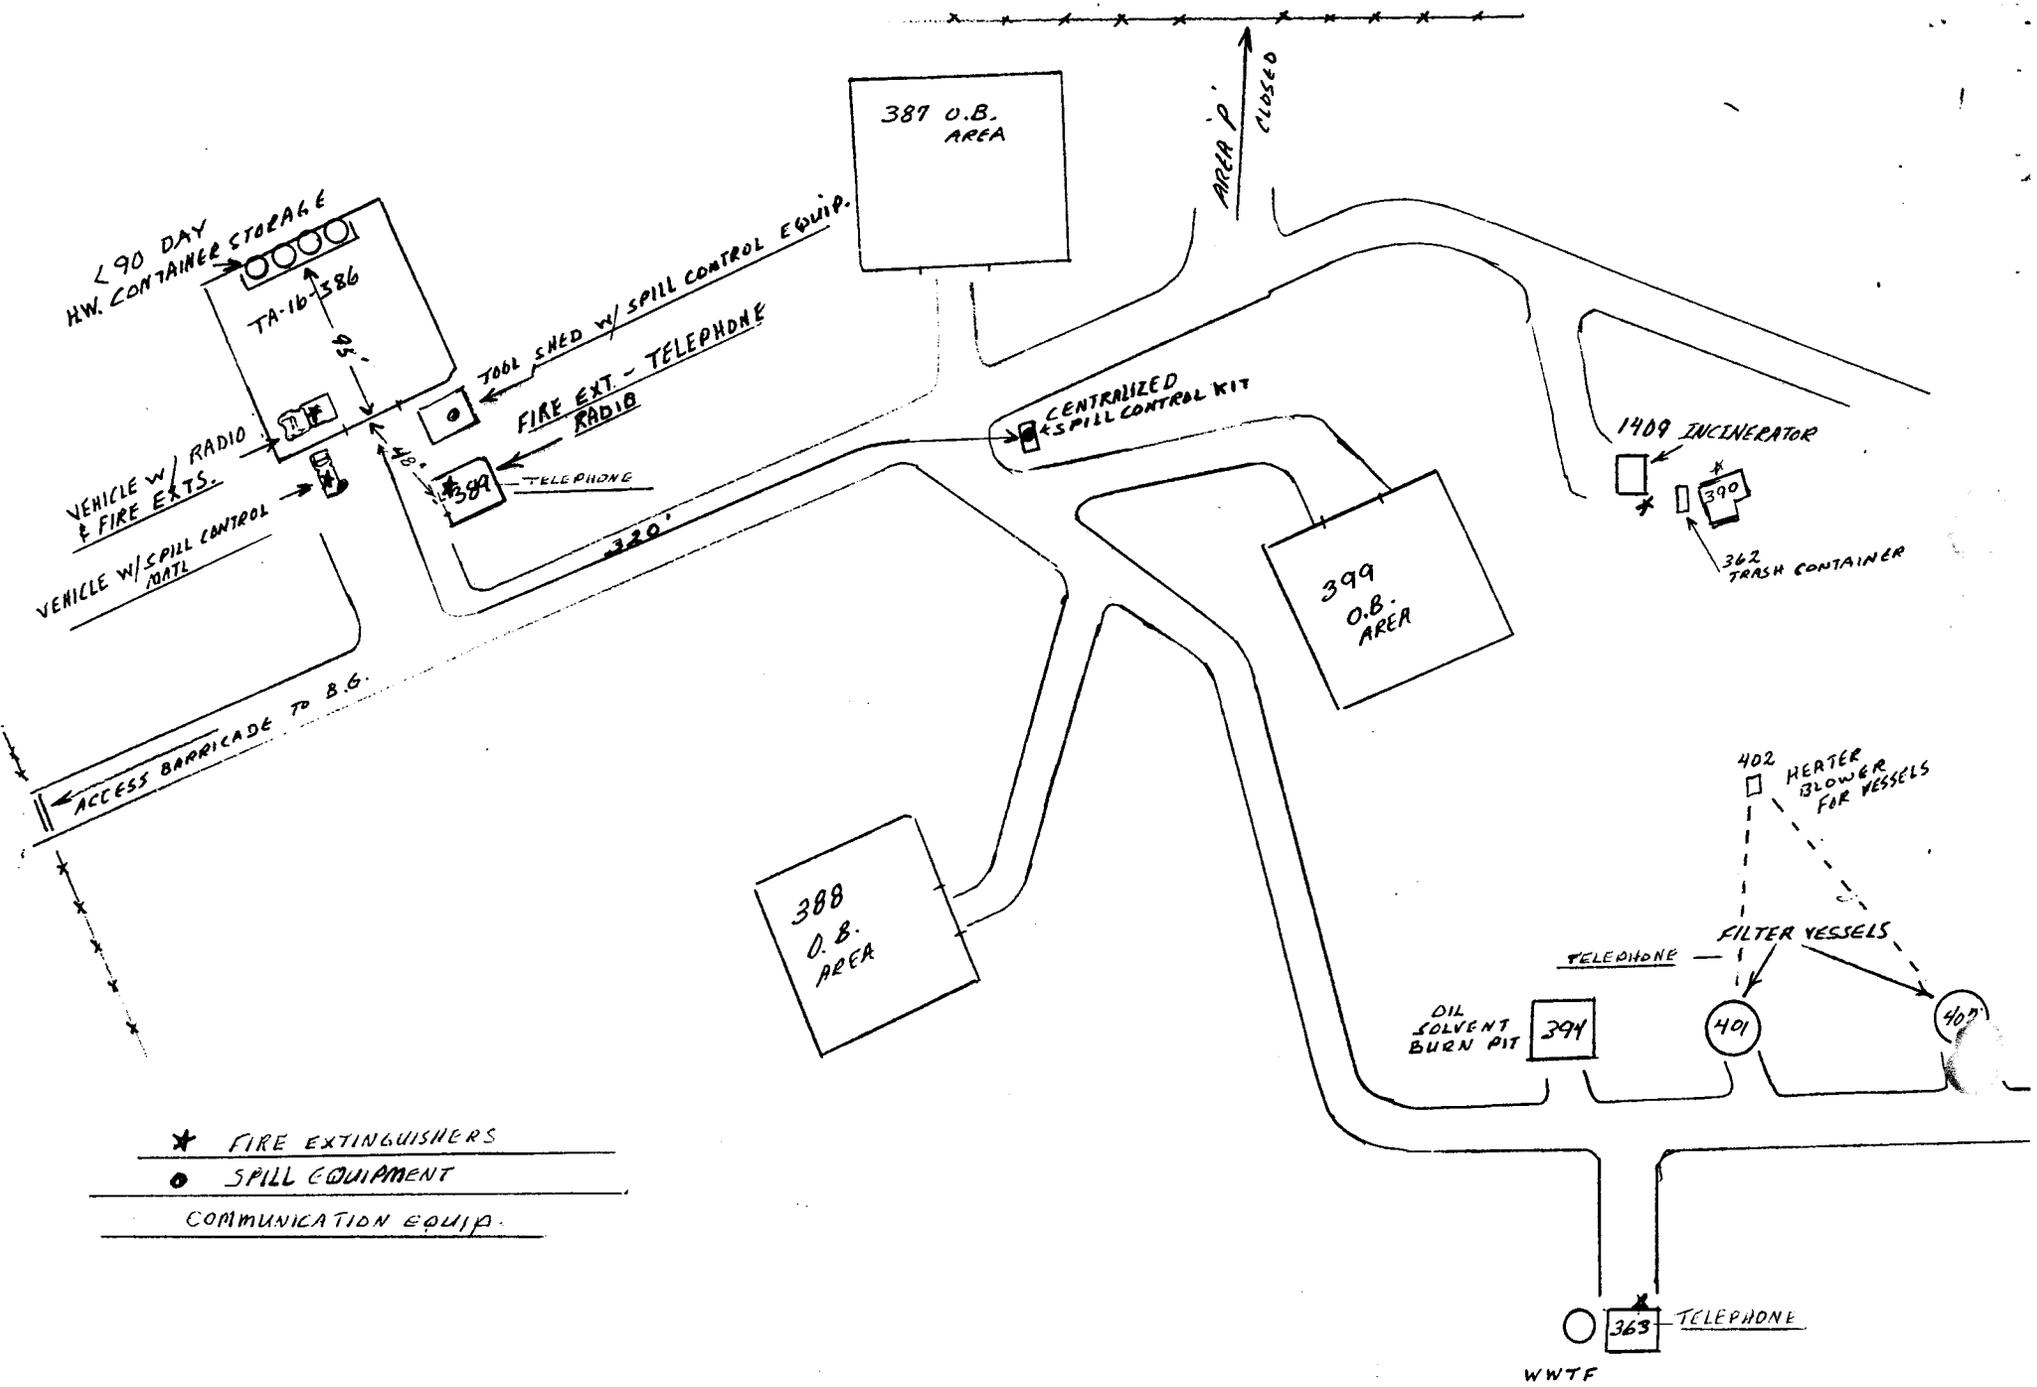
Attachment 1

**Apparent Finding** TA-16-386 - ESA-2 - This <90 day storage location did not have: any spill control equipment, an eyewash station located nearby, any communications at the site, nor any fire extinguishers.

**Response** Attachment 1. is a map of the TA-16 Burning Ground facility with locations of fire extinguishers, telephones, radios, eyewash stations and spill control equipment. Because of the nature of operations, the entire facility has been formally designated as a <90 day storage area. The majority of hazardous and non-hazardous waste is located within a fenced area shown on Attachment 1. Spill control equipment is located permanently at a central location within the facility. Additional spill control equipment is available in the vacuum truck typically parked within 10 feet of the storage area at the 386 pad, and in the tool shed located adjacent to the storage area. An eyewash station is located in the burn ground control building (16-389), approximately 48 feet from the storage area gate. Communications equipment available include a telephone and radio inside the control building, one radio located in the HE transportation truck parked usually inside or within 25 feet of the storage area, and a personnel pager worn by the lead supervisor. Several fire extinguishers are available to operating personnel at the storage area including one in the control building, and five more located in the three trucks parked in or within 25 feet of the front of the storage area and three more located throughout the facility. All the above listed emergency equipment have been in place since the entire burn ground was designated as a < 90 day storage area.
