7 May 1997

RE: Department of Energy Oversight Bureau (DOE OB) Inspection Observations and Recommendations concerning NPDES outfalls scheduled for deletion through the Waste Stream Characterization Program at Los Alamos National Laboratory (LANL).

DOE OB Inspection Observations and Recommendations

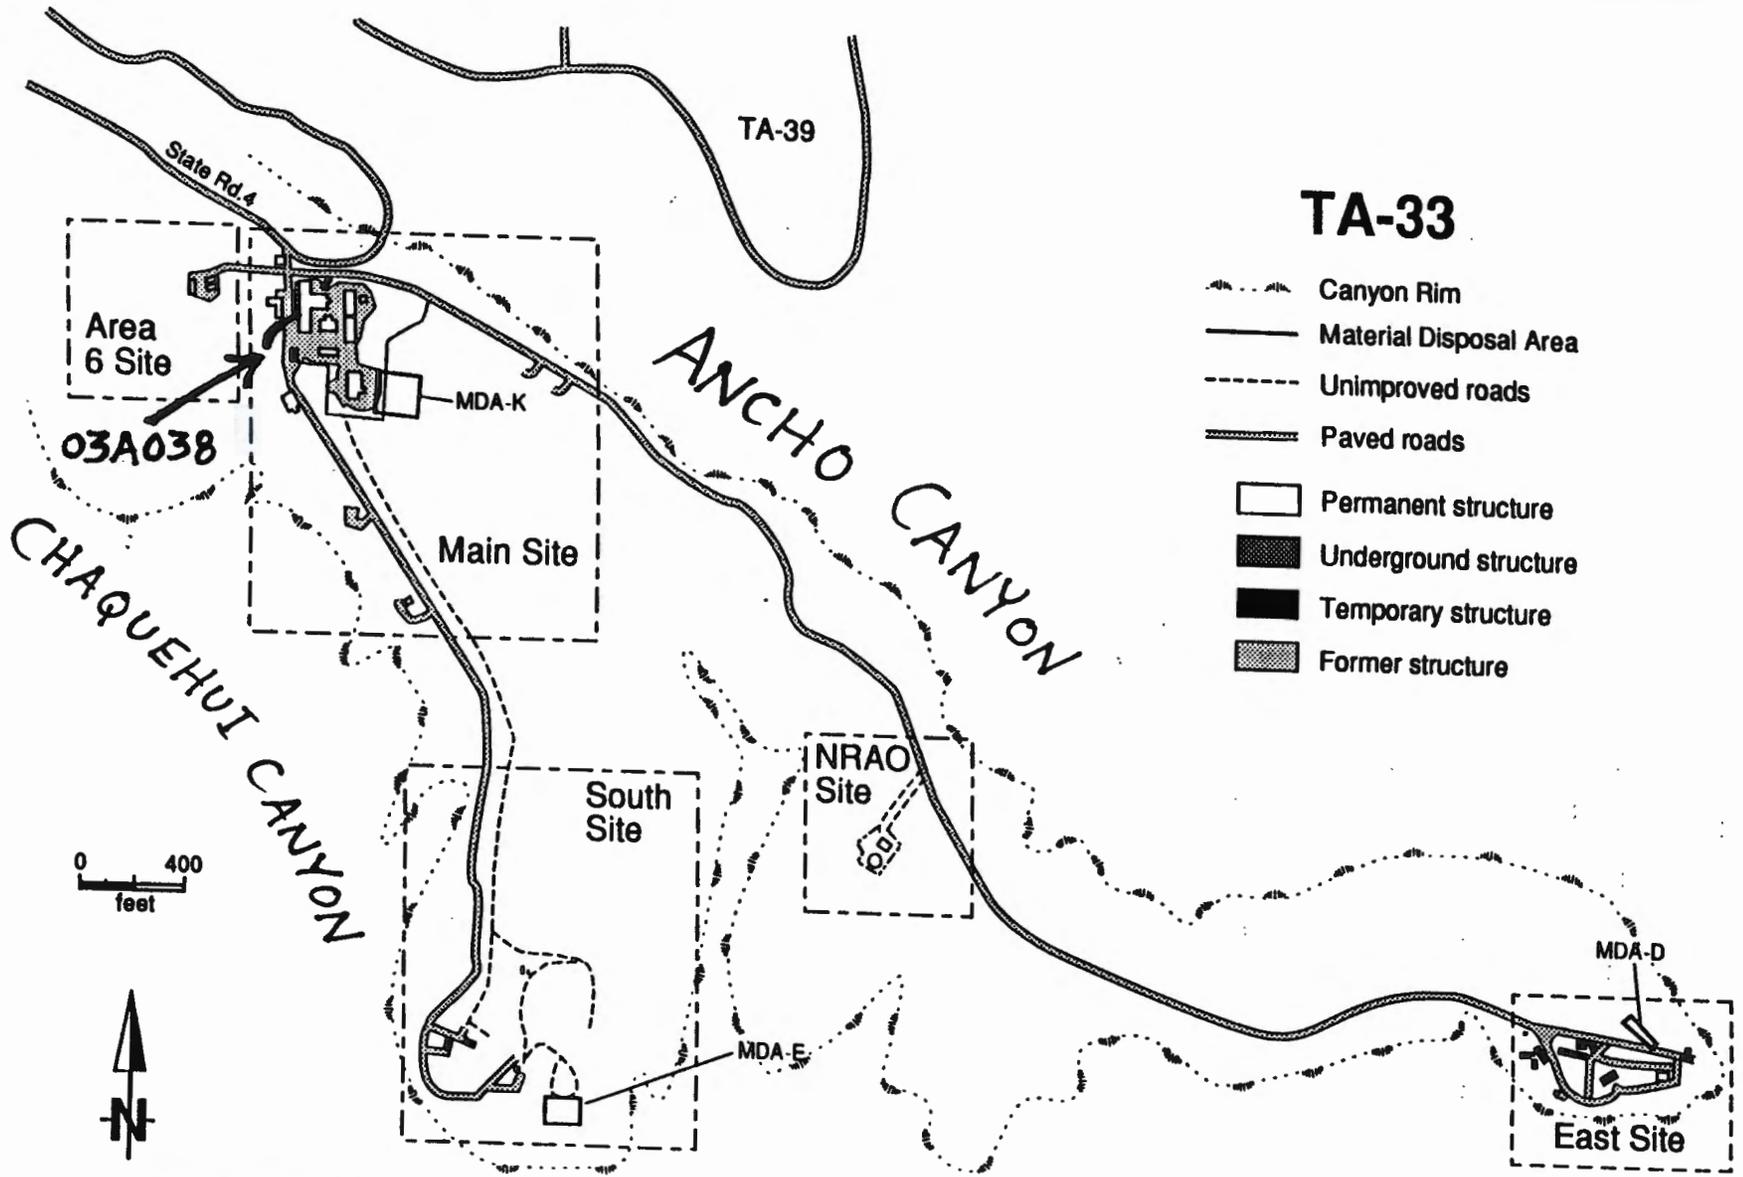
OUTFALL: 03A038

LOCATION: Building TA-33-114 (see TA-33 attachment)

DELETION METHOD: The air conditioner condensate line and floor drains were plugged and capped, and a floor sump re-routed into a sanitary line to the SWSC.

OBSERVATIONS: All work needed to close this outfall from the interior of building was performed. This outfall will continue to receive storm-water from exterior roof and storm drains. These exterior sources are not known to be SWMUs or come in contact with any SWMUs. This outfall exits to a pipe that discharges to a tributary of Chaquehui Canyon. This outfall does not discharge to any known SWMUs immediately below or down-gradient of the pipe. It has not been officially determined whether future storm-water discharges from this outfall will be addressed under a general storm-water NPDES permit.

RECOMMENDATION: The DOE OB recommends that this outfall be taken off the industrial NPDES permit.

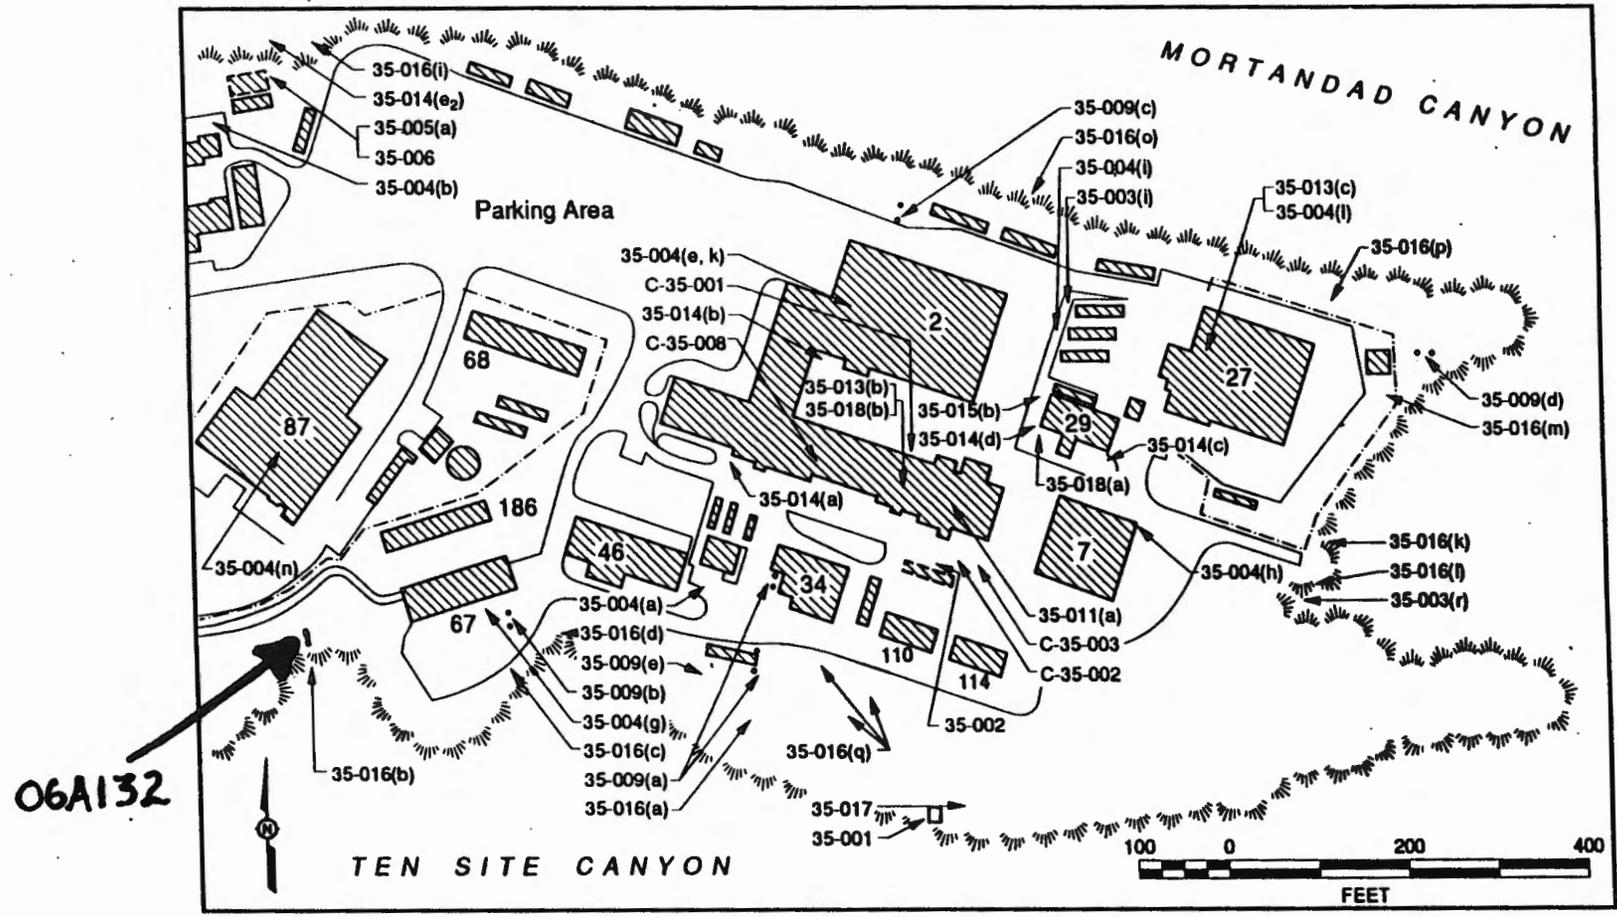
TA-35 EAST

OUTFALL: 06A132

LOCATION: Building TA-35-87 (see TA-35 attachment)

DELETION METHOD: All source sinks were removed with piping and all building outlets were plugged and capped. The photo/darkroom waste line was reconfigured to a rinse only line. This line will be connected to the sanitary line to the SWSC following a waste profile assessment. All photo-chemicals are now re-used and/or disposed of properly as hazardous waste. All the floor drains were re-routed into a sanitary line to the SWSC.

OBSERVATIONS: All work needed to close this outfall from the interior of building was performed. This outfall exits to a 6 inch white PVC pipe that discharges to Tensite Canyon south of Building TA-35-87. This outfall is still listed as SWMU 35-016(b) which formerly discharged photographic processing effluents. This outfall will continue to receive storm-water from exterior roof

drains. These exterior sources are not known to be SWMUs or come in contact with any SWMUs. Additional SWMUs are known to exist in Tensite Canyon down-gradient of the pipe discharge area. It has not been officially determined whether future storm-water discharges from this outfall will be addressed under a general storm-water NPDES permit.

RECOMMENDATION: The DOE OB recommends that this outfall be taken off the NPDES industrial permit. Because this outfall is a SWMU, the DOE OB additionally recommends that the pipe and the area immediately below the outfall be investigated for contamination before storm-water is freely allowed to be discharged. If such investigation results show that soils or sediments are impacted, we recommend that this outfall not be used for storm-water discharges because this would cause migration of contaminants down-gradient. In addition, we also recommend the implementation of best management practices such as run-on controls in order to divert any storm-water away from SWMUs directly below and down-gradient of the outfall pipe.

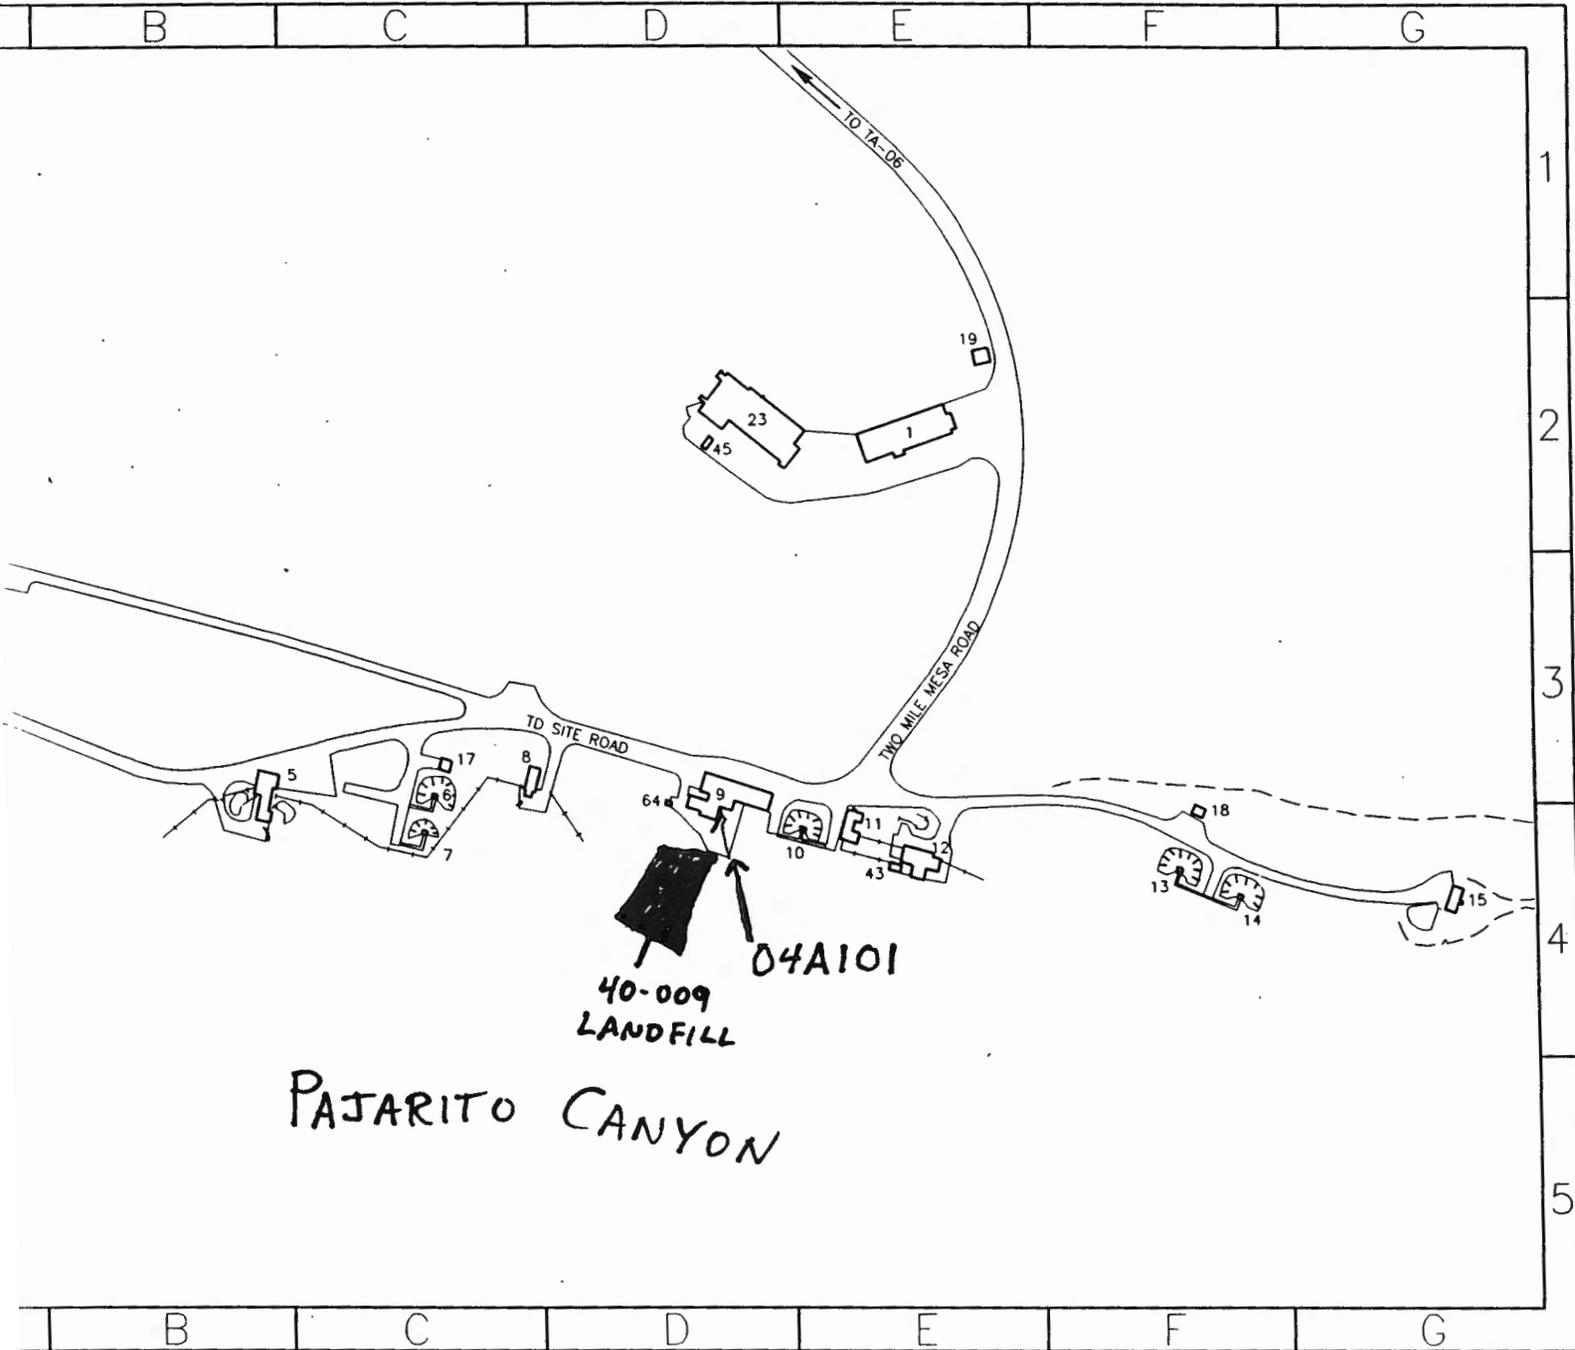
OUTFALL: 04A101

LOCATION: Building TA-40-9 (see TA-40 attachment)

DELETION METHOD: The eyewash station and source sink were removed with piping and all building outlets were plugged and capped. The water heater and all laser cooling lines were reconfigured to a recirculating closed-loop system. All floor drains were plugged and capped.

OBSERVATIONS: All work needed to close this outfall from the interior of building was performed. This outfall exits to a 6 inch white PVC pipe that discharges to Pajarito Canyon south of Building TA-40-9. This outfall will continue to receive storm-water from exterior roof and storm drains. These exterior sources are not known to be SWMUs or come in contact with any SWMUs. It has not been officially determined whether future storm-water discharges from this outfall will be addressed under a general storm-water NPDES permit. This outfall does not discharge to any known SWMU immediately below the pipe, but directly down-gradient exists SWMU 40-009, an old landfill that contains debris from the decommissioning of buildings at TA-15. It could not be determined during the inspection if discharges from outfall 04A101 run-on to SWMU 40-009.

RECOMMENDATION: The DOE OB recommends that this outfall be taken off the industrial NPDES permit. Because this outfall potentially discharges to a down-gradient

SWMU, the DOE OB additionally recommends that a determination be made if storm-water discharges from this outfall produce run-on to SWMU 40-009. If such run-on occurs, we recommend that this outfall not be used for storm-water discharges. In addition, we also recommend the implementation of best management practices such as run-on controls in order to divert any storm-water away from SWMUs directly below and down-gradient of the outfall pipe.
