*State of New Mexico*  
**ENVIRONMENT DEPARTMENT**  
**DOE OVERSIGHT BUREAU**  
P.O. Box 1663, MS/J-993  
Los Alamos, New Mexico 87545

8 August 1997

**RE:** Department of Energy Oversight Bureau (DOE OB) Inspection Observations and Recommendations concerning NPDES outfalls scheduled for deletion through the Waste Stream Characterization Program at Los Alamos National Laboratory (LANL).

### DOE OB Inspection Observations and Recommendations

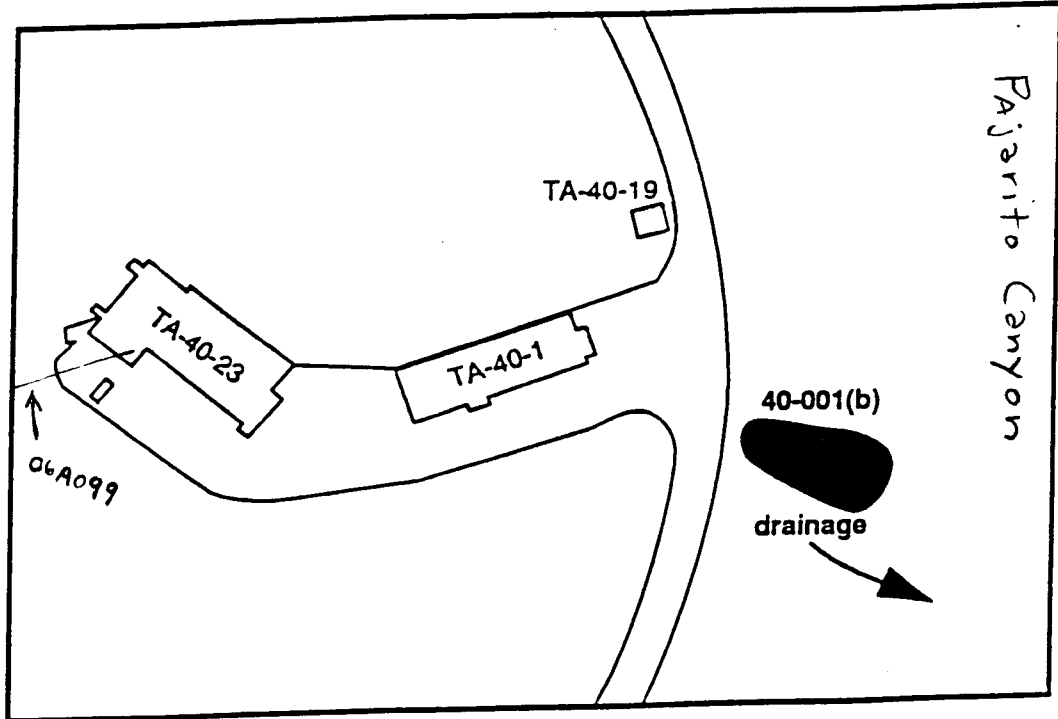
TA-40 — 06A099

**DELETION METHOD:** The photo-lab sink inside the building has been converted to a recirculating system. The sink and floor drains have been plugged. All remaining building drains have been tied into the sanitary line. The end of the outfall has been plugged with an aluminum cap, but the outfall owner (A. R. Martinez, 665-1962) wasn't sure if roof drains had been routed to the outfall.

**OUTFALL STATUS:** Possible continued use only during storm water events.

★ Figure 5-25. Location of 40-001(b).  
Building schematic shows  
2 roof drains discharging to  
06A099

**RECOMMENDATION:** The DOE OB would recommend that this outfall be taken off the NPDES industrial permit after addressing the following concerns: The DOE OB questions why this photo-processing outfall was never listed as a PRS in the RFI Work Plan for OU-1111. Because this outfall might be a PRS and appears to be located up-gradient of SWMU 40-001(c), the DOE OB recommends that the pipe and the drainage area immediately below the outfall be investigated through the AP 4.5 procedure. If the preliminary results show a probability that soils or sediments are impacted, we recommend that this outfall not be used for storm water discharges because this would cause migration of contaminants down-gradient. In addition, we also recommend the implementation of best management practices such as run on controls in order to divert any storm water away from the outfall drainage and any PRSs directly below or down-gradient of the outfall pipe.

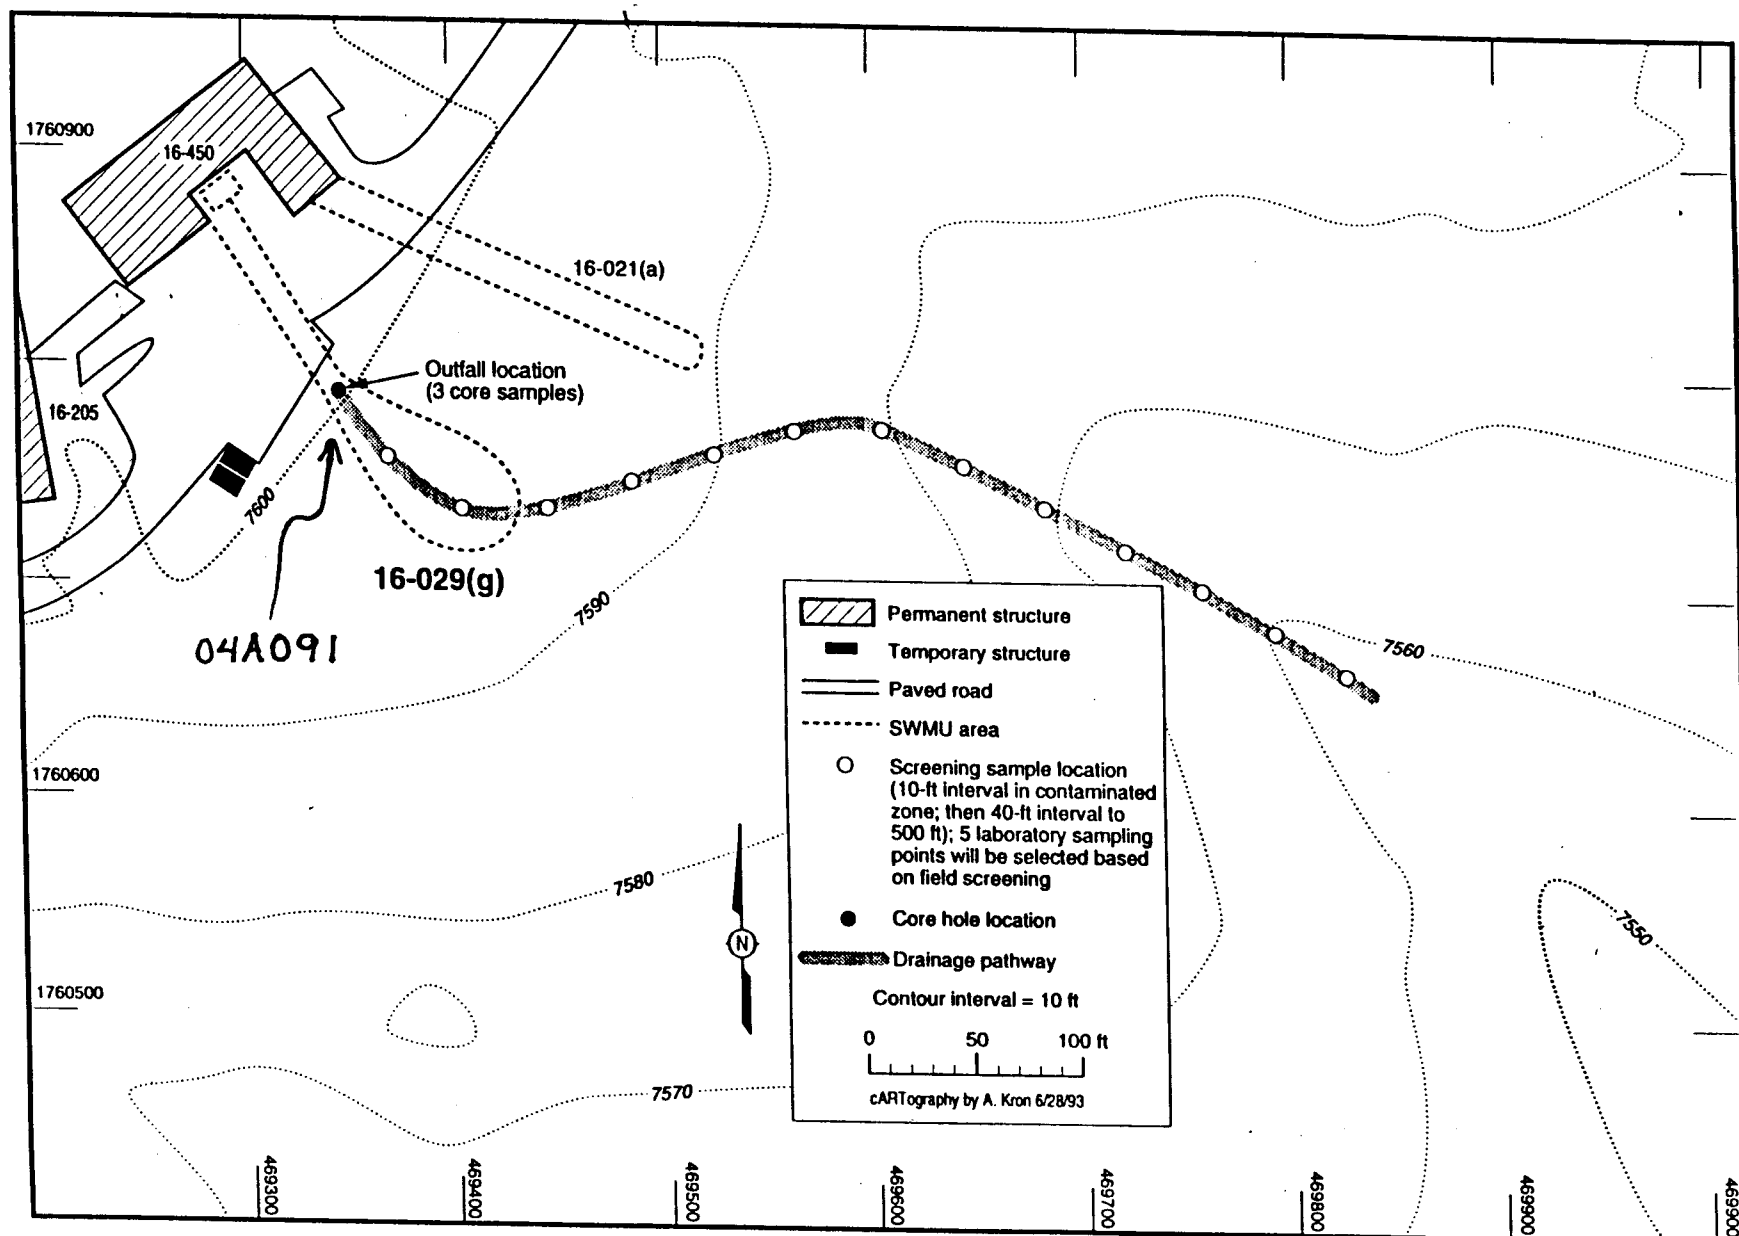
TA-16 - 04A091

DELETION METHOD: The sump for building TA-16-450 is now plugged, with no exit outlet to the outfall, and scheduled for removal by the facility owner. The removal date is late summer 1997. The flow from the process troughs is still allowed to go to the sump, but it is now captured in large containers within the sump and periodically and properly removed as needed. The FU-3 ER Project will sample under the sump while the excavation pit is open in addition to sampling the outfall drainage area.

Fig. 5-24. Schematic field screening sampling locations for SWMU 16-029(g).

**RECOMMENDATION:** The DOE OB would recommend that this outfall be taken off the NPDES industrial permit after addressing the following concerns: Because this outfall is listed as SWMU 16-029(g), the DOE OB recommends that the pipe and the drainage area immediately below the outfall be investigated through the AP 4.5 procedure. Even though the probable contaminant source, the sump, is scheduled for removal later this summer, it is not known when the outfall drainage area will be scheduled for an ER investigation. See comment for 03A036, Building TA-21-152 above.
