Subject: Submittal of the Documentation of Completion of Cross-Vane Structure Corrective Maintenance Actions in Pueblo Canyon

Documentation of Completion of Cross-Vane Structure Corrective Maintenance Actions in Pueblo Canyon

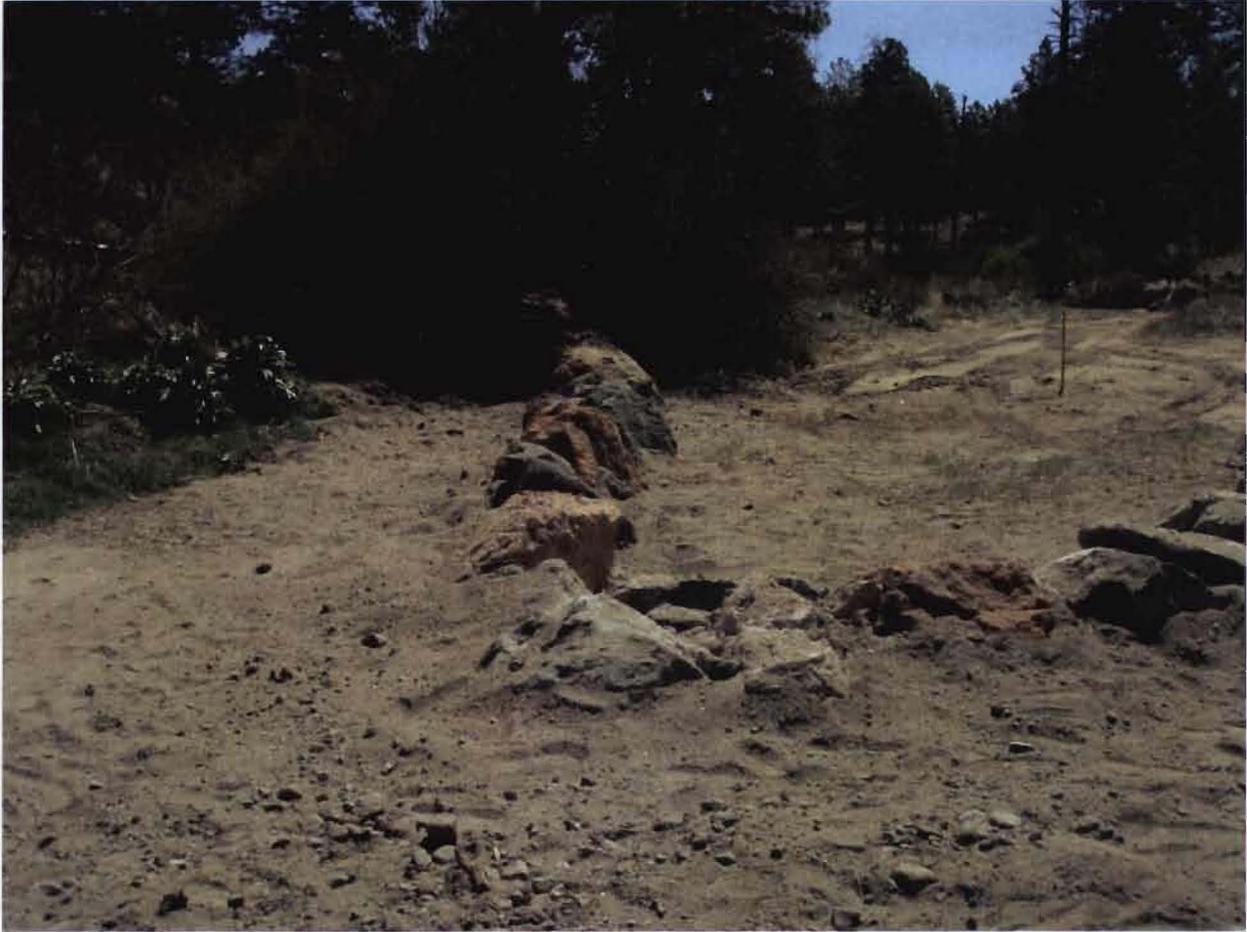
Figure 1 Pueblo Canyon cross vane 1 looking eastward (downcanyon). Note that the vertex of the structure is at stream-bed elevation.

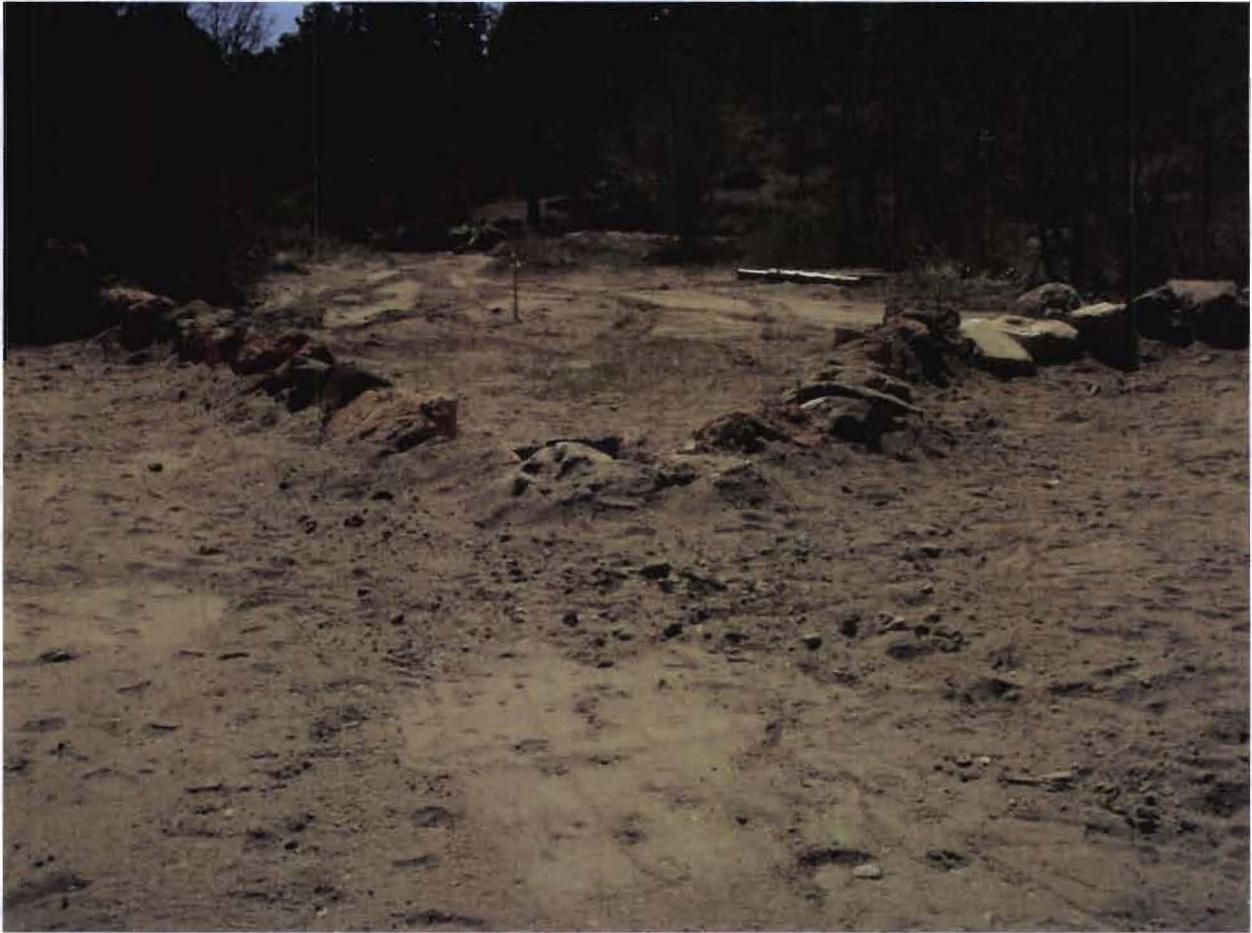
Figure 2 Pueblo Canyon cross vane 2 looking eastward (downcanyon). Note that the vertex is at the elevation of the stream bed, and the gaps in large rocks are filled.

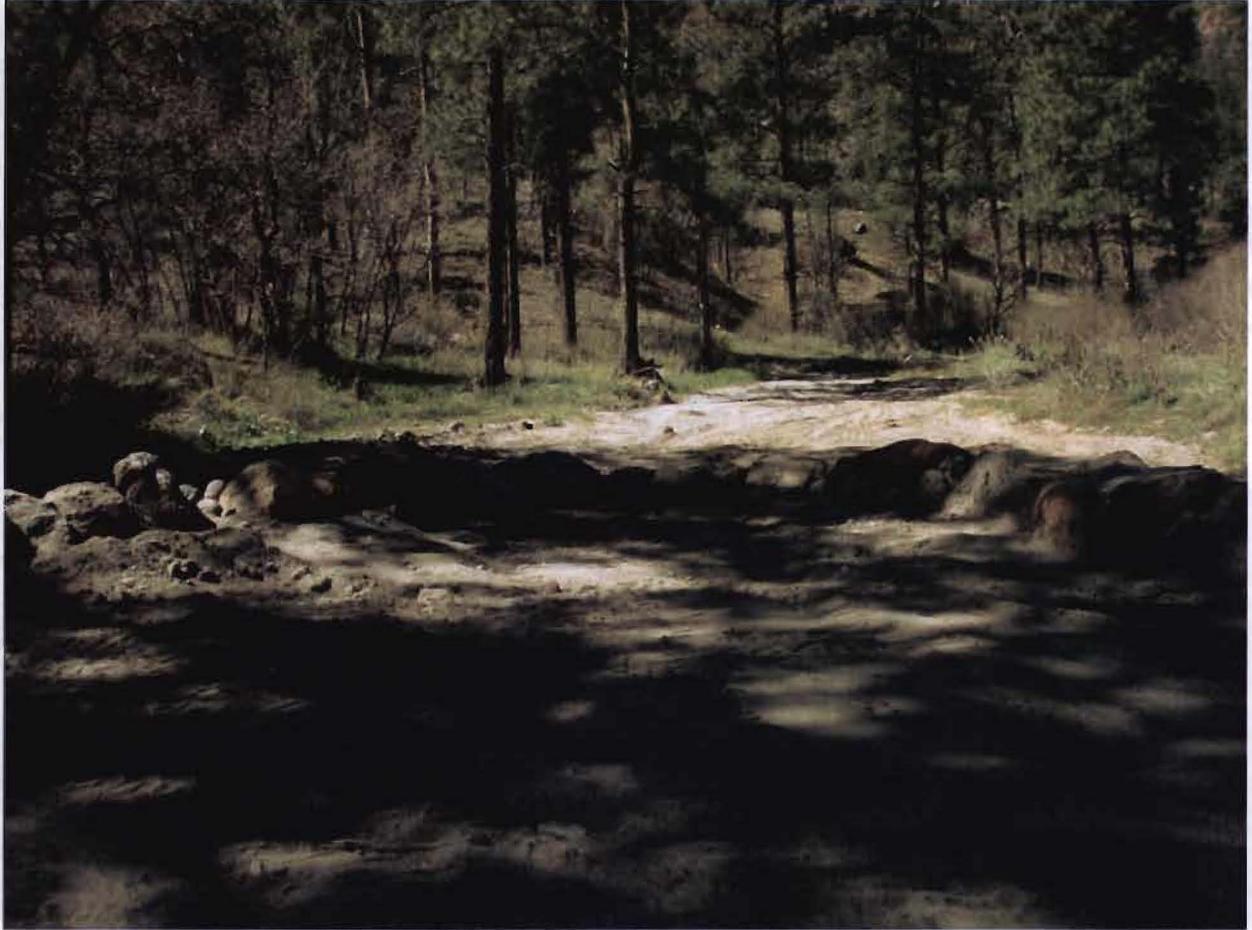
Figure 3 Pueblo Canyon cross vane 3 looking westward (upcanyon). Note that the vertex is at the elevation of the stream bed, and the gaps in the large rocks are filled.
