SUBJECT: FINAL ACCELERATED CLEANUP REPORTS

January 1996

LA-UR-96-432

**Voluntary Corrective Action Completion Report
Potential Release Site 0-032
Former Zia Motor Pool
Storm Water Drainline**

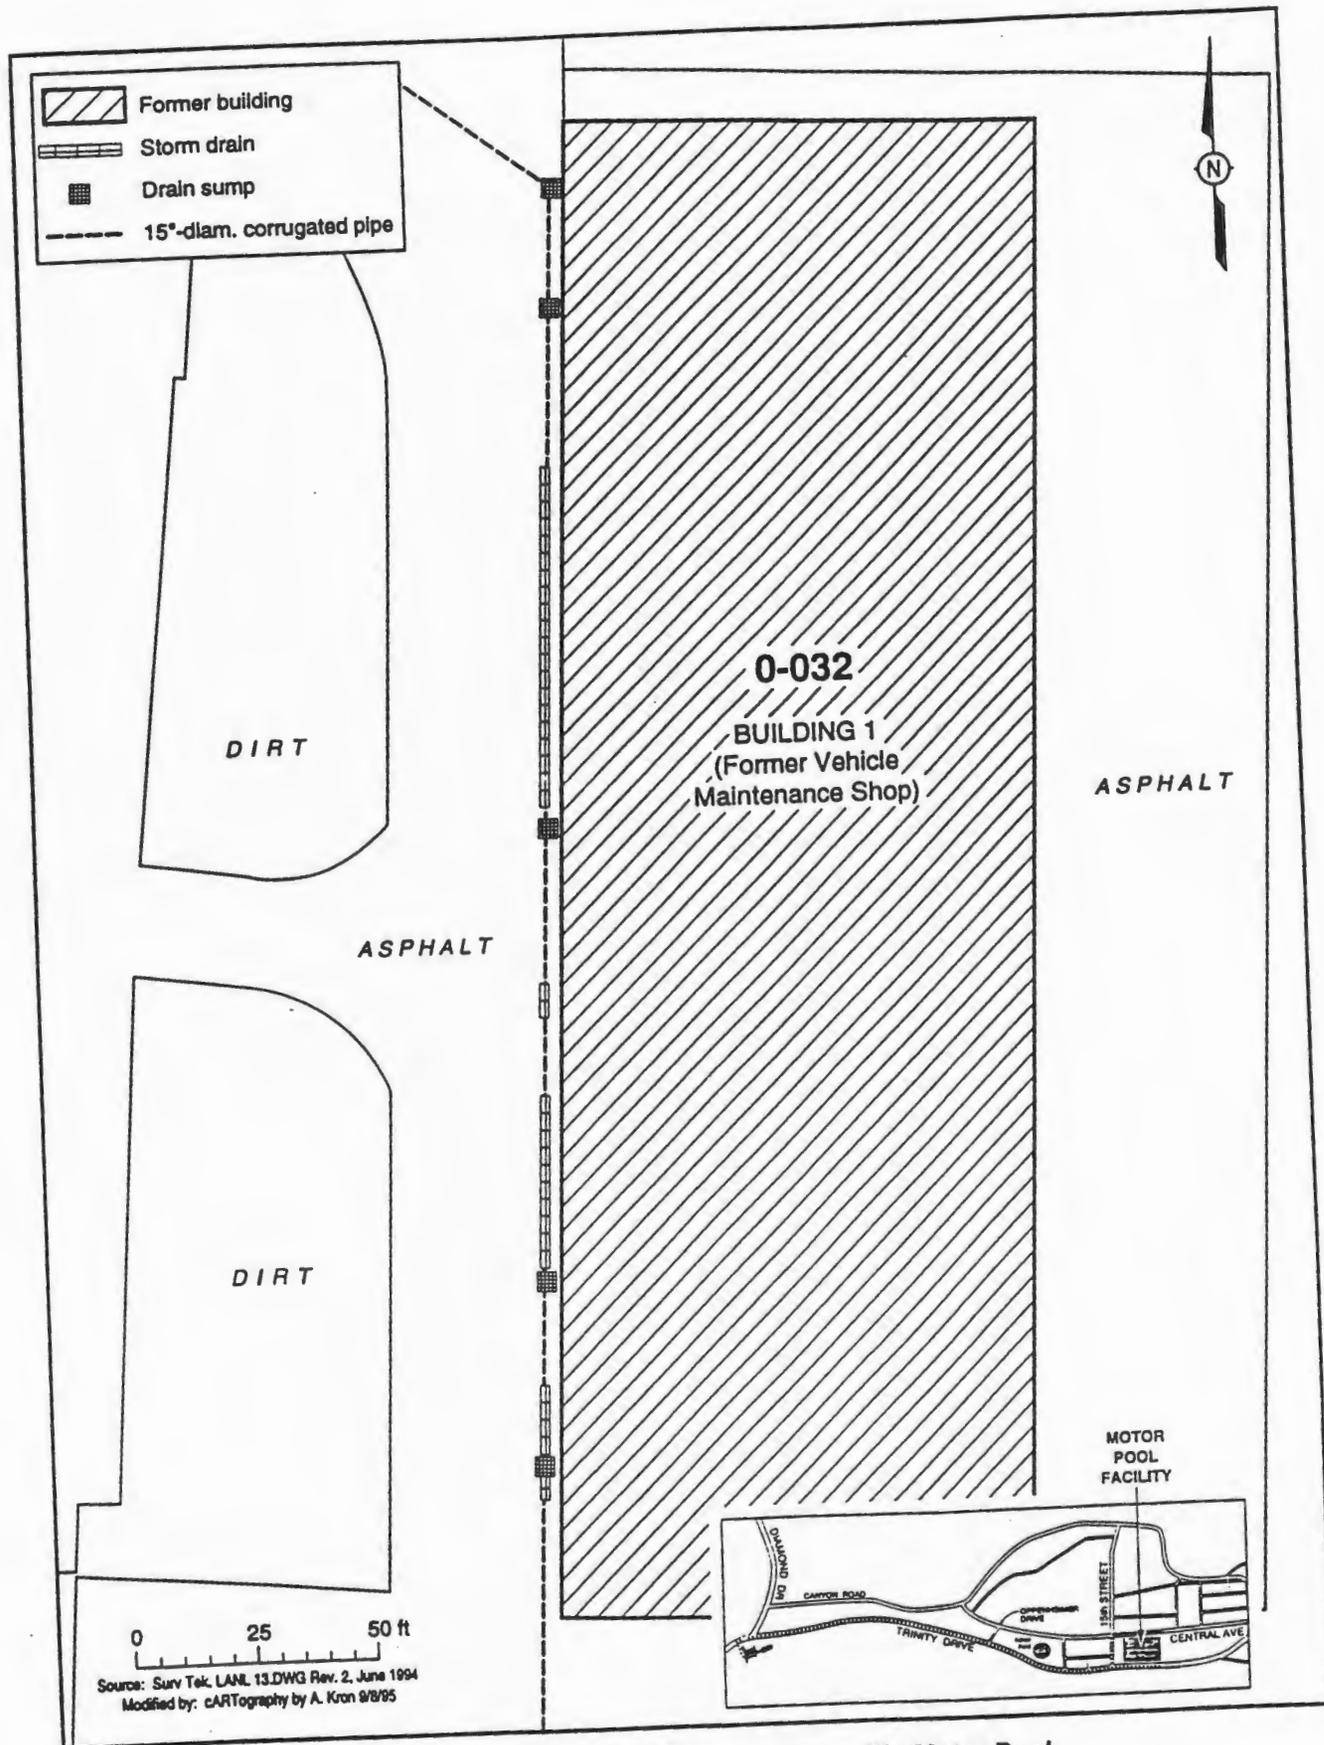
Potential Release Site (PRS) 0-032 includes a storm water drainline that drained the west side of the former Vehicle Maintenance Shop, Building 1, for Zia Company (Figure 1). The building has been demolished and removed. This site is not listed in the Laboratory's Hazardous and Solid Waste Amendments (HSWA) module to the Los Alamos National Laboratory, Resource Conservation and Recovery Act, EPA I. D. NM0890010515.

Figure 1. Location of storm drain piping at PRS 0-032, former Zia Motor Pool.
