SUBJECT SURVEY OF FIRING POINTS OPERATED BY M DIVISION

Radiation Survey  
of  
Firing Sites

Depleted Uranium - D38 ( $^{238}\text{U}$ )

## Radiological Survey on Firing Sites

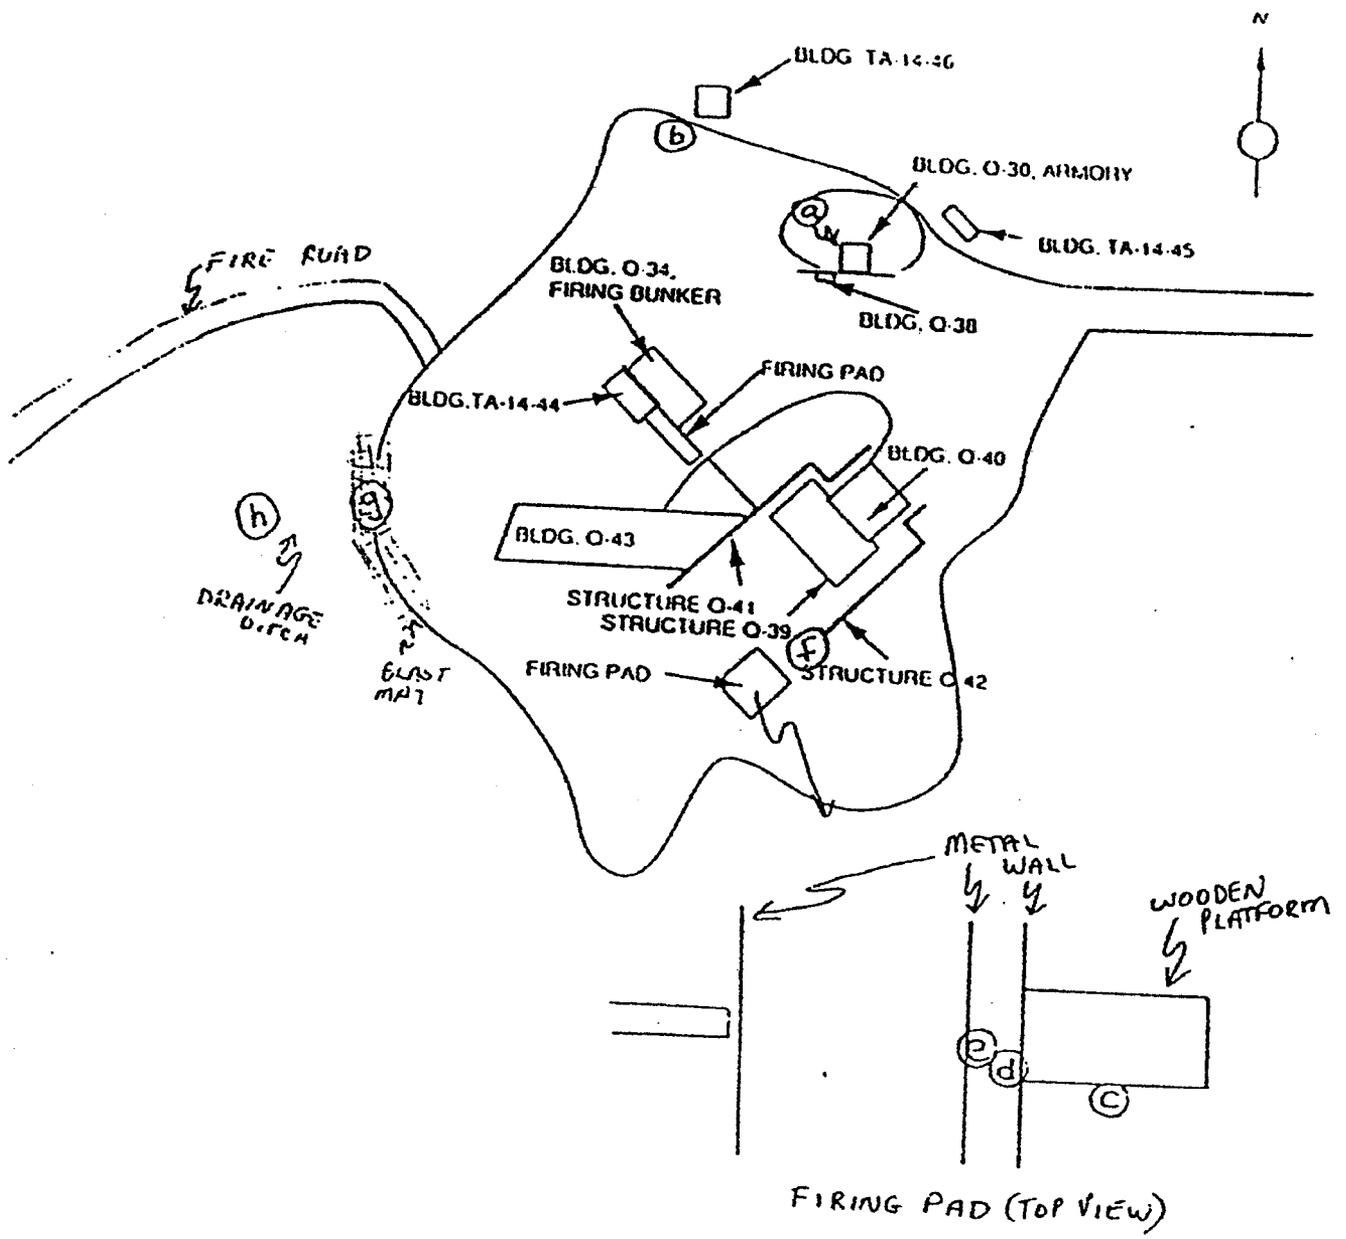
2. Diagram of Q-Site

a. There are several paint can containers and a cardboard box located inside Bldg Q-30, Armory that contain D38. (See location "a")

(1) Paint Cans: The radiation measurement at the surface of the paint cans containing D38 range from 1500 to 2500 cpm with a 1 to 3 mR/hr exposure rate. The exposure rate is 0.1 mR/hr at 30 cm from the paint cans.

(2) Cardboard Box: The radiation measurement at the surface of the cardboard box containing D38 is  $\approx$  40,000 cpm with a 4 mR/hr exposure rate. The exposure rate is 0.2 mR/hr at 30 cm from the cardboard box.

b. There are two pallets of metal targets and parts located west of Bldg Q-30 that have D38 contaminated metal (See location "b"). The radiation measurement at the surface of the contaminated metal is  $\approx$  15,000 cpm with a 2 mR/hr exposure rate. The exposure rate is 0.1 mR/hr at 30 cm from the pieces of contaminated metal. There is no visible pieces of D38 seen on the contaminated pieces of metal.

c. The firing pad has several areas of contamination. (See enlarged diagram of the firing pad provided above)

(1) Wooden platform. The radiation measurement at the surface of the wooden platform is slightly above background, approximately twice background.

(2) Ground Underneath Wooden Platform. The radiation measurement at the surface of the ground underneath the wooden platform is  $\approx$  5000 cpm with a 0.2 mR/hr exposure rate. The exposure rate is 0.1 mR/hr at 30 cm from the ground. (See location "c")

(3) Metal Blast Wall. The inside of the metal blast wall next to the wooden platform had some pits that contained D38. The D38 contamination is not visible. The radiation measurement at the surface of the pitted metal blast wall is  $\approx$  20,000 cpm with a 0.6 mR/hr exposure rate. The exposure rate is 0.1 mR/hr at 30 cm from the blast wall. (See location "d")

(4) Metal Blast Wall. The second metal blast wall from the wooden platform had some pits that contained D38. The D38 contamination is not visible. The radiation measurement at the surface of the pitted metal blast wall is  $\approx$  10,000 cpm with a 0.6 mR/hr exposure rate. The exposure rate is 0.1 mR/hr at 30 cm from the blast wall. (See location "e")

d. There is a visible piece of oxidized D38 located on the ground northeast of the firing pad. The radiation measurement at the surface of the piece of D38 is 160,000 cpm with a 6 mR/hr

exposure rate. The exposure rate is 0.1 mR/hr at 30 cm. (See location "f")

e. The blast mats located at the edge of the drop off, used to control erosion, has several areas of D38 contamination. The radiation measurement at the surface of the contaminated blast mats is  $\approx 20,000$  cpm with a 0.8 mR/hr exposure rate. The exposure rate is 0.1 mR/hr at 30 cm from the blast mats. (See location "g")

f. The drainage over the edge of the drop off had small pieces of visible D38. The radiation measurement of the pieces found were  $\approx 500$  cpm with a 0.1 mR/hr exposure rate. (See location "h")

a. A soil sample was taken approximately one inch underneath the piece of D38 location "f". The results of the  $2.4 \times 10^{-4} \mu\text{Ci/g}$

b. A soil sample was taken underneath the wooden platform at the firing pad, location "c". The results  $1.9 \times 10^{-3} \mu\text{Ci/g}$

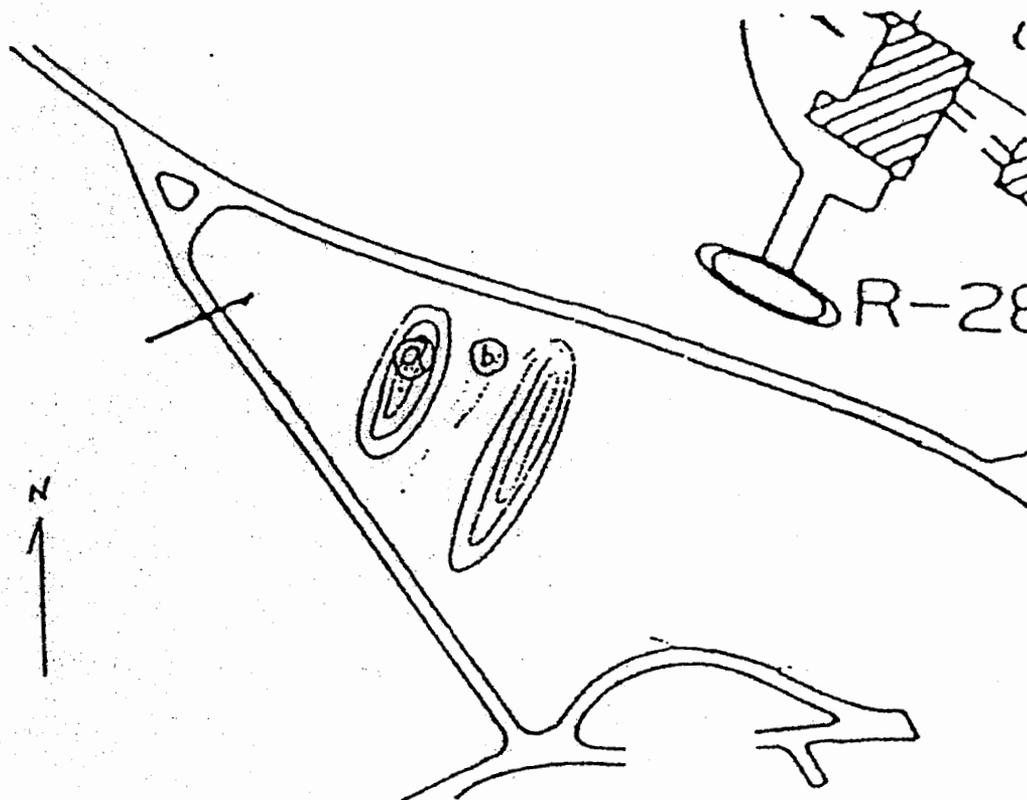
a. Diagram of EF Site.

(1) Top of soil mound, location "a" on EF Site diagram. The radiation measurement at the surface of the soil is  $\approx 170,000$  cpm with a 20 mR/hr exposure rate. The exposure rate is less than 5 mR/hr at 30 cm from the soil surface.

(2) There is contamination in the eroded area between the two mounds. The radiation measurement at the surface of the soil between the two mounds is  $\approx 825,000$  cpm with a 80 mR/hr exposure rate. The exposure rate is less than 5 mR/hr at 30 cm from the soil surface. (See location "b" on EF Site diagram)

Due to the elevated levels of D38 at the abandoned EF site, this site should be fenced to limit entry. Soil contamination signs and controlled area signs should be placed along the fence at approximately 20 foot intervals. Due to the very low levels at TA-40 only a D38 contamination sign is suggested for the firing site 4 area.

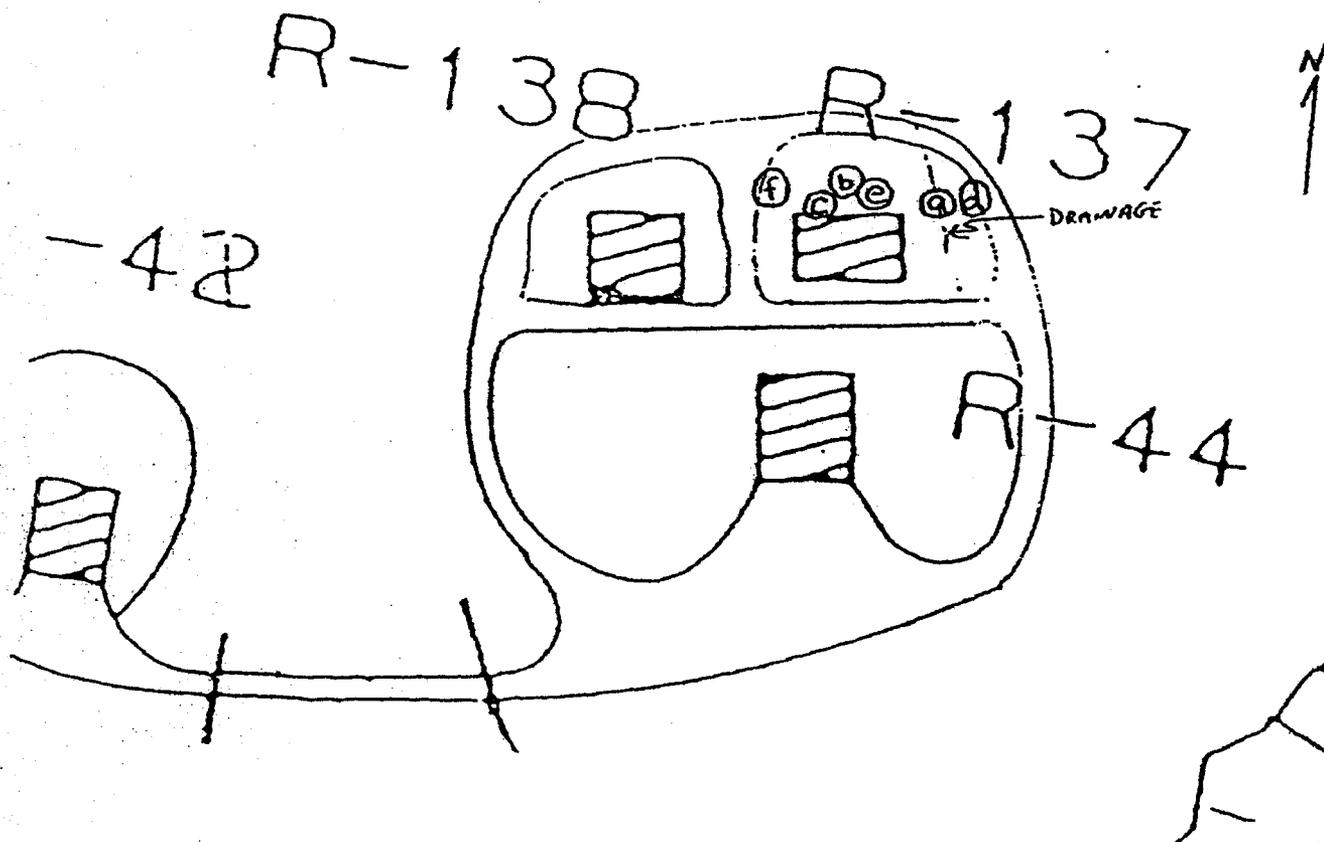
a. Diagram of R-44 Site

(1) Eroded drainage area east of Bldg R-137. The radiation measurement at the surface of the soil is  $\approx 32,000$  cpm with a 0.5 mR/hr exposure rate. The exposure rate is  $\approx 0.1$  mR/hr at 30 cm from the surface of the soil. (See location "a" on the D-44 Site diagram)

(2) Small pieces of D38 on the ground in front of the blast wall, Bldg R-137. The radiation measurement at the surface of the soil over the small D38 pieces is  $\approx 4,000$  cpm with a 1 to 2 mR/hr exposure rate. The exposure rate is  $\approx 0.1$  mR/hr at 30 cm from the surface of the soil. (See location "b" on the D-44 Site diagram)

(3) The blast wall-(shield) on the side of Bldg R-137 has several areas of contamination. The radiation measurement at the surface of the blast wall is  $\approx 175,000$  cpm with a 10 mR/hr exposure rate. The exposure rate is  $\approx 0.5$  mR/hr at 10 cm from the blast wall. (See location "c" on the R-44 Site diagram)

(4) The ground east of Bldg R-137 on the other side of the eroded drainage area. The radiation measurement at the surface of the ground is  $\approx 25,000$  cpm with a 50 mR/hr exposure rate. The exposure rate is  $\approx 1$  mR/hr at 30 cm from the contaminated ground. (See location "d" on the R-44 Site diagram)

(5) The general outside area had numerous small pieces of D38 on the ground. The radiation measurement of these small pieces ranged from  $\approx 1500$  to 2000 cpm with a range of 1 to 2 mR/hr exposure rate. The exposure rate is  $\approx 0.1$  mR/hr at 30 cm from the surface of the ground.

(1) A soil sample was taken approximately in front of the blast wall of Bldg R-137, see location "e" on the R-44 Site diagram. The results of the soil sample  $5.4 \times 10^{-2}$  mCi/l

(2) A soil sample was northwest of Bldg R-137, see location "f" on the R-44 Site diagram. The results  $5.4 \times 10^{-2}$  mCi/l

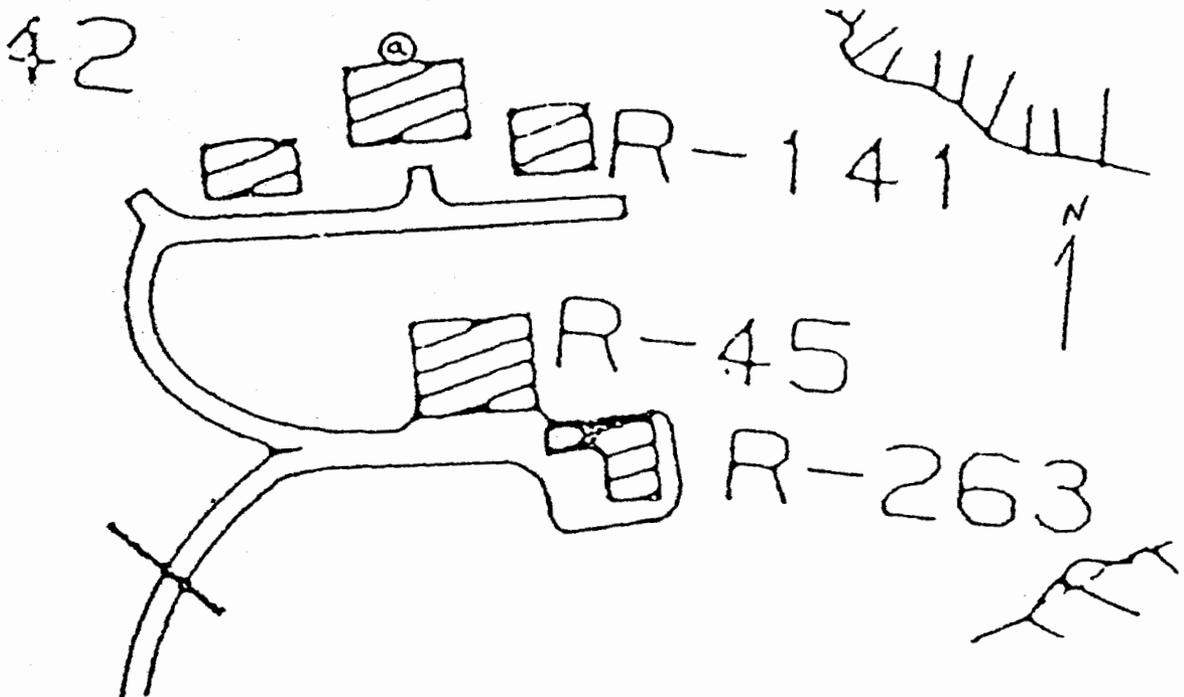
a. Diagram of R-45 Site

c. Location of D38 at R-45. The north wall of the Bldg R-314 was contaminated. The radiation measurement at the surface of the building ranged from 26,000 to 45,000 cpm with the highest reading of 10 mR/hr exposure rate. The exposure rate is  $\approx 0.3$  mR/hr at 30 cm from the surface of the wall. (See location "a" on the R-45 Site diagram)

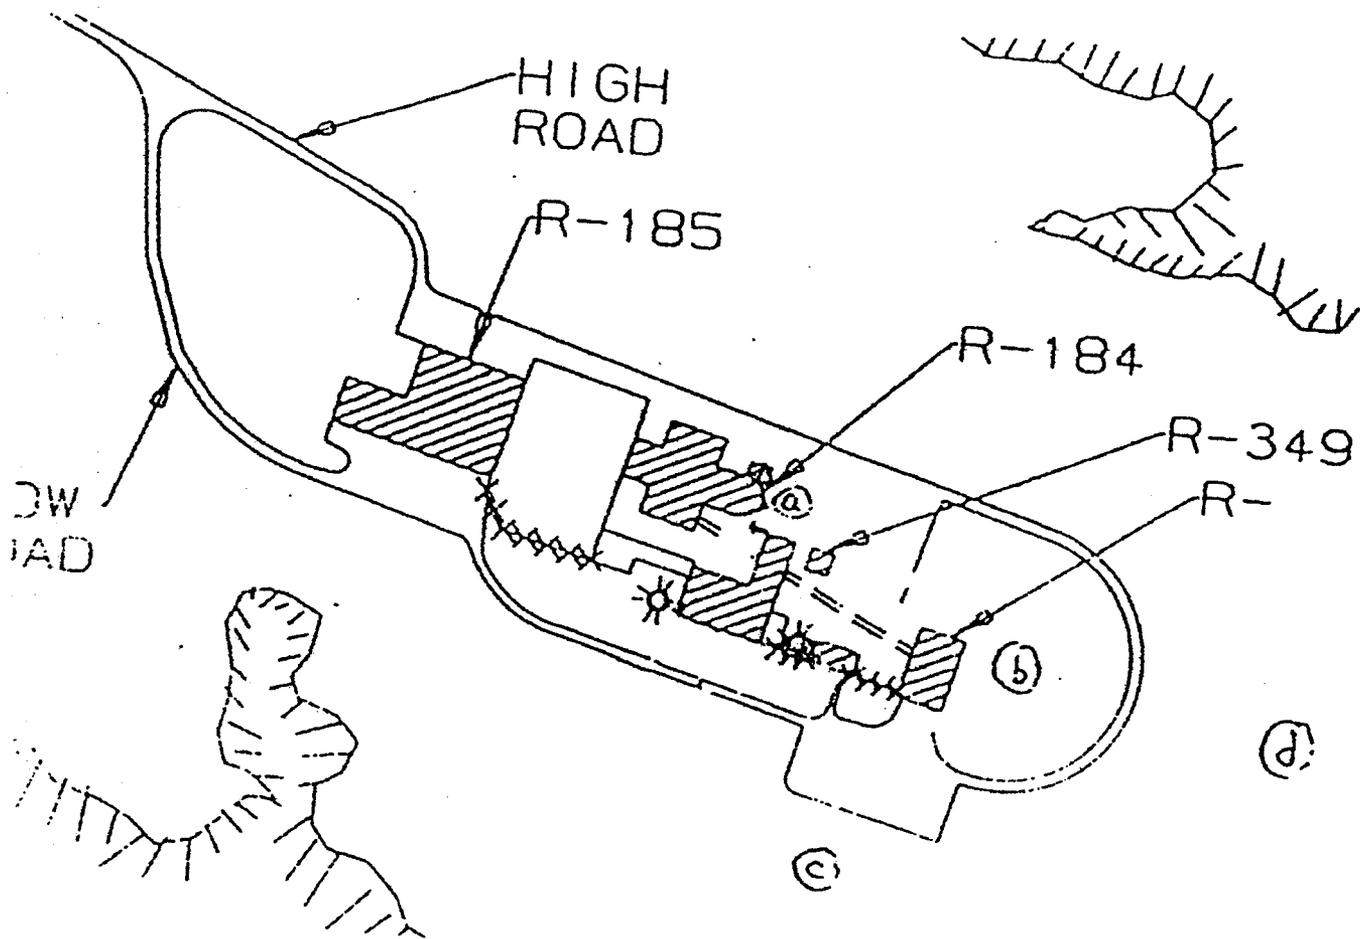
### a. Diagram of PHERMEX Site

(1) There are metal plates on the ground outside Bldg R-184 that are contaminated with D38. The highest radiation measurement at the surface of the metal plates is  $\approx 50,000$  cpm with a 5 mR/hr exposure rate. The exposure rate is less than 0.2 mR/hr at 30 cm from the surface of the metal plates. (See location "a" on the PHERMEX Site diagram)

(2) The general area outside Bldg R-186 has an elevated level due to D38 on the soil. The radiation measurement at the surface of the ground ranges between 1,000 to 2,000 cpm with a 0.5 mR/hr exposure rate. The exposure rate is  $\approx 0.1$  mR/hr at 30 cm from the surface of the ground. (See location "b" on the PHERMEX Site diagram)

(3) The old impact area is contaminated with D38. The radiation measurement at the surface of the blast shield is  $\approx 40,000$  cpm with a 2.5 mR/hr exposure rate. The exposure rate is  $\approx 0.1$  mR/hr at 30 cm from the surface of the wall. (See location "c" on the PHERMEX Site diagram)

(4) There is a material storage area outside the road that is contaminated with D38. The highest radiation measurement at the surface of the ground is  $\approx 50,000$  cpm with a 4 mR/hr exposure rate. The exposure rate is less than 1.5 mR/hr at 30 cm from the surface of the ground. (See location "d" on the PHERMEX Site diagram)

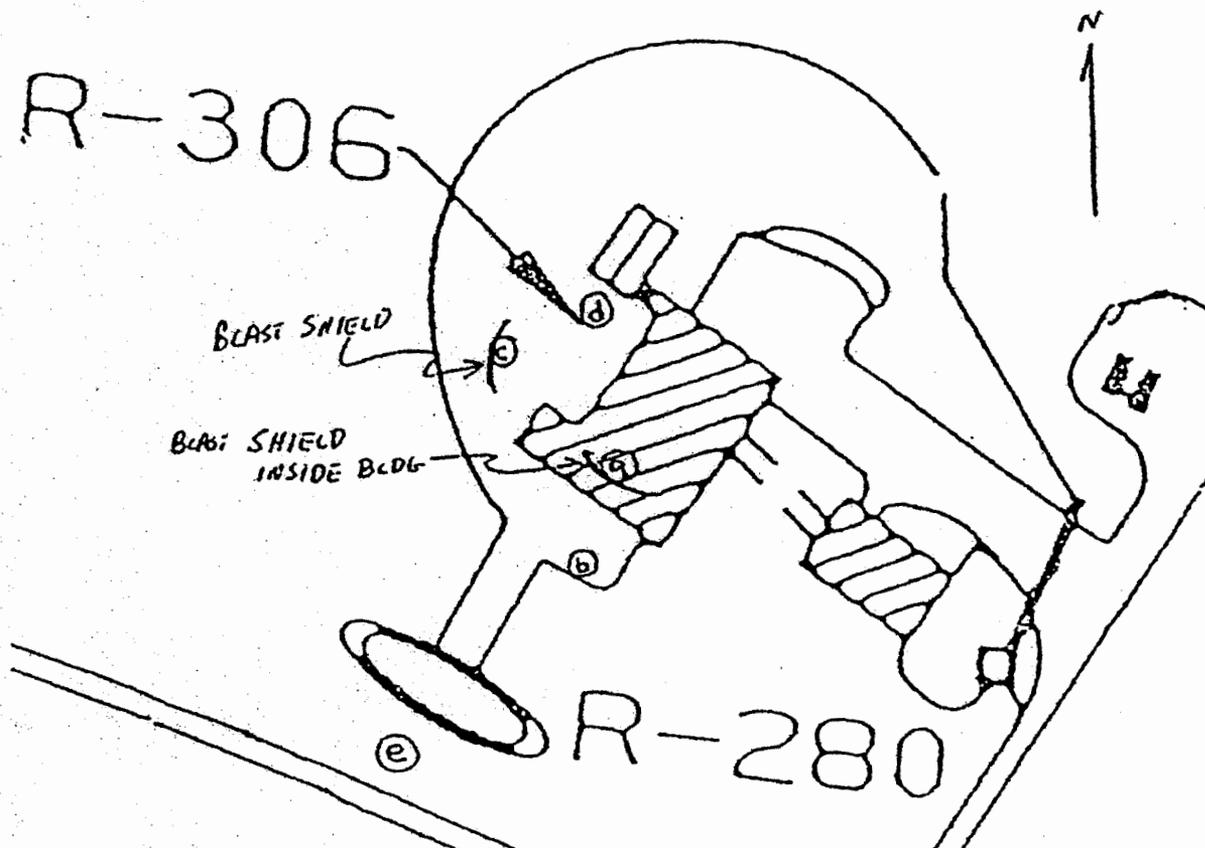
### a. Diagram of R-306 Site

(2) The berm southwest of Bldg R-306. The radiation measurement at the surface of the ground at the berm is  $\approx 8,000$  cpm with a 0.3 mR/hr exposure rate. The exposure rate is  $\approx 0.1$  mR/hr at 30 cm from the surface of the ground. (See location "b" on the R-306 Site diagram)

(3) The old blast shield located northwest of Bldg R-306 has contaminated areas. The radiation measurement at the surface of the blast shield is  $\approx 80,000$  cpm with a 5 mR/hr exposure rate. The exposure rate is  $\approx 0.1$  mR/hr at 30 cm from the surface of the wall. (See location "c" on the R-306 Site diagram)

(4) There are several pieces of oxidized D38 on the ground northwest of Bldg R-306. The highest radiation measurement at the surface of the ground over a piece of D38 is  $\approx 675,000$  cpm with a 25 mR/hr exposure rate. The exposure rate is less than 1 mR/hr at 30 cm from the surface of the wall. (See location "d" on the R-306 Site diagram)

(5) There are several pieces of oxidized D38 on the remote ridge southwest of Bldg R-306. The radiation measurement at the surface of the ground over the pieces of D38 is  $\approx 800,000$  cpm with a 40 mR/hr exposure rate. The exposure rate is less than 5 mR/hr at 30 cm from the surface of the wall. (See location "e" on the R-306 Site diagram)

(1) The blast shield inside Bldg R-306 has several contaminated pits. The radiation measurement at the surface of the blast shield is  $\approx 210,000$  cpm with a 5 mR/hr exposure rate. The exposure rate is less than 1 mR/hr at 30 cm from the surface of the wall. (See location "a" on the R-306 Site diagram)

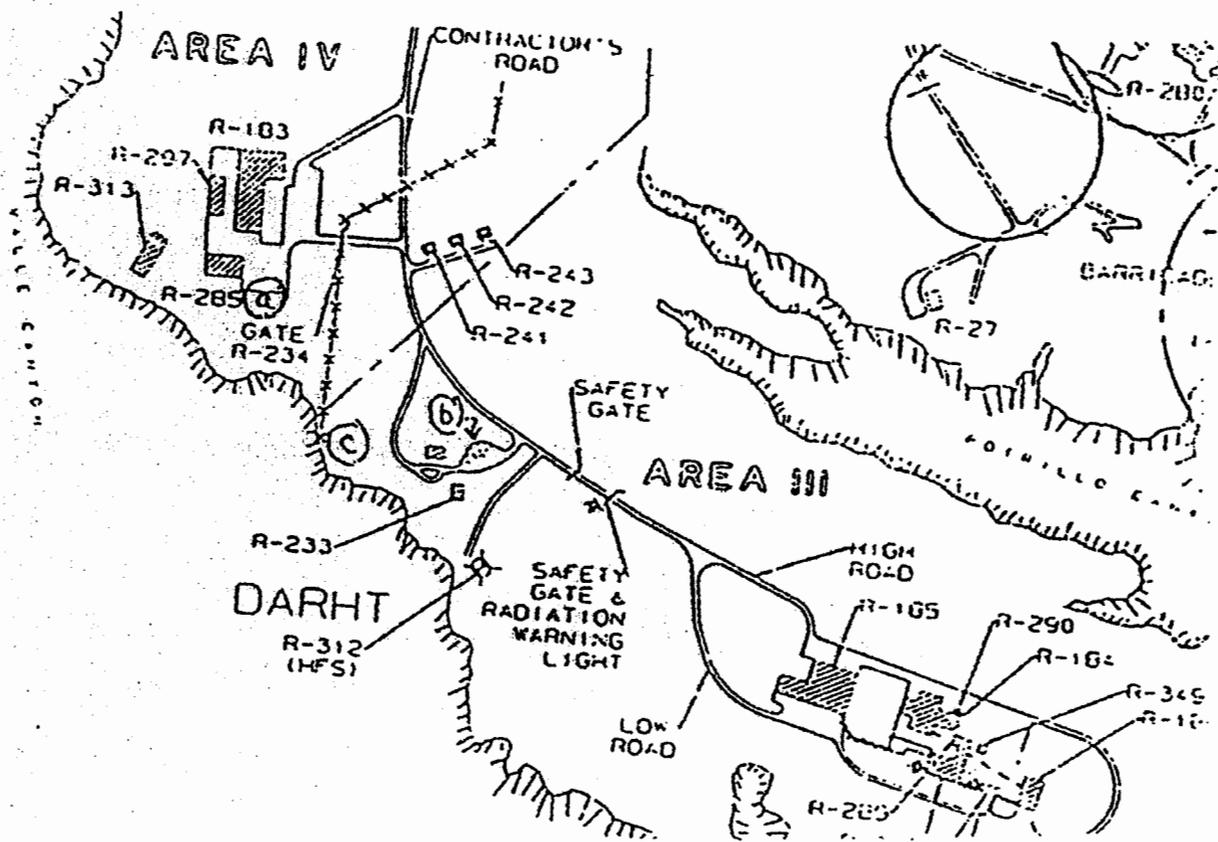
a. Diagram of DARHT Area

(1) There is D38 contamination in the soil around the berm area by Bldg R-285. This location is where the vessels were washed out and D38 contamination was deposited on the ground. The highest radiation measurement at the surface of the ground is  $\approx 50,000$  cpm with a 5 mR/hr exposure rate. The exposure rate is less than 0.1 mR/hr at 30 cm from the surface of the ground. (See location "a" on the DARHT Area diagram)

(2) The general area between Bldg R-233 and the main road is contaminated with D38 on the soil. The highest radiation measurement at the surface of the ground is  $\approx 10,000$  cpm with a 0.5 mR/hr exposure rate. The exposure rate is  $\approx 0.1$  mR/hr at 30 cm from the surface of the ground. (See location "b" on the DARHT Area diagram)

(3) There is a material storage area that is contaminated with D38. The highest radiation measurement at the surface of the ground is  $\approx 5,000$  cpm with a 0.5 mR/hr exposure rate. The exposure rate is less than 0.1 mR/hr at 30 cm from the surface of the ground. (See location "c" on the DARHT Area diagram)

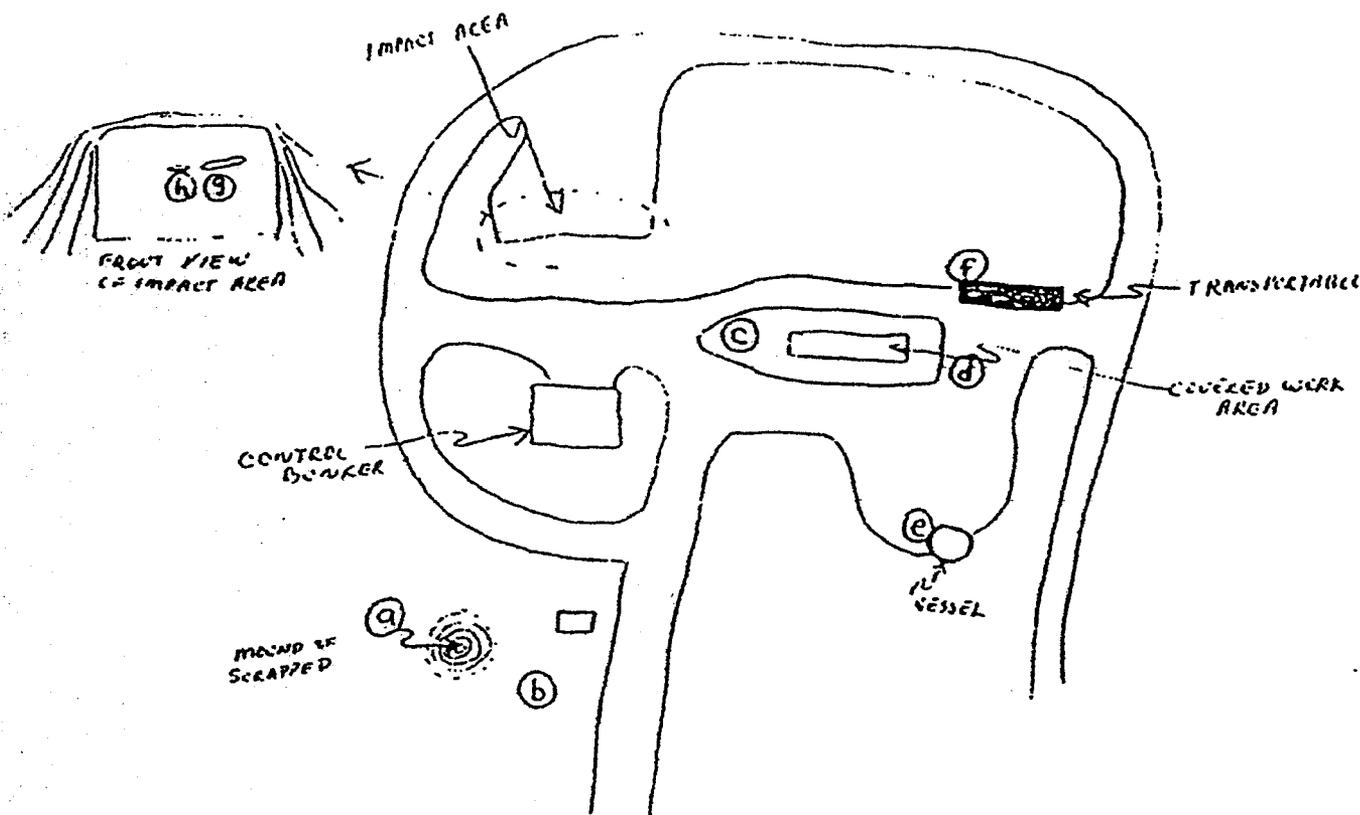
a. Diagram of IJ Site.

(7) The impact hill has two areas of contamination.

(a) Location "g" on the IJ Site diagram:

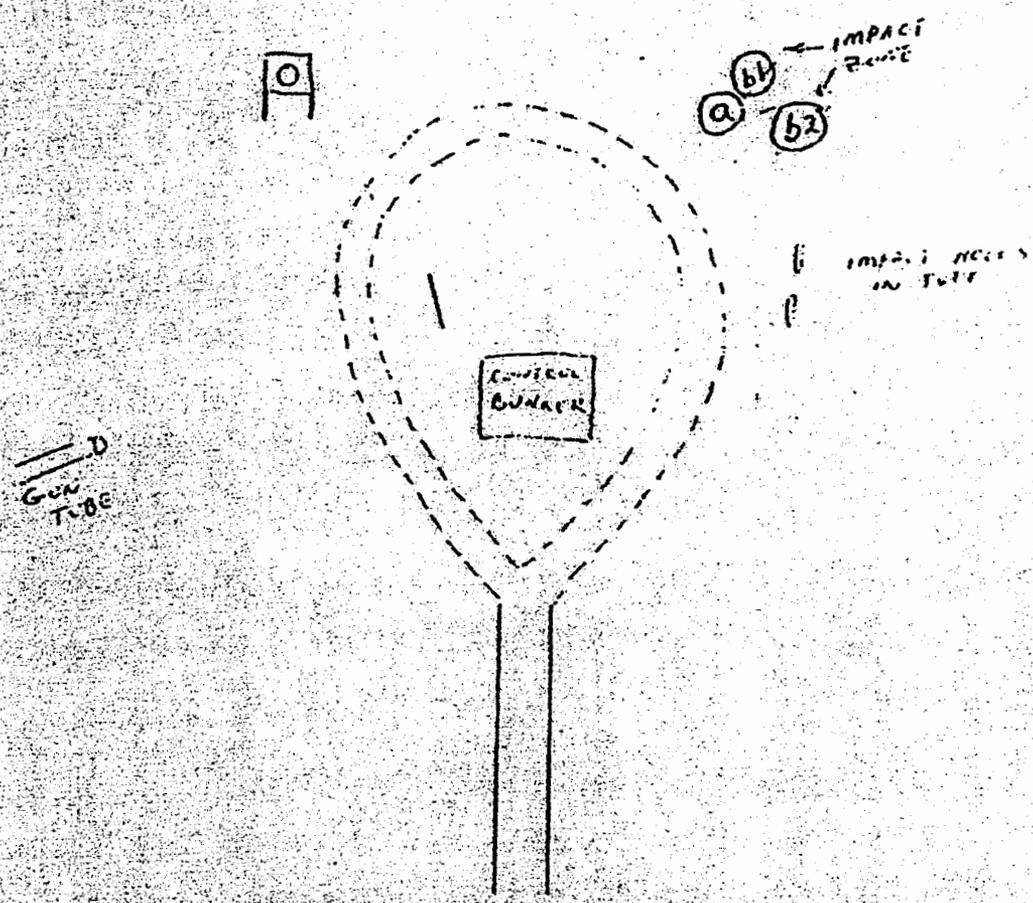
a. Diagram of Meenie Site

(3) There was no other D38 contamination found on site.

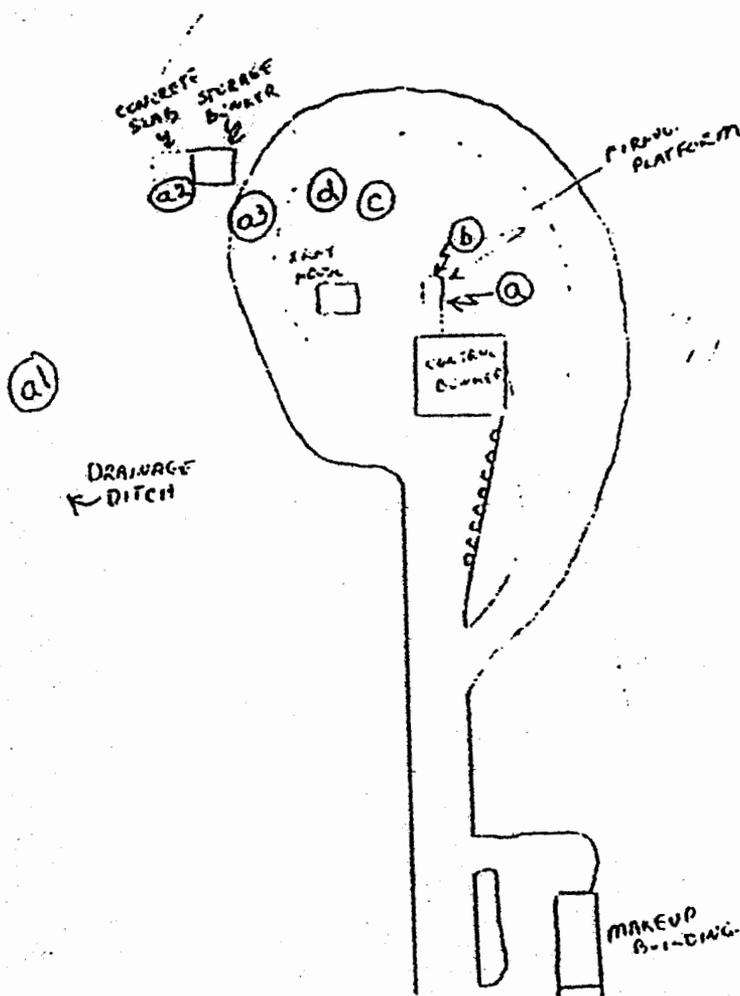
- (3) Diagram of Minie Site during and immediately after.  
(diagram 2)

(a) Same area with elevated radiation measurement as listed above. There were no new areas of contamination noted at this site prior to the firing of the penetrator.

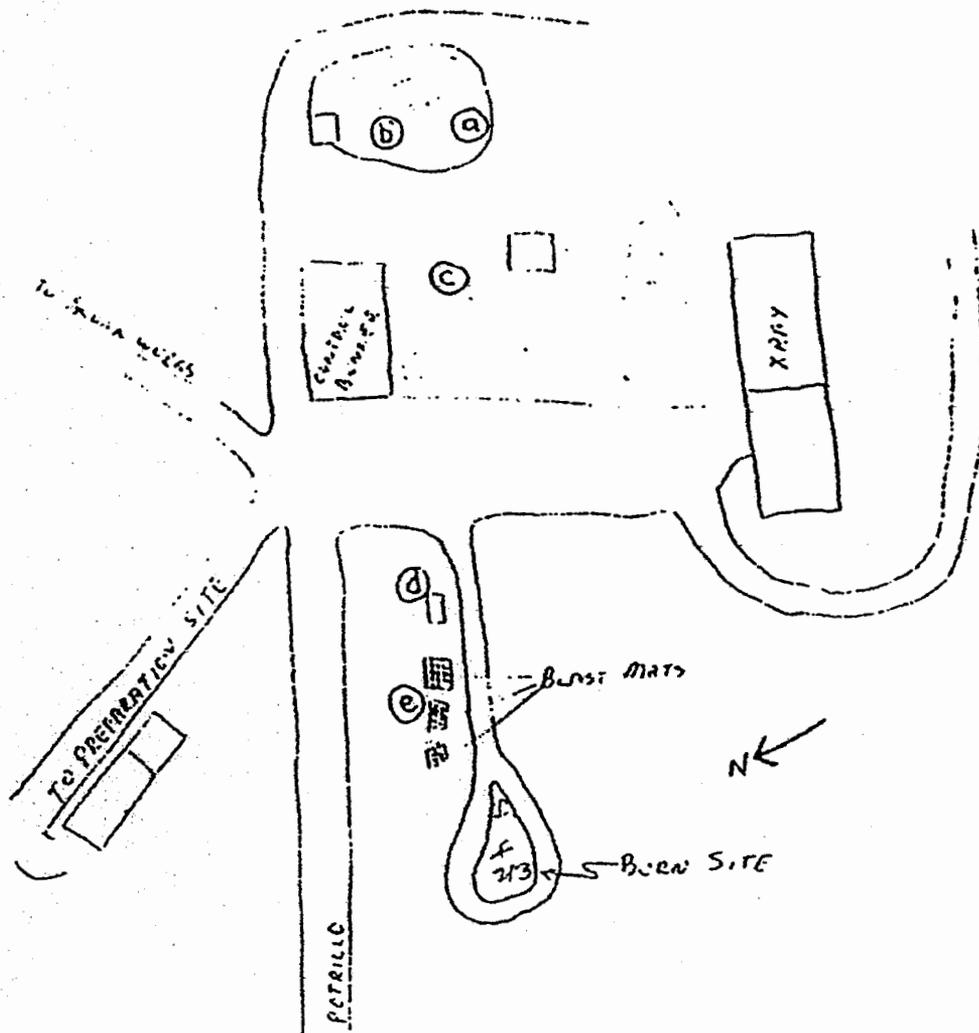
a. Diagram of Lower Slobbovia.

(4) There is a pitted 4 x 8 foot metal plate that is contaminated with D38. This metal plate is located next to the dirt road of the burning site. The radiation measurement at the surface of the metal plate is  $\approx 10,000$  cpm with a 0.5 mR/hr exposure rate. The exposure rate is less than 0.1 mR/hr at 30 cm from the metal plate. (See location "d" on the Lower Slobbovia Site diagram)

(5) The blast mats next to the dirt road of the burning site are contaminated with D38. The highest radiation measurement at the surface of the blast mat is  $\approx 1500$  cpm with a 0.8 mR/hr exposure rate. The exposure rate is less than 0.1 mR/hr at 30 cm from the blast mat. (See location "e" on the Lower Slobbovia Site diagram)

e. Soil Samples. There were three soil samples taken in the burn area, see location "f" on the Lower Slobbovia diagram.
